Bostwick Creek 9 Key Elements Plan

La Crosse County

Department of Land Conservation

September 2018

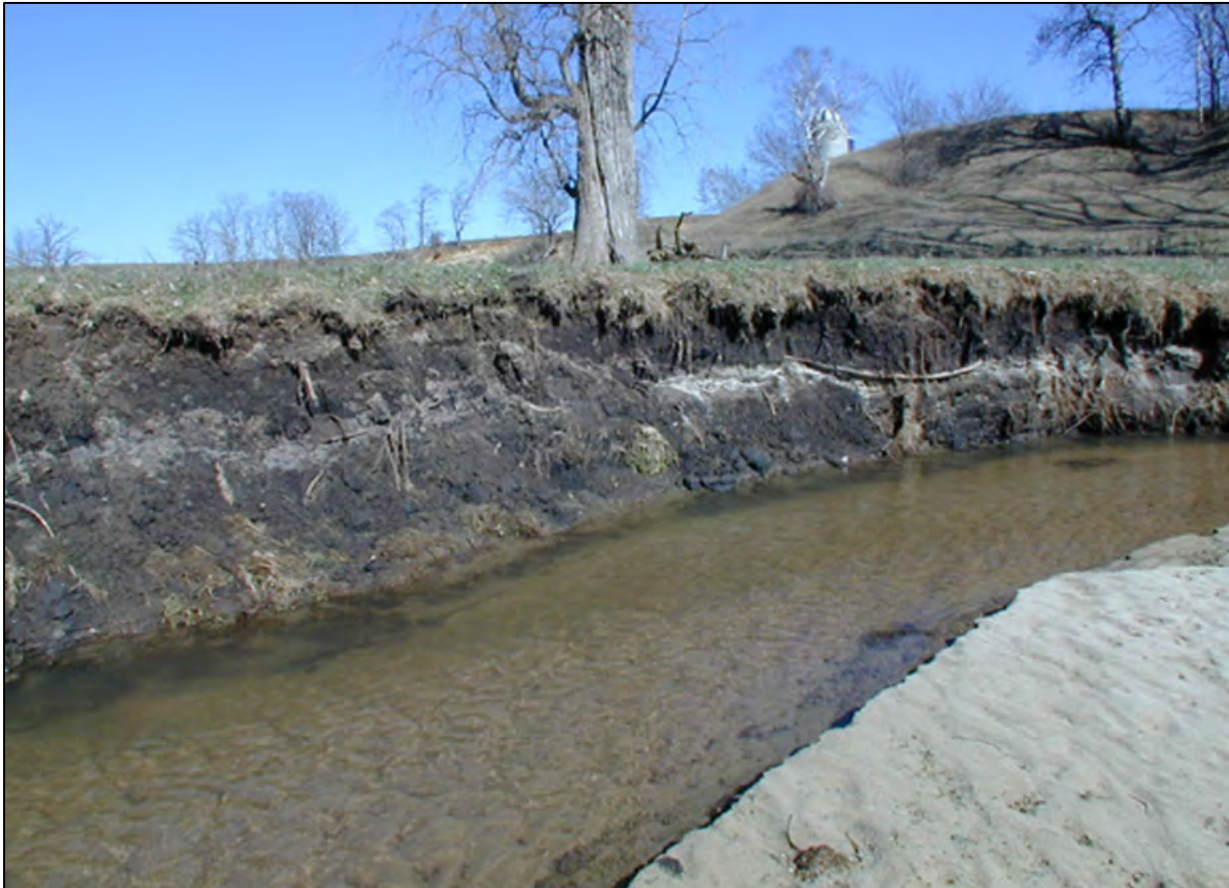
Figure 18 Streambank Erosion Photo

Streambank erosion is a common problem in the Driftless Region of Wisconsin. The steep, incised valley bottoms often contain several feet or more of deposited sediments from upland erosion. These streams meander extensively through these deposits as it flows down gradient. When intense rainfall events occur, the streams quickly swell and the force of the rushing water easily erodes the sediments from the streambanks. The STEPL model estimates that streambank erosion accounts for 8,213 tons of sediment per year and 10,806 pounds of phosphorus per year. The presence of cattle and unmanaged grazing practices along the streambanks also contributes to the acceleration of eroding sites. Eroding streambanks is the primary cause of excessive in-stream sedimentation that degrades fish habitat and other aquatic biota. See Figure 18.

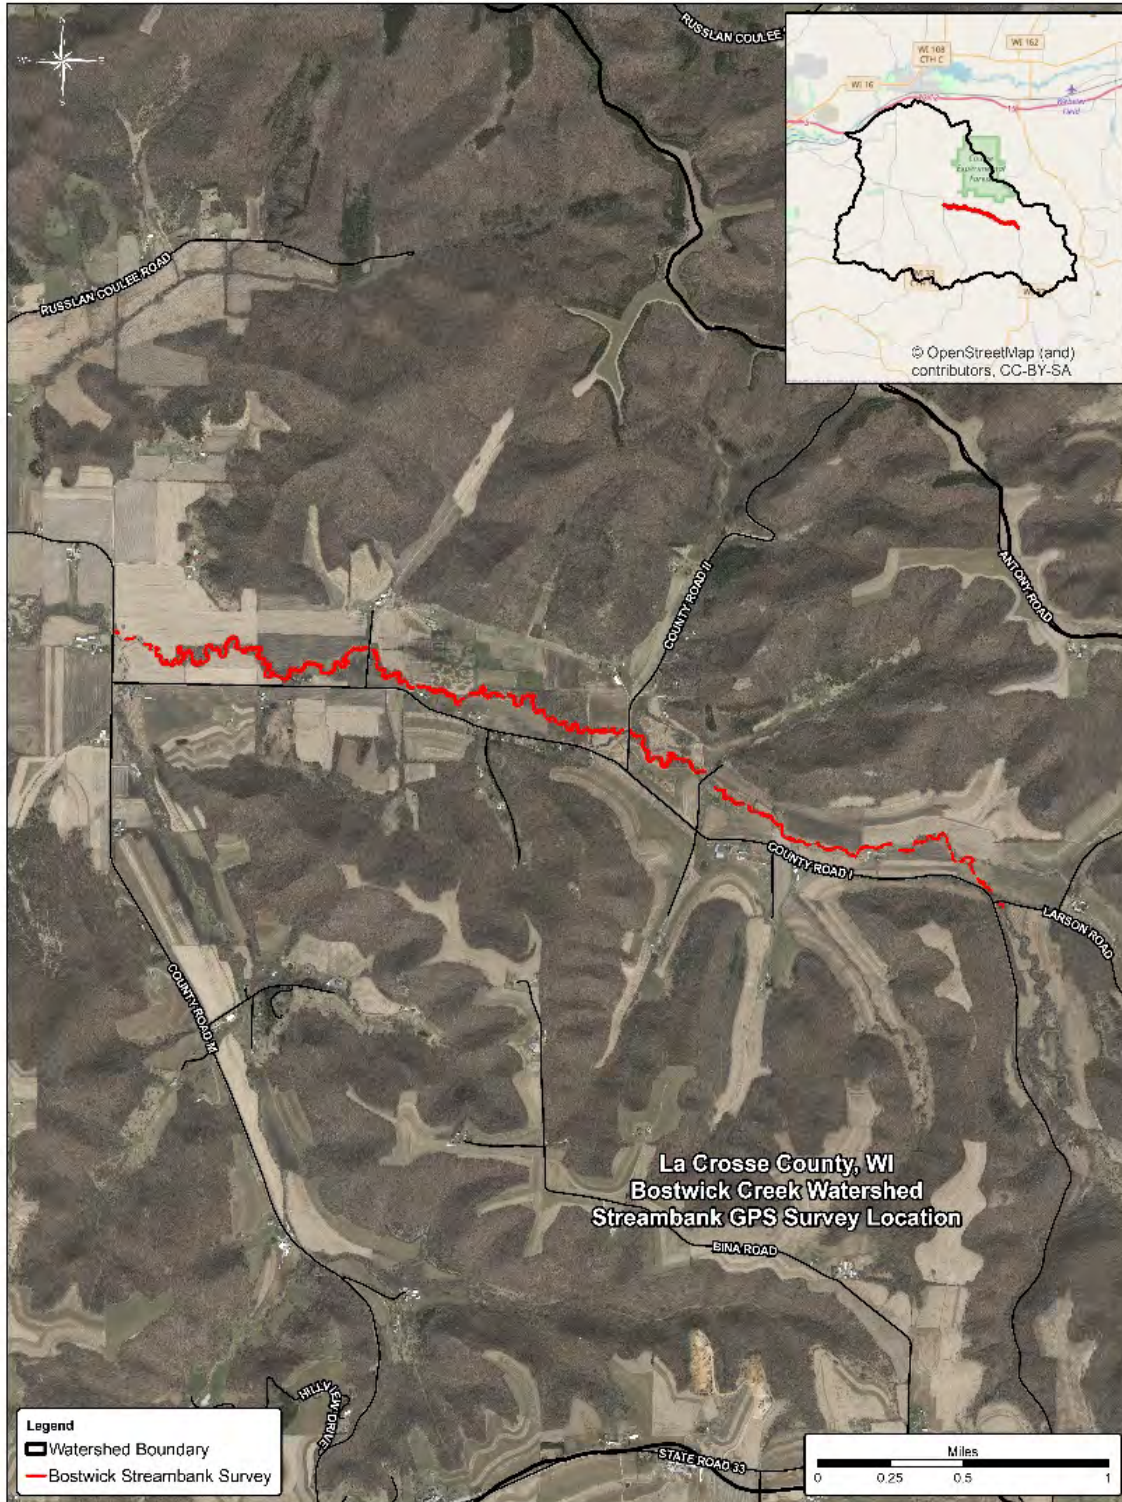
Figure 19 Bostwick Creek Watershed Streambank GPS Survey

In the summer of 2017, the main stem of Bostwick Creek was inventoried to determine the location and extent of streambank erosion. Two Department staff measured each eroded site from Larson Road down to County Highway M. Measurements included the height, length and recession rate of each eroded site. Streambank erosion on tributaries to Bostwick Creek were estimated by rating the size of the tributaries watershed with the inventoried main stem. With the aid of the County's Lidar data, streambank erosion was estimated by comparing the 2008 Lidar flight with the 2017 flight. This provided staff with a fairly accurate prediction of the streambank erosion rates on the tributaries to Bostwick Creek.

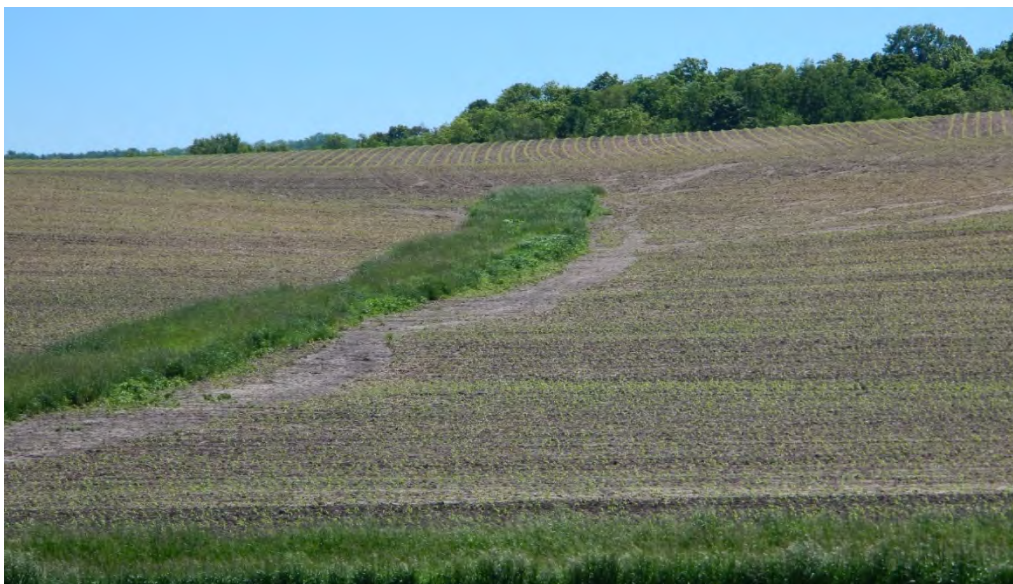
Figure 26 In-field Gully Formation Photo

Gully erosion in the Driftless Region of Wisconsin usually occurs in two forms. One type of gully formation occurs after heavy rainfall or snowmelt events and are referred to as ephemeral gullies. These can be seen in crop fields where erosion control practices failed to provide adequate protection against the erosive forces of a runoff event. These types of gullies often cause sedimentation to occur at field edges and road ditches. Often times this sediment is carried to nearby streams and degrades water quality. These gullies are typically repaired by the farm operator after crops have been harvested and may not reappear for years. See Figure 26

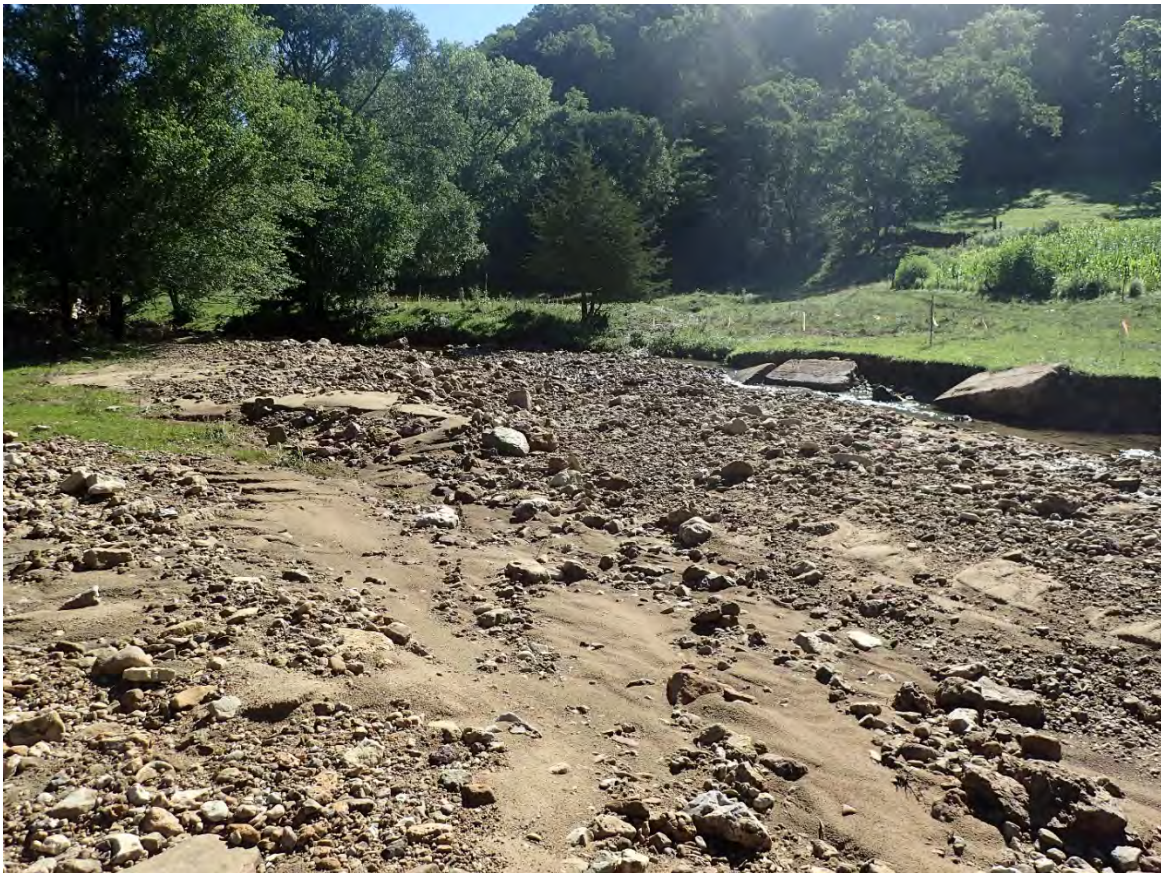
Figure 27 Dry Run Gully Deposits Photo

Under normal runoff events, these gullies are not considered to be active but rather serve as a conveyance system for runoff water from the uplands to the valley bottoms below. Under extreme runoff events, such as those that occurred in 2007, 2008 and 2017, these dry run gullies become raging torrents of water capable of transporting large boulders, rock and rubble downslope. These events can result in the littering of crop fields and stream beds with rock and rubble that have permanently redirected stream channels. See Figure 27

Dry run gullies are numerous throughout the watershed and their contribution to sediment loading under normal runoff events is questionable. During extreme runoff events, these gullies transport material at rates that exceed soil loss calculation models. Utilization of conservation practices on ridge top crop fields that promote infiltration and slows runoff rates are important to reducing the downslope impacts from dry run gullies.

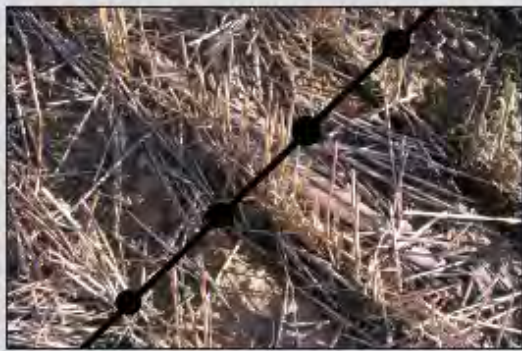
Illustration of line-transect method for residue.

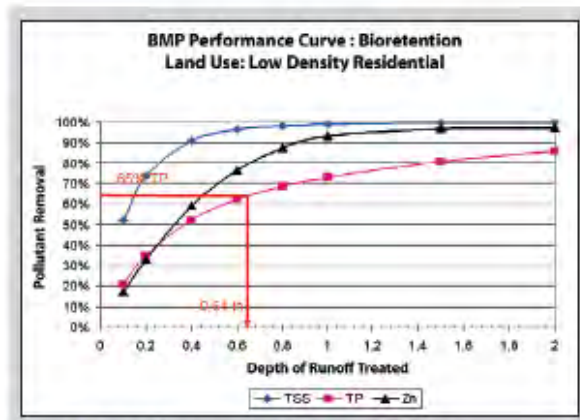
Figure 1. BMP Performance Curve for Bioretention BMP (Tetra Tech 2010).

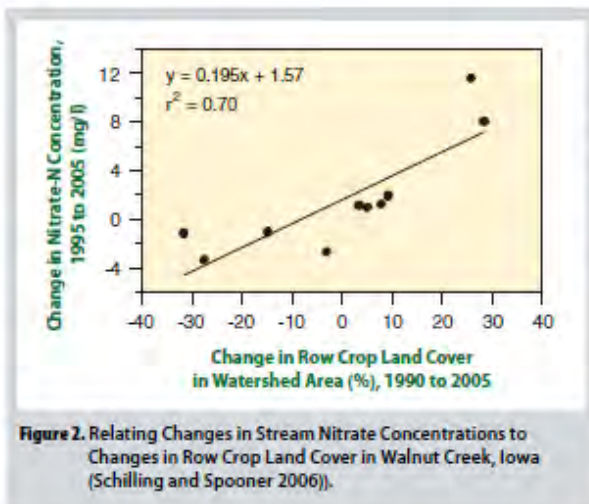
Figure 2. Relating Changes in Stream Nitrate Concentrations to Changes in Row Crop Land Cover in Walnut Creek, Iowa (Schilling and Spooner 2006).
