Kangaroo Lake

Door County, Wisconsin

Comprehensive Management Plan Update

December 2018

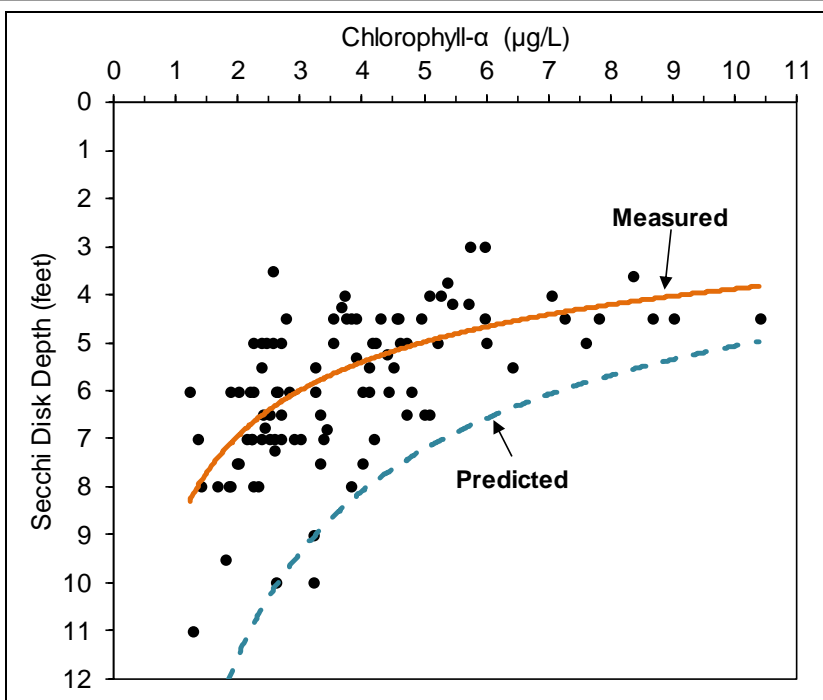
Figure 3.1-7. Kangaroo Lake measured relationship between chlorophyll and Secchi disk depth (orange solid line) and predicted Secchi disk depth based on measured chlorophyll (dashed blue line). Secchi disk depth lower than predicted based on measured chlorophyll due to wind-driven sediment resuspension which reduces water clarity. Predicted Secchi disk depth calculated using predictive equations from Carlson 1977. Data displayed were collected from 1993-2017.

Lake align with predicted concentrations based on total phosphorus, measured summer Secchi disk transparency is approximately 3.0 feet lower than predicted based upon measured chlorophyll-*a*. This is an indication that another factor(s) apart from phytoplankton abundance is affecting water clarity in Kangaroo Lake.

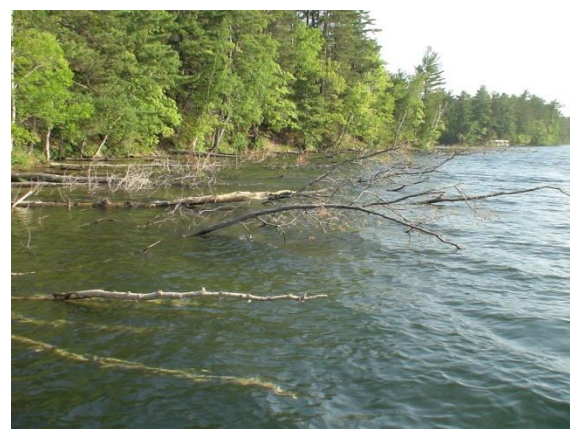
Photograph 3.3-1. Example of coarse woody habitat in a lake.

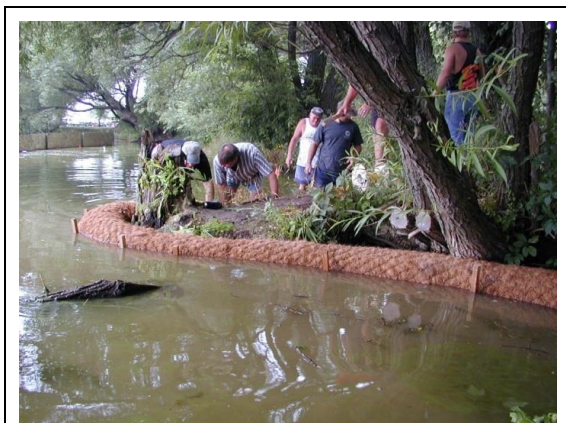
Photograph 3.3-2. Example of a bio-log restoration site.

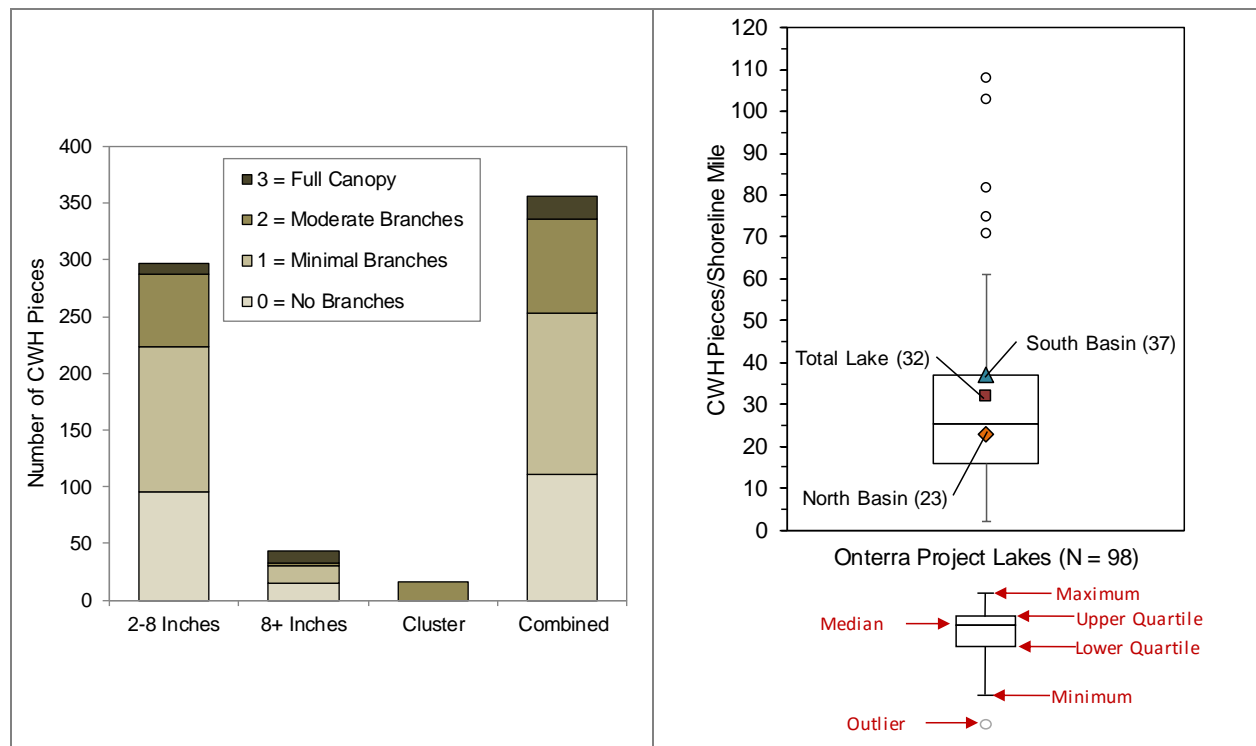
Figure 3.3-3. Kangaroo Lake coarse woody habitat (CWH) size and branching categories (left) and box plot of the ratio of CWH pieces per shoreline mile relative to 98 lakes surveyed by Onterra in Wisconsin since 2012.

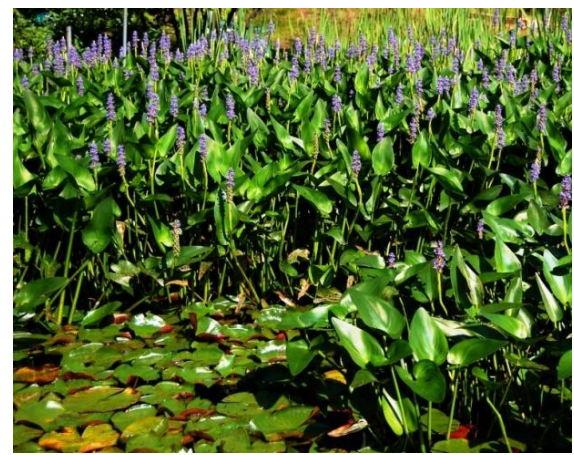
Photograph 3.4-1. Example of emergent and floating-leaf communities.

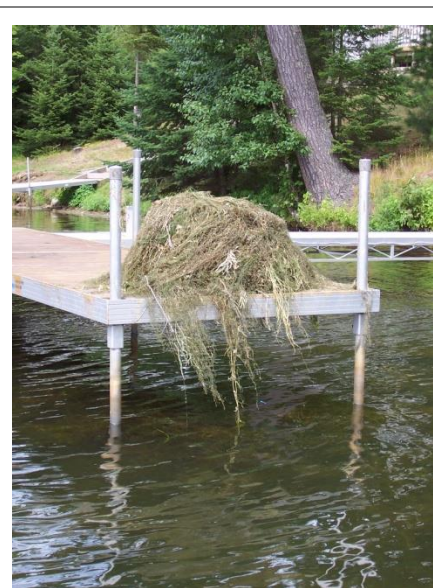
Photograph 3.4-2. Example of aquatic plants that have been removed manually.

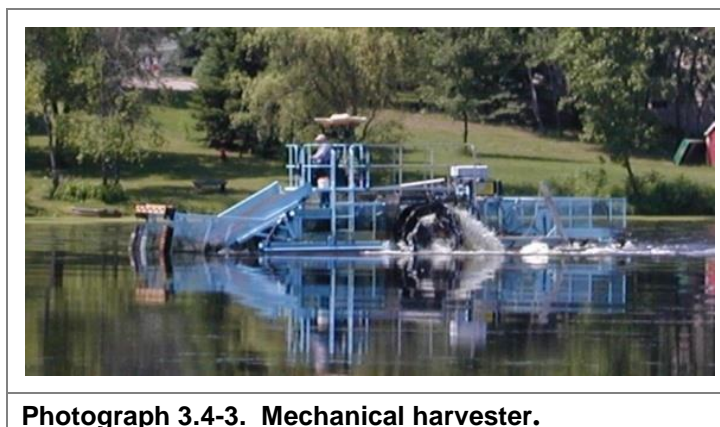
Photograph 3.4-3. Mechanical harvester.

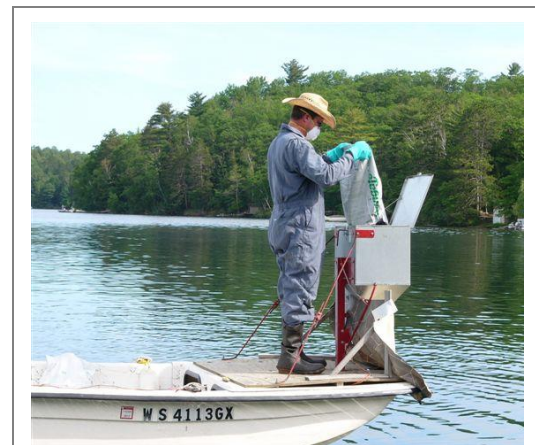
Photograph 3.4-4. Granular herbicide application.

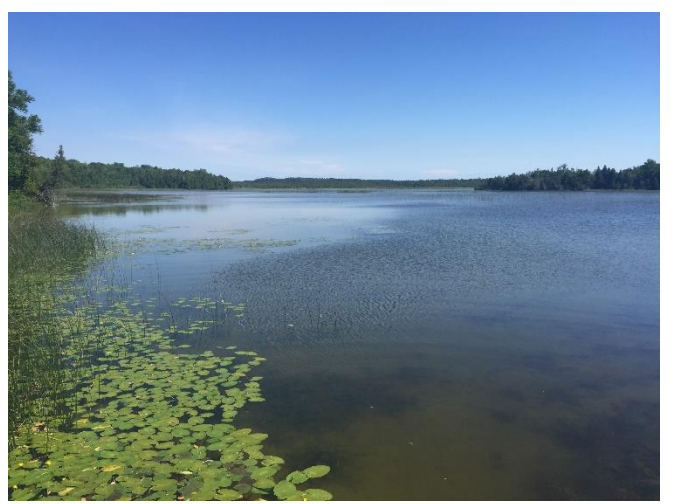
Photo 3.4-5. Floating-leaf and emergent aquatic plant communities in the north basin of Kangaroo Lake. Photo credit Onterra, 2016.

Four surveys aimed at assessing the aquatic plant communities (Photograph 3.4-5) within both the north and south basins of Kangaroo Lake were completed in 2016. During these surveys, a total of 28 aquatic plant species were located (Table 3.4-1). These include 12 emergent and floating-leaf species and 16 submergent species. Of the 28 species located, only one was a non-native, invasive species: Eurasian watermilfoil. Because of its ecological, sociological, and economical significance, the population of Eurasian watermilfoil in Kangaroo Lake is discussed in detail in the subsequent Non-Native Aquatic Plant Subsection. While Door County contains large populations of the non-native grass *Phragmites*, the north basin of Kangaroo Lake was found to contain a population of the native subspecies (subsp. *americanus*). No plants of the non-native subspecies (subsp. *australis*) were located in 2016.

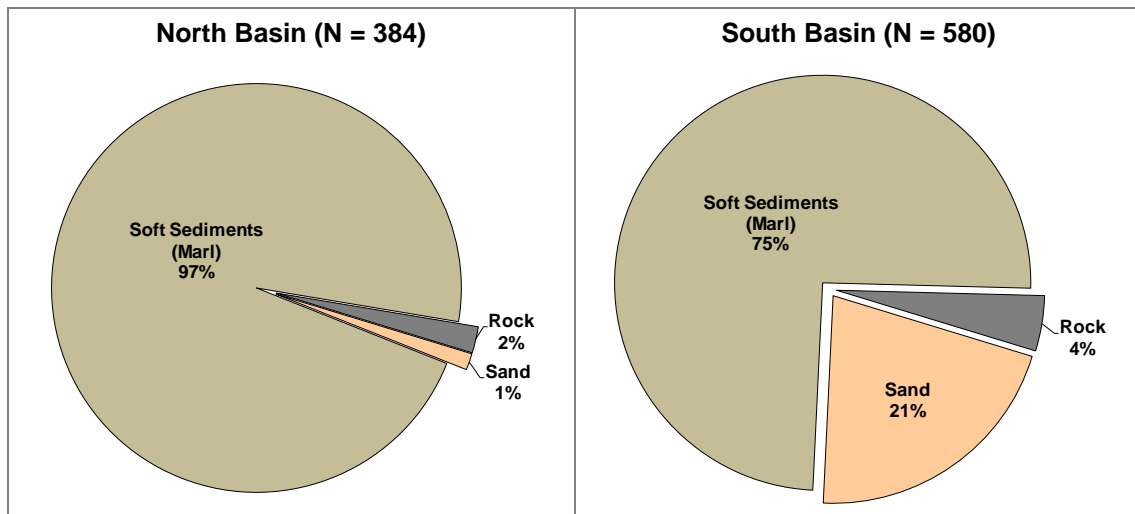
Figure 3.4-4. Kangaroo Lake proportion of substrate types. Created using data from 2016 whole-lake point-intercept surveys.

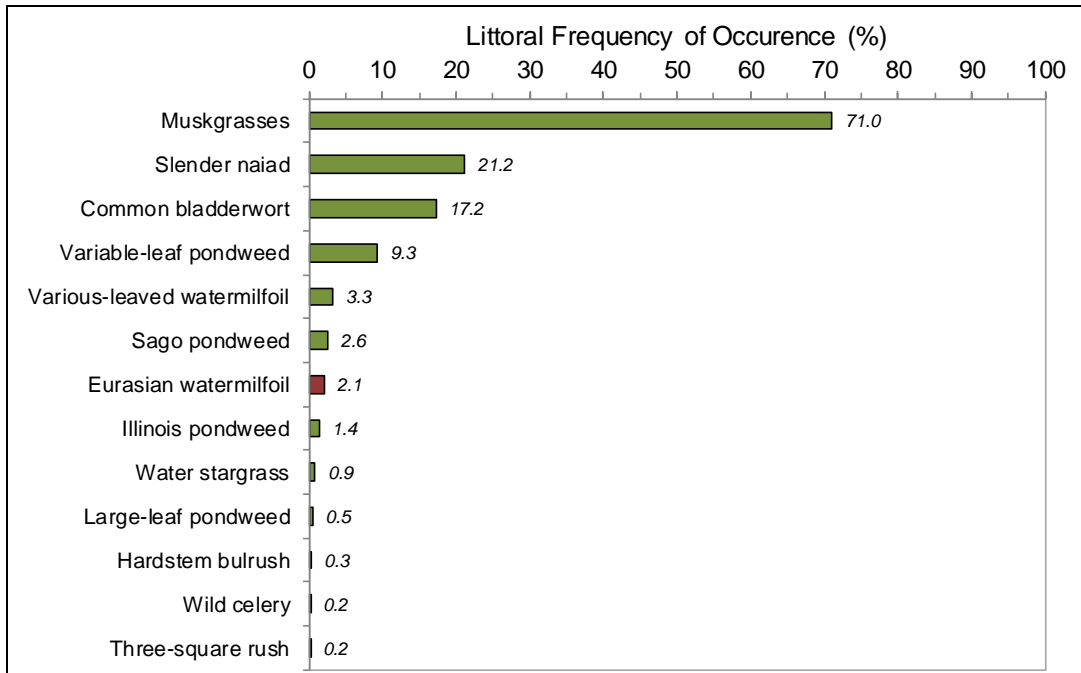
Figure 3.4-6. Littoral frequency of aquatic plant species in the south basin of Kangaroo Lake. Created using data from 2016 whole-lake point-intercept survey. Exotic species indicated with red.

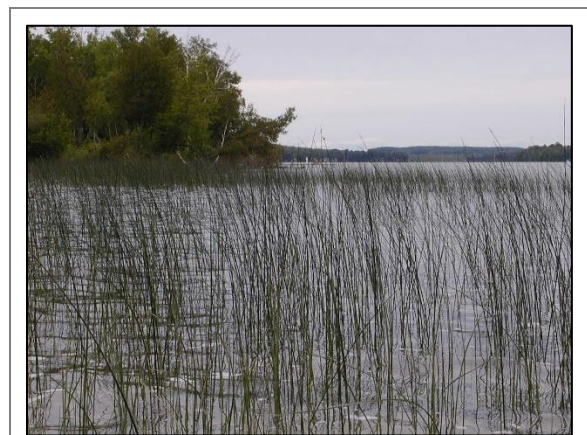
Photo 3.4-7. Hardstem bulrush (*Schoenoplectus acutus*) community in the south basin of Kangaroo Lake. Photo credit Onterra.

While the north basin supports a large community of emergent and floating-leaf aquatic plants, information provided by long-term lake residents indicate that the south basin once supported a larger population of emergent plant communities primarily comprised of hardstem bulrush (*Schoenoplectus acutus*; Photo 3.4-7). Hardstem bulrush, one of Wisconsin’s largest sedges, is found growing along wet shorelines and in standing water of up to 8.0 feet. Hardstem bulrush is most often found growing over harder substrates, but can also be found growing in marl or peat. Historical locations of hardstem bulrush populations within the south basin provided by Kangaroo Lake residents indicate there was potentially up to 175 acres of these communities in the early to mid-20th century. In 2016, approximately 13 acres of emergent communities containing at least some hardstem bulrush were delineated, representing a 93% decrease in acreage from historical levels (Map 9).

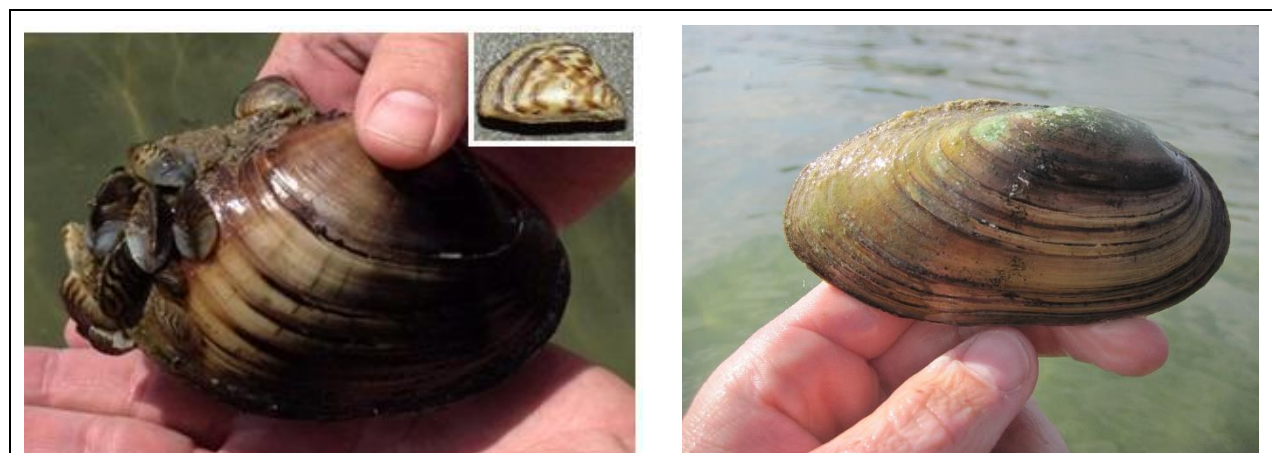
Photo 3.5-1. Left: Non-native zebra mussels (*Dreissena polymorpha*) attached to a native plain pocketbook mussel (*Lampsilis cardium*). Right: Native giant floater mussel (*Pyganodon grandis*) found in Kangaroo Lake. Photo credit Onterra.

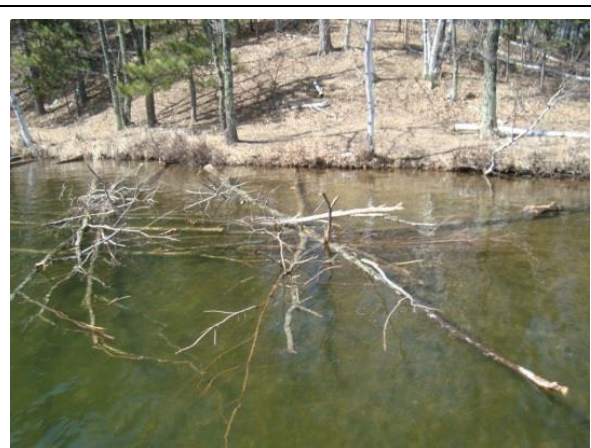
Photo 3.6-3. Fish Stick Example. (Photo courtesy of WDNR 2013).

Kangaroo Lake is an excellent candidate to install coarse woody habitat and the KLA, with the help of volunteers, has already taken advantage of the fish sticks program. During 2015, 2016 and 2017 14, 30 and 33 trees, respectively, were dropped for the fish sticks project.
