Comprehensive Lake Management Plan for Big Bearskin Lake, Oneida County, Wisconsin

April 2000

Prepared for
Big Bearskin Lake Association
Harshaw, WI

Prepared by
Steve McComas
Blue Water Science
550 South Snelling Ave
St. Paul, MN 55116
651.690.9602

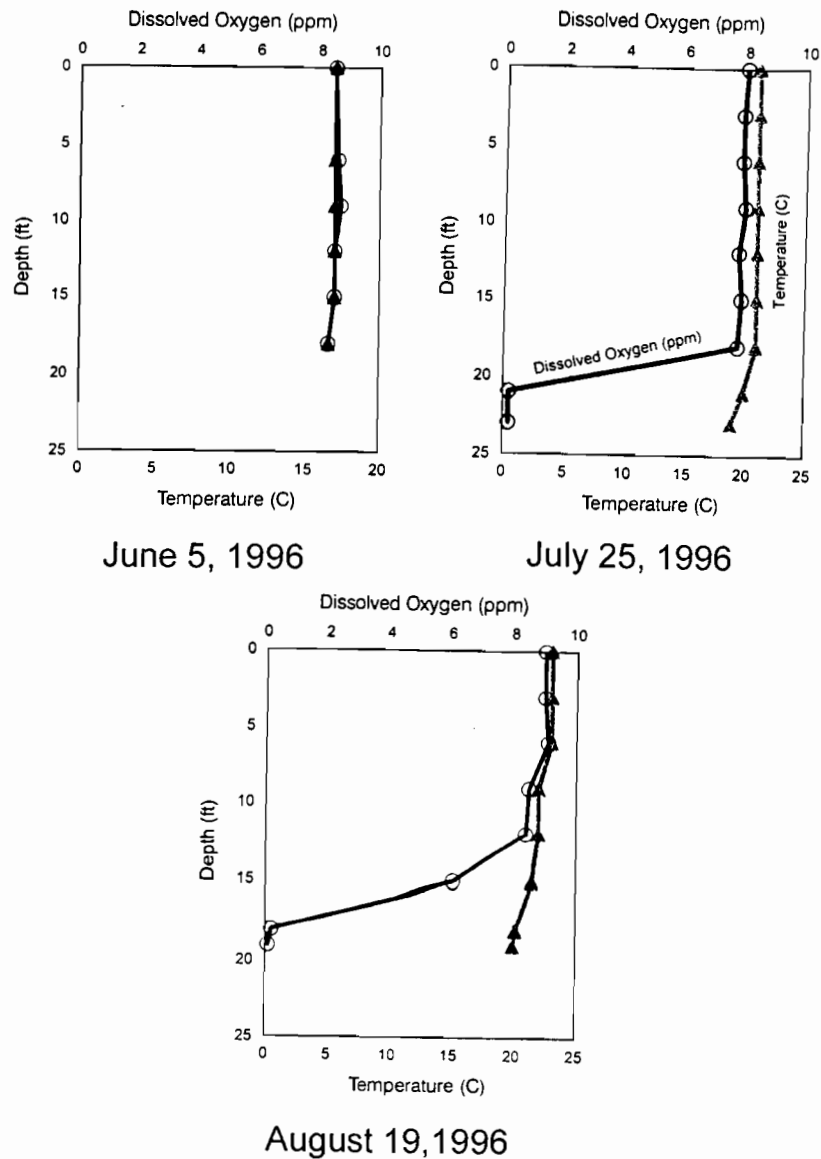
Figure 6. Dissolved oxygen/temperature profiles for the summer of 1996 for Big Bearskin Lake.

The June 5 profile indicates that the lake is well mixed throughout the water column. By July 25, there was a steep decline in oxygen from 18 to 21 feet in the thermocline. Below 21 feet (in the hypolimnion), the water was devoid of oxygen. Most fish species have trouble tolerating oxygen concentrations less than about 4 ppm, so anglers are advised not to drop a line much lower than 20 ft in mid to late summer. The August 19 profile was quite similar to the July profile. The only slight difference was that the decline in oxygen concentrations in the metalimnion was slightly more rapid.
