# Wetland Delineation Report

**Tumbledown Trail Golf Club**

**Town of Middleton  
Dane County, Wisconsin**

**raSmith Project No. 1180370**

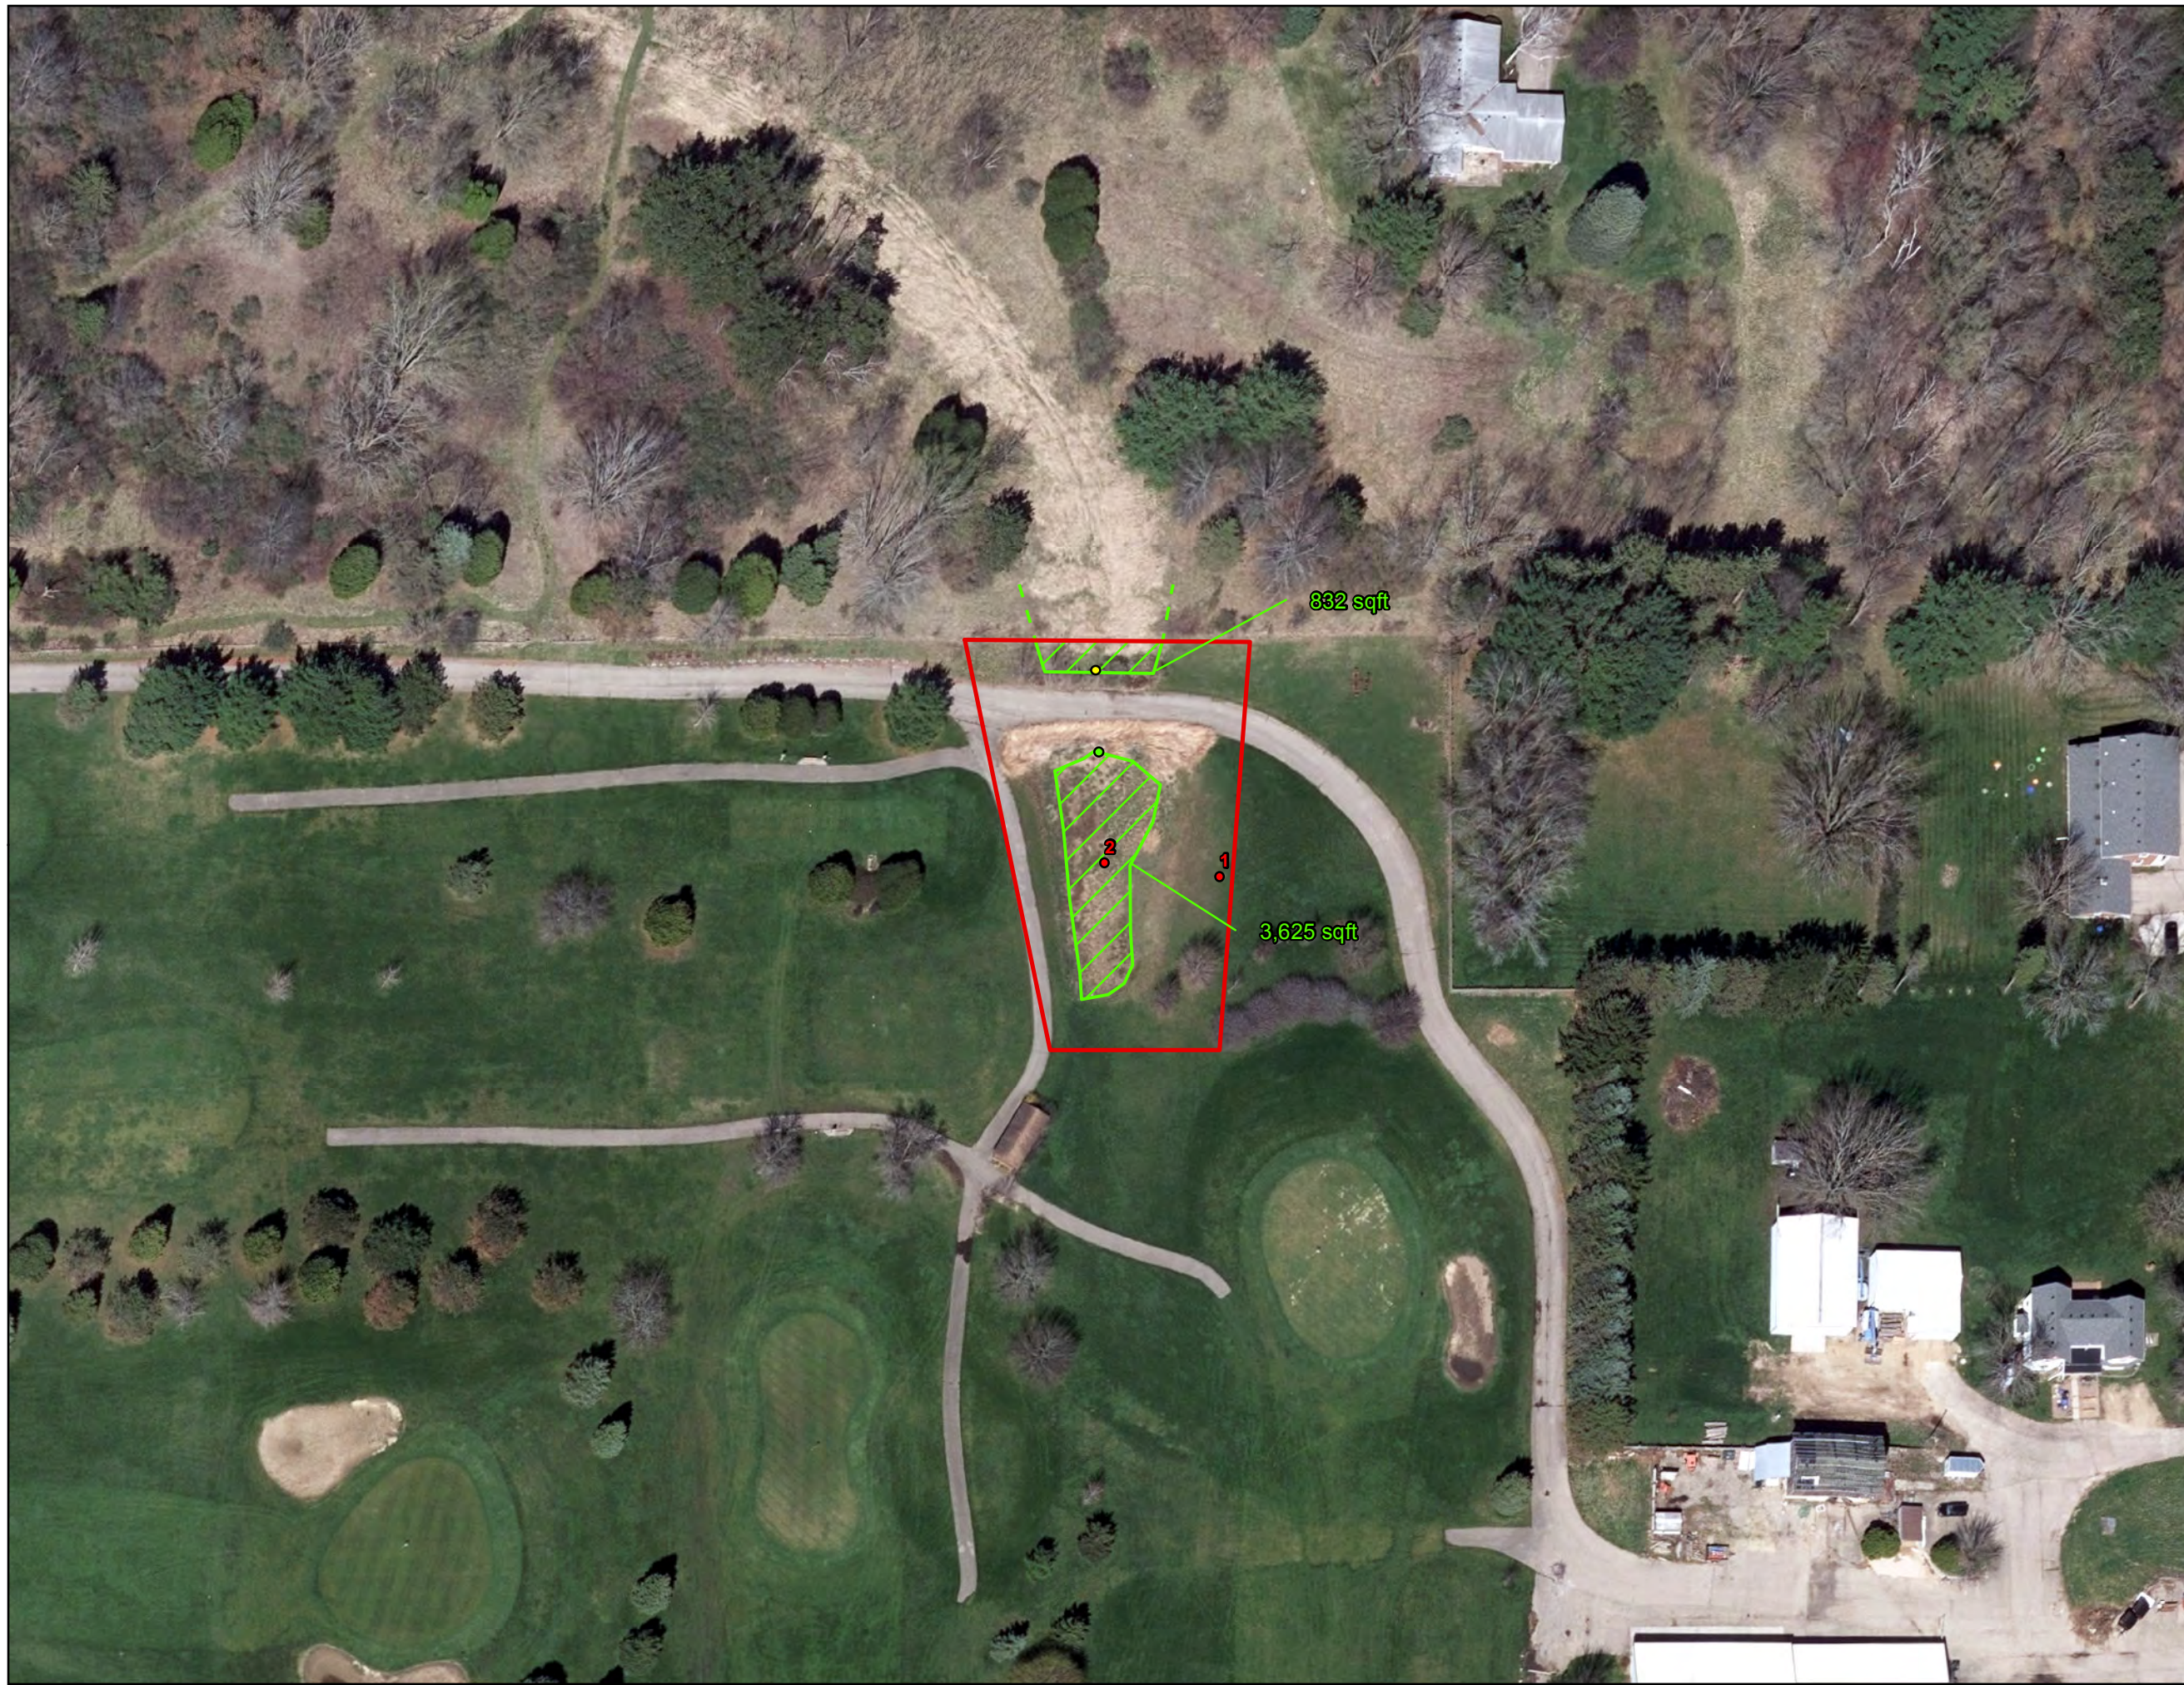
Figure 2  
Wetland Boundary  
Map

The delineated wetland is a 4,457 ft<sup>2</sup> frequently flooded basin and swale. One sampling point (Point 2) was examined within the wetland. The wetland is not mapped by the NWI.

Based on the wetland delineation completed by raSmith, one wetland feature was identified within the Study Area: a frequently flooded basin and swale (4,457 ft<sup>2</sup>).

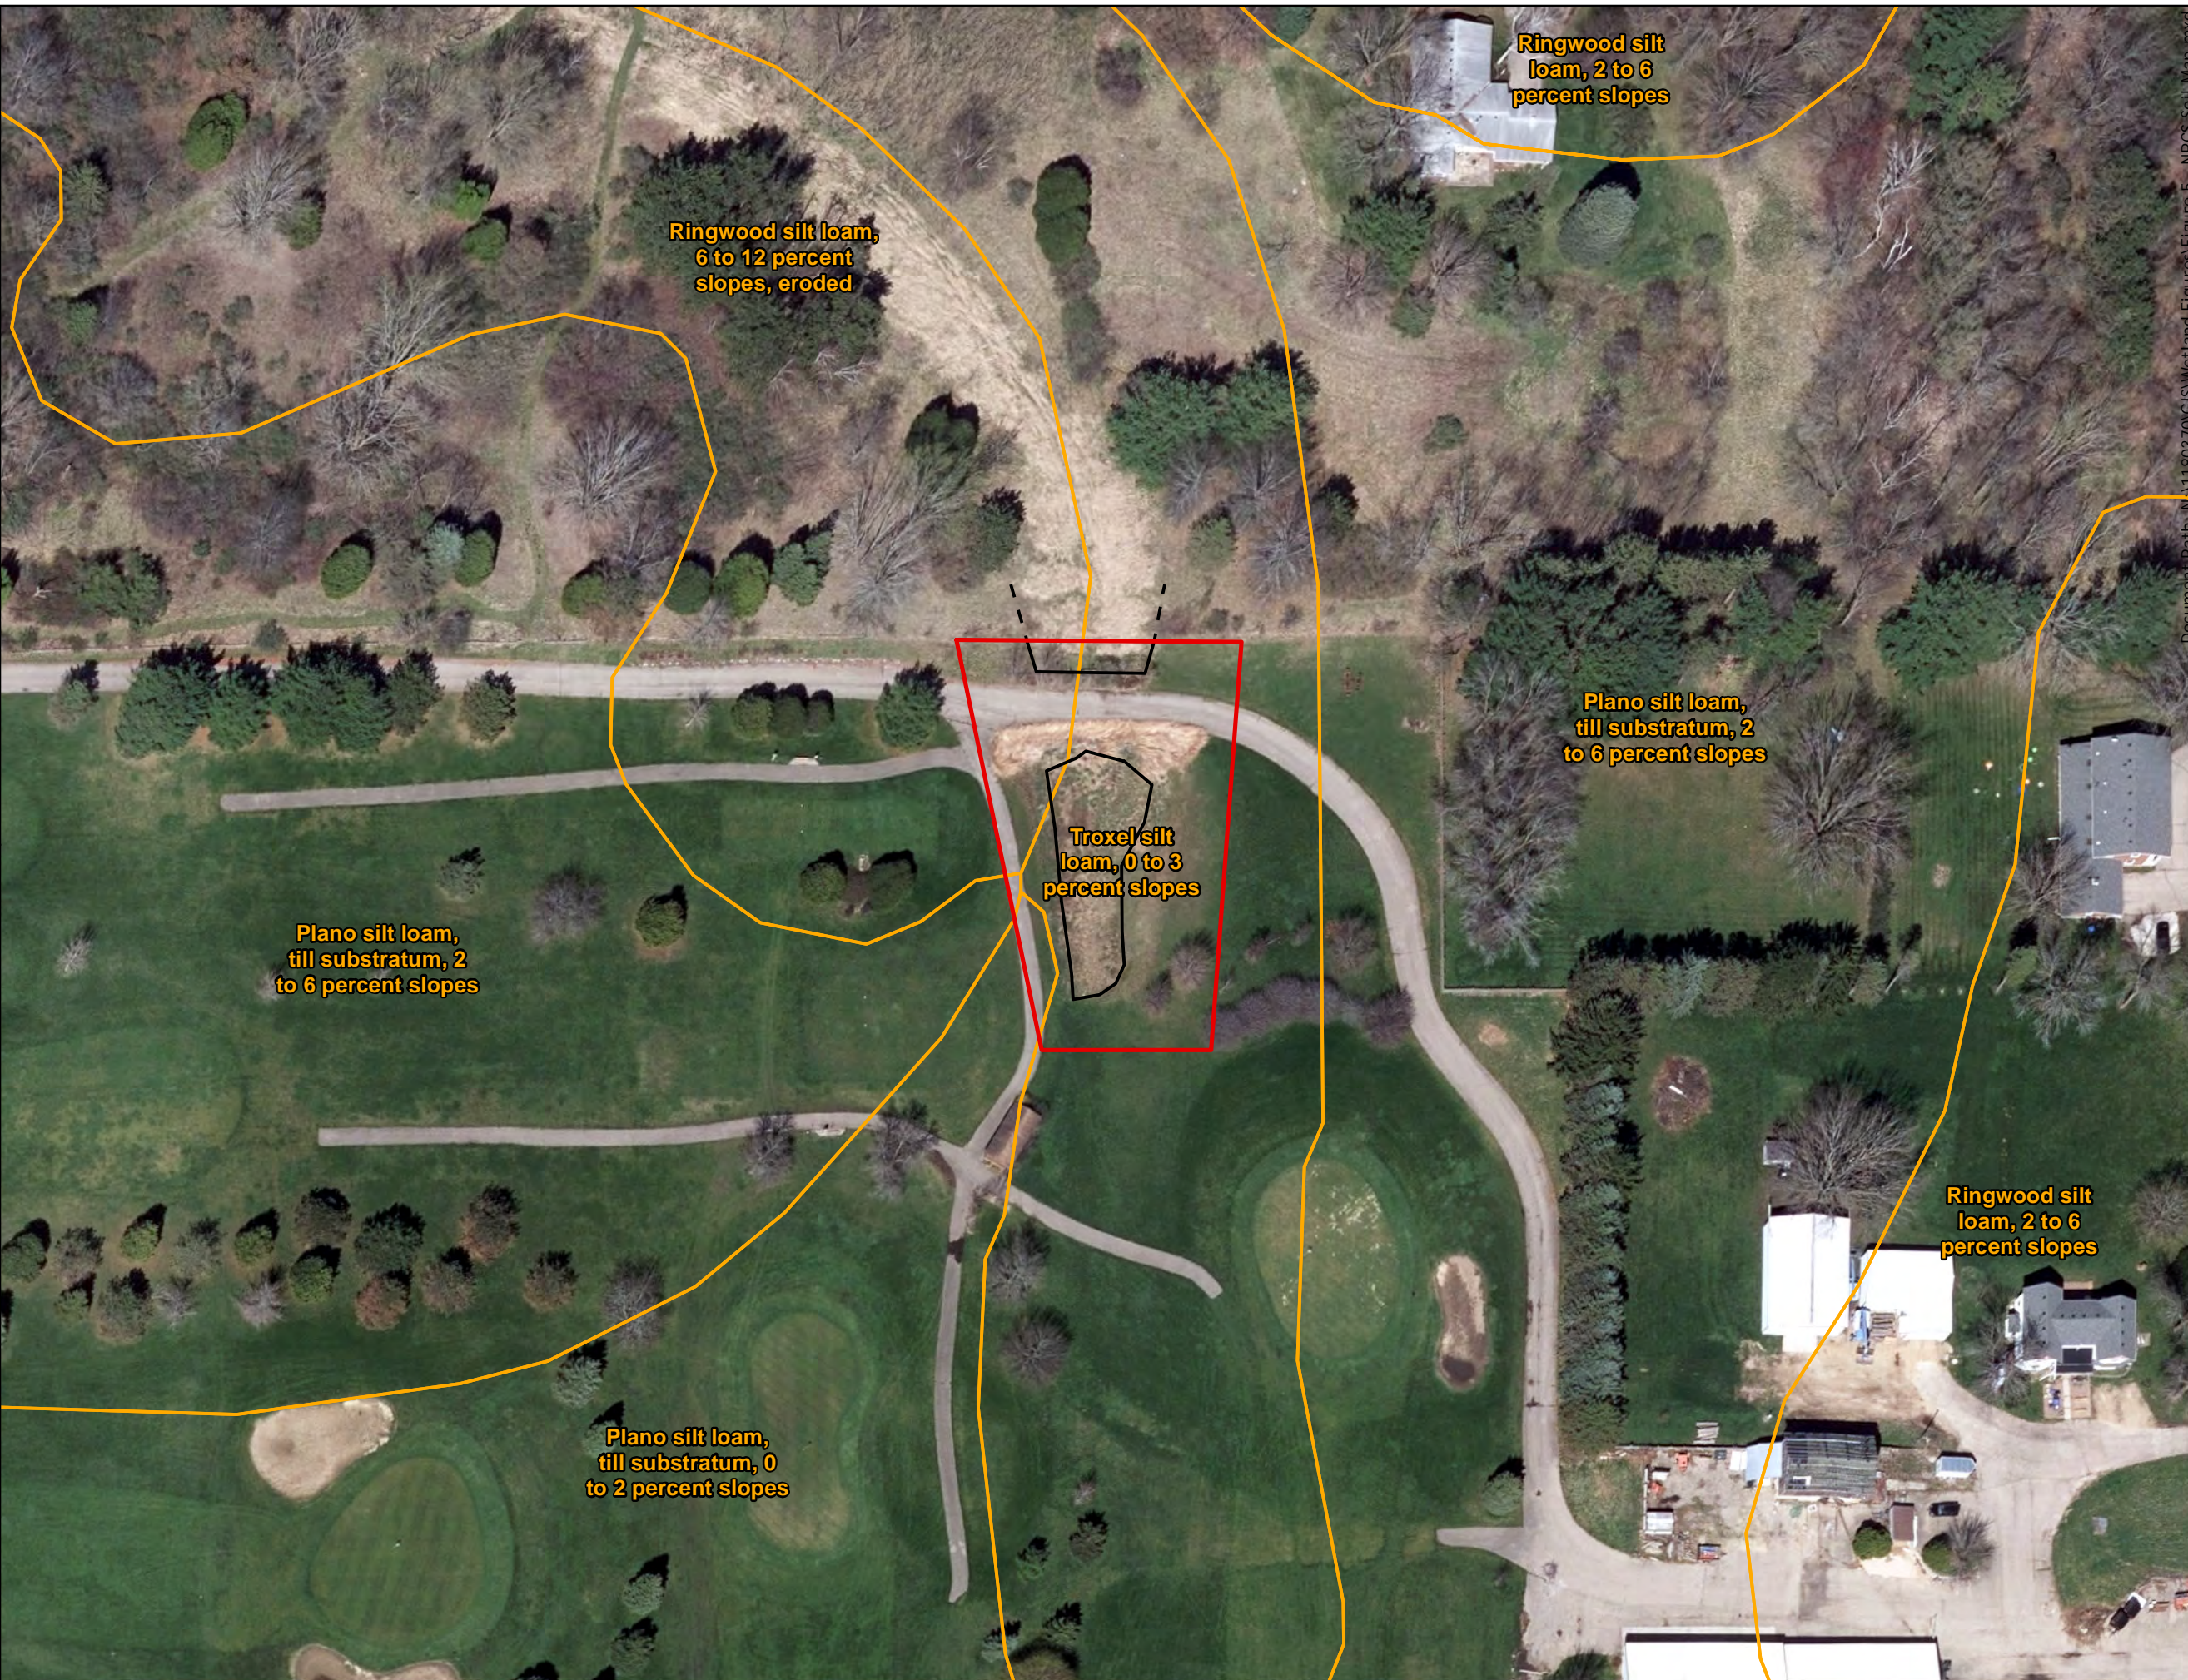
Figure 5  
 NRCS Soil Map

The NRCS soil map shows four mapped soil types within the Study Area: Plano silt loam, till substratum, 2-6% slopes (non-hydric), Plano silt loam, till substratum, 0-2% slopes (non-hydric), Ringwood silt loam, 6-12% slopes, eroded (non-hydric), and Troxel silt loam, 0-3% slopes (non-hydric). None of the mapped soils are considered wetland indicator soils.

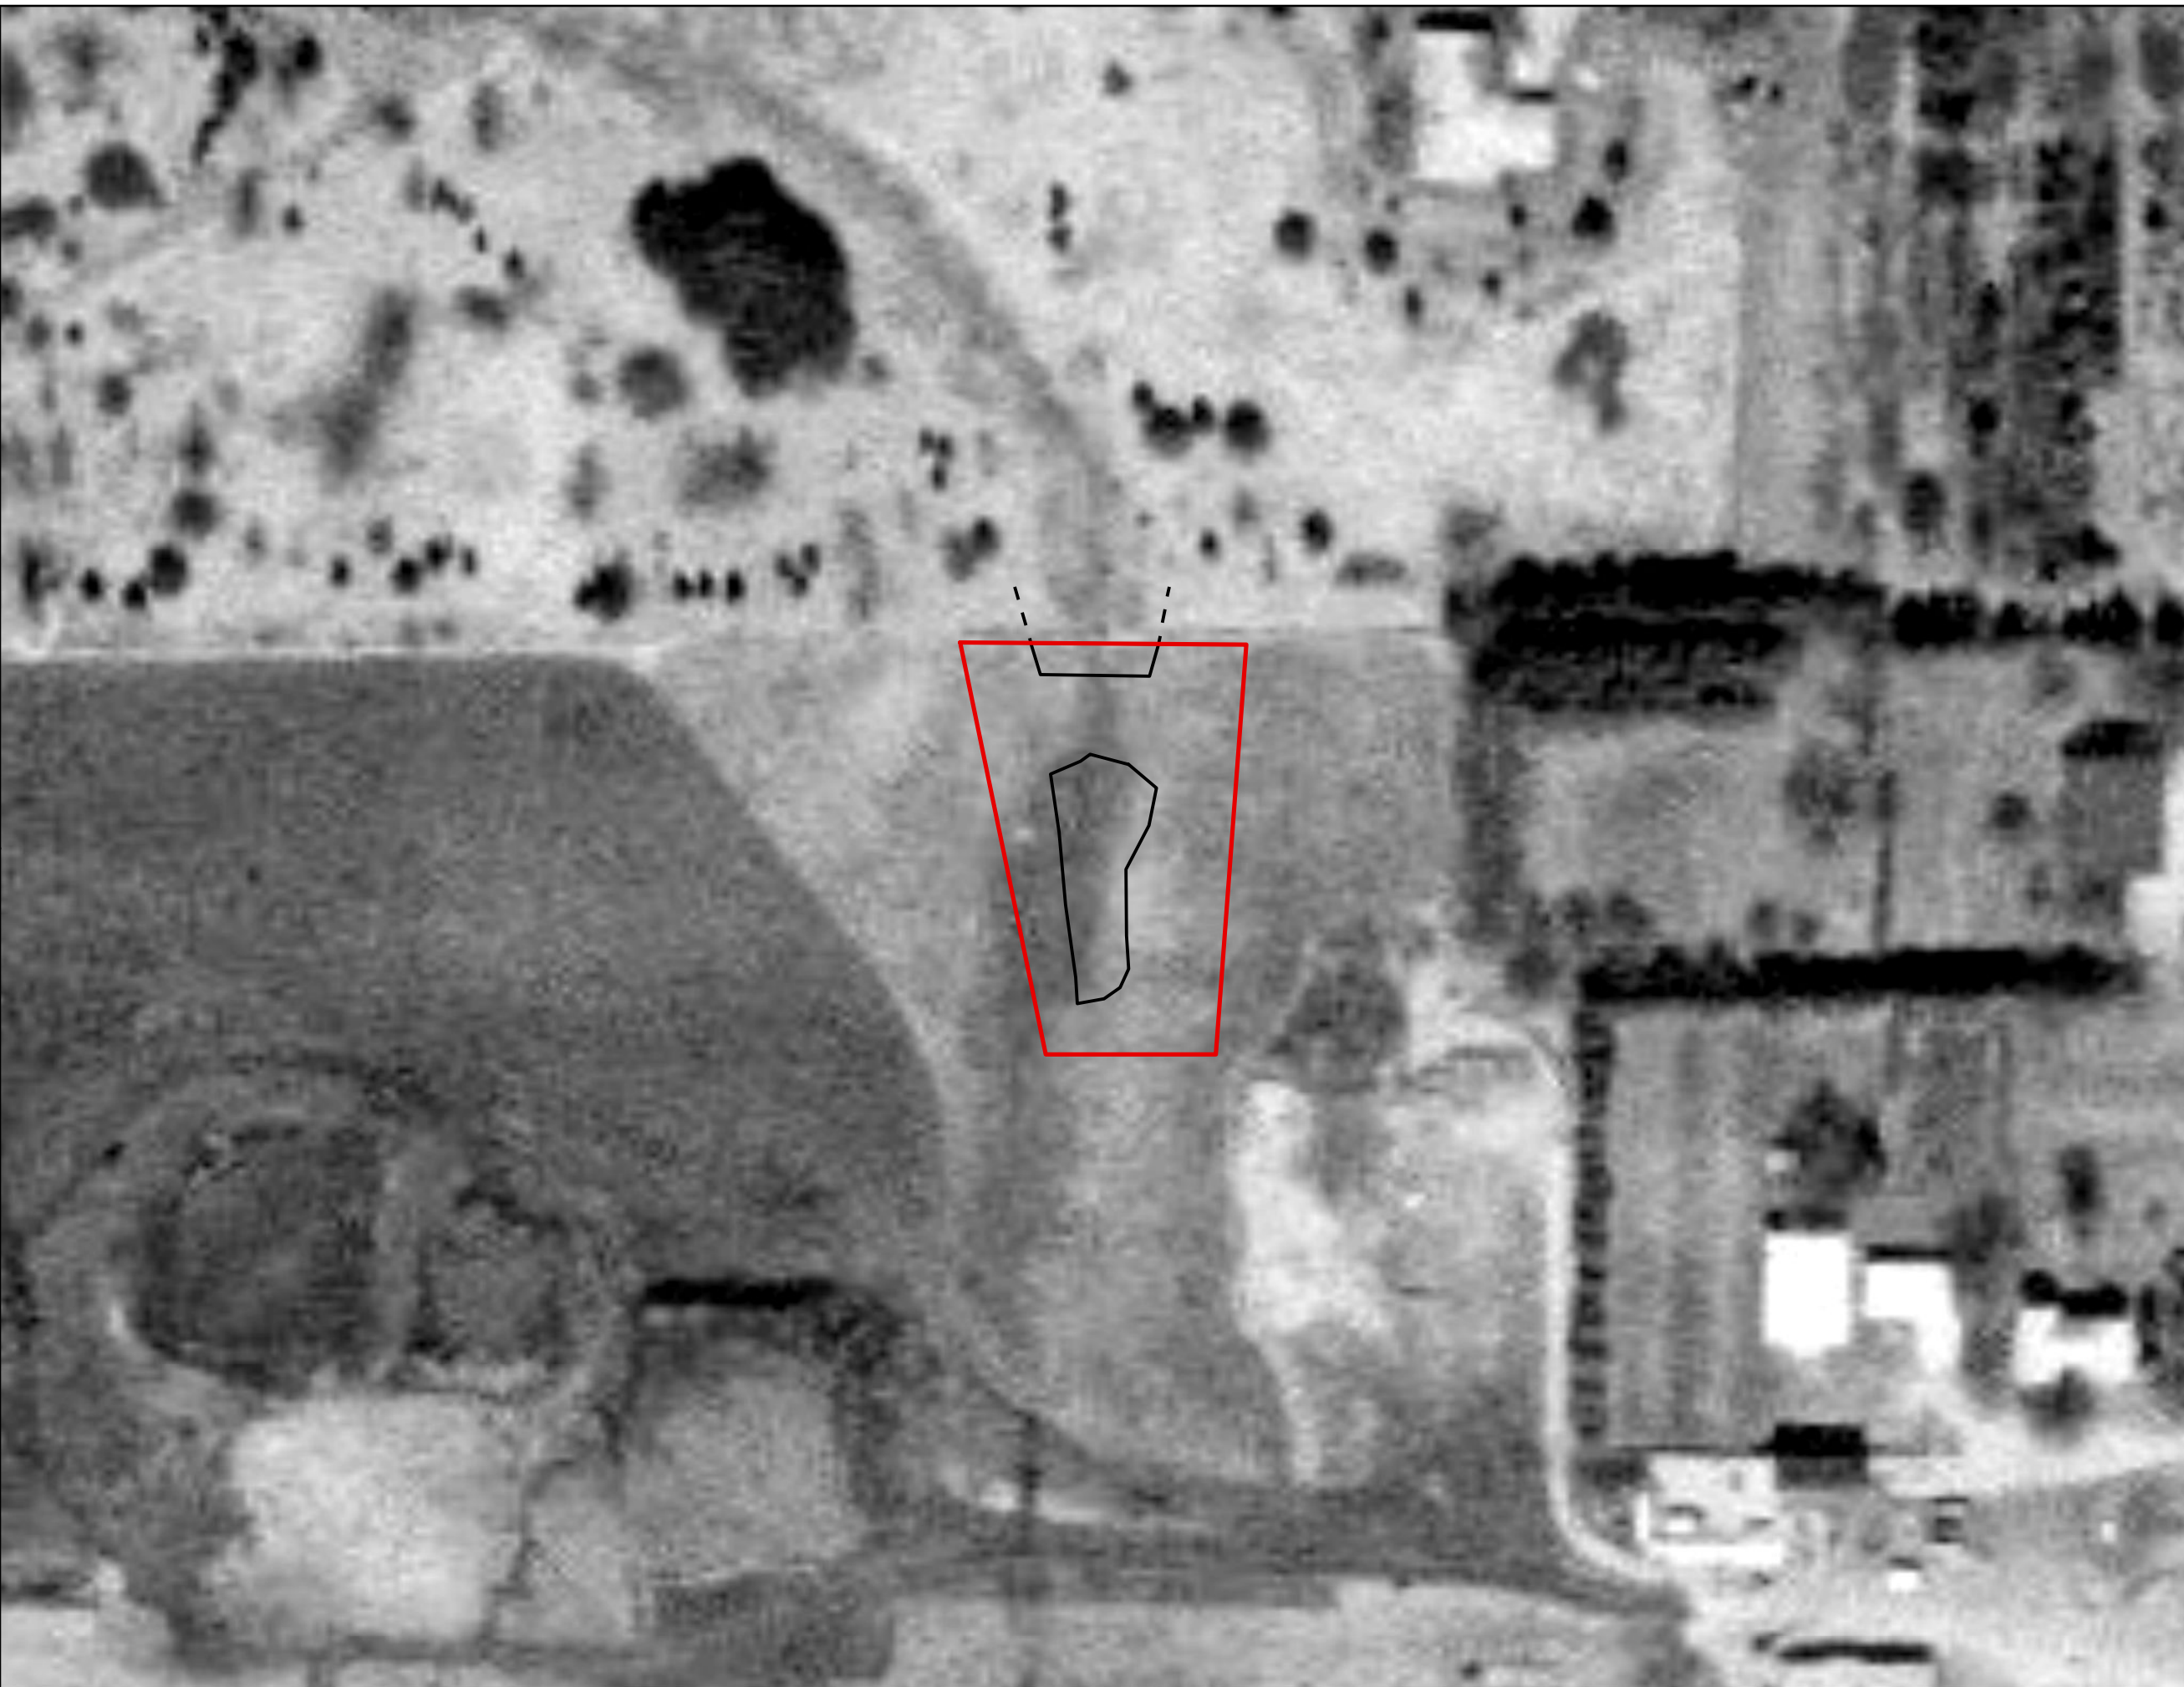
Figure 6A  
1995 Aerial Photo

Based on a review of aerial photographs from 1995, 2000, 2010, 2014 and 2017, the Study Area changed significantly between 1995 and 2000 when the golf course was constructed. The 2000 photo shows an agricultural swale was impounded behind an access road and water control structure and the landscape around the swale was reshaped for the new golf course.

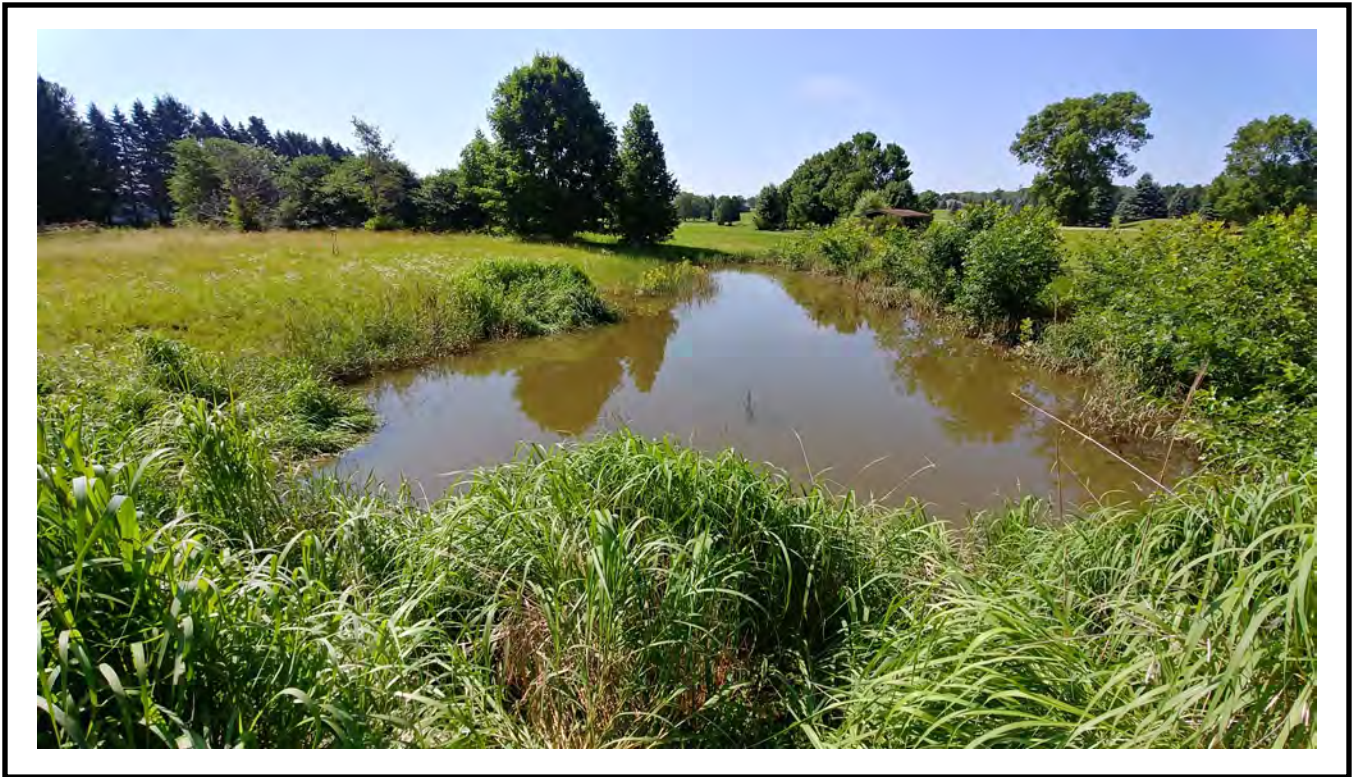
Vegetation was not present at the wetland sampling point due to standing water depth (>24 inches, June 29). Sparse hydrophytic vegetation including reed canary grass (*Phalaris arundinacea*), pampas grass (*Cortaderia selloana*), tall scouring-rush (*Equisetum hyemale*), and green ash (*Fraxinus pennsylvanica*), was present around the edges of the wetland. Dead reed canary grass that was underwater on June 29 can be seen the site photo from July 11.

**Photograph 1 (6/29/18):** Flooded basin, looking south from access road. Sampling Point 1 is located on the slope to the left.

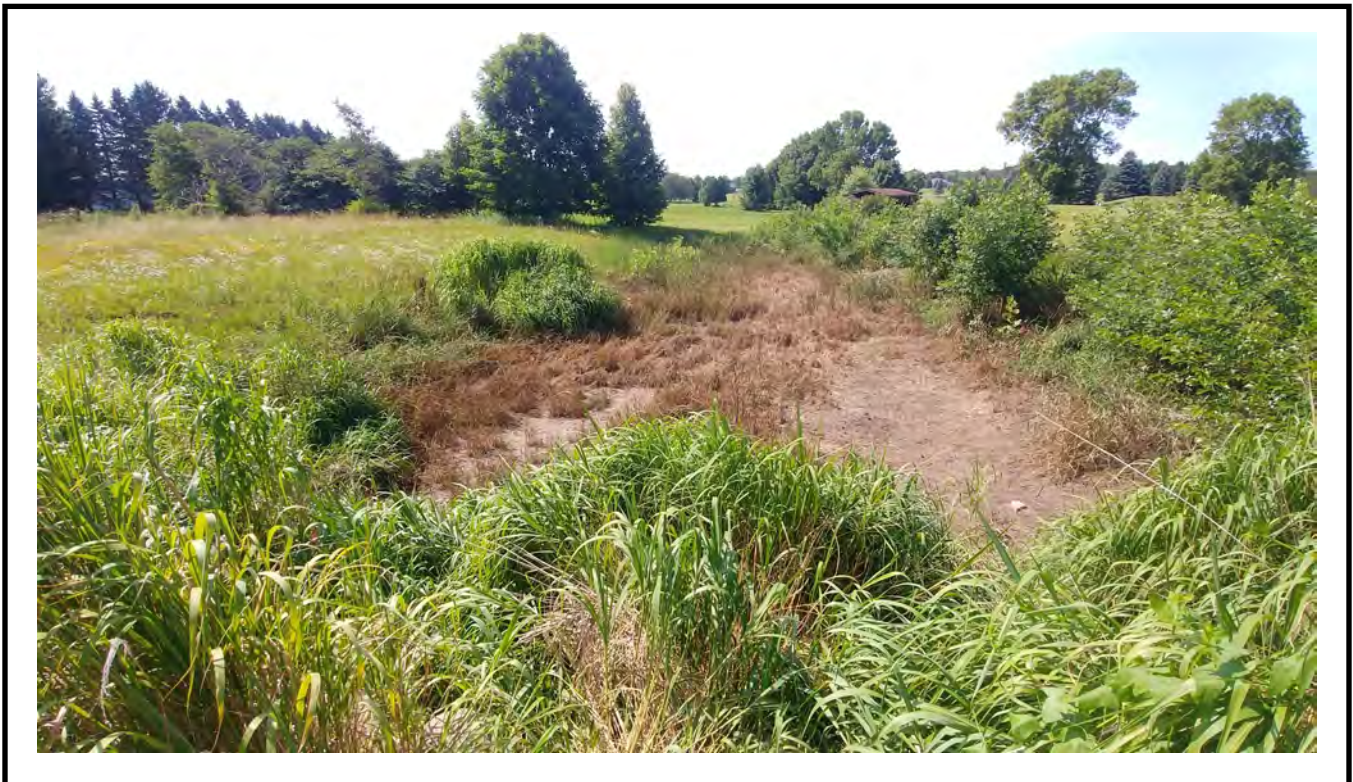
**Photograph 2 (7/11/18):** Previously flooded basin, now dry, looking south from access road.

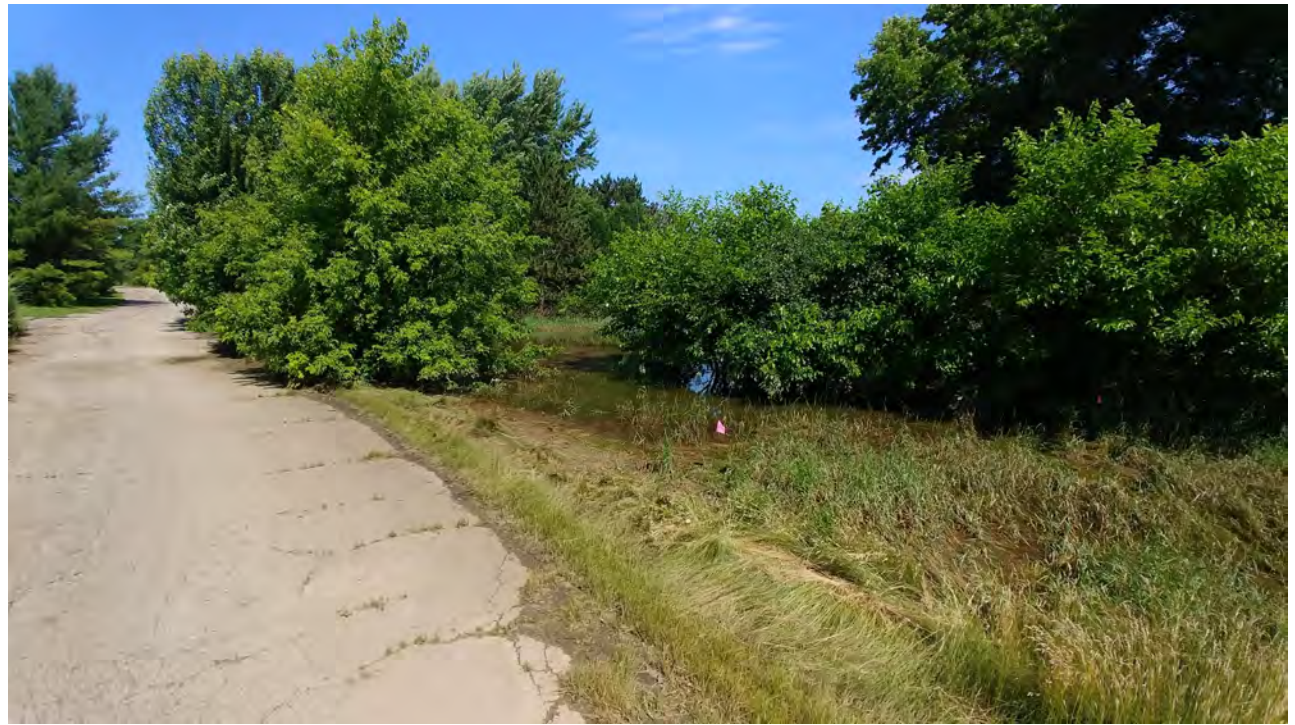
The delineated wetland occurs at the low end of a long linear swale that acts as an overflow for a regional storm water pond, located north of Mineral Point Road. During heavy precipitation events, water from the storm water pond flows through the swale until it reaches the water control structure. Water impounds behind the structure until it overflows the swale, crosses the road and flows into the basin. The basin also collects surface water from the surrounding golf course. Three primary (Surface Water, High Water Table, and Saturation) and one secondary indicator of wetland hydrology (Geomorphic Position) was observed in the wetland.

**Photograph 3 (6/29/18):** Flooded swale, looking west from access road. Bent over vegetation can be seen in the foreground where water flowed over the road.

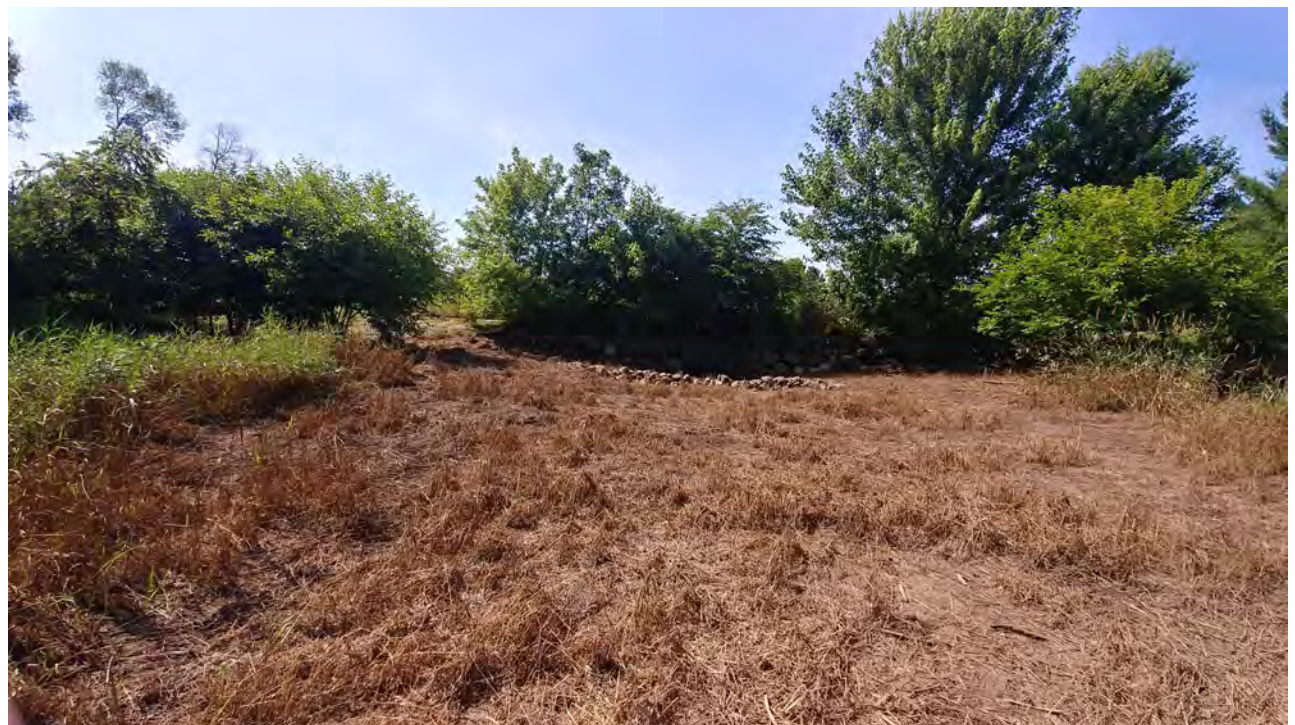
**Photograph 4 (7/11/18):** Previously flooded swale, looking south toward access road.

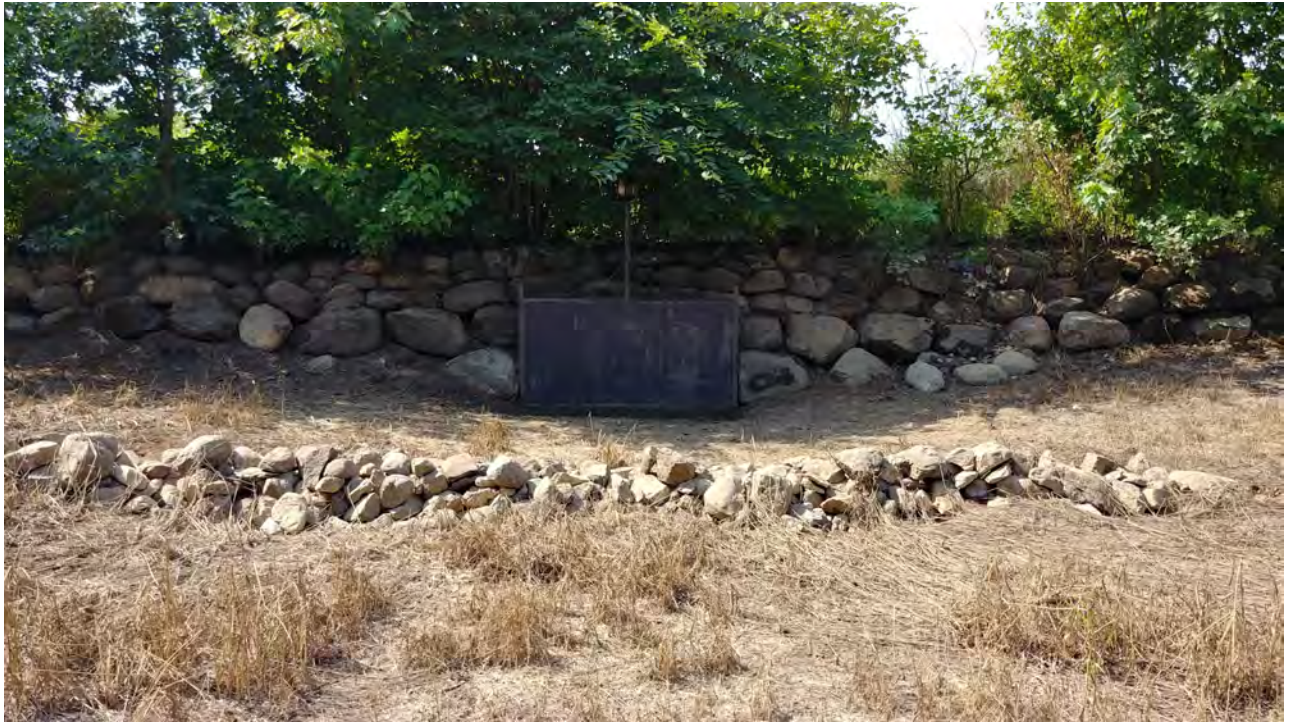
**Photograph 5 (7/11/18):** Water control structure on north side of access road, looking south.
