June and August SCUBA Dive Assessment and August Warm-water Point-intercept Survey for Eurasian water milfoil (*Myriophyllum spicatum*)

George Lake - WBIC: (2465700)

Bayfield County, Wisconsin

Surveys Conducted by and Report Prepared by: Endangered Resource Services, LLC Matthew S. Berg, Research Biologist St. Croix Falls, Wisconsin June 17 and August 11, 2015

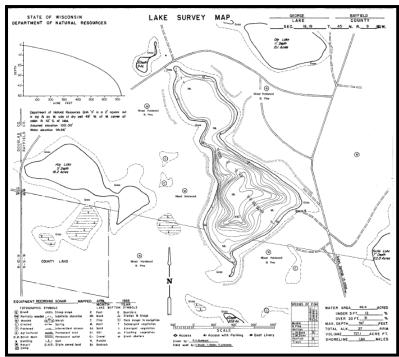
Figure 1: George Lake Bathymetric Map

George Lake (WBIC 2465700) is a 50 acre seepage lake on the west-central edge of Bayfield County, Wisconsin in the Town of Barnes (T45N R9W S18 SE SW). It reaches a maximum depth of 50ft at the southwest end of the southern basin and has an average depth of approximately 16ft (WDNR 2009). The lake is oligotrophic bordering on mesotrophic in nature with Secchi readings from 2000 to 2015 averaging 13.0ft (WDNR 2015). This good to very good water clarity produced a littoral zone that extended to 26ft in August of 2015. The bottom substrate is predominately sand along the shoreline, but this gradually transitions to sandy muck at most depths over 6ft (Figure 1) (Sather et al. 1971).

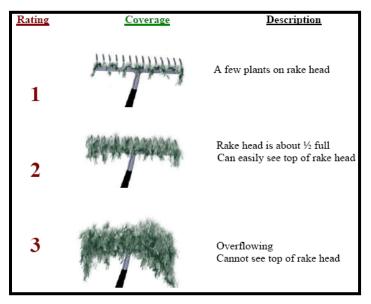
Figure 2: Rake Fullness Ratings (UWEX 2010)

Using a standard formula that takes into account the shoreline shape and distance, water clarity, depth, and total lake acres, Michelle Nault (WDNR) generated the 224 point sampling grid for George Lake that was used during the 2011, 2013, and 2015 surveys (Appendix I). Prior to beginning the point-intercept survey, we conducted a rapid boat survey of the lake to regain familiarity with the species present (Appendix II). All plants found were identified, and, if it was a species not found in 2011 or 2013, two vouchers were pressed and mounted with one to be sent to the state herbarium in Stevens Point for identification confirmation and another to be retained by the TOB. During the pointintercept survey, we located each sampel point using a handheld mapping GPS unit (Garmin 76CSX) and recorded a depth reading with a metered pole rake or hand held sonar (Vexilar LPS-1). At each of these points, we used the rake to sample an approximately 2.5ft section of the bottom. All plants on the rake, as well as any that were dislodged by the rake, were identified and assigned a rake fullness value of 1-3 as an estimation of abundance (Figure 2). We also recorded visual sightings of plants within six feet of the sample point. In addition to a rake rating for each species, a total rake fullness rating was also noted. Substrate type (lake bottom) was assigned at each site where the bottom was visible or it could be reliably determined using the rake.

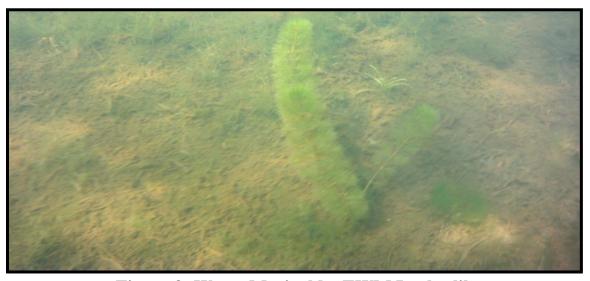
Figure 3: Water Marigold – EWM Look-alike

On June 17th, we searched the visible littoral zone of the lake and completed two SCUBA transects around the south basin following the 5ft and 10ft contour. Visibility was excellent, and we could see 10-15ft in each direction. In 2011, there were a very few lilypad beds in water over 4ft and the bulk of the Eurasian water-milfoil plants in the south basin was found around them. Despite taking an especially slow and careful looks at the bottom throughout these areas, we again turned up nothing to suggest that EWM was still present anywhere in the lake. Water marigold (*Bidens beckii*), the only near look alike to EWM in the lake, was present in a very narrow habitat band from approximately 6-8ft (Figure 3). It was more common than in either 2011 or 2013, but it never canopies and is not bed forming making it relatively easy to identify.

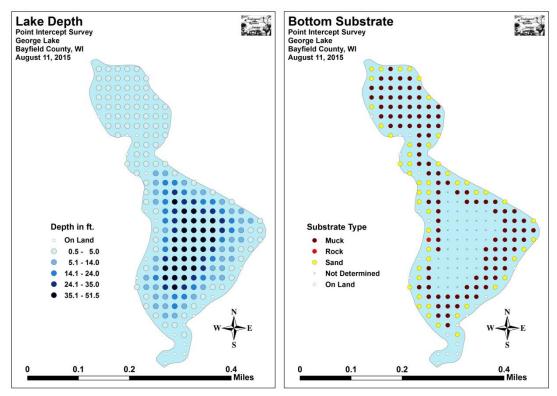
Figure 4: Lake Depth and Bottom Substrate

The George Lake survey grid contained 224 points (Figure 4); however, due to years of prolonged drought, 20 of these points were terrestrial at the time of the 2015 survey (down from 36 terrestrial points in 2013 and 38 points in 2011). Depth soundings taken at these points revealed the north bay is a shallow flat that has a maximum depth of 5.0ft. Conversely, the southern basin is a bowl that drops off rapidly from shore with the deep hole on the southwest side reaching 51.5ft at the time of the 2015 survey (Figure 4) (Appendix III).

Sugar sand lined the margins of the majority of the lake. This quickly transitioned to sandy muck at most depths beyond 6ft. The only dark organic muck occurred in parts of the north bay, and in the east and south bays of the south basin. Of the 158 survey points where we could determine the substrate, 67.7% were muck and sandy muck, 32.6% were pure sand, and a single nearshore point (0.7%) was gravel (Figure 4) (Appendix III).

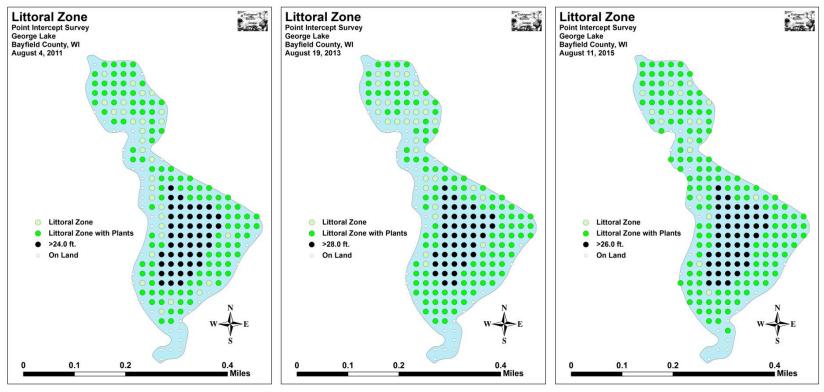
Figure 5: 2011, 2013, and 2015 Littoral Zone

In 2015, we found plants growing at 141 sites which equated to 69.1% of the current lake bottom and in 89.2% of the 26.0ft littoral zone (Table 1). This was a significant increase over the 116 sites with plants (61.7% of the 188 submerged points in 2013 and 79.5% of the then 28.0ft littoral zone. It was also a further increase over 2011 when plants were located at 109 points, and covered 58.6% of the lake bottom (186 submerged points) and 78.4% of the 24.0ft littoral zone (Figure 5). As in past years, growth was strongly skewed to deep water as the mean depth was 7.1ft (identical to 7.1 in 2013 and up from 6.5 in 2011), but the median depth was only 4.0ft (down from 4.5ft in 2013 but up from 3.5ft in 2011) (Appendix IV).

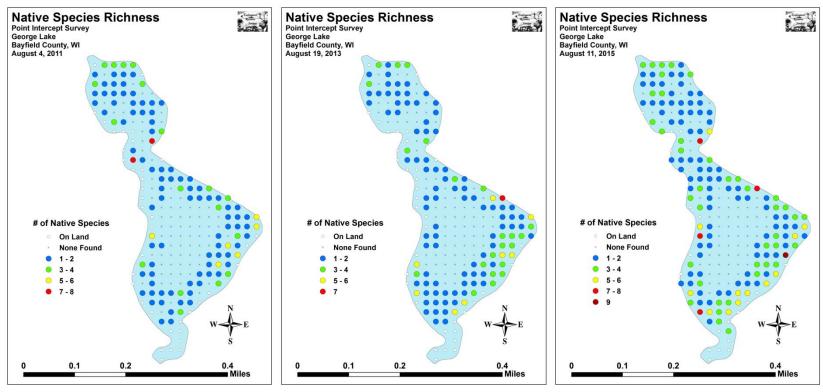
Figure 6: 2011, 2013, and 2015 Native Species Richness

Plant diversity on George Lake continues to be exceptionally high as we documented a Simpson Diversity Index value of 0.93 in 2011, 2013, and 2015. Total richness, after falling from 36 species in the rake in 2011 to 35 in 2013, jumped to 40 in 2015. In total, we found 46 species in and immediately adjacent to the lake (similar to 45 in 2011 and 44 in 2013). Despite this high total richness value, localized native species richness at sites with vegetation was relatively low at 2.54 species in 2015. This was, however, a moderately significant jump from 2.03 in 2011/2.06 in 2013 (Figure 6) (Appendix V).

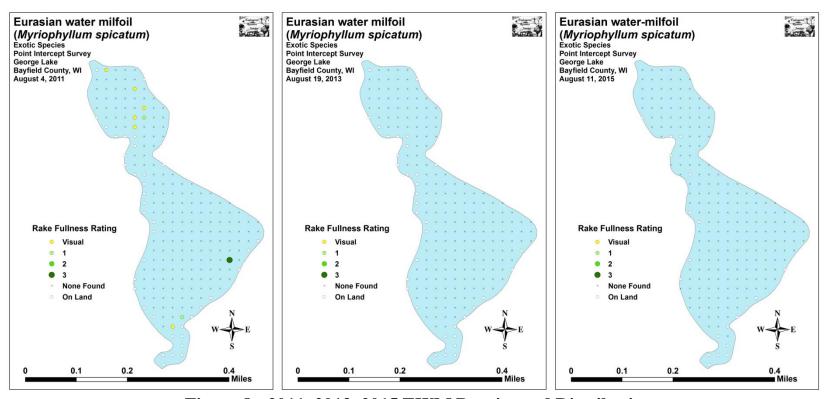
Figure 8: 2011, 2013, 2015 EWM Density and Distribution

The 2011 point-intercept survey found EWM at just three points (2.75% of the littoral zone) which resulted in a relative frequency of 1.34 (Table 2). Of these, one had a rake fullness of 3, and the remaining two a 1 which produced a mean rake fullness of 1.67. EWM was also reported as a visual at six additional points (Figure 8) (Appendix V). Following the June 5, 2012 herbicide treatment, we found no evidence of EWM during either the 2013 or 2015 point-intercept surveys (Figure 8). Although only the drop in visual sightings from 2011 to 2013 was statistically significant (Figure 9), these results were obviously highly significant from a management standpoint.

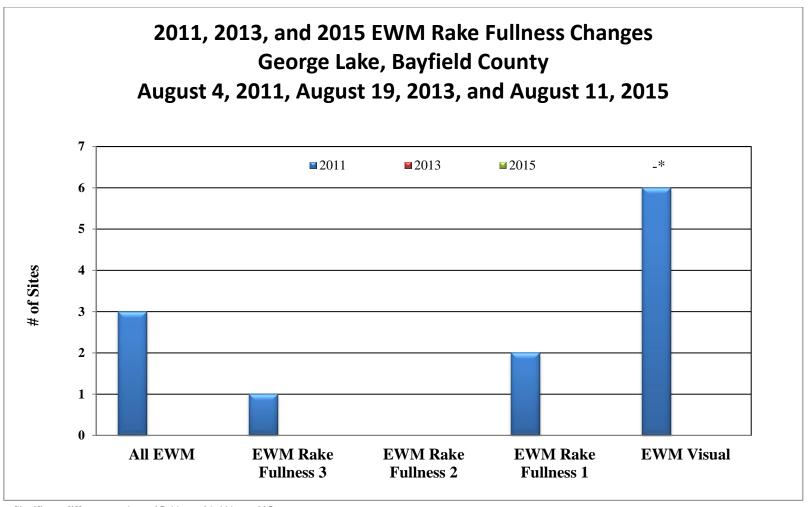
Figure 9: 2011, 2013, and 2015 Changes in EWM Rake Fullness

Significant differences = * p < .05, ** p < .01, *** p < .005

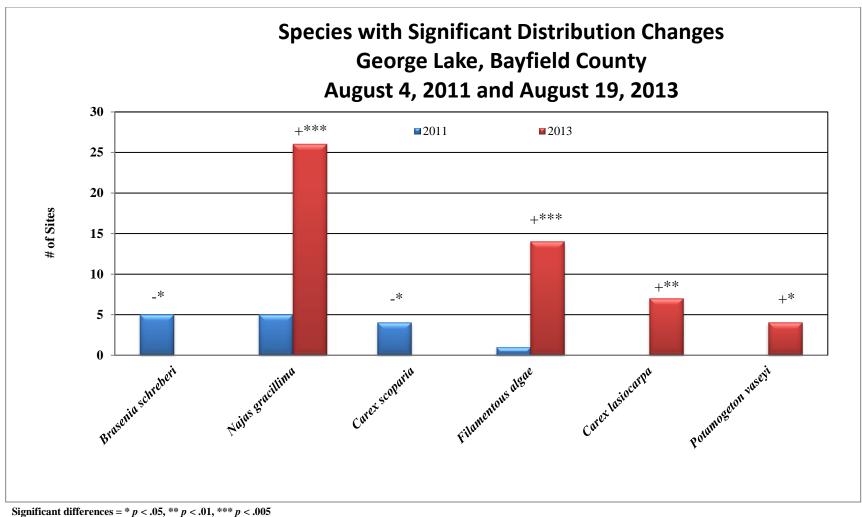
Figure 10: Macrophytes Showing Significant Distribution Changes from 2011-2013

The increase/decrease in the different species of sedge is likely due to shifting water levels as we noted several new sedges in 2013 not seen in 2011 as well as several sedges present in 2011 that were not located in 2013. We can offer no explanation about the increases in Northern naiad and Vasey's pondweed other than the changing water levels may have allowed seeds/nutlets in the substrate to germinate. Watershield, a dicot, may have been negatively impacted by the 2012 herbicide treatment, but, other than White water lily, we didn't note any other native species that seem to have declined posttreatment.

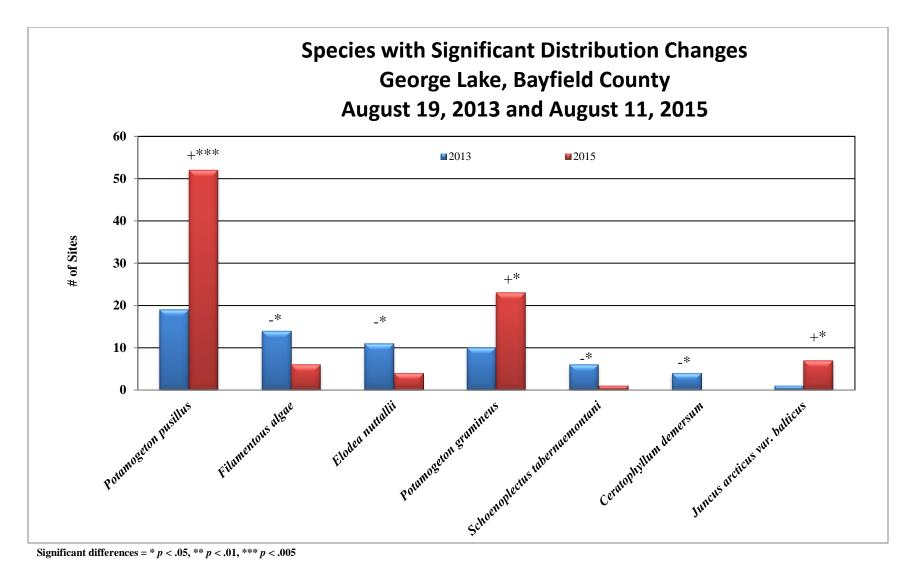
Figure 11: Macrophytes Showing Significant Distribution Changes from 2013-2015

Following the 2015 survey, we found seven species demonstrated significant changes since the 2013 survey (Figure 11). Small pondweed experienced a highly significant increase; and Variable pondweed and Baltic rush (*Juncus arcticus*) both had significant increases. The other four species, filamentous algae, Slender waterweed (*Elodea nuttallii*), Softstem bulrush (*Schoenoplectus tabernaemontani*), and Coontail (*Ceratophyllum demersum*) all experienced significant declines. As no active management has occurred on the lake since 2012, the most likely explanation for these changes is rising water levels.

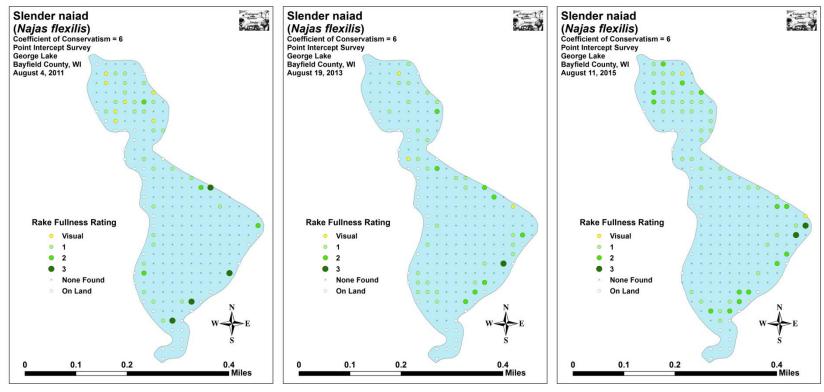
Figure 12: 2011, 2013, and 2015 Slender Naiad Density and Distribution

Slender naiad was the most common species in 2011, 2013, and 2015. From 2011 to 2013, it was almost unchanged in distribution (34 sites in 2011/37 in 2013) and density (mean rake of 1.35 in 2011 and 1.37). Although this density was nearly identical at 1.33 in 2015, the species distribution experienced a nearly significant (p = 0.07) increase to 55 sites (Figure 12). Visual analysis of the maps showed most of this increase was in the north bay.

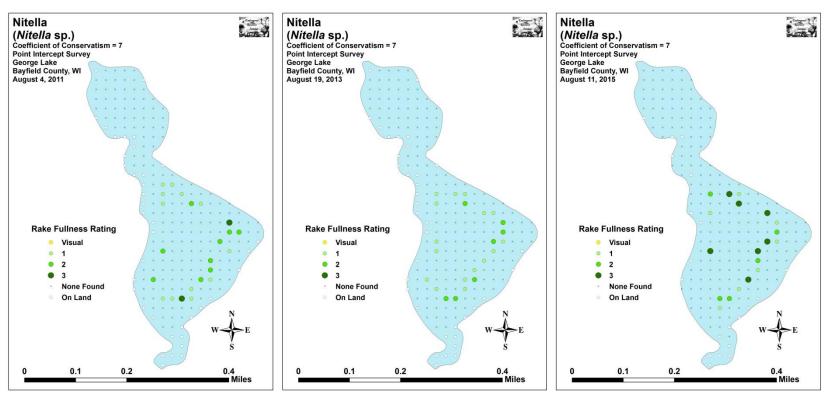
Figure 13: 2011, 2013, and 2015 Nitella Density and Distribution

Nitella was the second most common species in 2011 and the third most common in 2013 (Figure 13). It was unchanged in distribution (23 sites in both 2011 and 2013), but suffered a nearly significant (p = 0.07) decline in density from a mean rake of 1.57 in 2011 to 1.30 in 2013. In 2015, it was only the sixth most common species being found at 19 sites. Although this was a non-significant decline in distribution, density experienced a highly significant **increase** (p = 0.002) to a mean rake fullness of 2.00. This dense growth occurred in a band around the southern basin and likely simply reflects a shift in the location of optimum growing conditions. This assumption is based on our finding a similar band of dense Nitella in the lake each year from 2011-2015 during our dive surveys.

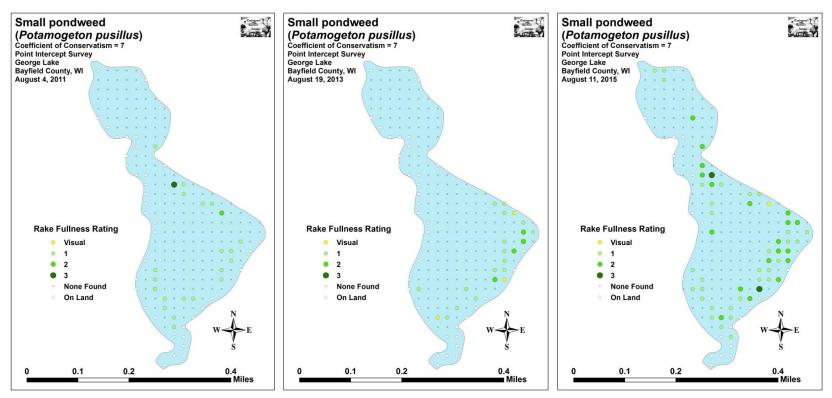
Figure 14: 2011, 2013, and 2015 Small Pondweed Density and Distribution

Small pondweed was the third most common species in 2011, the fourth most common in 2013, and the second most common in 2015 (Figure 14). In 2011, it was present at 22 points with a mean rake fullness of 1.14. In 2013, it experienced an insignificant decline in distribution to 19 sites and an insignificant increase in density to 1.21. However, in 2015, this species underwent a highly significant increase (p < 0.001) in distribution (52 sites) and a significant increase (p = 0.04) in density (mean rake of 1.44). The majority of this expansion occurred along the eastern shoreline of the south basin, but, for the first time, we also found plants scattered in the north bay.

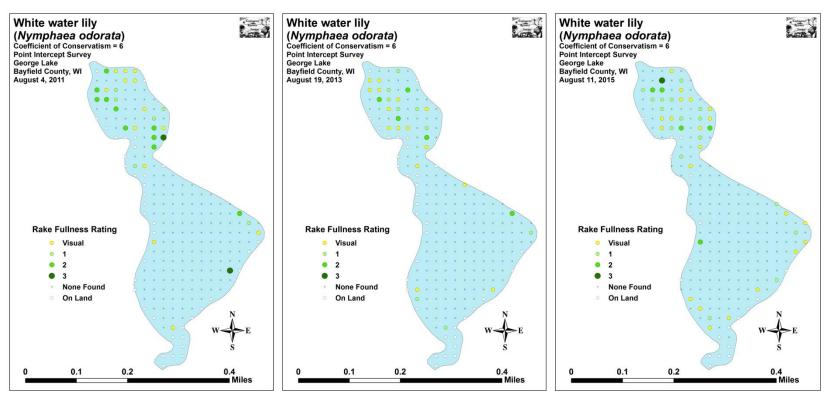
Figure 15: 2011, 2013, and 2015 White Water Lily Density and Distribution

White water lily, the fourth most common species in 2011, was present at 18 sites with a mean rake fullness of 1.78 (Figure 15). Following the 2012 herbicide application, it was the fifth most common species, and experience a non-significant decline in distribution to 14 sites, but a significant increase (p = 0.02) in density to a mean rake of 1.36. In 2015, we again found it to be the fifth most common species when it was present at 22 sites - a non-significant increase – with a slight decrease in density to 1.32. Most of this increase in distribution occurred in the north bay.

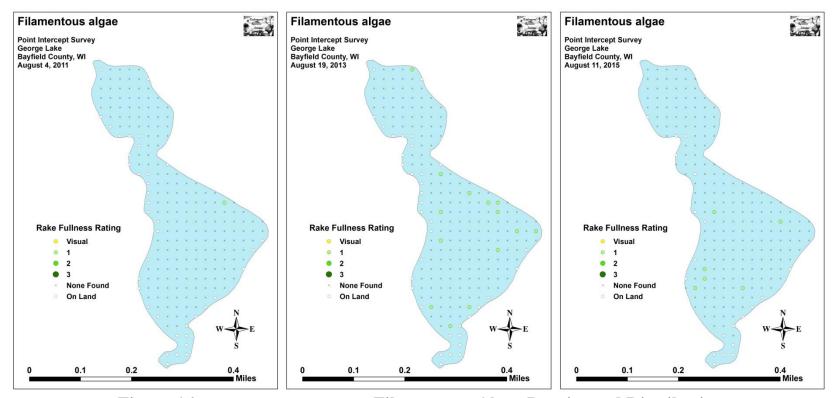
Figure 16: 2011, 2013, and 2015 Filamentous Algae Density and Distribution

Filamentous algae, normally associated with excessive nutrients in the water column, were located at 14 survey points in 2011 - a highly significant increase (p < 0.001) from 2011 when we found them at a single point (Figure 16). In 2015, these algae experienced a significant decline (p = 0.04) and were found at just six sites. As no point in any of the three years had a density higher than a rake fullness of 1, this is probably not of concern, and may be simply related to local nutrient recycling from decomposing plants.

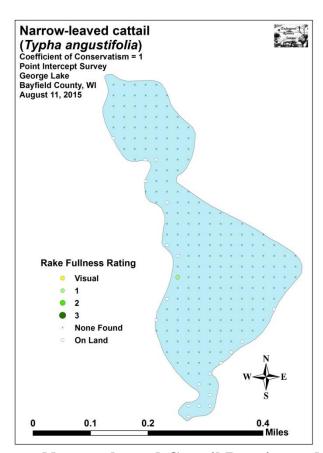
Figure 17: 2015 Narrow-leaved Cattail Density and Distribution

The only exotic species other than EWM found in any of the three surveys was Narrow-leaved cattail (*Typha angustifolia*) – a species that is native to southern but not northern Wisconsin. It is potentially invasive and often excludes the native Broad-leaved cattail (*Typha latifolia*) from places where the two are found together. Because of this, there is the potential that it will continue to spread beyond the single point it was found at during the 2015 survey (Figure 17), and the small bed located on the east shoreline near the entrance of the north bay.

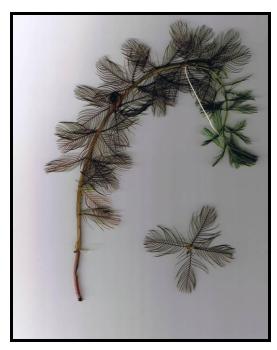
DESCRIPTION: Eurasian water milfoil is a submersed aquatic plant native to Europe, Asia, and northern Africa. It is the only non-native milfoil in Wisconsin. Like the native milfoils, the Eurasian variety has slender stems whorled by submersed feathery leaves and tiny flowers produced above the water surface. The flowers are located in the axils of the floral bracts, and are either four-petaled or without petals. The leaves are threadlike, typically uniform in diameter, and aggregated into a submersed terminal spike. The stem thickens below the inflorescence and doubles its width further down, often curving to lie parallel with the water surface. The fruits are four-jointed nut-like bodies. Without flowers or fruits, Eurasian water milfoil is nearly impossible to distinguish from Northern water milfoil. Eurasian water milfoil has 9-21 pairs of leaflets per leaf, while Northern milfoil typically has 7-11 pairs of leaflets. Coontail is often mistaken for the milfoils, but does not have individual leaflets.

Once established in an aquatic community, milfoil reproduces from shoot fragments and stolons (runners that creep along the lake bed). As an opportunistic species, Eurasian water milfoil is adapted for rapid growth early in spring. Stolons, lower stems, and roots persist over winter and store the carbohydrates that help milfoil claim the water column early in spring, photosynthesize, divide, and form a dense leaf canopy that shades out native aquatic plants. Its ability to spread rapidly by fragmentation and effectively block out sunlight needed for native plant growth often results in monotypic stands. Monotypic stands of Eurasian milfoil provide only a single habitat, and threaten the integrity of aquatic communities in a number of ways; for example, dense stands disrupt predator-prey relationships by fencing out larger fish, and reducing the number of nutrient-rich native plants available for waterfowl.

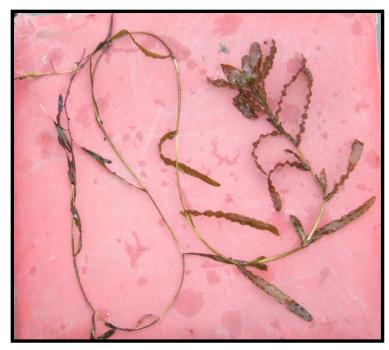
DESCRIPTION: Curly-leaf pondweed is an invasive aquatic perennial that is native to Eurasia, Africa, and Australia. It was accidentally introduced to United States waters in the mid-1880s by hobbyists who used it as an aquarium plant. The leaves are reddishgreen, oblong, and about 3 inches long, with distinct wavy edges that are finely toothed. The stem of the plant is flat, reddish-brown and grows from 1 to 3 feet long. The plant usually drops to the lake bottom by early August

LIFE HISTORY AND EFFECTS OF INVASION: Curly-leaf pondweed spreads through burr-like winter buds (turions), which are moved among waterways. These plants can also reproduce by seed, but this plays a relatively small role compared to the vegetative reproduction through turions. New plants form under the ice in winter, making curly-leaf pondweed one of the first nuisance aquatic plants to emerge in the spring.

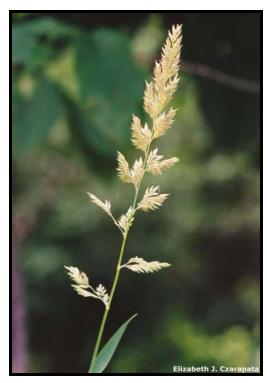
DESCRIPTION: Reed canary grass is a large, coarse grass that reaches 2 to 9 feet in height. It has an erect, hairless stem with gradually tapering leaf blades 3 1/2 to 10 inches long and 1/4 to 3/4 inch in width. Blades are flat and have a rough texture on both surfaces. The lead ligule is membranous and long. The compact panicles are erect or slightly spreading (depending on the plant's reproductive stage), and range from 3 to 16 inches long with branches 2 to 12 inches in length. Single flowers occur in dense clusters in May to mid-June. They are green to purple at first and change to beige over time. This grass is one of the first to sprout in spring, and forms a thick rhizome system that dominates the subsurface soil. Seeds are shiny brown in color.

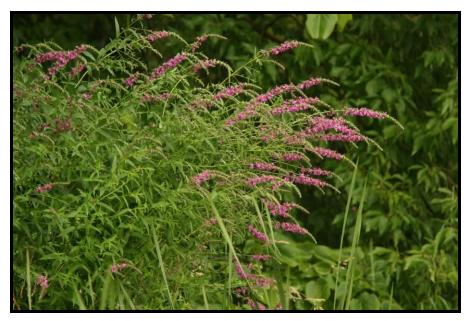
Purple loosestrife (Photo Courtesy Brian M. Collins)

DESCRIPTION: Purple loosestrife is a perennial herb 3-7 feet tall with a dense bushy growth of 1-50 stems. The stems, which range from green to purple, die back each year. Showy flowers vary from purple to magenta, possess 5-6 petals aggregated into numerous long spikes, and bloom from August to September. Leaves are opposite, nearly linear, and attached to four-sided stems without stalks. It has a large, woody taproot with fibrous rhizomes that form a dense mat.
