**WATER QUALITY STANDARDS REVIEW  
AND STREAM CLASSIFICATION FOR  
THE NORTH BRANCH OF THE PIKE RIVER,  
PIKE RIVER WATERSHED, KENOSHA COUNTY, WISCONSIN  
OCTOBER 1993**

by Tom Burzynski, Southeast District

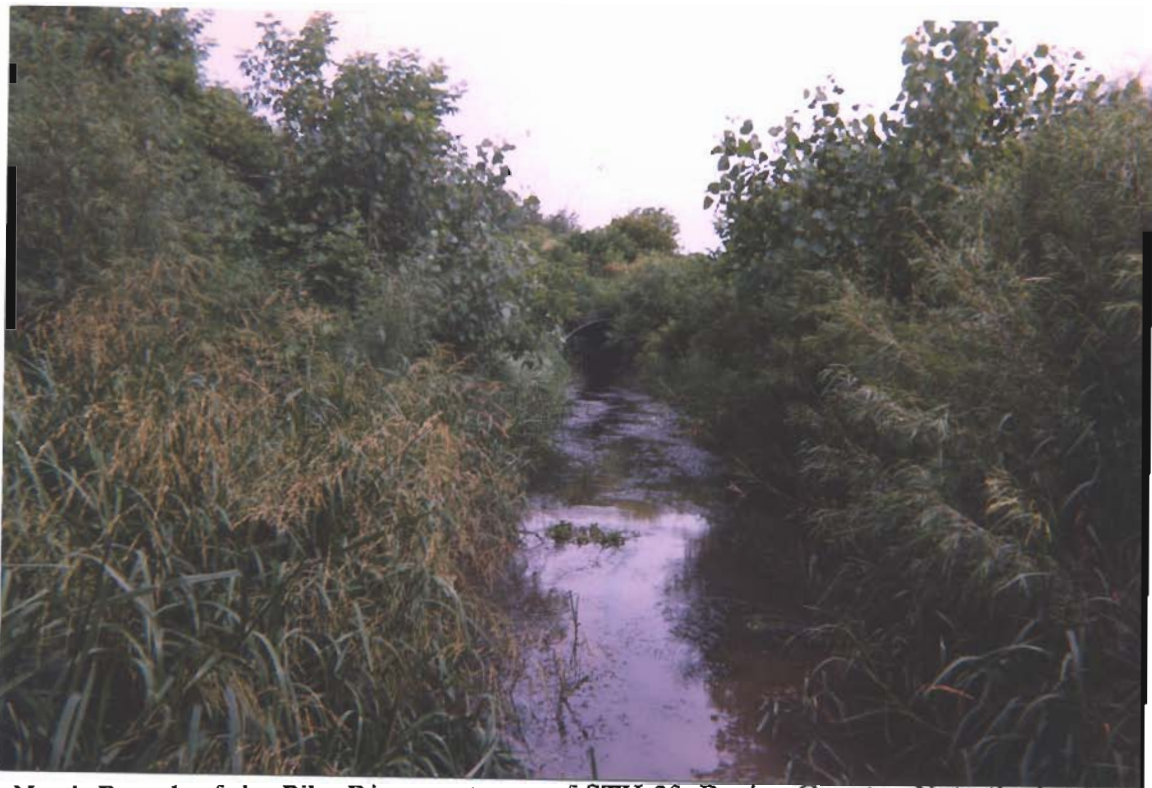
Figure 1. North Branch of the Pike River upstream of STH 20, Racine County. Note the bank vegetation, which is dominated by grasses, shrubs, and immature trees. Also note the presence of aquatic macrophytes in the stream channel.

Woody bank vegetation is present and well-established at the second site on the North Branch and consists of both mature trees and low shrubs. The understory vegetation is somewhat sparse, resulting in areas of bare soil along the banks. The bank vegetation at the first site on the North Branch consists mainly of shrubs and primarily immature trees. Bank vegetation on the Bartlett Branch is dominated by grasses at the Stuart Road site and by woody shrubs at the Old Spring Street site. Sparse understory vegetation is contributing to bank erosion at the Old Spring Street site.

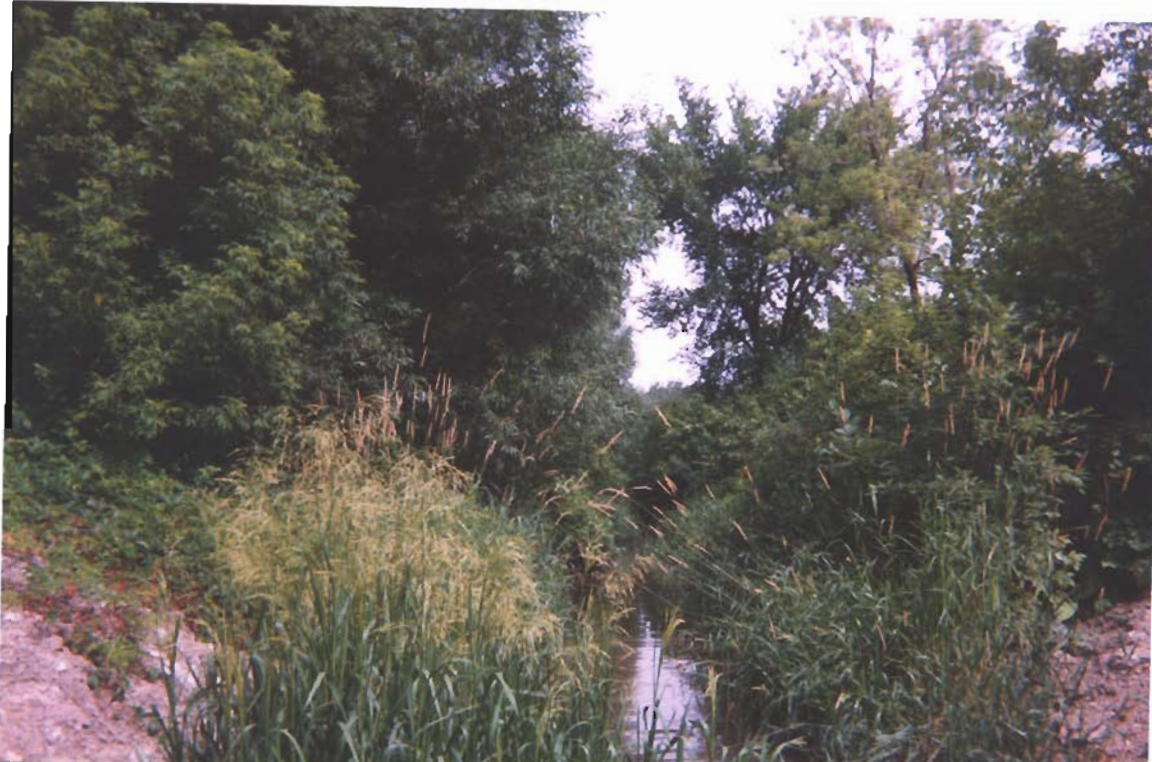
Figure 2. North Branch of the Pike River, upstream of the culvert at Kings Hill. Note the trees in the background.

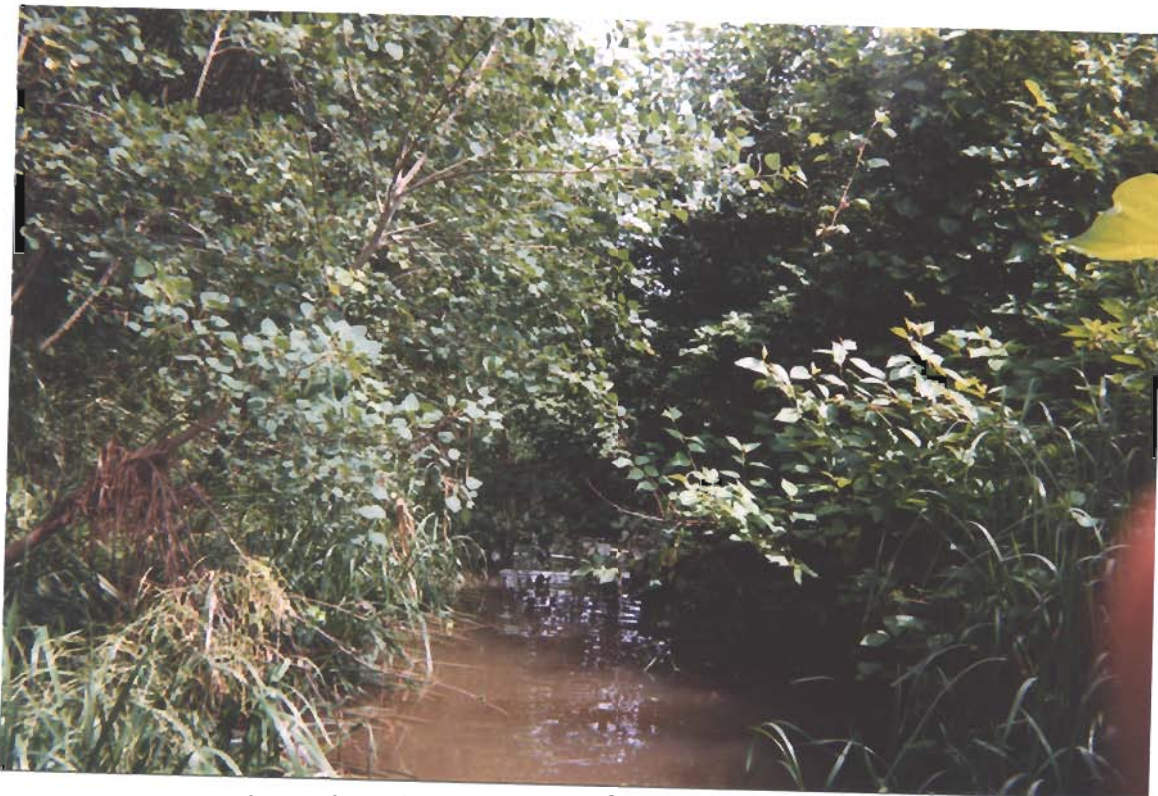
Figure 3. North Branch of the Pike River, upstream of the culvert at Knights Inn. Note the overhanging bank vegetation, which is shading the stream channel.

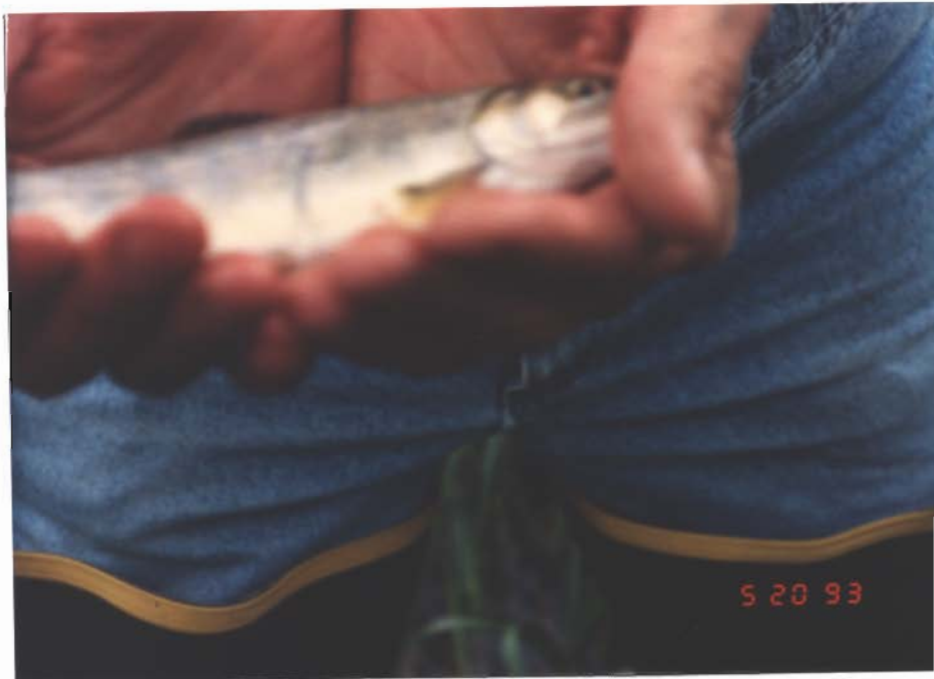
Figure 4. Brook trout captured during fish community survey on the North Branch of the Pike River near Mariner Drive. The North Branch may serve as a refuge for stocked trout and salmon before outmigration to Lake Michigan.
