TAINTER LAKE SEDIMENT STUDY

- DETERMINE THE SOURCES AND EFFECTS OF SEDIMENTATION ON UPPER TAINTER LAKE

- ❑ DOCUMENT THE VOLUME OF WATER THAT HAS BEEN DISPLACED BY SEDIMENT SINCE 1960 AT THE MOUTH OF THE RED CEDAR AND HAY RIVERS
- ❑ IDENTIFY THE SOURCES OF SEDIMENT
- ❑ ESTIMATE THE INFILL RATE OF THE LAKE
- ❑ CREATE A NEW BATHYMETRIC LAKE MAP

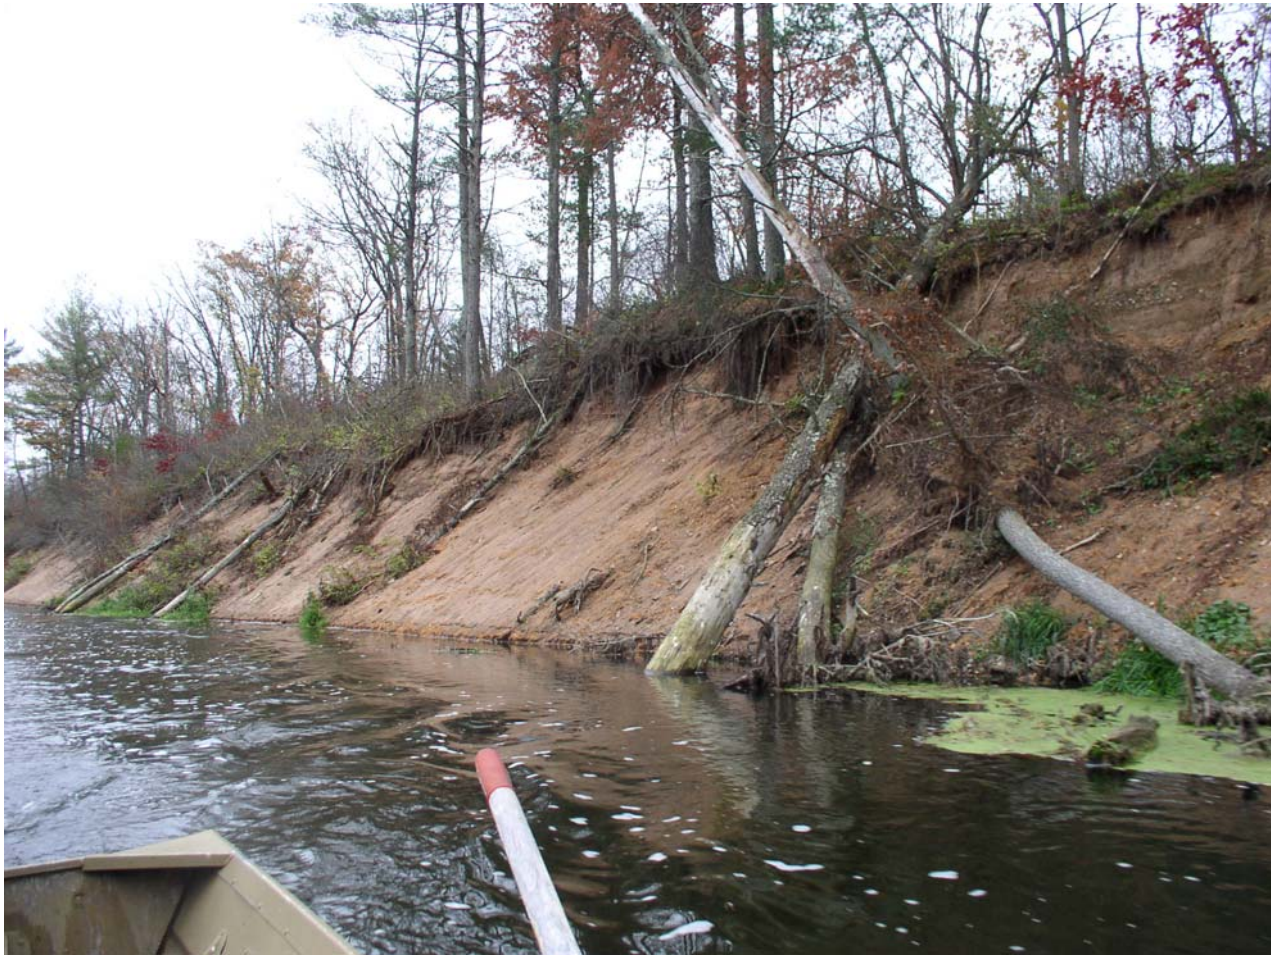
- ACTIVELY ERODING
- VOID OF ESTABLISHED VEGETATION
- RECEDING AT ONE FOOT PER YEAR

CLASS I BANK (600 FT. X 25 FT.)

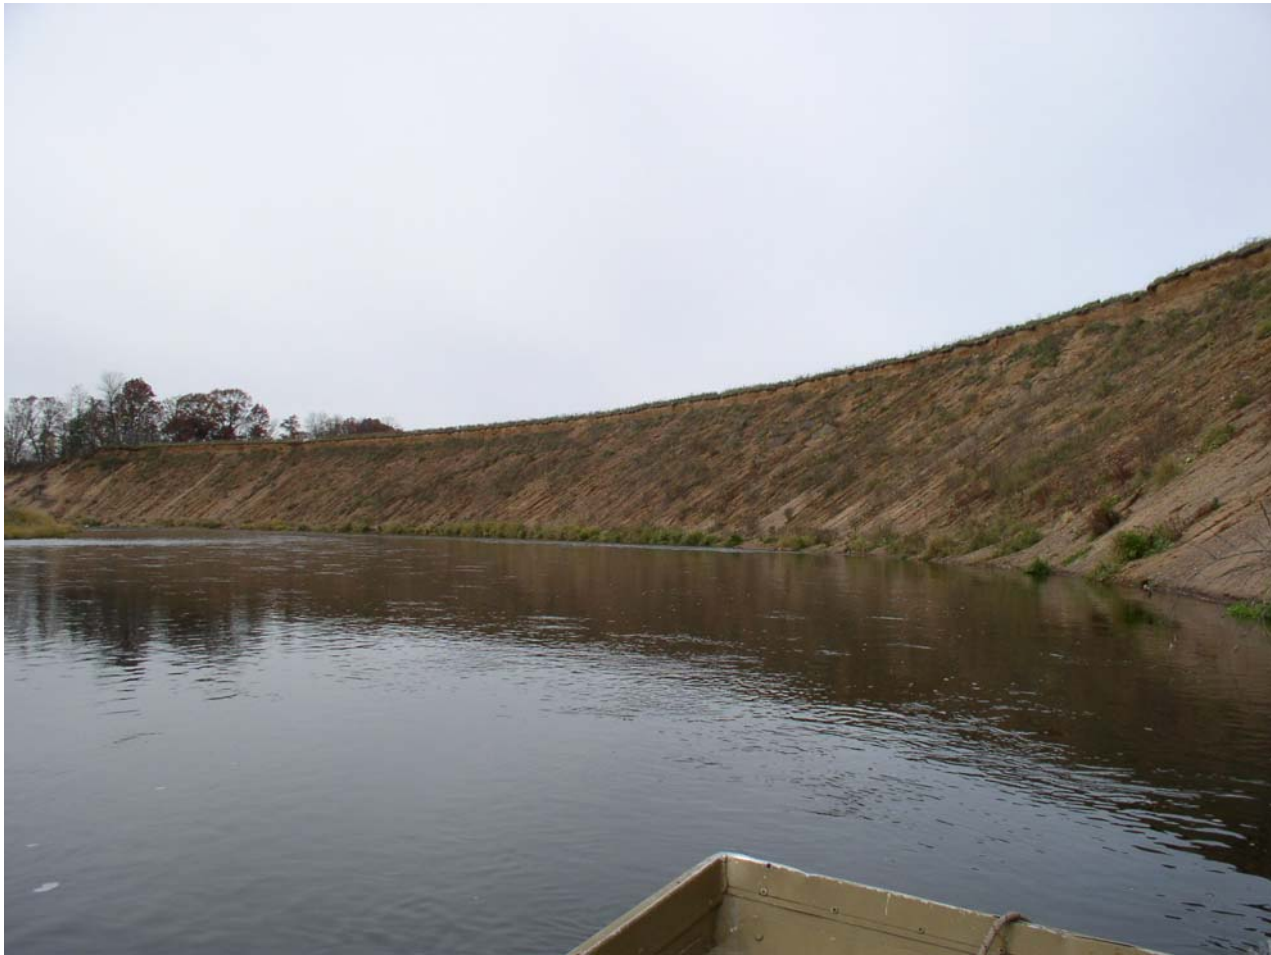
CLASS I BANK (1,200 FT. X 50 FT.)

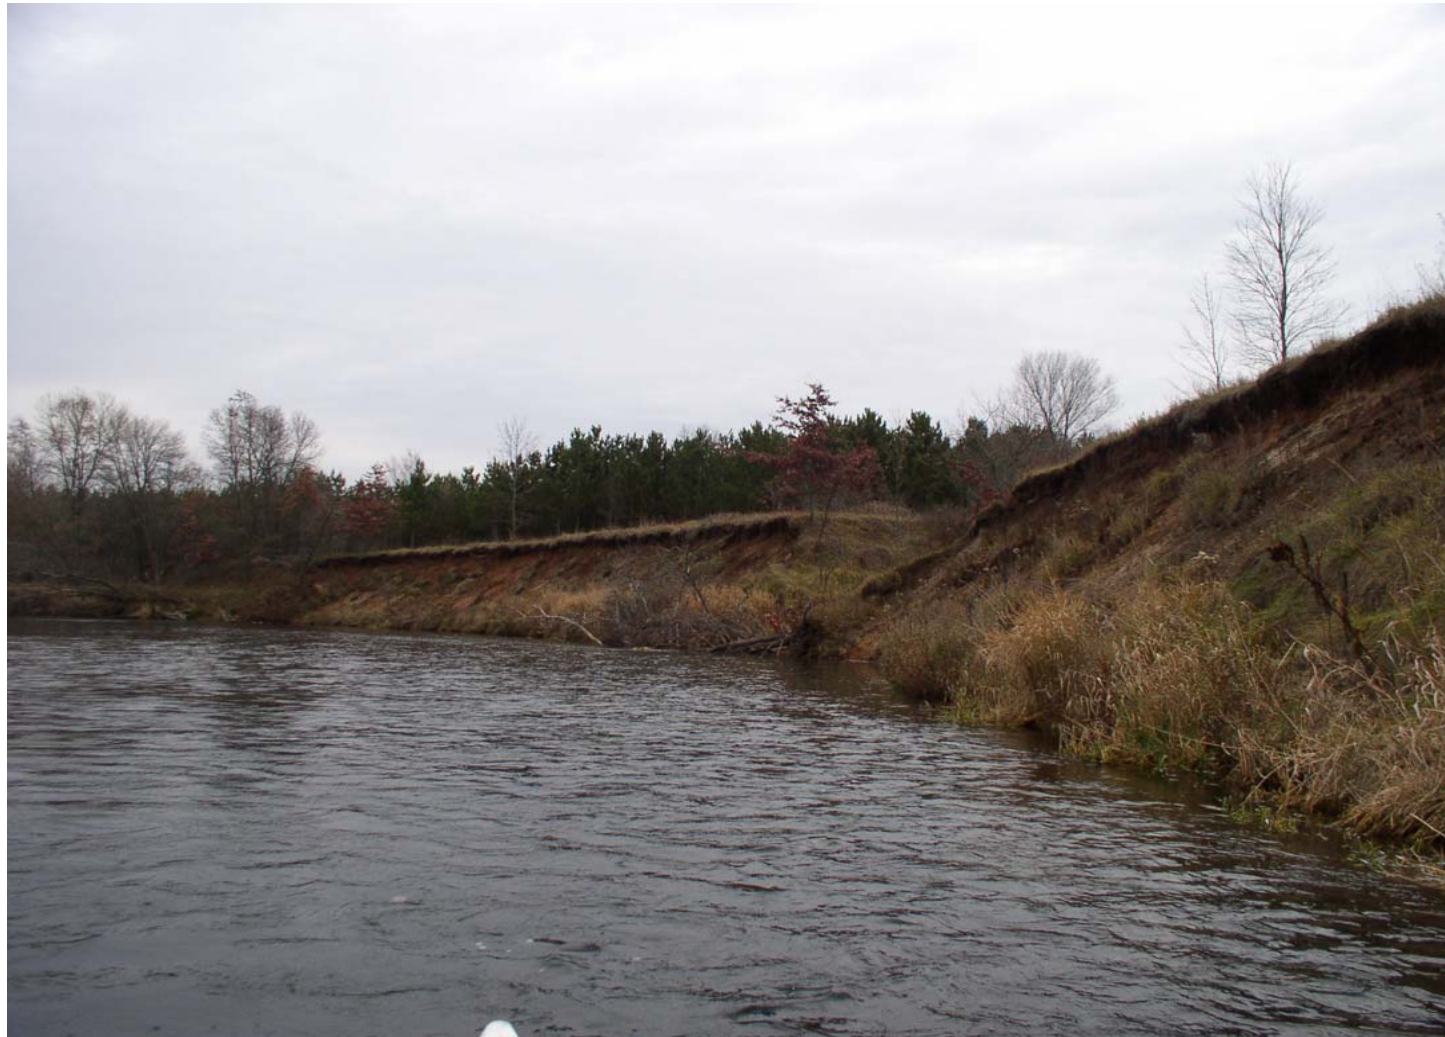
- INTERMITTENTLY ERODING
- 50% OR LESS ESTABLISHED VEGETATION
- RECEDING AT 0.5 FEET PER YEAR

CLASS II BANK – HAY RIVER

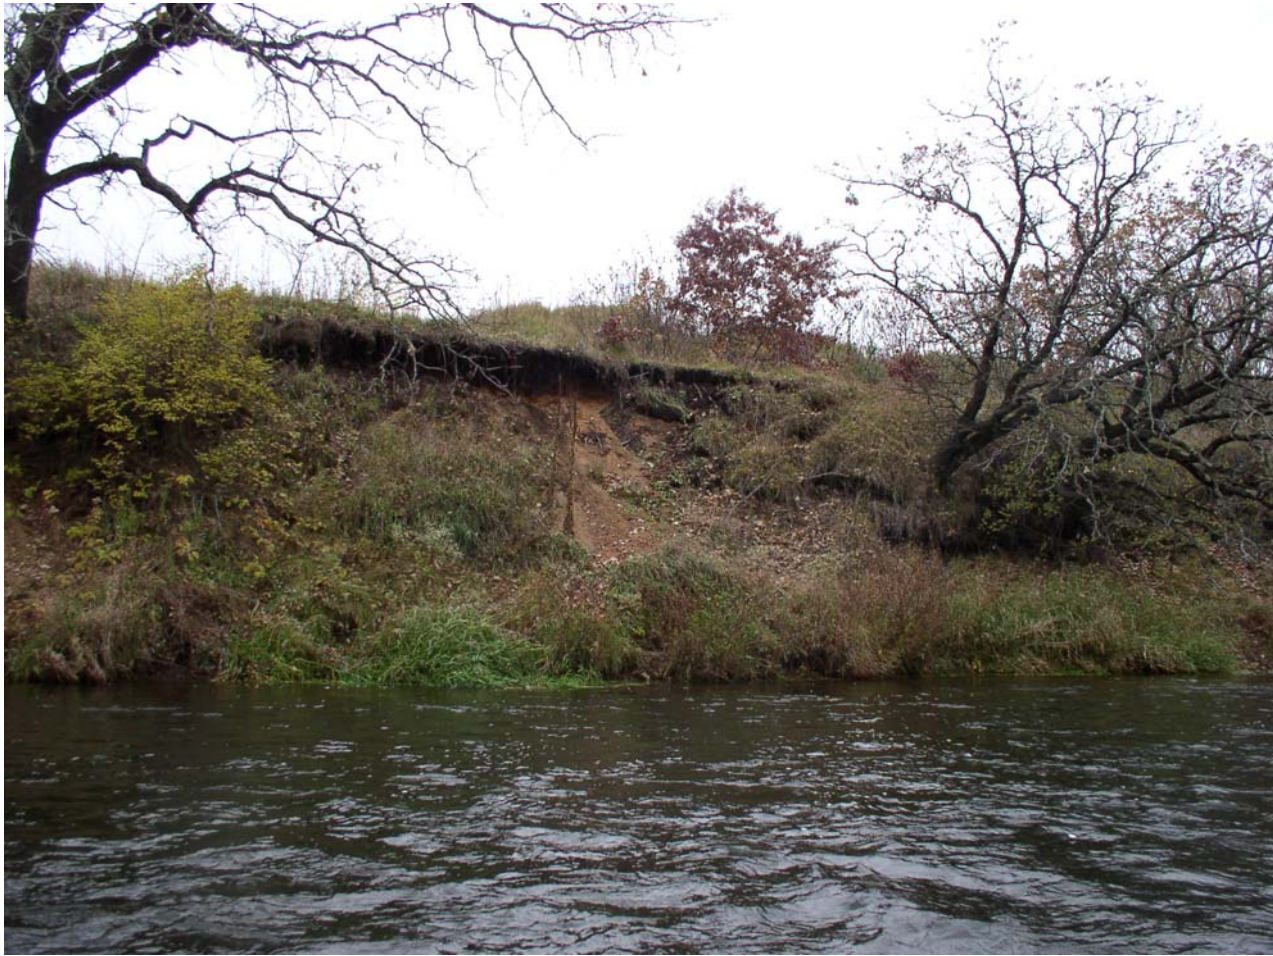
- INTERMITTENTLY ERODING
- 75% OR GREATER VEGETATION
- RECEDING 0.2 FEET PER YEAR

CLASS III BANK

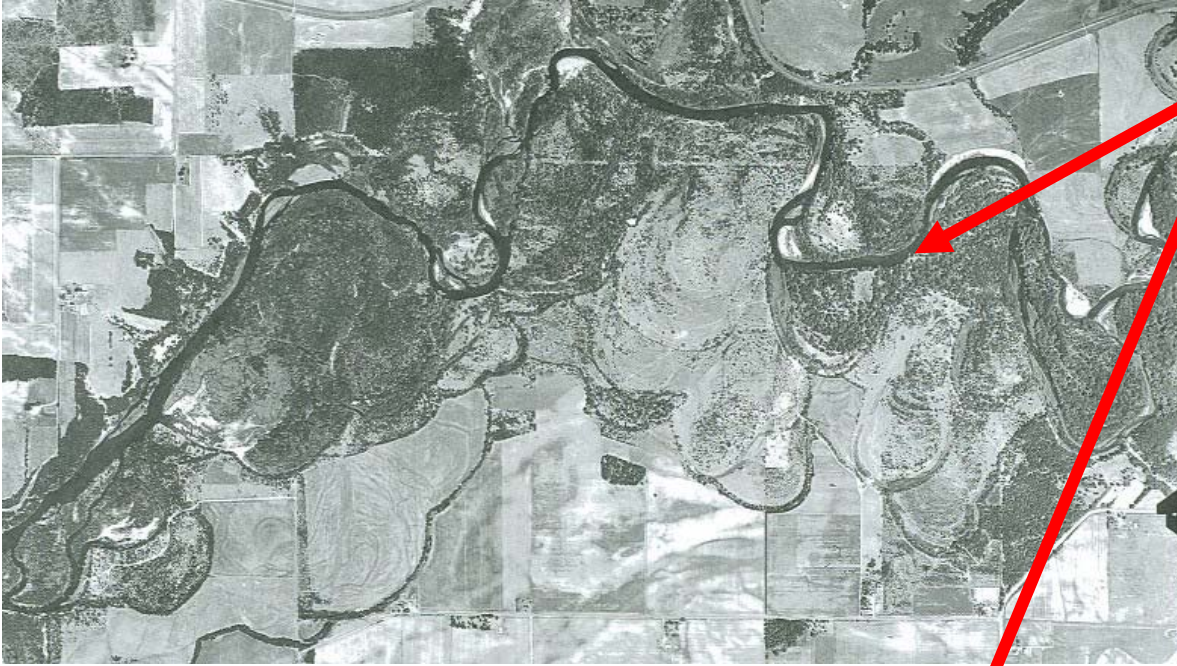
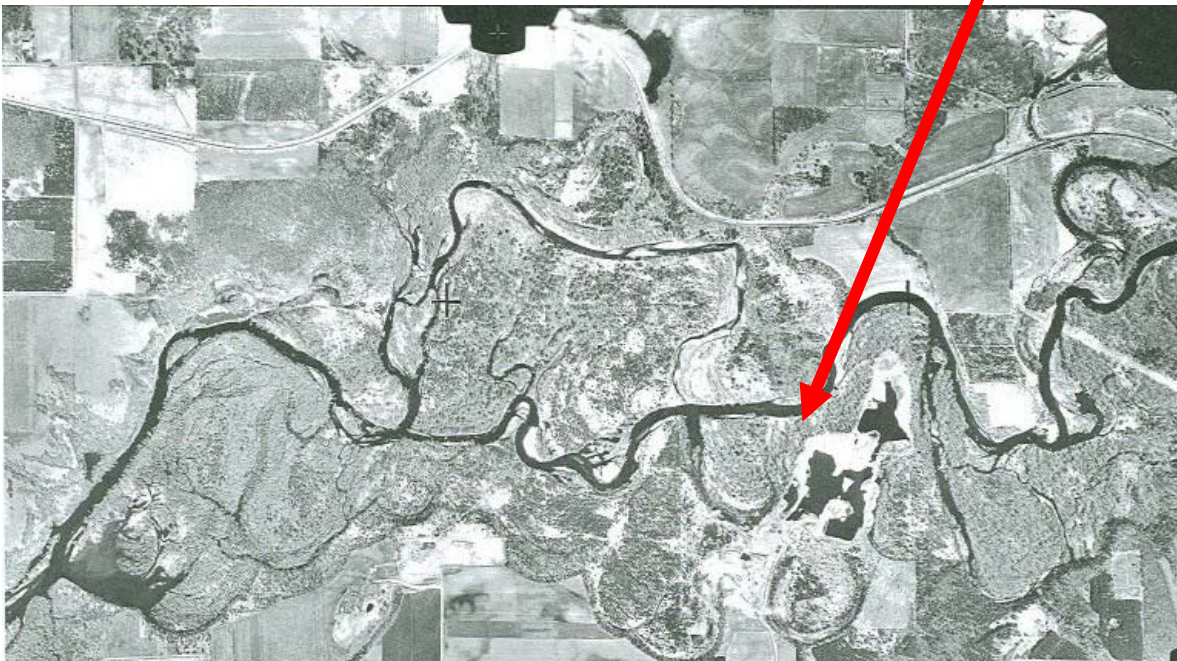
1958 vs 1986 CHANNEL CHANGES ITS COURSE

LENGTH OF
CHANNEL
GOES FROM 8,000 L.F.
TO 4,000 L.F. RAISING
VELOCITY OF FLOW.

THIS CAN PRODUCE A
HEAD CUTTING
EFFECT ON STREAM
CHANNEL CREATING
UNSTABLE BANKS.

EST. 113,600 CU. YDS.
OF SOIL DISPLACED
FROM NEW
CHANNEL.

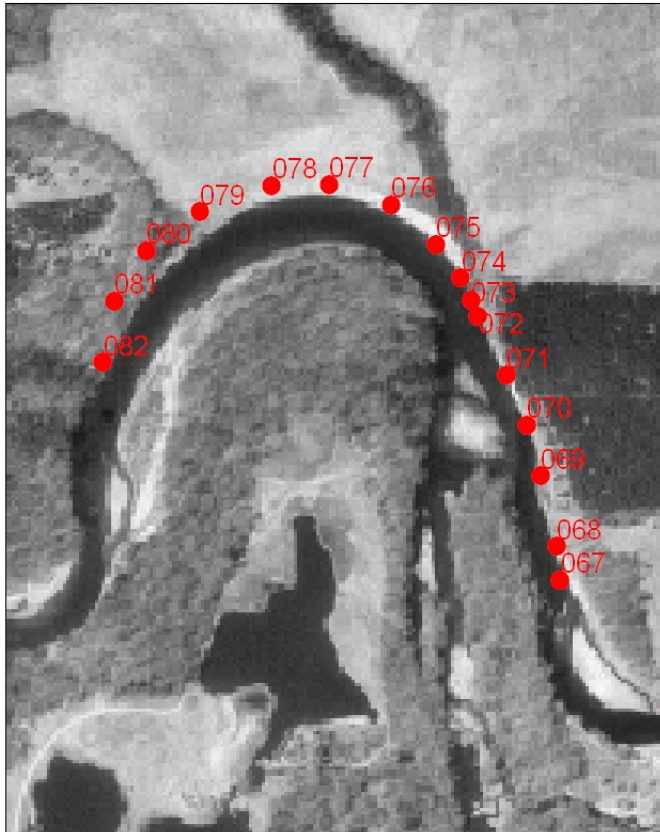
PLAN MAP

Name : Adrian Smith Bank

Class 1 1000 Feet @ 25 Feet High 1200 Feet @ 50 Feet High

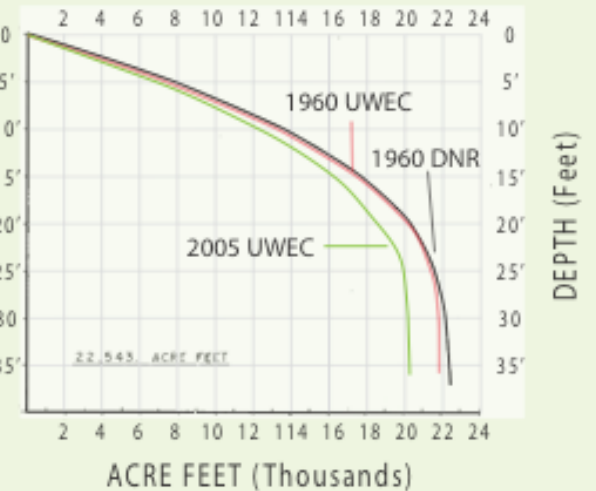
HYPSONOMETRIC VOLUME CURVES

Three different Hypsometric Volume graphs were constructed to compare changes in lake volume:

- The 1960 DNR Bathymetric map included a graph that was scanned and used as the 'base' for the graph above.
- The 1960 UWEC curve represents data derived from the 3D bathymetric surface based on the 1960 contour data.
- The 2005 UWEC curve represents data derived from the 3D bathymetric surface based on the 2005 lake survey.

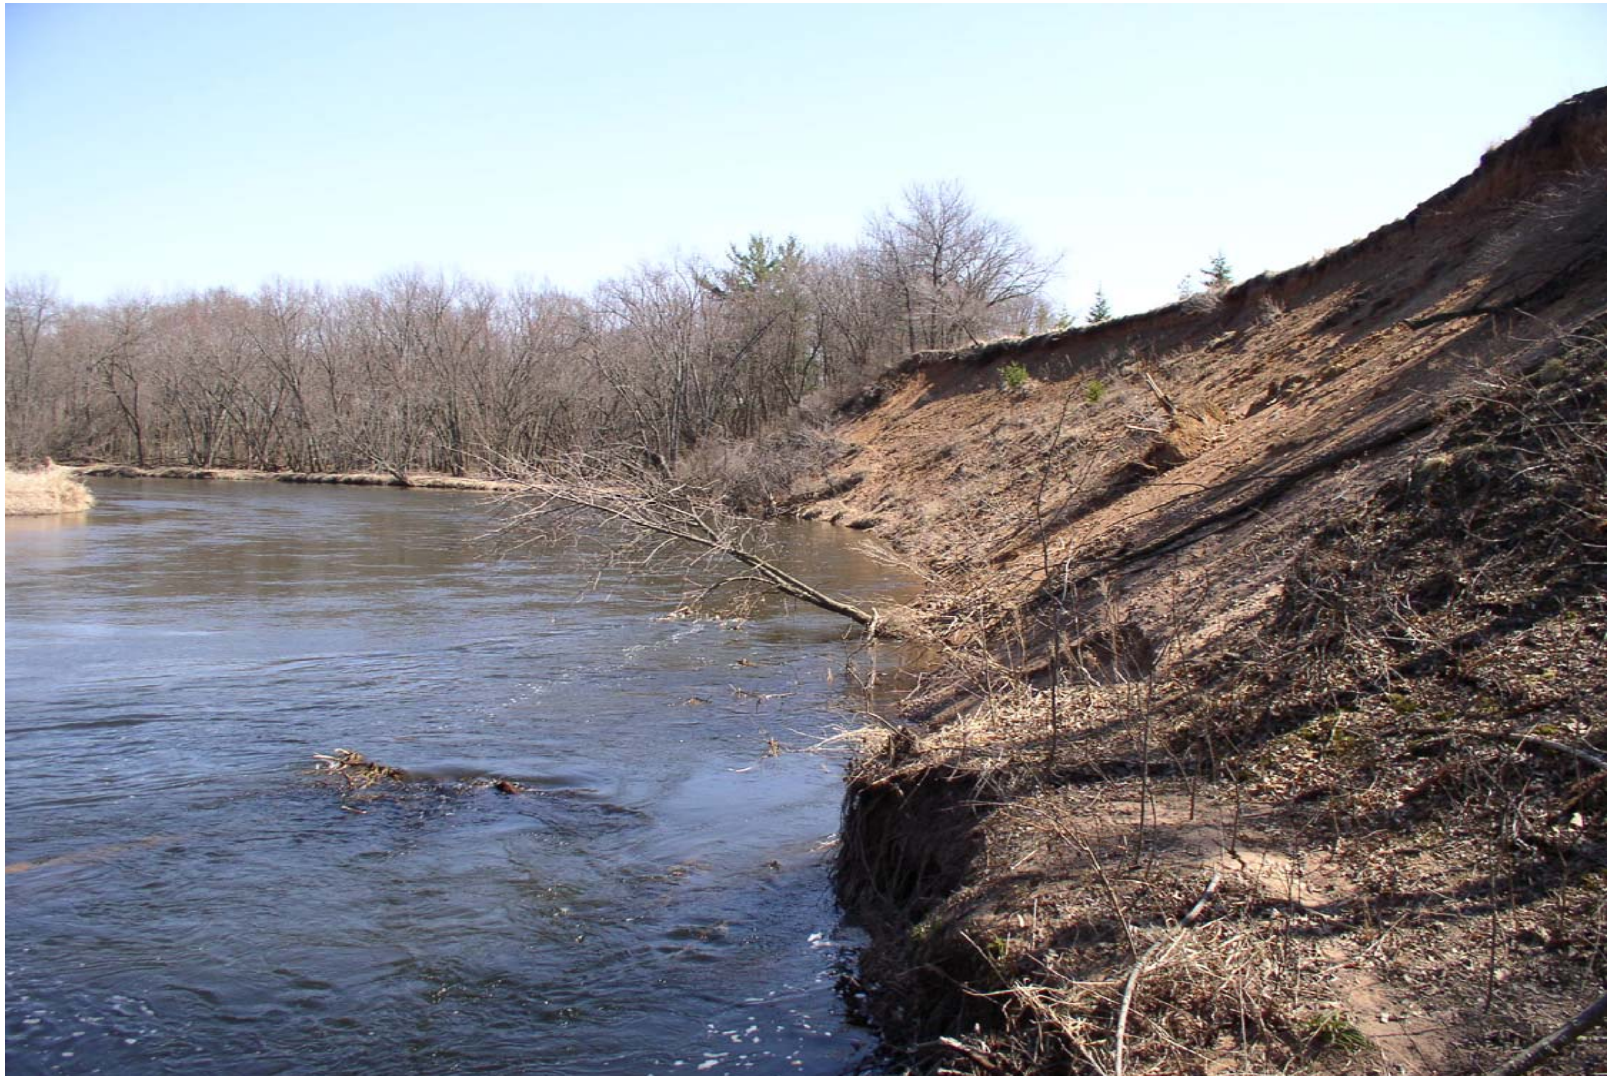
COLFAX SCHOOL BANK

50 FEET HIGH, 300 FEET LONG, EST. 556 CU. YDS./YR.

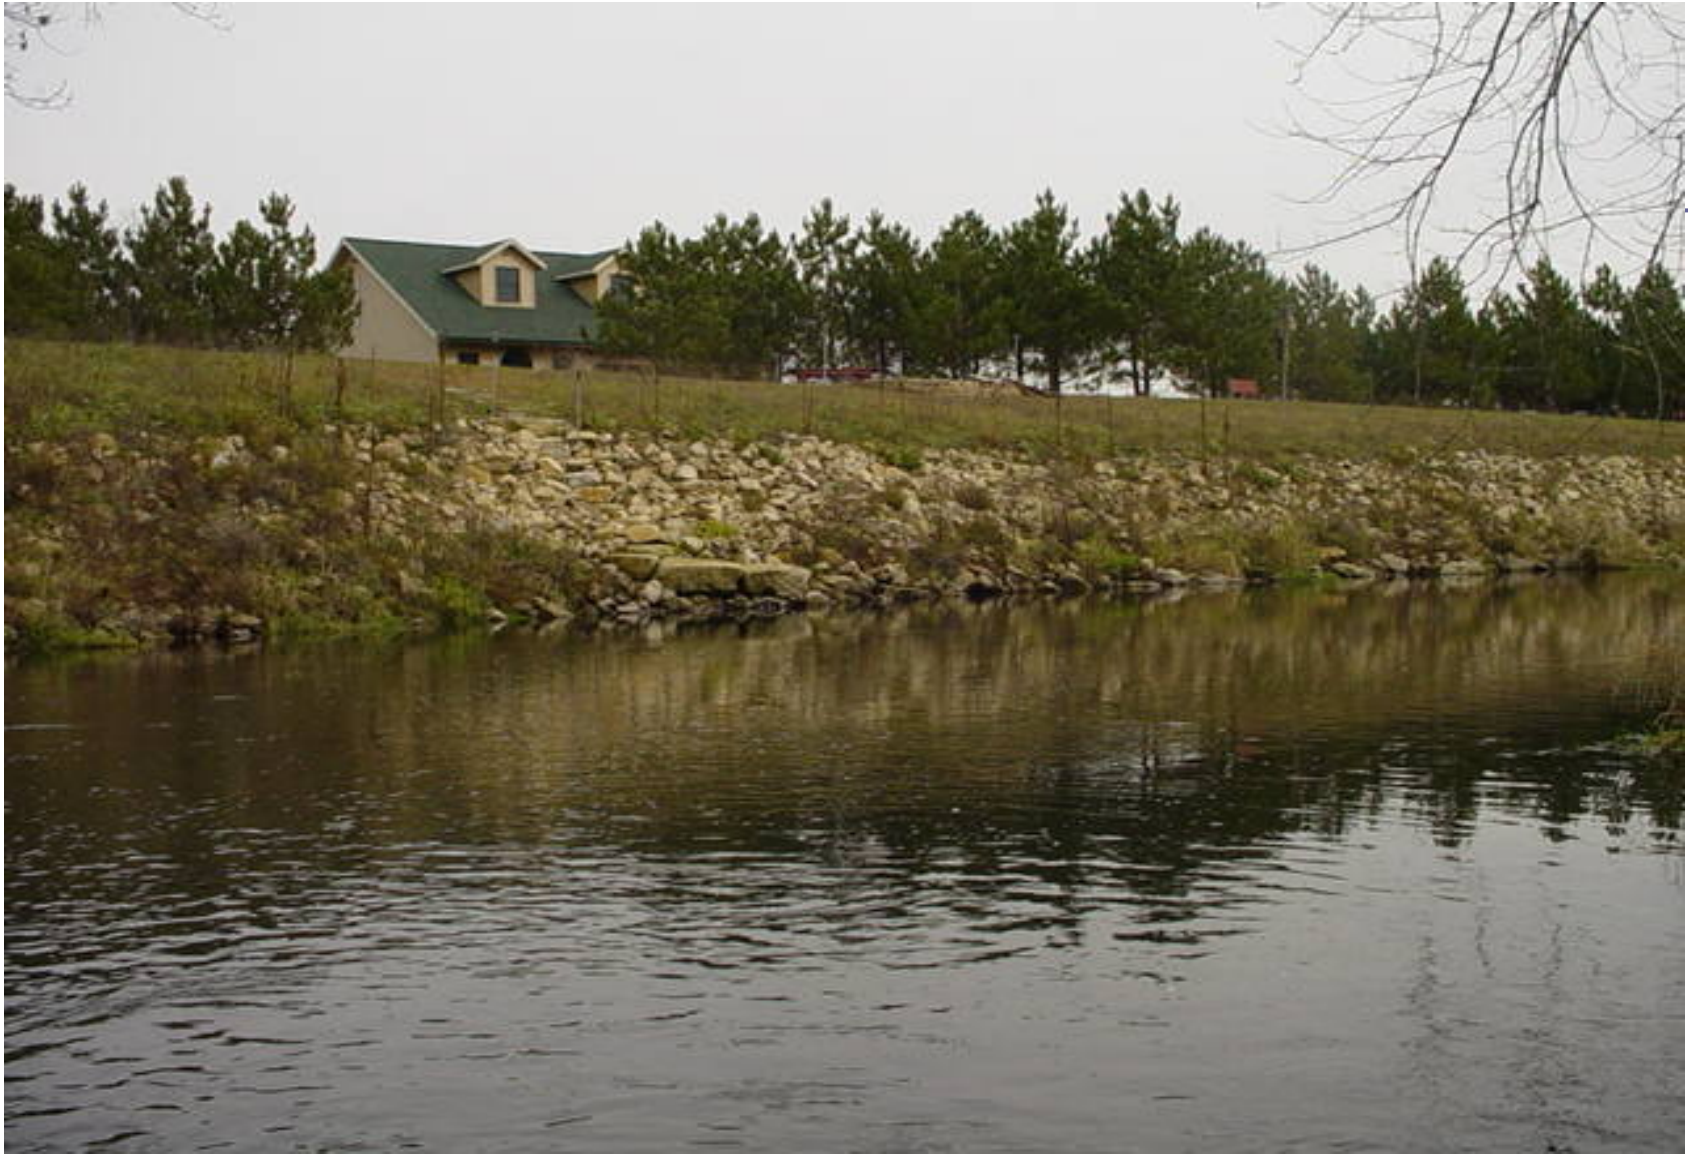
HAY RIVER, RIP RAP INSTALLED IN 2005
