**Hybrid Water Milfoil (*Myriophyllum spicatum* X
Myriophyllum sibiricum) Rapid Assessment Survey and
Diver Hand Removal Results for Horseshoe Lake
Polk/Barron County, Wisconsin
WBIC: 2630100**

**Survey Conducted by and Report Prepared by:
Endangered Resource Services
Matthew S. Berg, Research Biologist
St. Croix Falls, Wisconsin**

June 29, 2007; Revised July 30, 2007

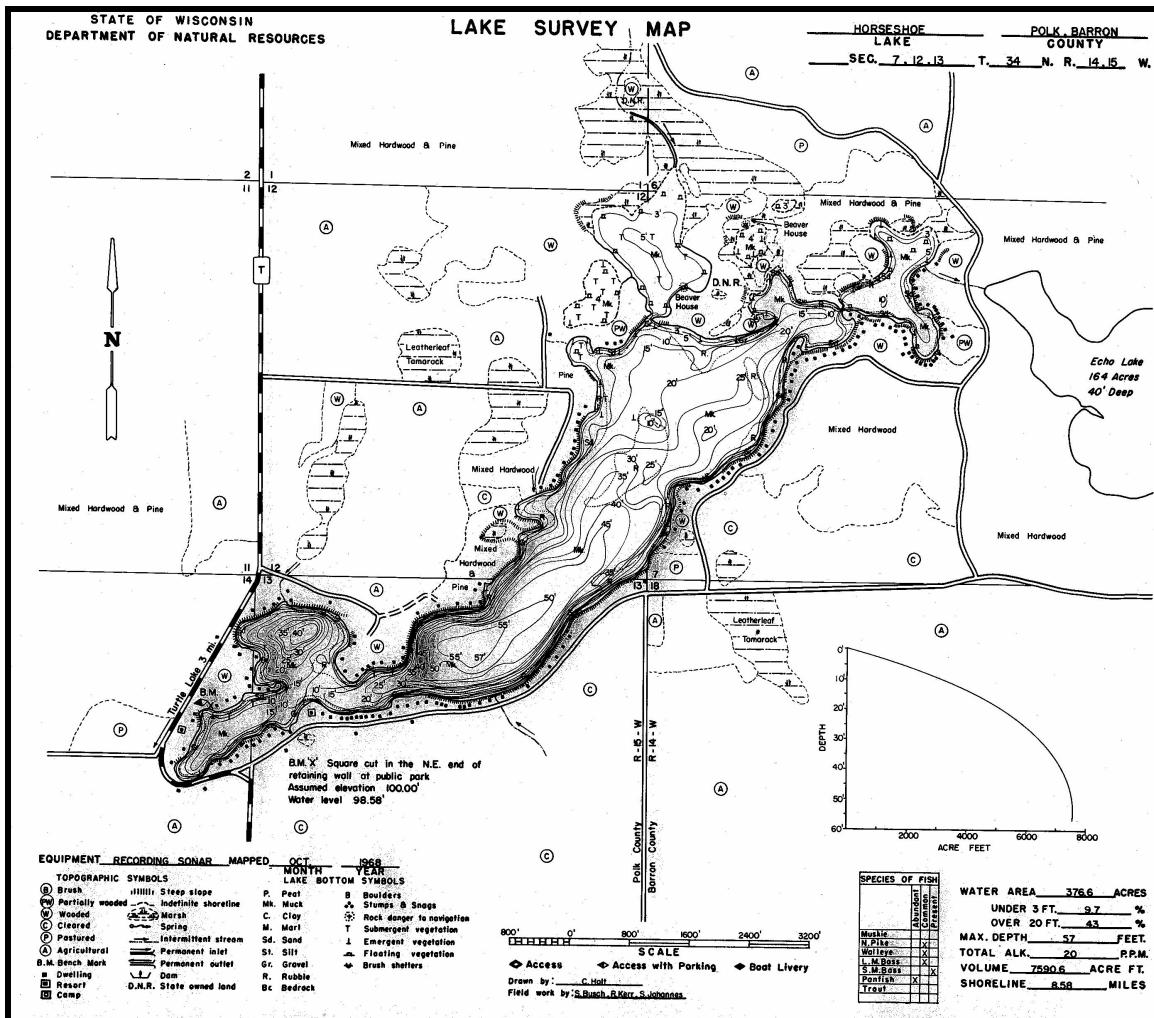
Horseshoe Lake (WBIC 2630100) is a 398-acre, mesotrophic, stratified, seepage lake located on the border of Polk and Barron Counties in northwest Wisconsin in the Town of Beaver (T34N R14W S06). The lake achieves a maximum depth of 57ft in the central basin, and has an average depth of approximately 25ft. The bottom is predominately sand and rock in the central basin with scattered patches of muck located throughout. Muck bottoms are more common, and have a higher organic content (brown in color) in the lake's sheltered bays on the northeast end. Water clarity is good with Secchi visibility at depths of up to 18ft. under normal summer conditions (WDNR 2007).

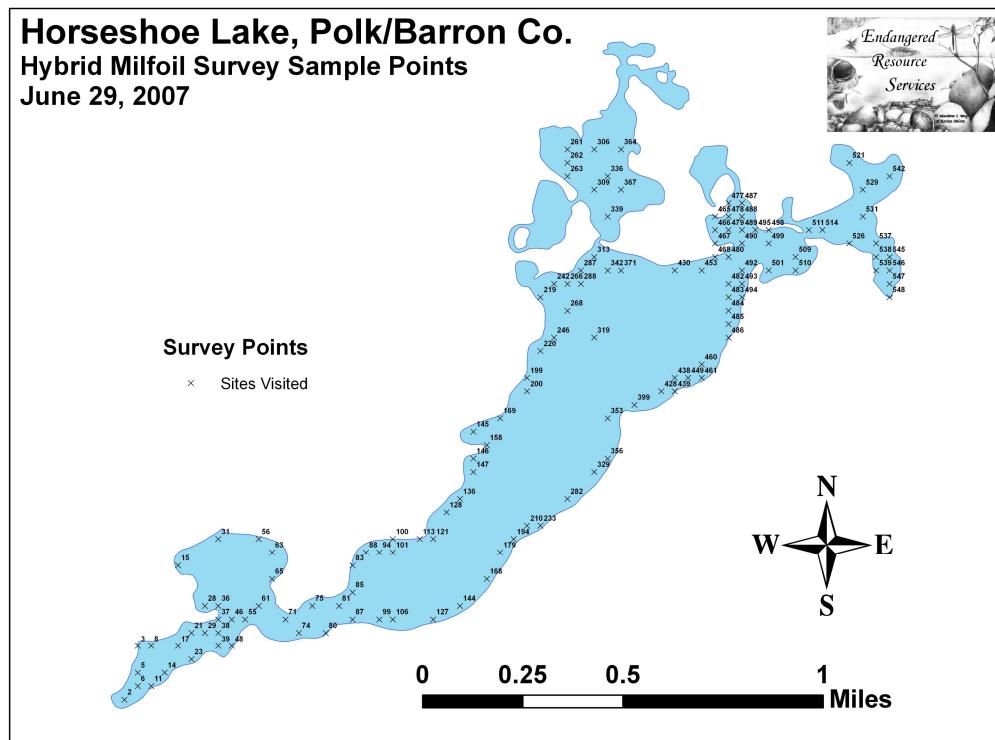
Figure 3: Rapid Survey Sample Points

We surveyed 131 points (Figure 3) for Hybrid water milfoil and Curly-leaf pondweed (*Potamogeton crispus*).

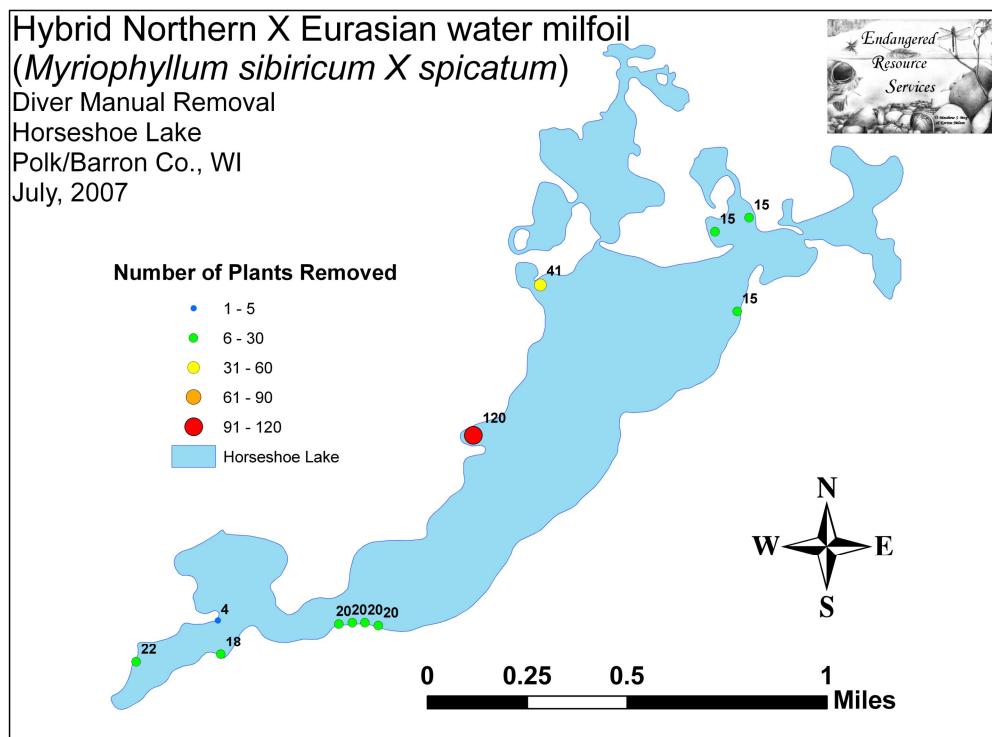
Figure 6: Hybrid Water Milfoil Removal Sites

Divers removed approximately 330 plants/stem clusters from 12 general areas on the lake over a two day period (Figure 6). Similar to the previous survey, divers found that HWM plants were widely distributed throughout the lake, but plant density was extremely low. With few exceptions, divers reported that plants were single or in small groups. Most were found growing in 3-12ft of water over muck bottoms. Common associate species include Fern pondweed (*Potamogeton robbinsii*), Small pondweed (*Potamogeton pusillus*), and Clasping-leaf pondweed (*Potamogeton richardsonii*). Two points of concern that should be revisited early in the 2008 growing season were the areas around sites 466 and 488 where scattered individuals were found growing among the lily pads. Looking before the lily pads canopy would make it easier to assess the level of HWM at these points. This bay also contained the lake's only known population of the state listed species Farwell's water milfoil.

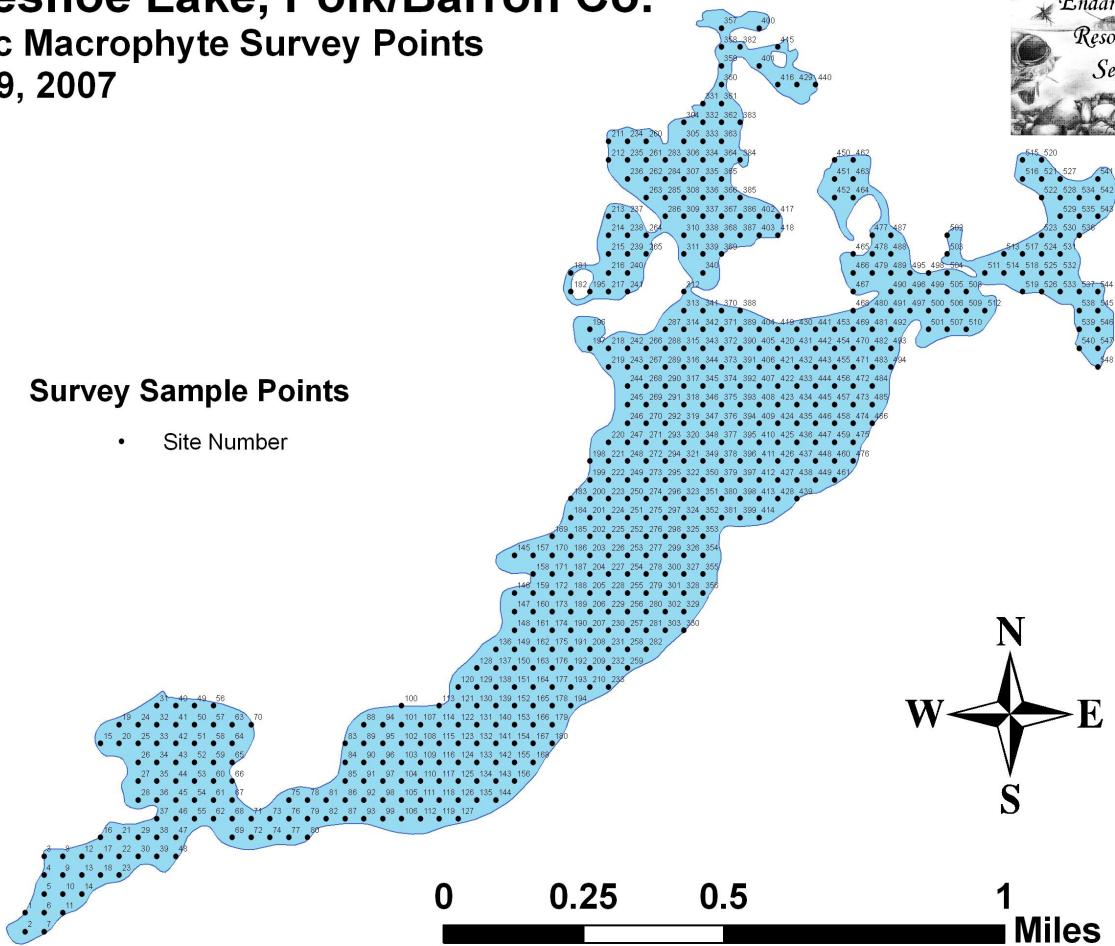
Appendix I: Horseshoe Lake Map with Sample Points

Aquatic Macrophyte Survey Points

June 29, 2007
