PURPLE LOOSESTRIFE ASSESSMENT – 2019

**Dells Pond, Chippewa Falls Flowage, Lake Wissota, Old Abe Flowage,
Cornell Flowage, Holcombe Flowage, and Jim Falls Spillway Channel**

**Xcel Energy
P.O. Box 8
Eau Claire, WI 54702**

October 27, 2019

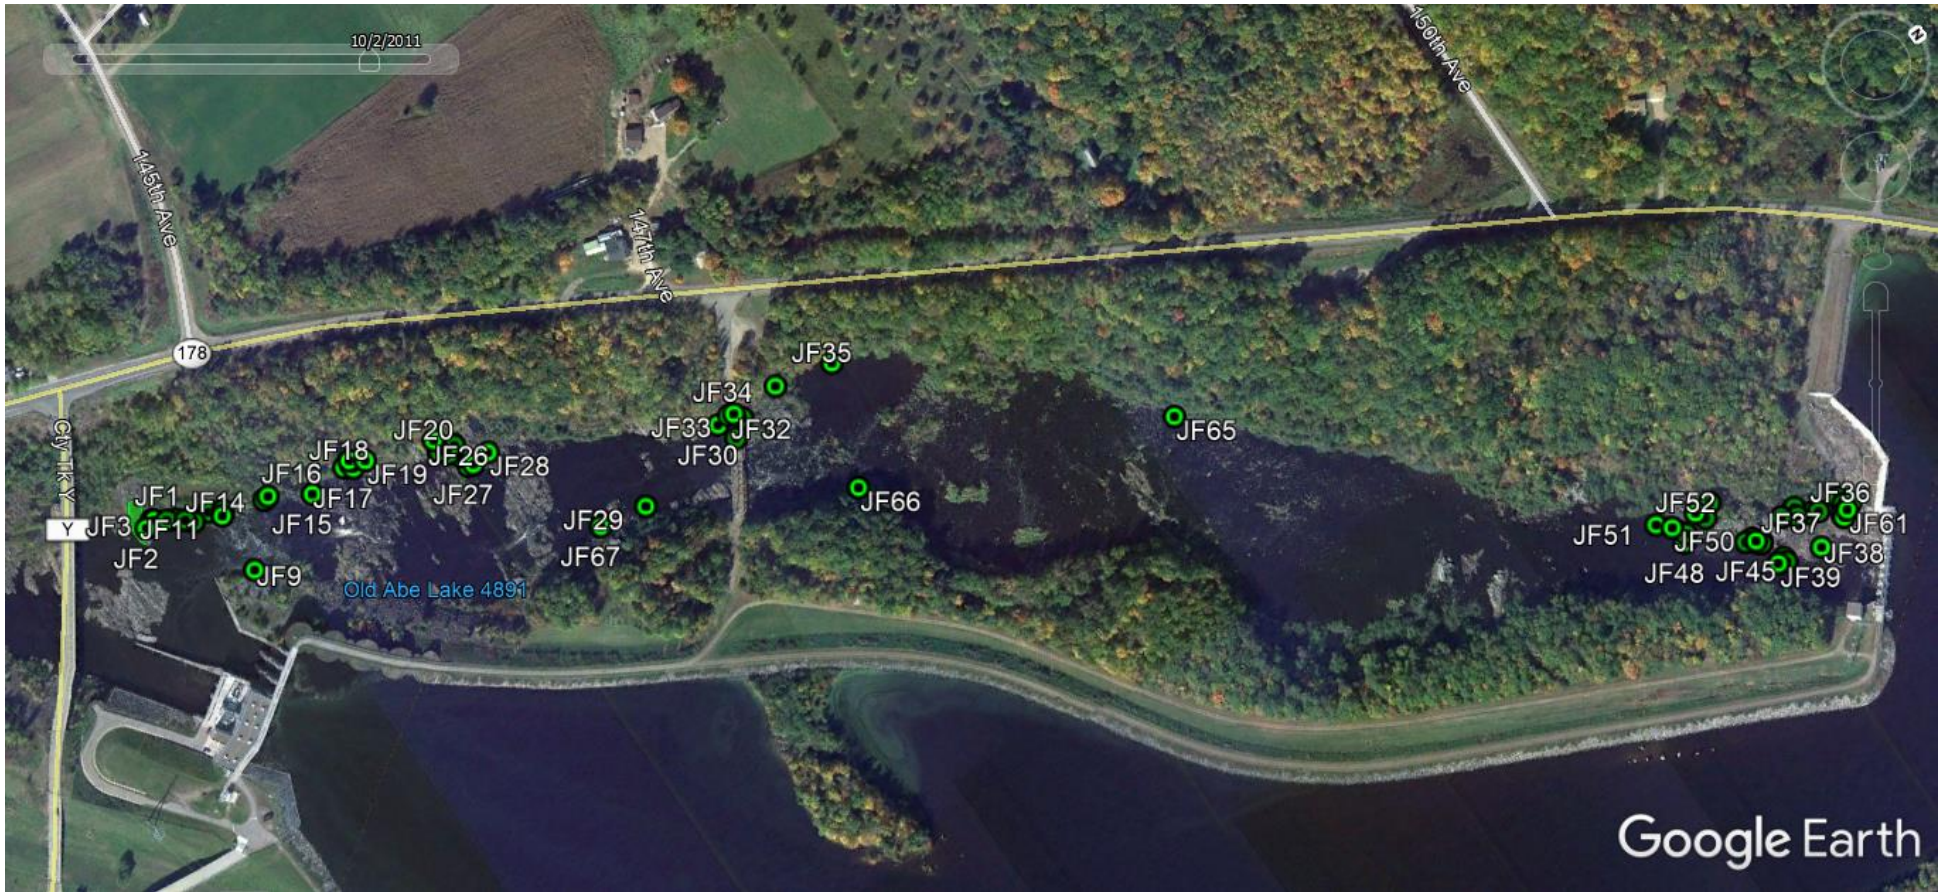
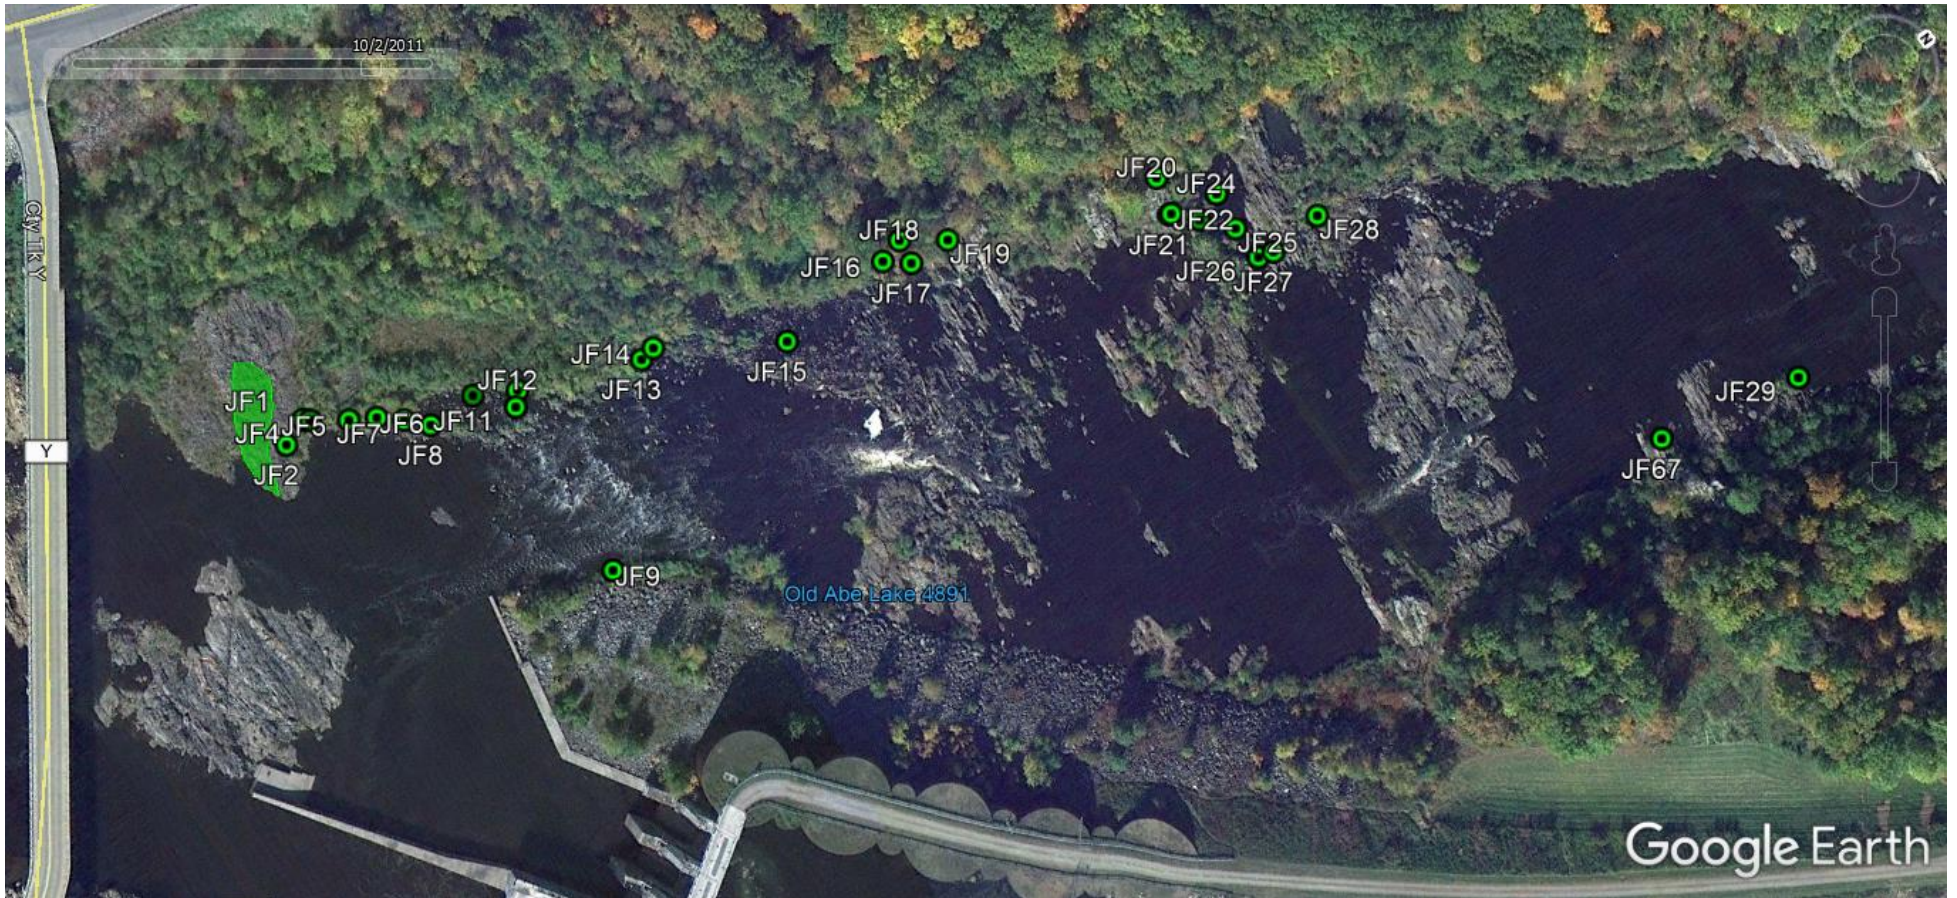
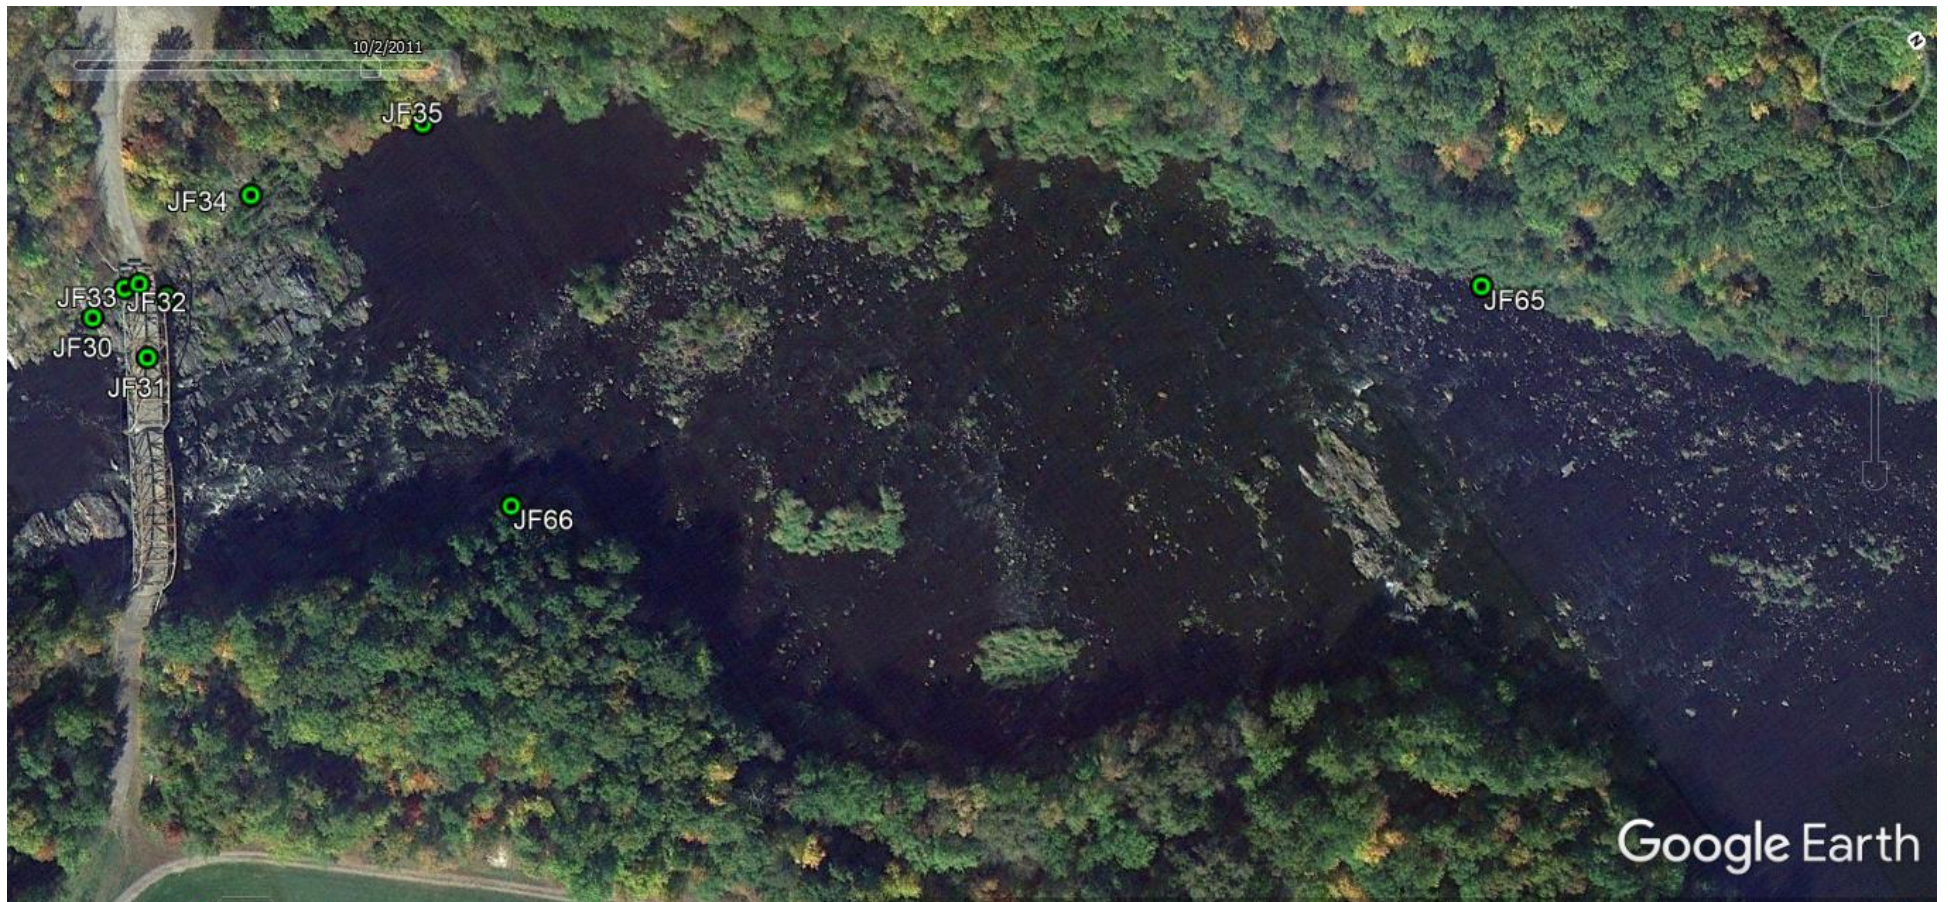
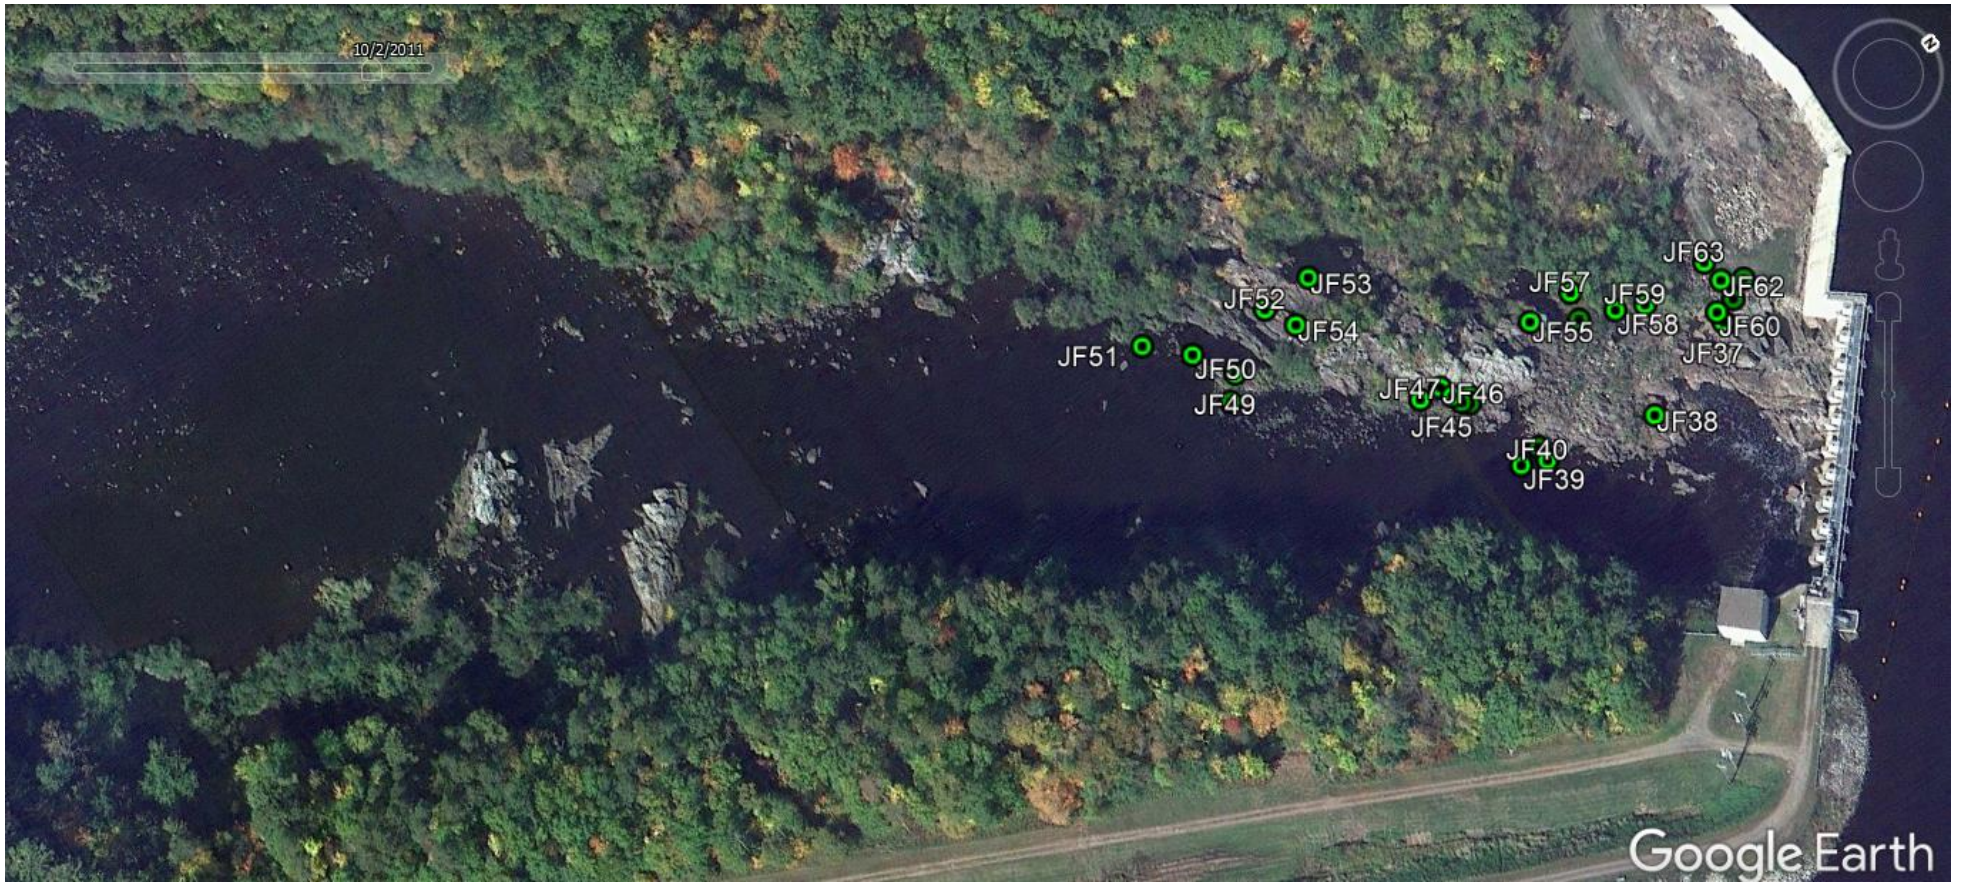
Jim Falls Spillway Channel Purple Loosestrife Assessment – 2019 (Map 1 of 4)

The minimum flow channel at Jim Falls Hydro remains infested with a relatively high concentration of purple loosestrife plants. A significant decrease in the number of plants was noted in 2012 followed by a rebound in 2013 and 2014 and another decline in 2015 and increase in 2016. In 2017, the amount of loosestrife again was seen to decrease and the 2018 survey revealed almost no change from the previous year (Table 3). In 2019, the area again saw somewhat of a rebound in loosestrife infestation. Loosestrife was found scattered throughout the channel, with the lower third being moderately infested (see maps of Jim Falls Spillway Channel). The area of greatest concentration occurs just upstream from the County Highway Y Bridge (see Jim Falls Spillway map 2). The coverage of loosestrife in this area has steadily decreased, however, from approximately 5,431 square feet in 2017 to 3,600 square feet in 2018, and now 2,556 square feet in 2019 (Table 4). The loosestrife is scattered throughout the area and therefore is not classified as abundant. A steady decline in the overall density of the plants in this area has also been noted over the last several years. The number of loosestrife sites and length of infected shoreline in both the upper and lower portions of the spillway channel increased slightly from last year. Collectively, these locations accounted for 329 feet of infested shoreline versus 262 feet in 2018. Most of these locations were

comprised of small plant clumps infesting between one and ten feet of shoreline, with a few more significant areas of infestation.

Nine years have passed since the introduction of the bio-control beetles into the Jim Falls minimum flow channel. While it is difficult to make a determination as to their success, the fact that the density of loosestrife in the lower area of the spillway channel continues to decrease, and the fact that loosestrife infestation in the remaining portion of the channel appears to be stabilizing are encouraging.
