Presque Isle Wilderness Waters Program

Aquatic Plant Management Plan – Round Lake

White Water Associates, Inc.
Dean Premo, Ph.D.
429 River Lane, P.O. Box 27
Amasa, Michigan 49903

Date: May 2018

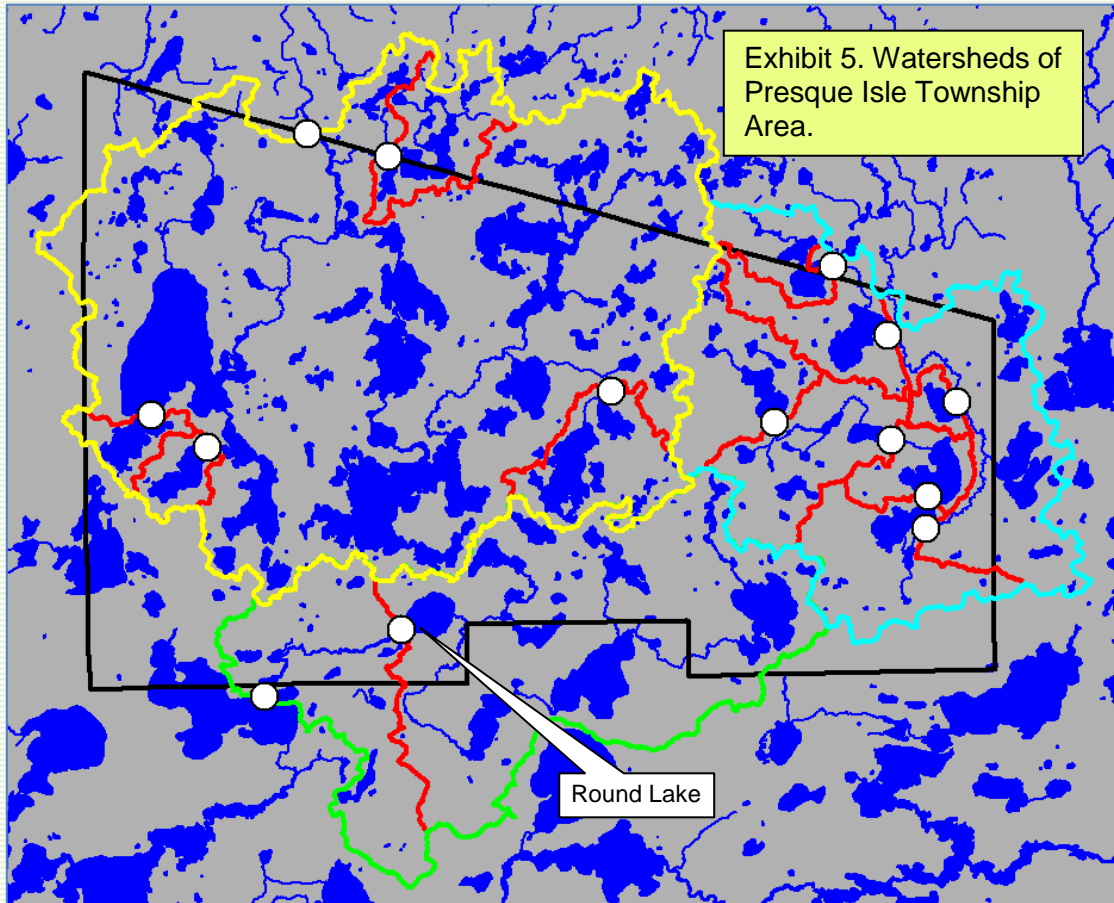
Description: Portions of 3 federal hydrologic sub-watersheds are illustrated: (1) S.Br. Presque Isle River (bounded by yellow), (2) Pomeroy Cr-E.Br. Presque Isle River (bounded by blue and yellow), and (3) Rice Cr. (bounded by green, yellow, and blue). Also shown are the smaller watersheds of individual water bodies subject to the Wilderness Waters studies (bounded by red). White dots show outlet points for the smaller watersheds.

The Presque Isle Township waterscape sits on a large-scale watershed divide. Some of the water drains north through the Presque Isle River system and eventually enters Lake Superior. Some of the water drains into the Wisconsin River system to the Mississippi River and to the Gulf of Mexico. In fact there are two federal hydrologic sub-basins (designated by 8-digit HUC codes) that include Presque Isle Township. The Black-Presque Isle Rivers sub-basin (HUC#04020101) drains north to Lake Superior and the Flambeau River sub-basin (HUC#0705002) drains southwesterly to the Mississippi River. The Black-Presque Isle Rivers sub-basin contains two federal hydrologic sub-watersheds within Presque Isle Township: the South Branch Presque Isle River sub-watershed (HUC#040201010303) and the Pomeroy Creek-East Branch Presque Isle River sub-watershed (HUC#040201010301). The Flambeau River sub-basin contains one sub-watershed within Presque Isle Township: the Rice Creek sub-watershed (HUC#07050020103). Exhibit 5 illustrates these watersheds and the watersheds of the water bodies subject to the Wilderness Waters Program studies. Round Lake is contained within the Rice Creek sub-watershed (Exhibit 5).

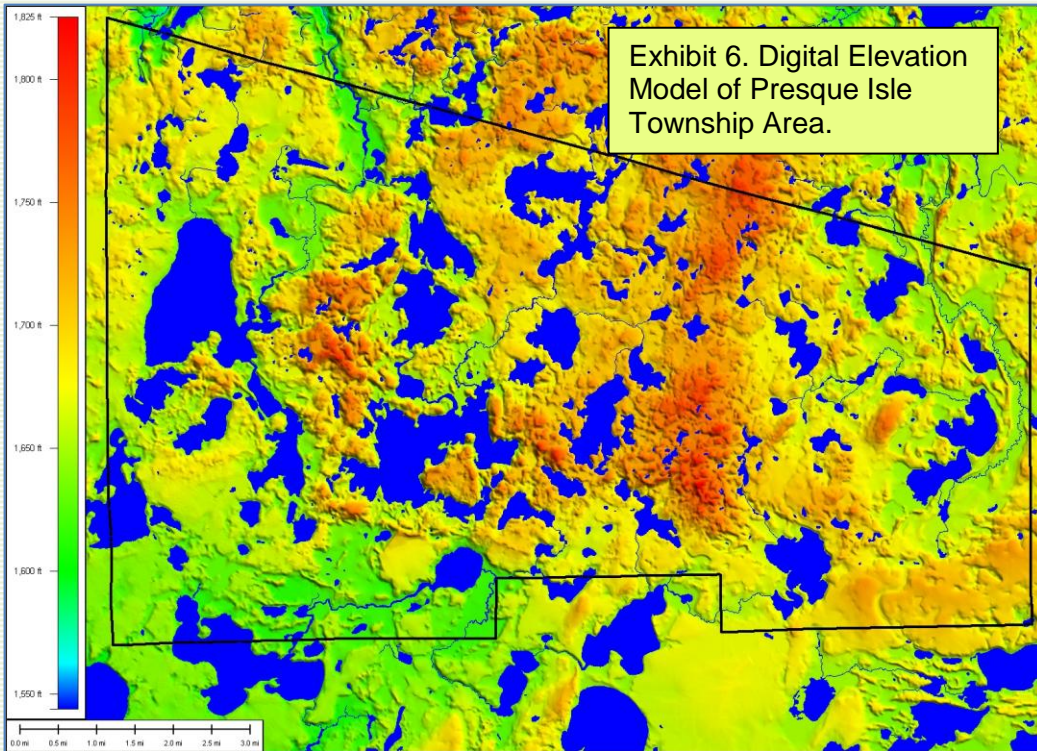
The elevation in Presque Isle Township ranges from around 1,550 feet above sea level to 1,750 feet above sea level. A digital elevation model is provided as Exhibit 6 and shows the relative elevations for the area with orange areas of the landscape being the highest elevations and greens and blues being the lowest elevations.

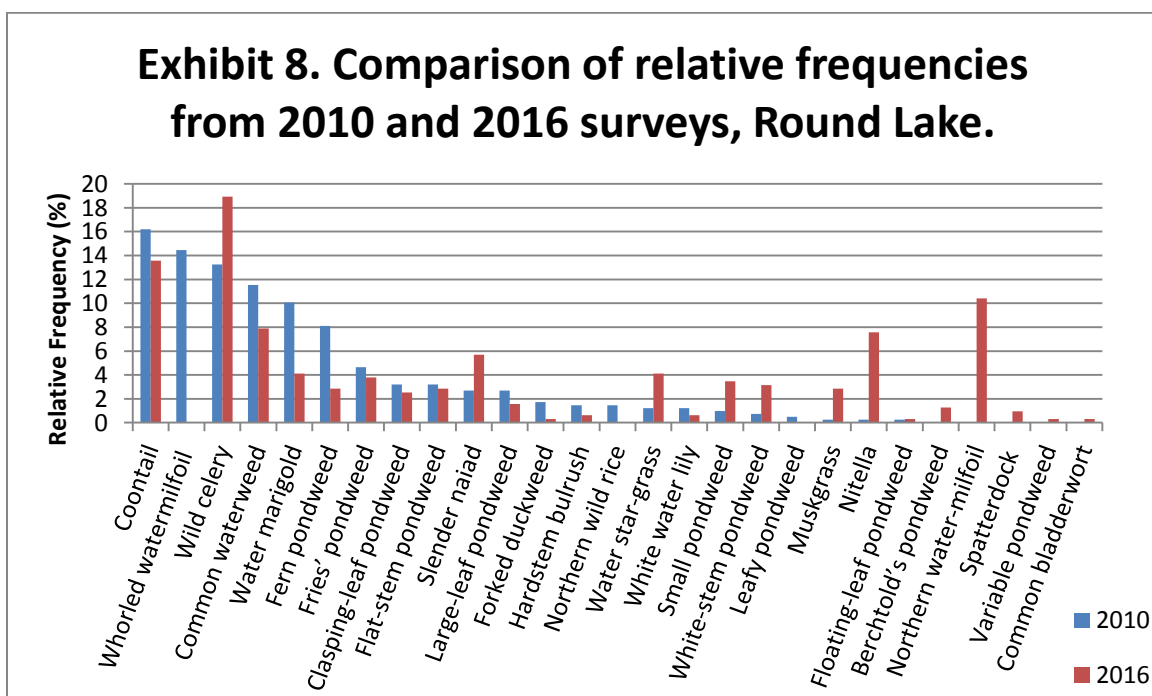
Exhibit 8 displays the relative frequency of plants found in 2010 and 2016. It appears that the distribution of plants was higher in 2010 than in 2016. Also noted is the absence of whorled water-milfoil, but the presence of northern water-milfoil. It's possible that in the 2010 survey, whorled water-milfoil was misidentified and was truly northern water-milfoil.

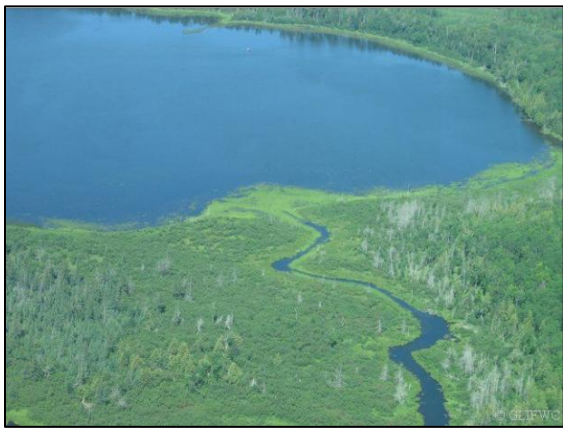
Aerial image of Round Lake (GLIFWC, 2006).

According to the 2010 *Wisconsin Ceded Territory Manoomin Inventory*, “There is consistently a bed of rice on Round Lake in the vicinity of the Rice Creek inlet. Good beds also occur on the outlet, but these are largely confined to the creek rather than the lake proper” (David, 2010).

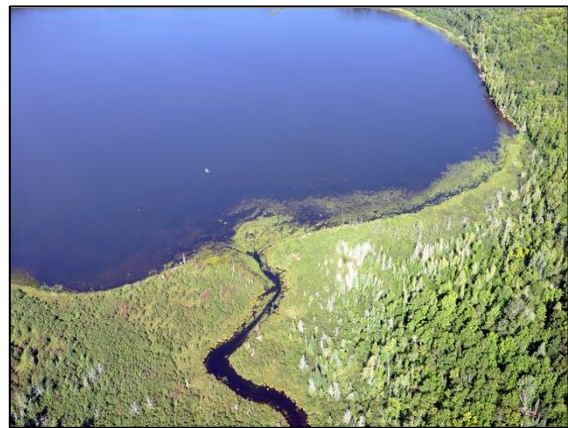
Aerial image of Round Lake (GLIFWC, 2009).

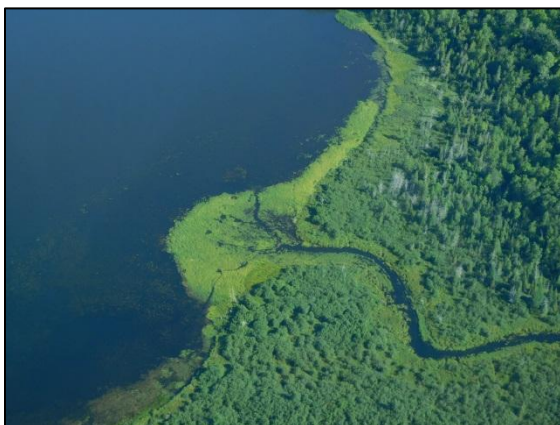
Aerial image of Round Lake (GLIFWC, 2015).

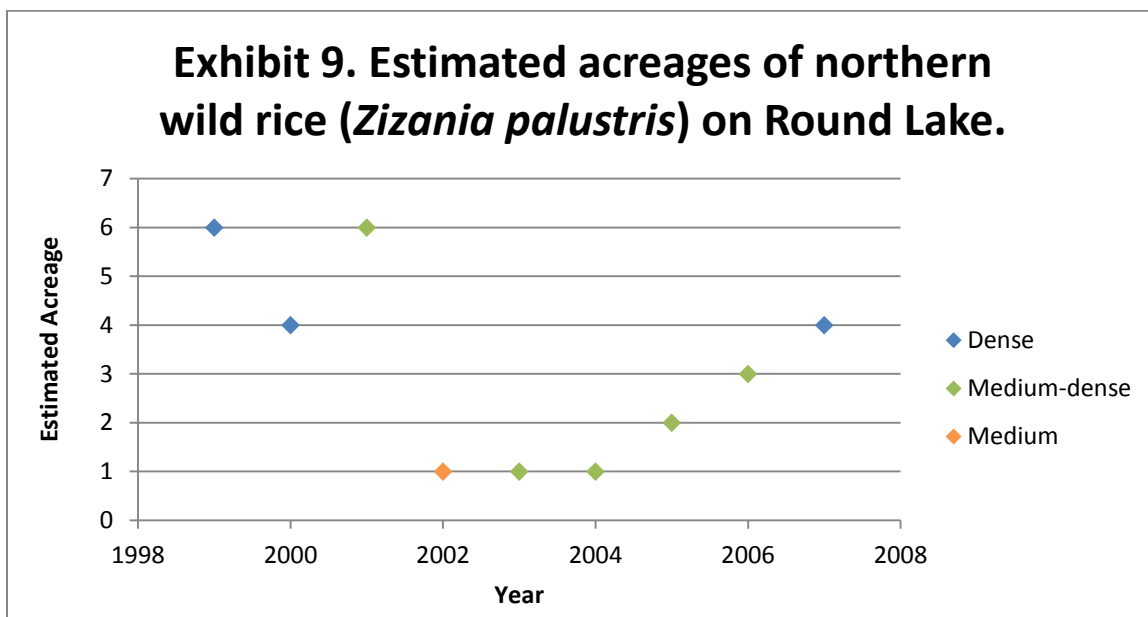
(Adapted from David, 1999-2015)

Exhibit 9 displays GLIFWC’s estimated acreages (via aerial survey) of wild rice in Round Lake. During each survey, estimated density was also recorded (different colors in Exhibit 9). As we can see, the densest rice stands were observed in 1999, 2000 and 2005. Overall, wild rice stands in Round Lake maintained an estimated medium-dense density, even if estimated acreages varied. No density data was available after 2007.

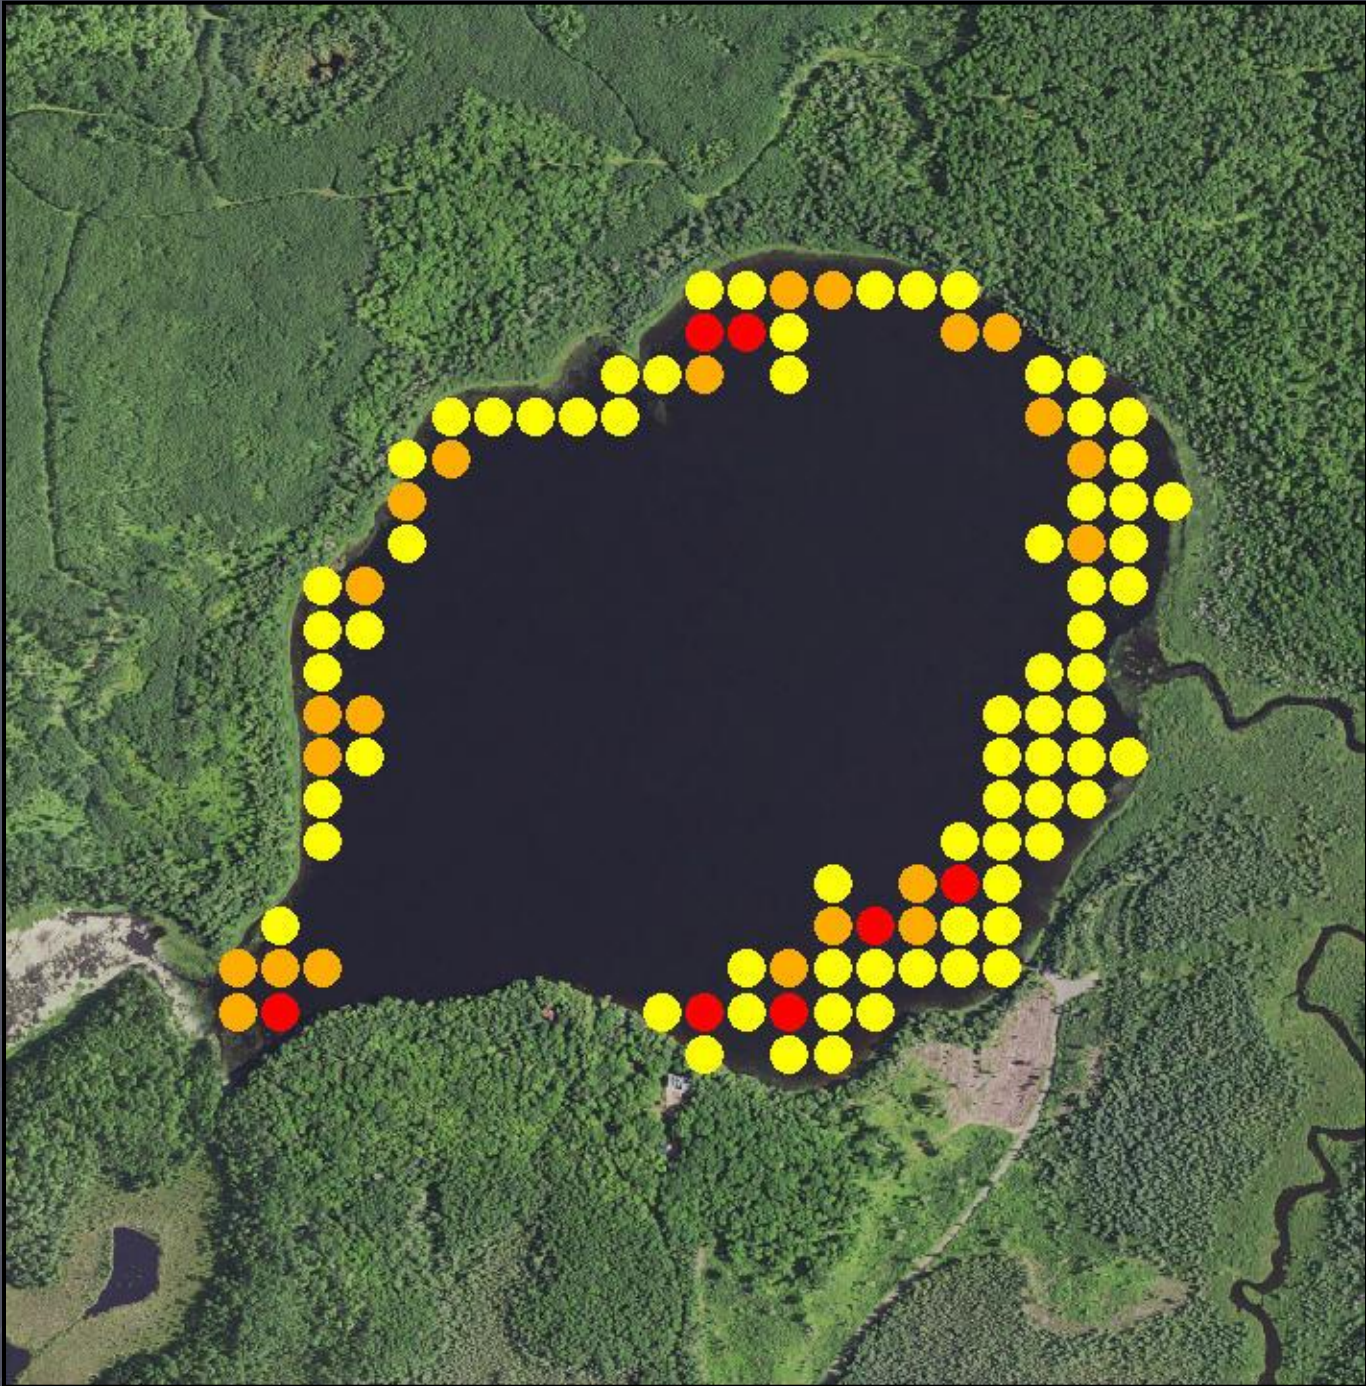
Figure 3. Maximum Depth of Plant Colonization in Round Lake.

The maximum depth of plant colonization is 16.5 feet (Table 1 and Figure 3). Rooted vegetation was found at 98 of the 163 sample sites with depth \leq the maximum depth of plant colonization (60% of sites). These sites are displayed as a black dot within a circle on Figure 4. This indicates that although availability of appropriate depth may limit the distribution of plants, it is not the only habitat factor involved. Substrate is another feature that influences plant distribution (e.g., soft substrate often harbors more plants than hard substrate). Figure 5 presents the substrates encountered during the aquatic plant survey (mud, sand, or rock).

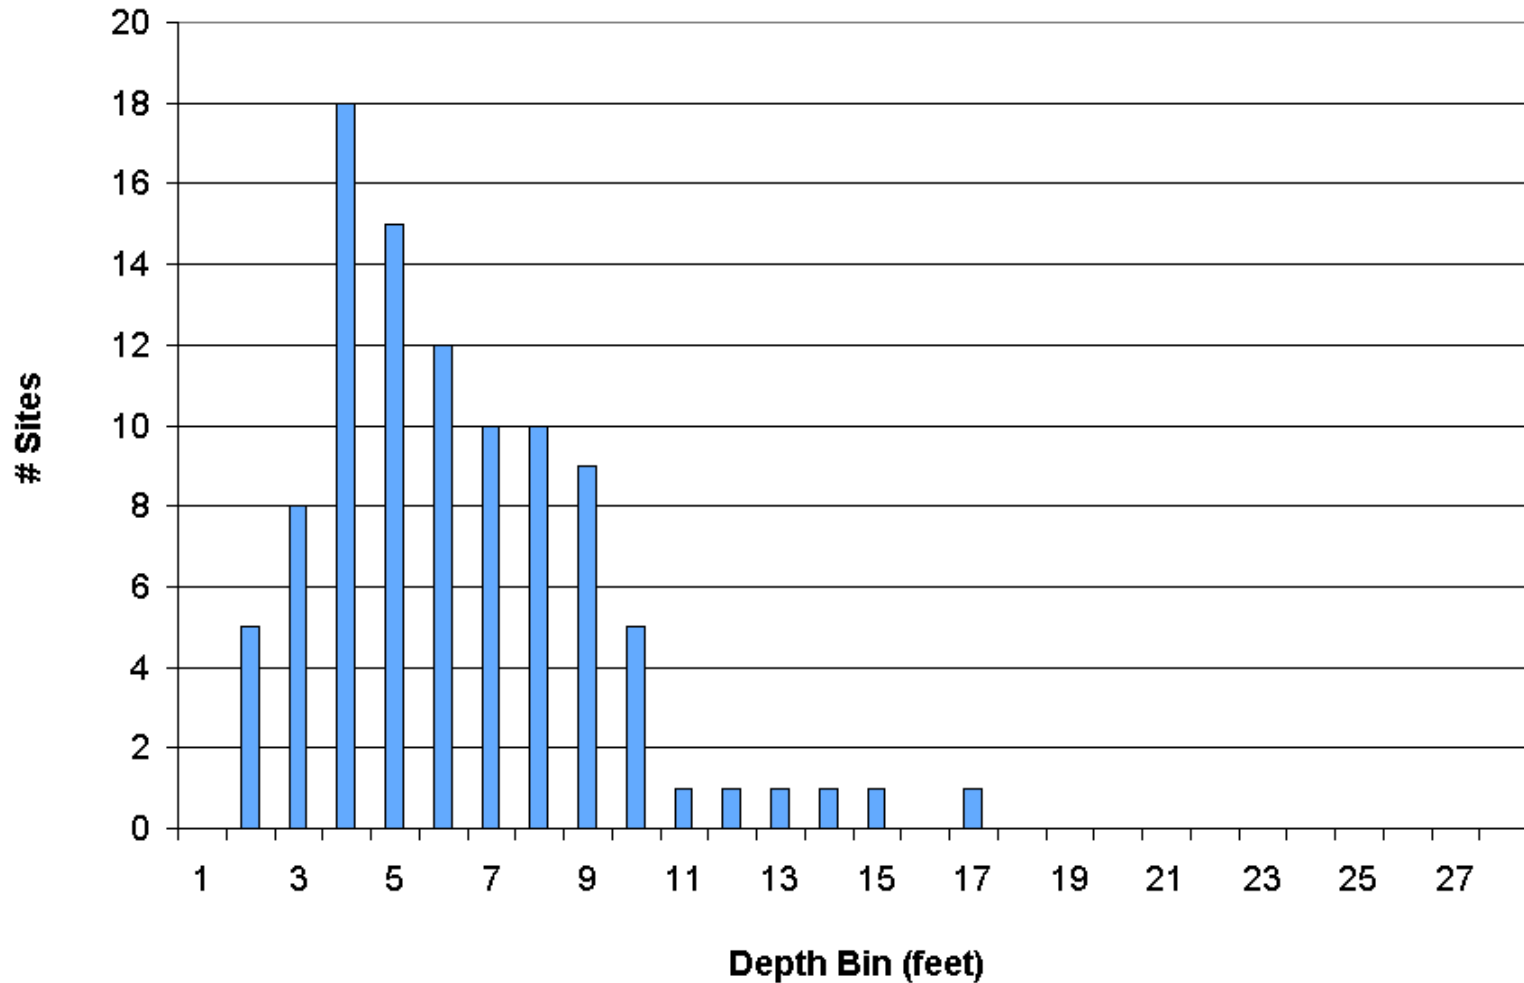
Figure 4. Round Lake sampling sites less than or equal to maximum depth of rooted vegetation (2016).

- Site less than or equal to maximum depth of plant colonization (MDC).
- Plant find(s) at site less than or equal to MDC.

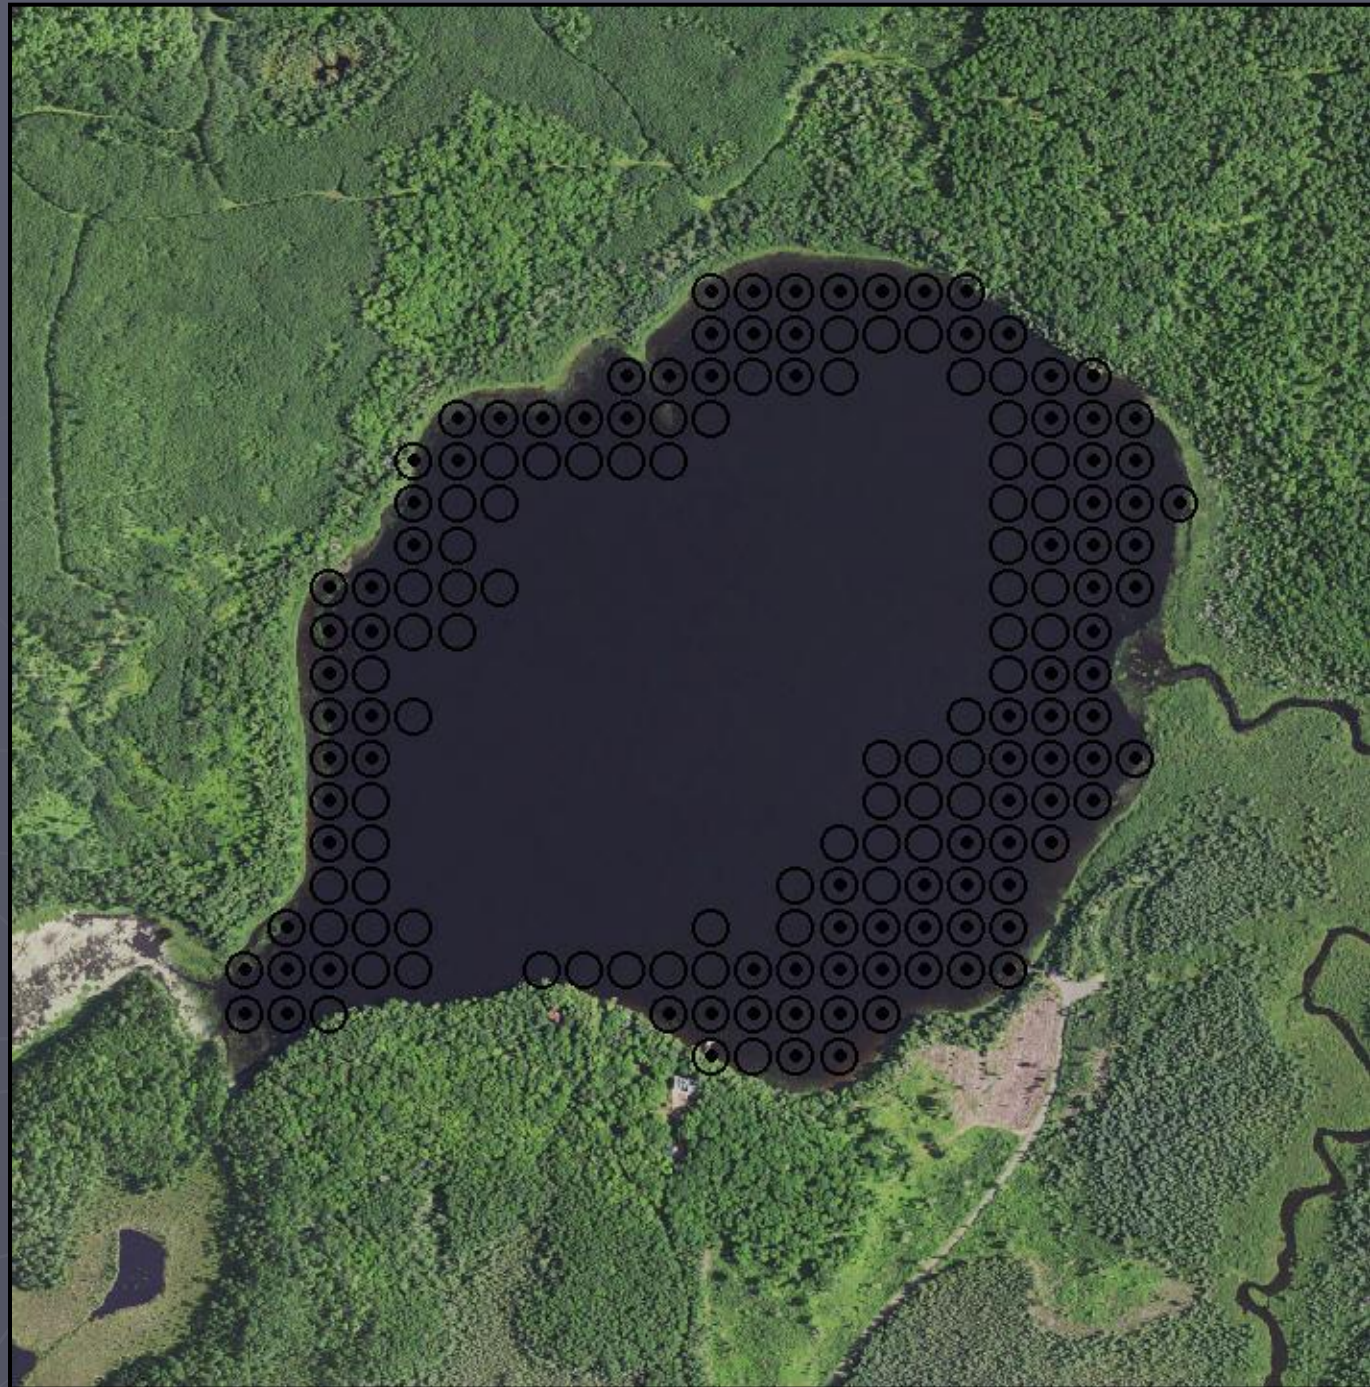
Figure 5. Round Lake substrate encountered at point-intercept plant sampling sites (2016).

- Muck
- Rock
- Sand

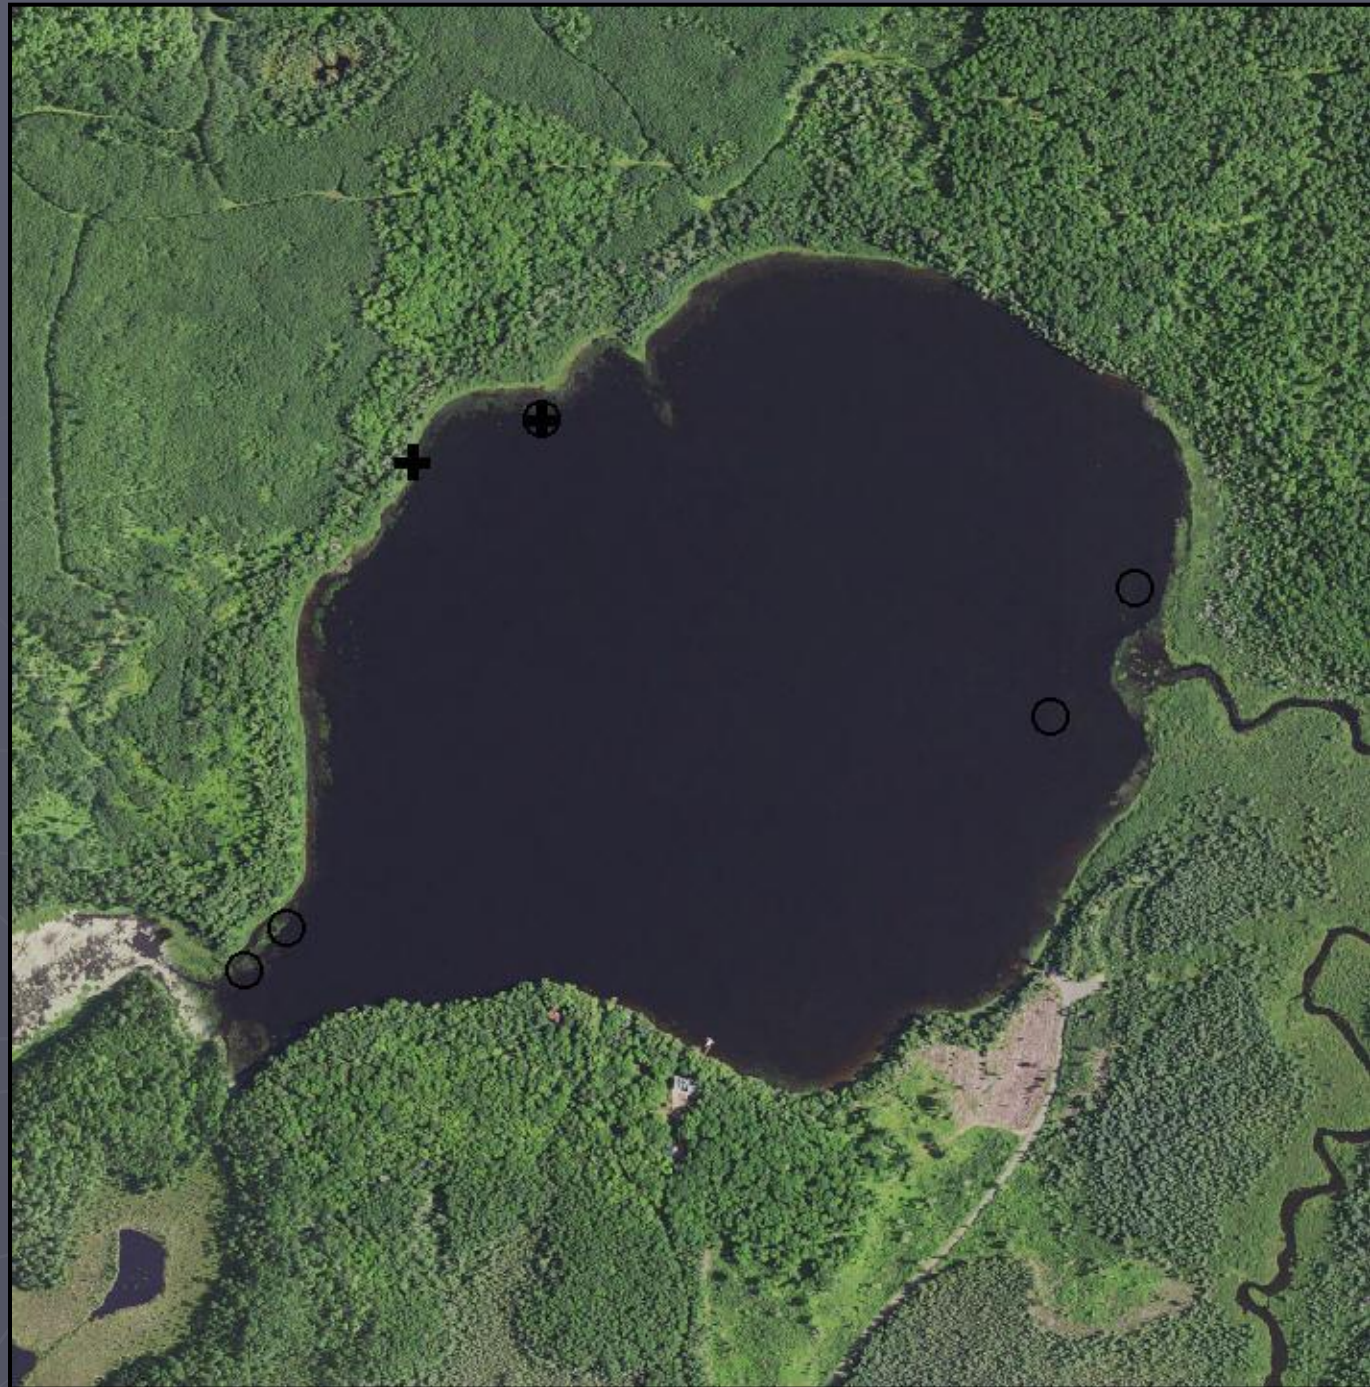
Figure 8. Distribution of plant species, Round Lake (2016).

Vallisneria americana,
Wild celery

- 1 (Rake fullness)
- 2
- 3
- ▼ Visual
- × Not found
- × Unsampled (depth)
- × Non-navigable

Table 2 provides information about the frequency of occurrence of the plant species recorded in the lake. Several metrics are provided, including total number of sites in which each species was found and frequency of occurrence at sites \leq the maximum depth of rooted vegetation. This frequency metric is standardized as a “relative frequency” (also shown in Table 2) by dividing the frequency of occurrence for a given species by the sum of frequency of occurrence for all plants and multiplying by 100 to form a percentage. The resulting relative frequencies for all species total 100%. The relative frequencies for the plant species collected with a rake are graphically displayed in descending order on Figure 6. This display shows that *Vallisneria americana* (wild celery) had the highest relative frequency followed by *Ceratophyllum demersum* (coontail). The lowest relative frequencies are at the far right of the graph. As examples of individual species distributions, we show the occurrences of a few of the most frequently and least frequently encountered plants in Figures 8-16.

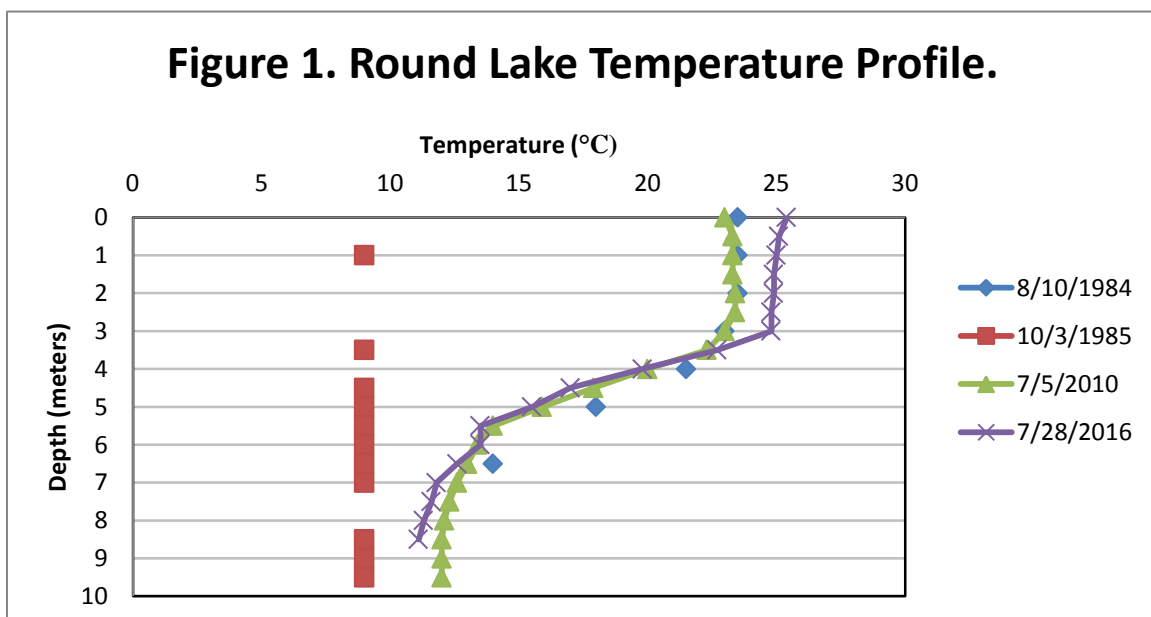
Measuring the temperature of a lake at different depths will determine the influence it has on the physical, biological, and chemical aspects of the lake. Lake water temperature influences the rate of decomposition, nutrient recycling, lake stratification, and dissolved oxygen (D.O.) concentration. Temperature can also affect the distribution of fish species throughout a lake. Figure 1 indicates that the lake stratified between 3 and 5 meters in July and August. Figure 2 shows the lake in October, 1985 had no stratification, which is normal at that time of year.

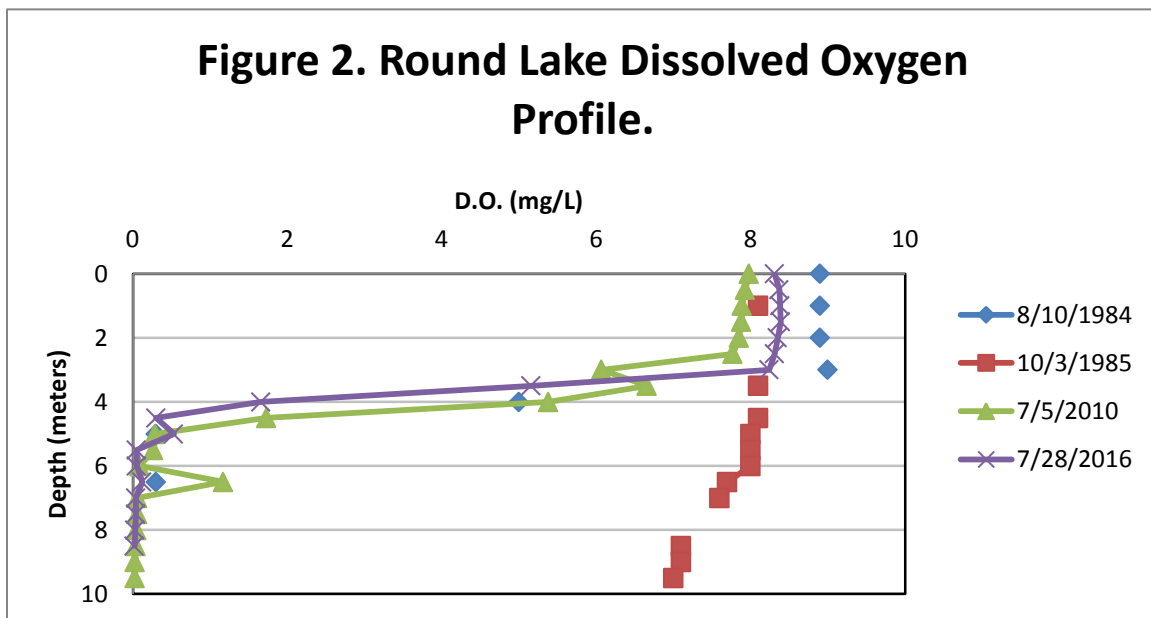
The dissolved oxygen content of lake water is vital in determining presence of fish species and other aquatic organisms. Dissolved oxygen also has a strong influence on the chemical and physical conditions of a lake. The amount of dissolved oxygen is dependent on the water temperature, atmospheric pressure, and biological activity. Oxygen levels are increased by aquatic plant photosynthesis, but reduced by respiration of plants, decomposer organisms, fish, and invertebrates. The amount of dissolved oxygen available in a lake, particularly in the deeper parts of a lake, is critical to overall health. Figure 2 shows 1984, 2010 and 2016 oxygen levels were near zero at 5 meters. In October, 1985, dissolved oxygen levels ranged from 8.1 mg/L at 1 meter to 7 mg/L at 9 meters deep.

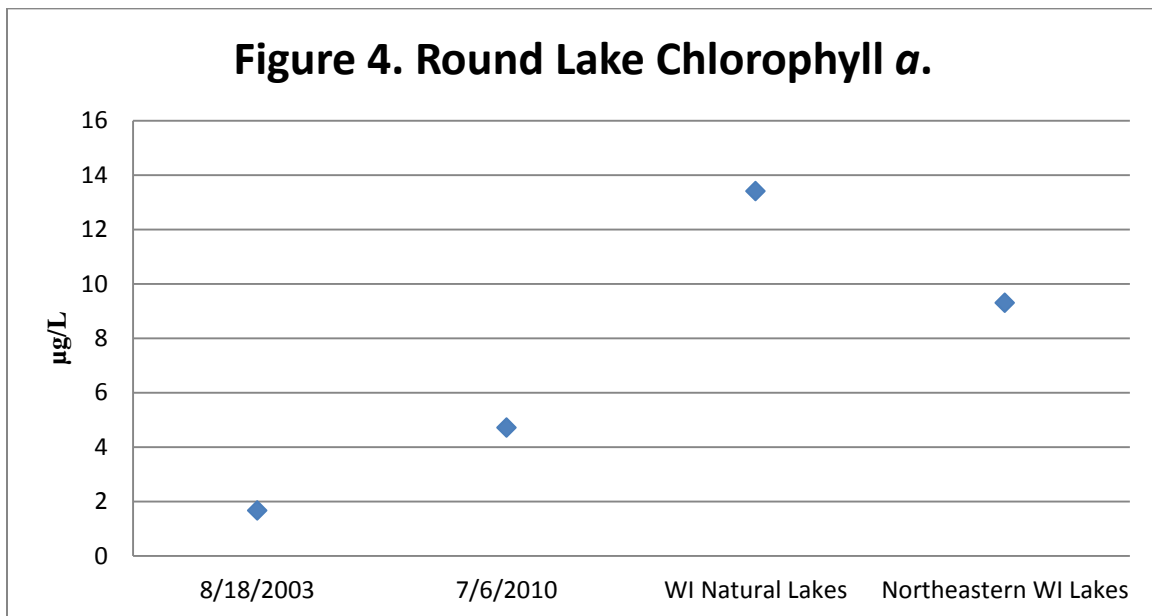
Chlorophyll *a* is the photosynthetic pigment that makes plants and algae green. Chlorophyll *a* in lake water is therefore an indicator of the amount of algae. Chlorophyll *a* concentrations greater than 10 µg/L are perceived as a mild algae bloom, while concentrations greater than 20 µg/L are perceived as a nuisance. Chlorophyll *a* was monitored in Round Lake three times (Figure 4). Figure 4 indicates the chlorophyll *a* levels are low at the times sampled in Round Lake.

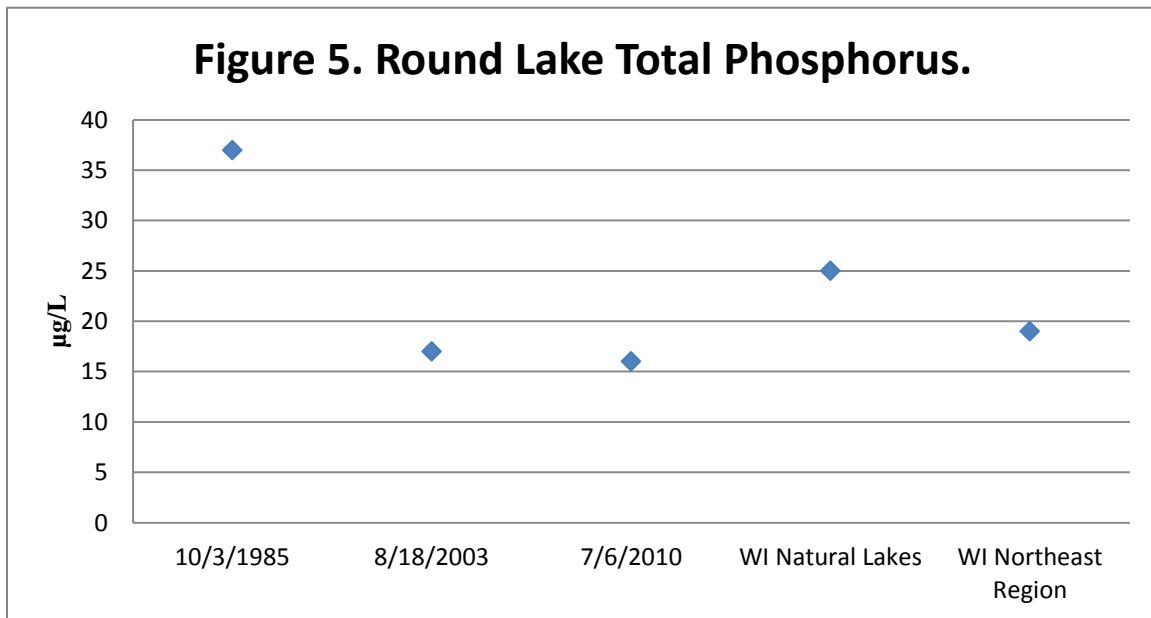
Phosphorus originates from a variety of sources, many of which are related to human activities. Major sources include human and animal wastes, soil erosion, detergents, septic systems and runoff from farmland or lawns (Shaw et al., 2004). Phosphorus provokes complex reactions in lakes. An analysis of phosphorus often includes both soluble reactive phosphorus and total phosphorus. Soluble reactive phosphorus dissolves in the water and directly influences plant growth (Shaw et al., 2004). Its concentration varies in most lakes over short periods of time as plants take it up and release it. Total phosphorus is considered a better indicator of a lake's nutrient status than soluble reactive phosphorus because its levels remain more stable (Shaw et al., 2004). Total phosphorus includes soluble phosphorus and the phosphorus in plant and animal fragments suspended in lake water. Ideally, soluble reactive phosphorus concentrations should be 10 µg/L or less at spring turnover to prevent summer algae blooms (Shaw et al., 2004). A concentration of total phosphorus below 20 µg/L for lakes should be maintained to prevent nuisance algal blooms (Shaw et al., 2004). Round Lake's total phosphorus levels were below nuisance levels in 2003 and 2010 (Figure 5). In 1985, the total phosphorus exceeded 20 µg/L. Figure 6 classifies Round Lake as "fair" in 1985, and "good" in 2003 and 2010, with respect to phosphorus.

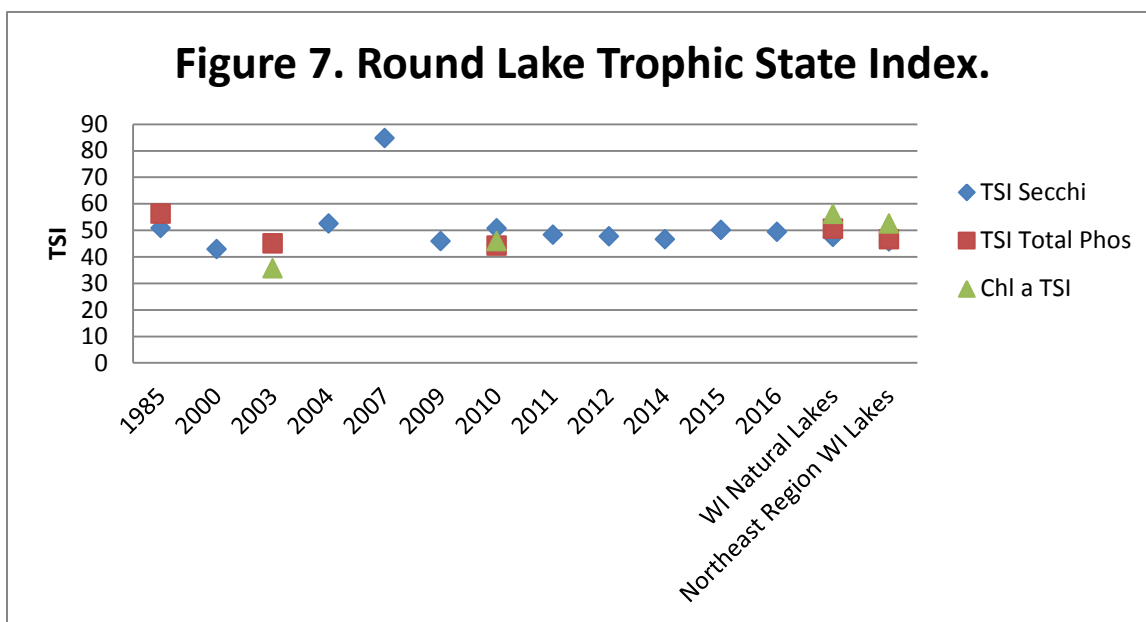
Figure 7 illustrates the Trophic State Index for Round Lake, using chlorophyll *a* and total phosphorus. The TSI shows Round Lake to be “mesotrophic” (Table 2).

30-40	Oligotrophic: clear, deep water; possible oxygen depletion in lower depths; few aquatic plants or algal blooms; low in nutrients; large game fish usual fishery
40-50	Mesotrophic: moderately clear water; mixed fishery, esp. panfish; moderate aquatic plant growth and occasional algal blooms; may have low oxygen levels near bottom in summer
50-60	Mildly Eutrophic: decreased water clarity; anoxic near bottom; may have heavy algal bloom and plant growth; high in nutrients; shallow eutrophic lakes may have winterkill of fish; rough fish common
60-70	Eutrophic: dominated by blue-green algae; algae scums common; prolific aquatic plant growth; high nutrient levels; rough fish common; susceptible to oxygen depletion and winter fishkill
70-80	Hypereutrophic: heavy algal blooms through most of summer; dense aquatic plant growth; poor water clarity; high nutrient levels

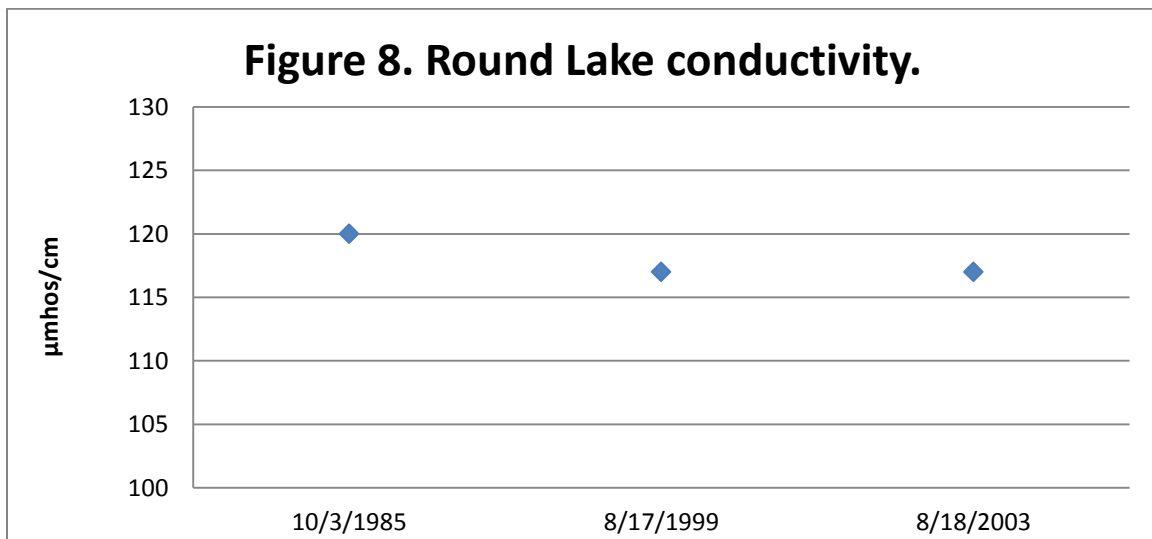
Conductivity is a measure of the ability of water to conduct an electric current. Conductivity is reported in micromhos per centimeter ($\mu\text{mhos/cm}$) and is directly related to the total dissolved inorganic chemicals in the water. Usually, values are approximately two times the water hardness, unless the water is receiving high concentrations of human-induced contaminants (Shaw et al., 2004). Conductivity in Round Lake was around 120 $\mu\text{mhos/cm}$ in 1985, but remained around 117 $\mu\text{mhos/cm}$ in 1999 and 2003 (Figure 8).

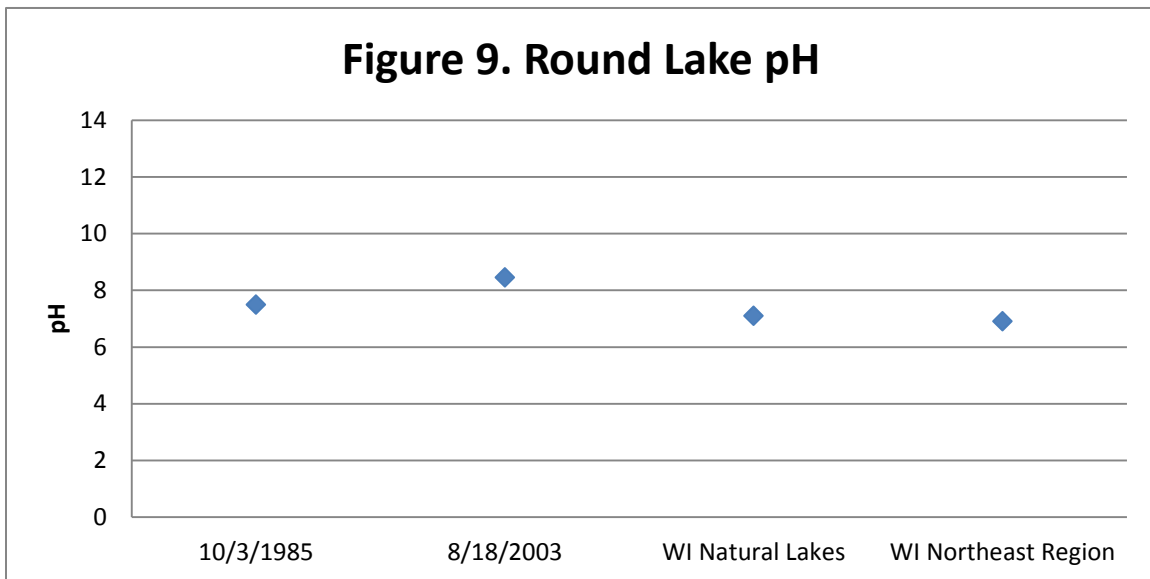
The acidity level of a lake's water regulates the solubility of many minerals. A pH level of 7 is considered neutral. The pH level in Wisconsin lakes ranges from 4.5 in acid, bog lakes to 8.4 in hard water, marl lakes (Shaw et al., 2004). Natural rainfall in Wisconsin averages a pH of 5.6. Some minerals become available under low pH (especially aluminum, zinc, and mercury) and can inhibit fish reproduction and/or survival. Mercury and aluminum are not only toxic to many kinds of wildlife, but also to humans (especially those that eat tainted fish). The pH scale is logarithmic, so every 1.0 unit change in pH increases the acidity tenfold. Water with a pH of 6 is 10 times more acidic than water with pH of 7. A lake's pH level is important for the release of potentially harmful substances and affects plant growth, fish reproduction and survival. A lake with neutral or slightly alkaline pH is a good lake for fish and plant survival. Figure 9 indicates that Round Lake is alkaline (pH higher than 7).

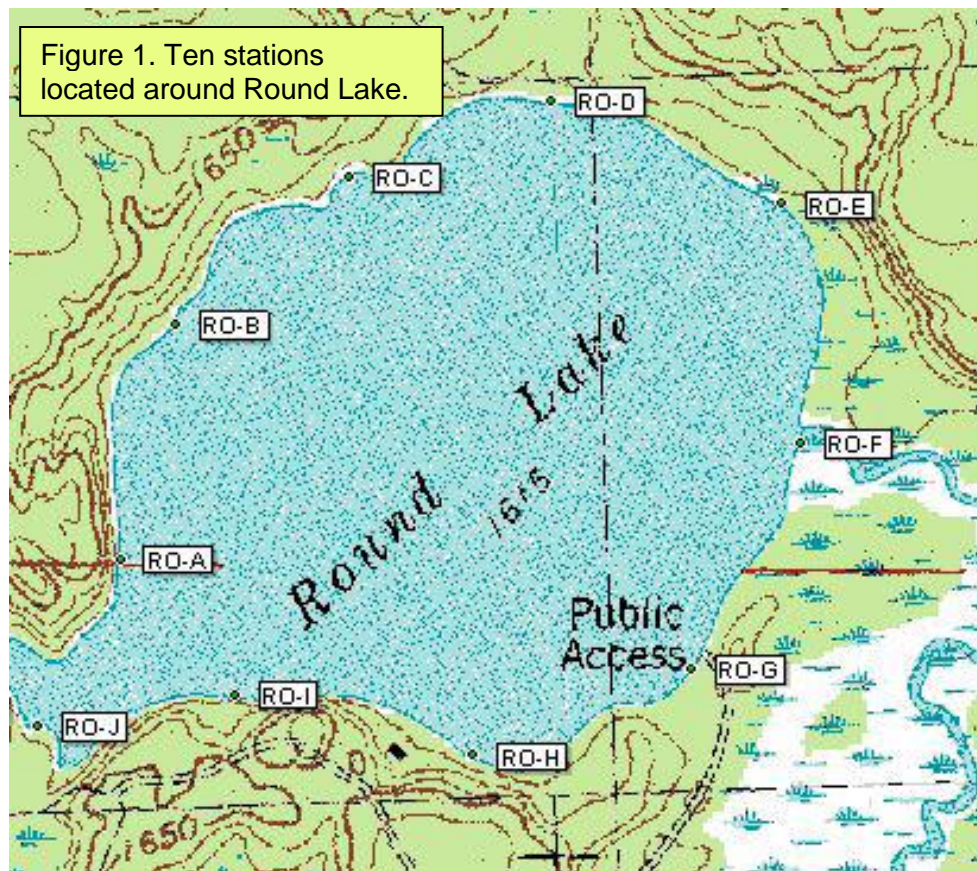
Ten physical habitat (P-Hab) stations were spaced equidistantly around the lake (Figure 1 and 2). At each site, biologists recorded information about the littoral zone bottom substrate, littoral zone aquatic macrophytes (plants), littoral zone fish cover, riparian zone canopy, understory and ground cover, shoreline substrates, human influences, classification of fish habitat, bank features, any invasive species observed (terrestrial or aquatic), land cover, human development and the number of piers between sites.
