Presque Isle Wilderness Waters Program

Aquatic Plant Management Plan – Lynx Lake

Date: March 2019

Cite as: Premo, Dean, Angie Stine, and Kent Premo. 2019. Presque Isle Wilderness Waters Program: Lynx Lake Aquatic Plant Management Plan. White Water Associates, Inc.

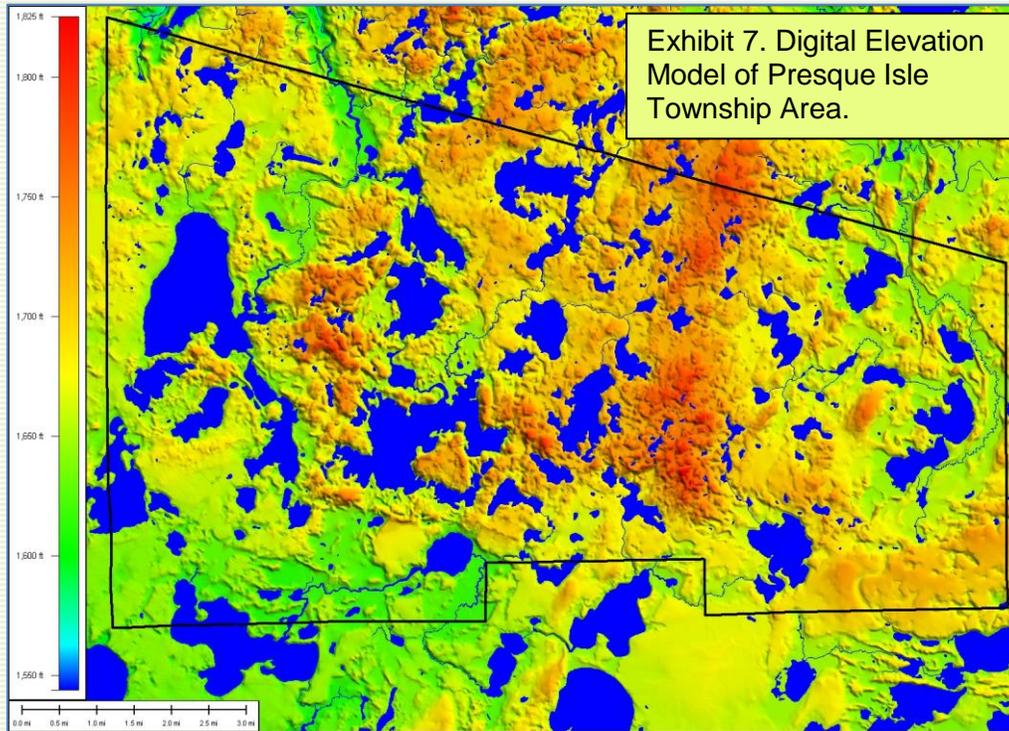
The elevation in Presque Isle Township ranges from around 1,550 feet above sea level to 1,825 feet above sea level. A digital elevation model is provided as Exhibit 7 and shows the relative elevations for the area with orange areas of the landscape being the highest elevations and greens and blues being the lowest elevations.

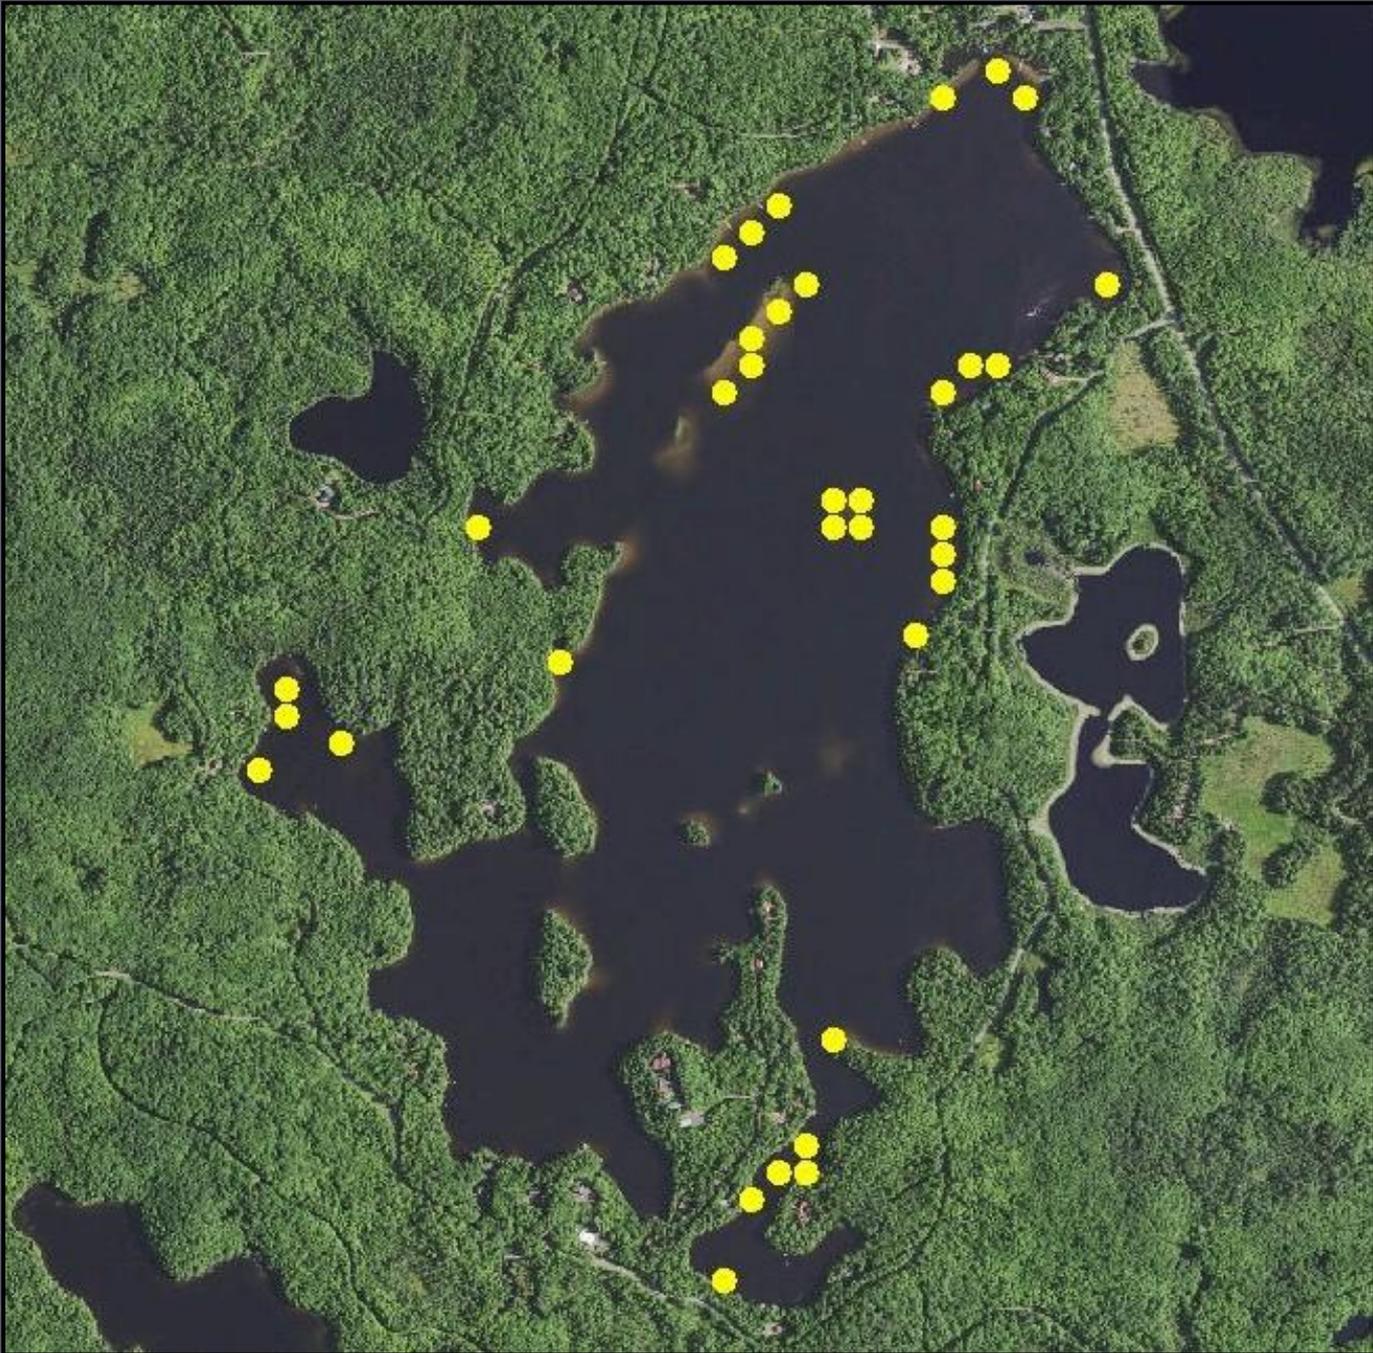
Figure 2. Rake fullness ratings for Lynx Lake sample sites (2017).

Species richness refers to the total number of species recorded. When considering plant species recorded at sampling points only, species richness was slightly higher in 2008 (17 species collected on the rake) when compared to 2017 (13 species collected on the rake)(see Exhibit 9 and Table 1). This difference, however, is fairly small. During the surveys, additional plant species observed but not collected at the sampling points are also documented. In 2017, a total of 13 species of aquatic plants were recorded in Lynx Lake at the sample points but an additional 17 species were seen near shore on the boat survey, indicating a diverse plant community. Table 1 displays summary statistics for the 2008 and 2017 survey. Table 2 provides a list of the species encountered, including common and scientific name along with summarizing statistics for the 2017 survey.² In 2017, the number of species encountered at any given sample point ranged from 0 to 4 and 35 sample points were found to have aquatic vegetation present. The average number of species encountered at these vegetated sites was 0.52. The actual number of species encountered at each of the vegetated sites in 2017 is graphically displayed on Figure 1. Plant density is estimated by a “rake fullness” metric (3 being the highest possible density). These densities (considering all species) are displayed for each sampling site on Figure 2.

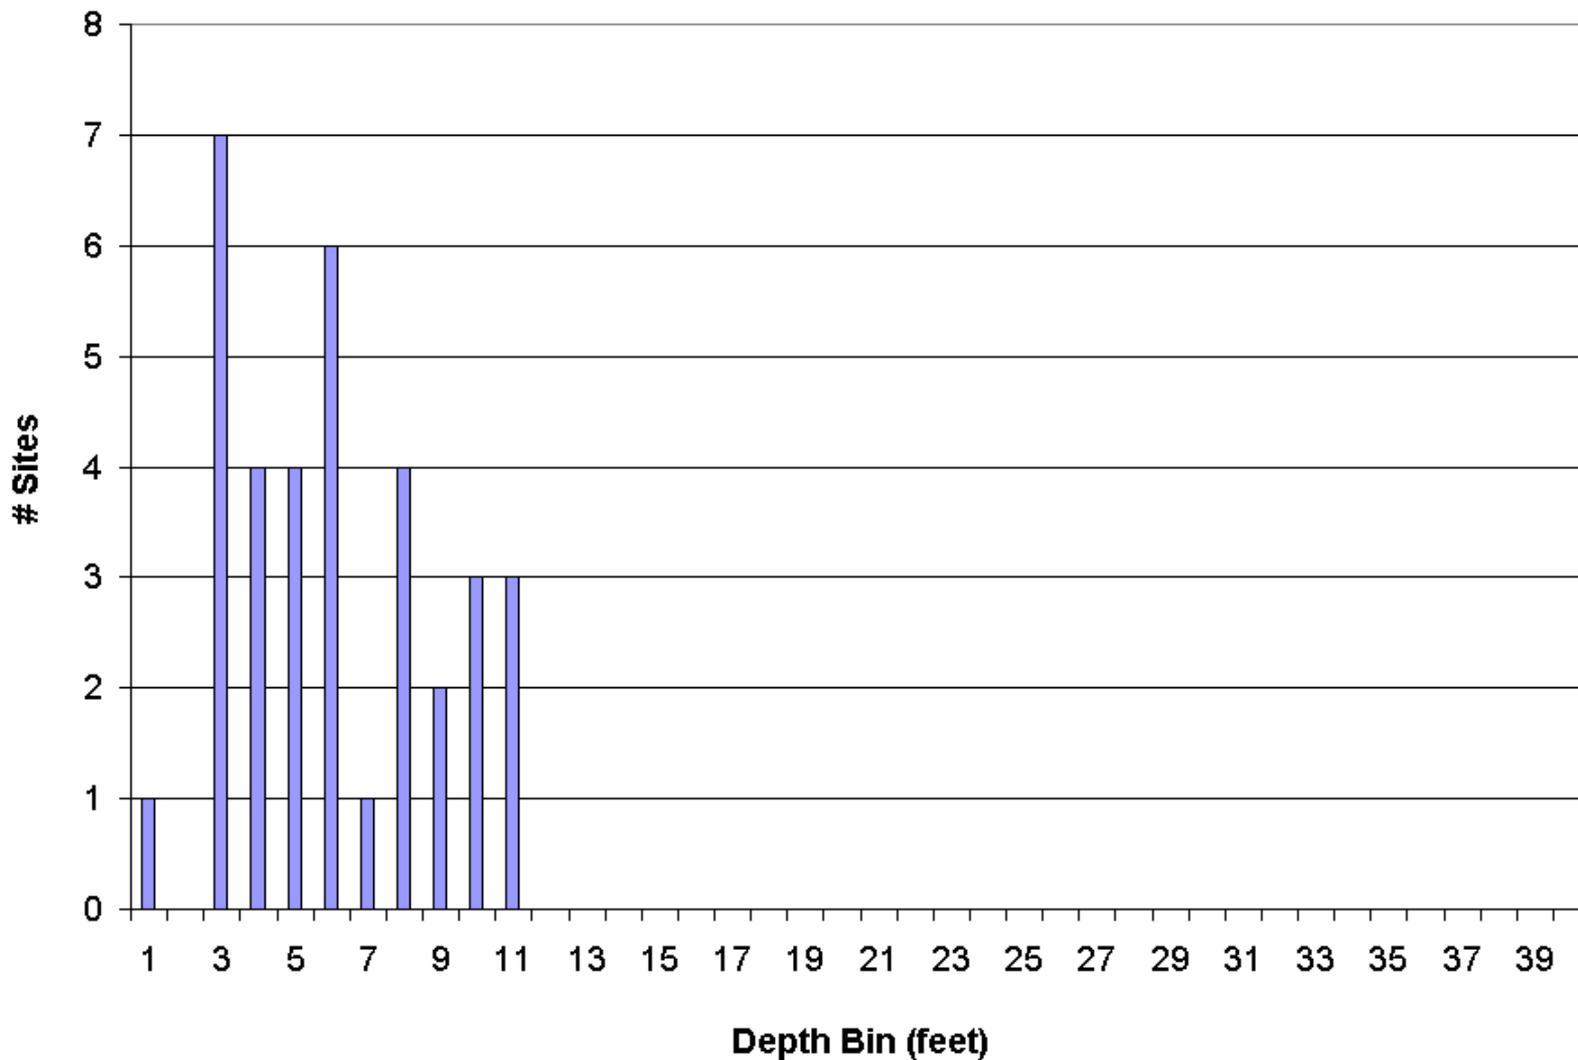
Figure 3. Maximum Depth of Plant Colonization, Lynx Lake

The maximum depth of plant colonization in 2017 was 10.5 feet (Table 1 and Figure 3). Rooted vegetation was found at 35 of the 99 sample sites with depth \leq the maximum depth of plant colonization (35.35% of sites). These sites are displayed as a black dot within a circle on Figure 4. This indicates that although availability of appropriate depth may limit the distribution of plants, it is not the only habitat factor involved. Substrate is another feature that influences plant distribution (e.g., soft substrate often harbors more plants than hard substrate). Figures 5 presents the substrates encountered during the aquatic plant survey (mud, sand, or rock).

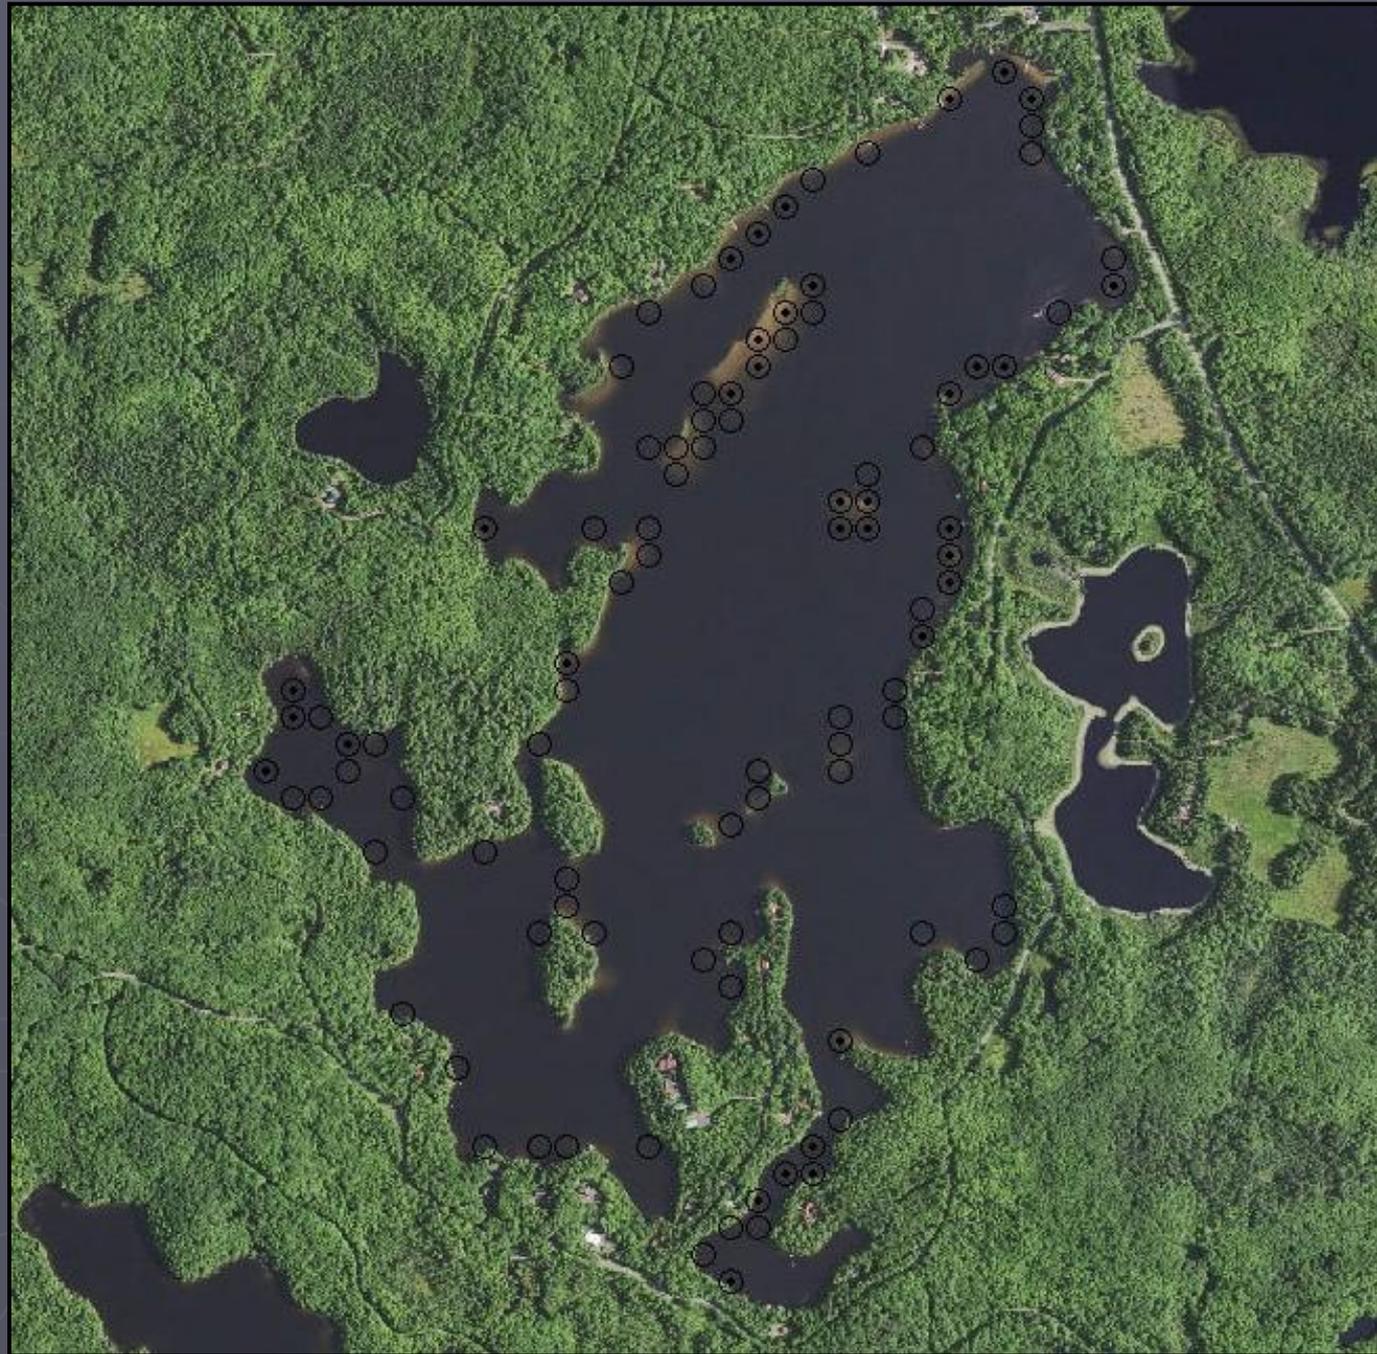
Figure 4. Lynx Lake
sampling sites less than
or equal to
maximum depth of
rooted vegetation
(2017).

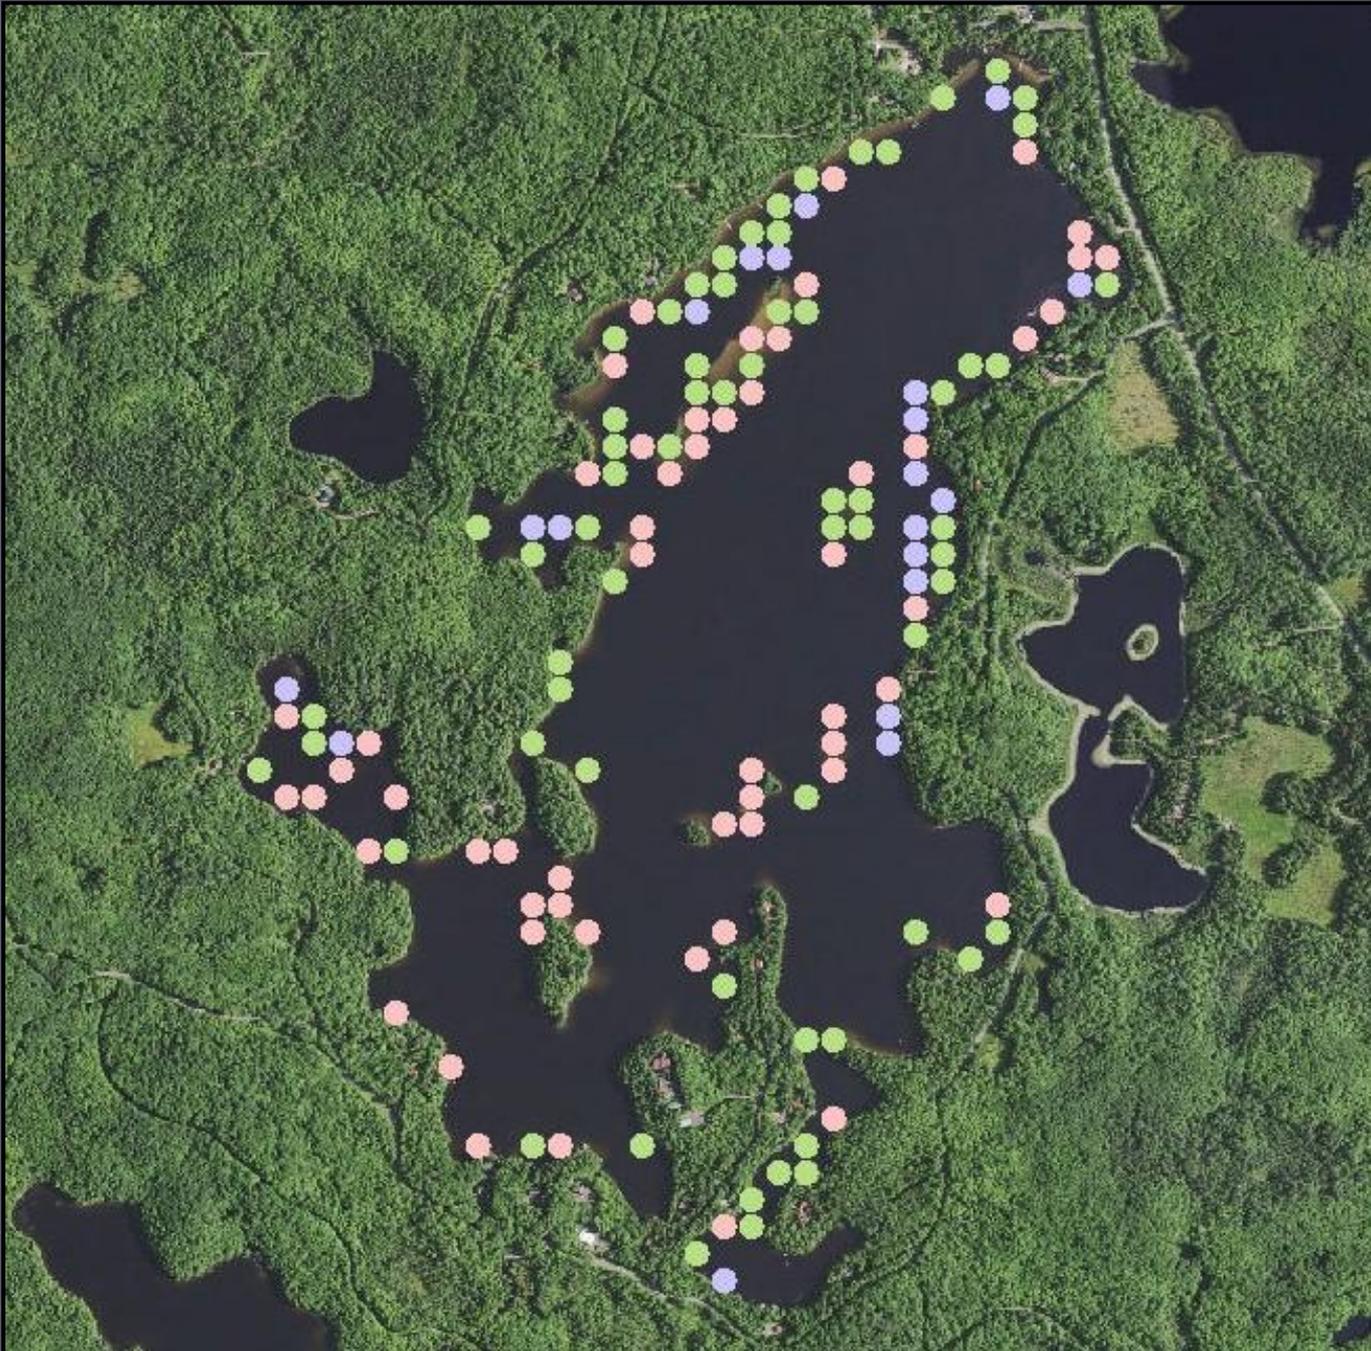
Figure 5. Lynx Lake substrate encountered at point-intercept plant sampling sites (2017).

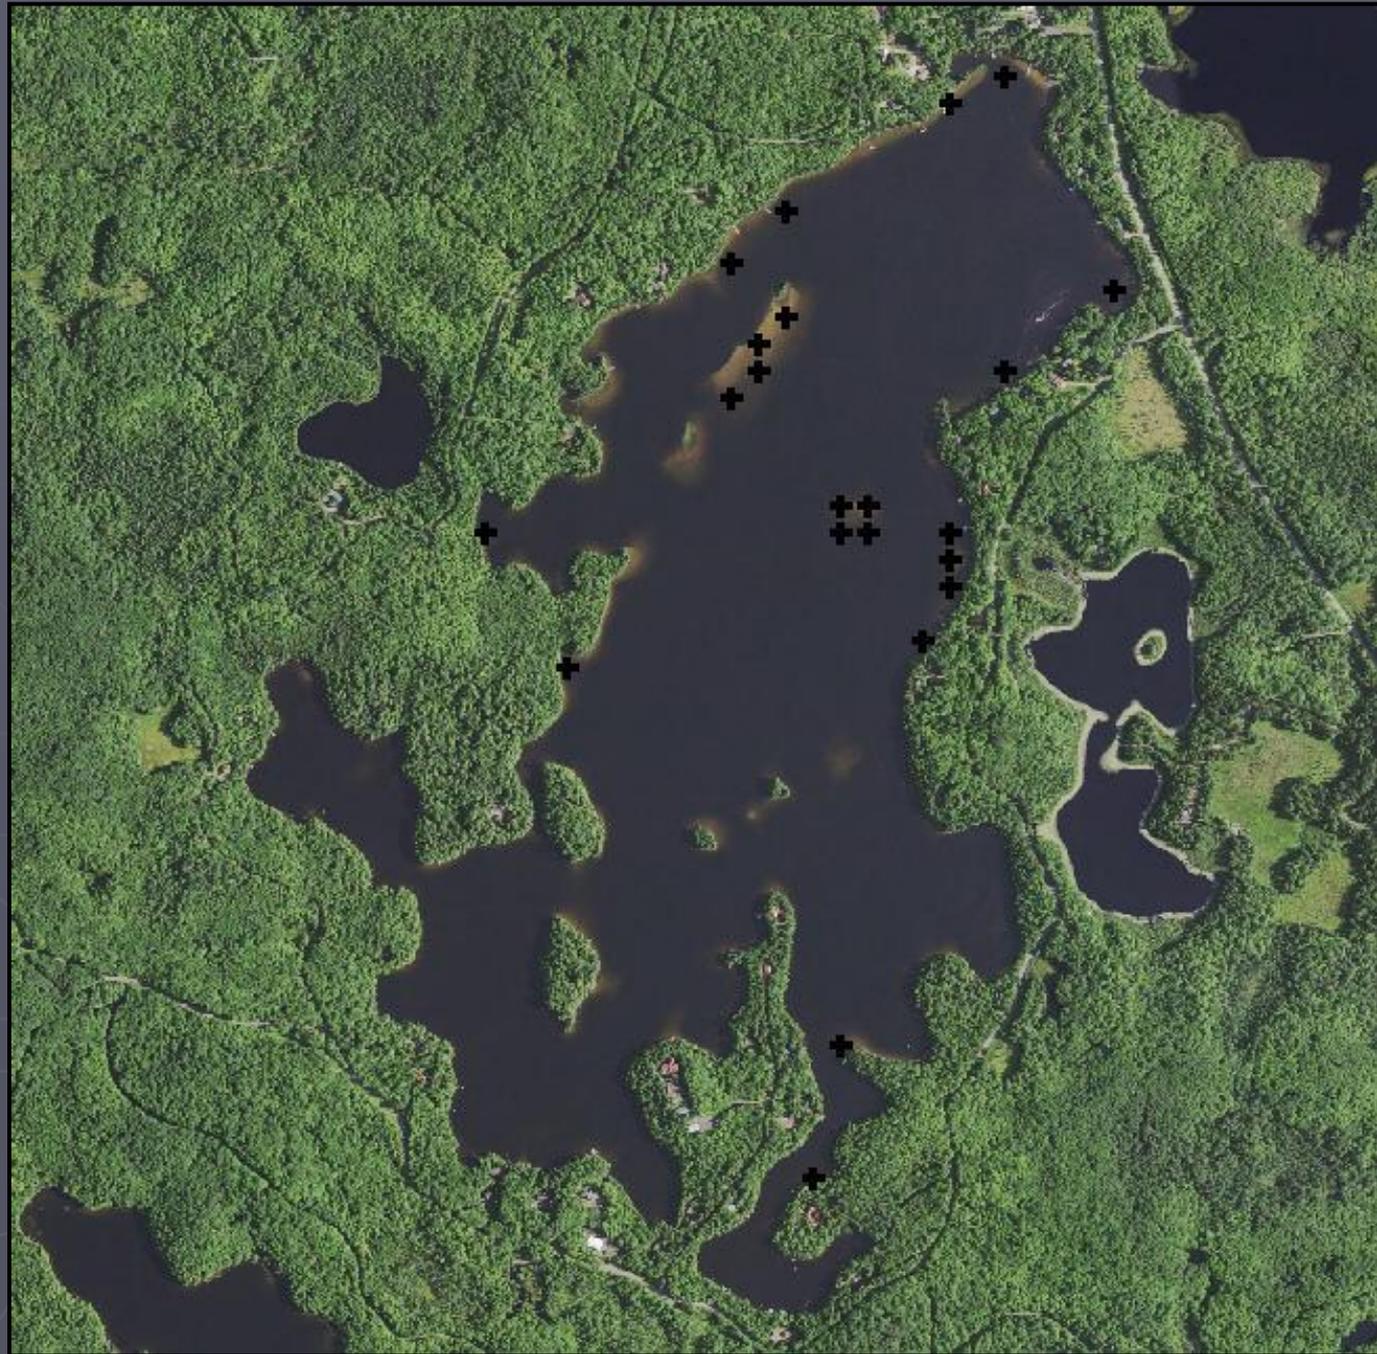
Figure 7. Lynx Lake point-intercept plant sampling sites with emergent and floating aquatic plants (2017).

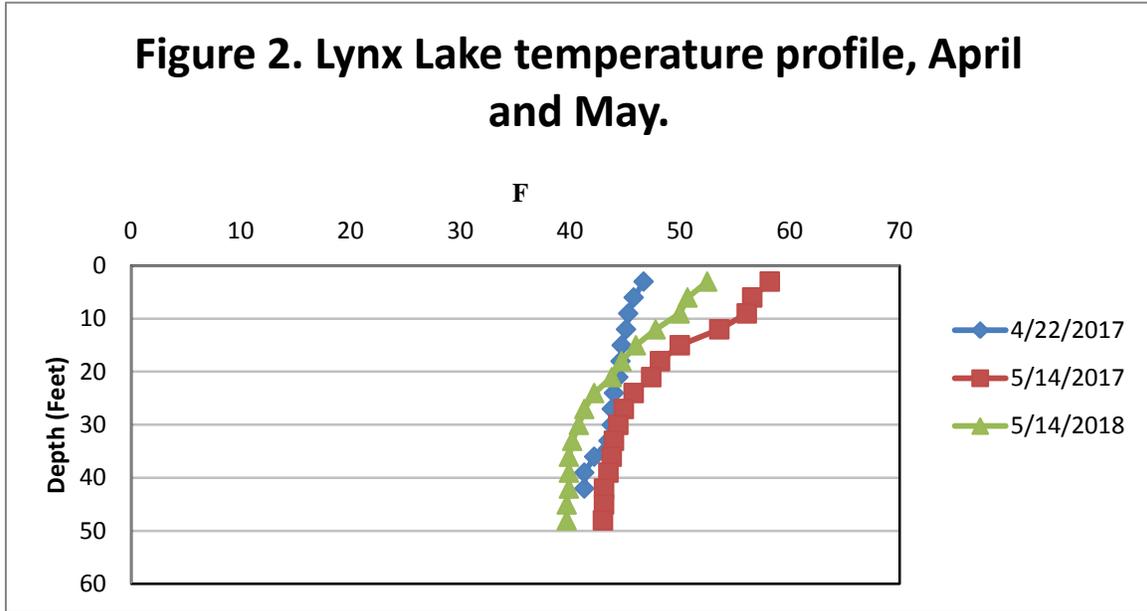
Figure 2. Lynx Lake temperature profile, April and May.

Measuring the temperature of a lake at different depths will determine the influence it has on the physical, biological, and chemical aspects of the lake. Lake water temperature influences the rate of decomposition, nutrient recycling, lake stratification, and dissolved oxygen (D.O.) concentration. Temperature can also affect the distribution of fish species throughout a lake. Figure 2 present water temperature Lynx Lake water temperature profiles for April and May. These samples show very little stratification during these months. In June (Figure 3), the temperature profiles show some stratification from surface to bottom. In July and August, temperature profiles show definite stratification (Figure 4). During this time, the lake

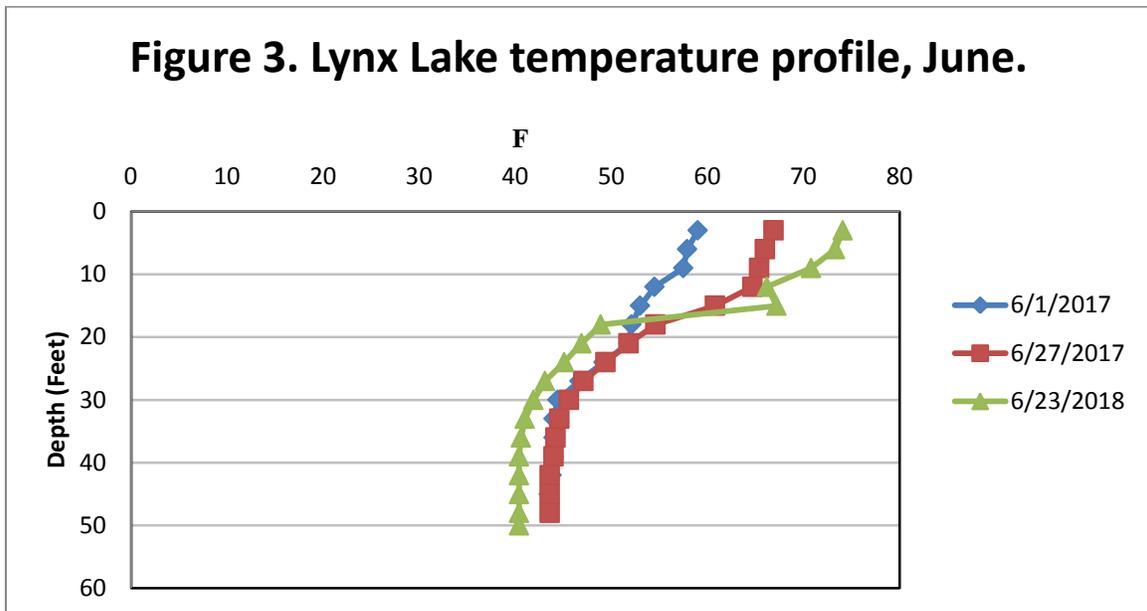
Figure 3. Lynx Lake temperature profile, June.

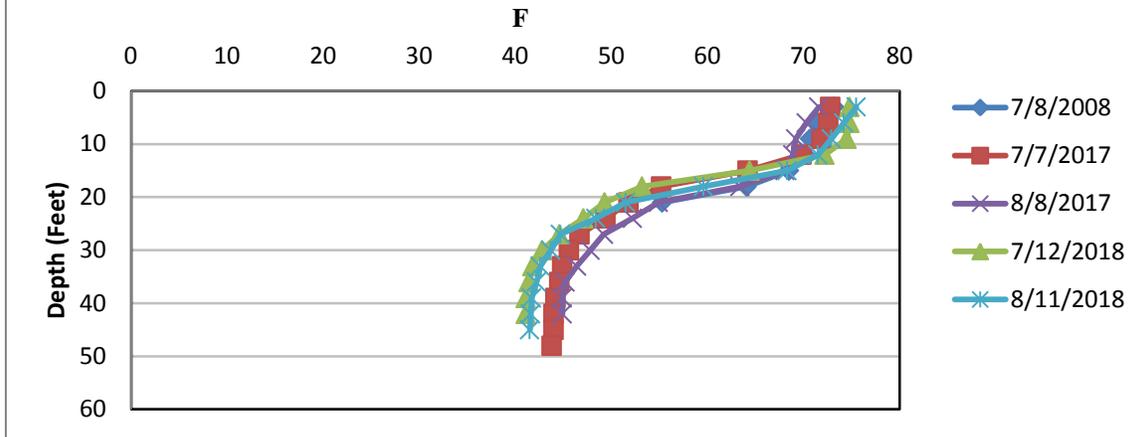
Figure 4. Lynx Lake temperature profile, July and August.

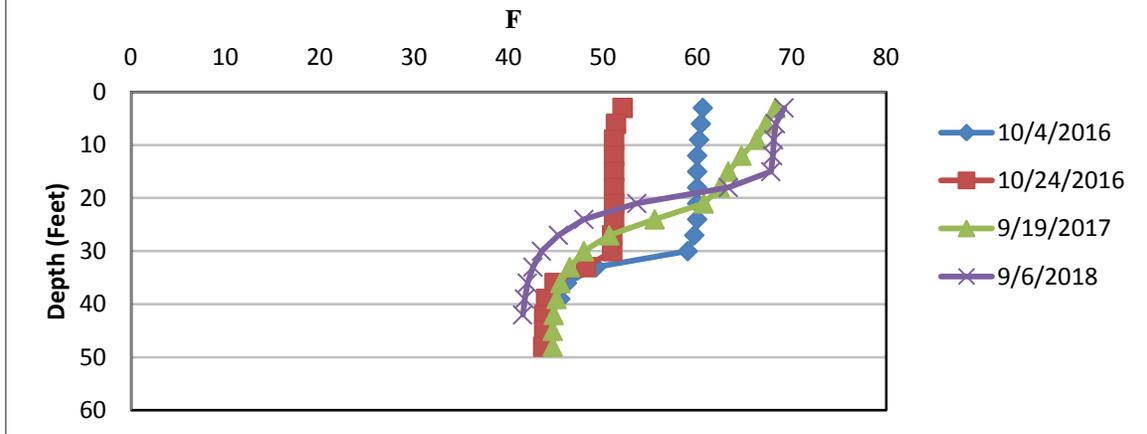
Figure 5. Lynx Lake temperature profile, September and October.

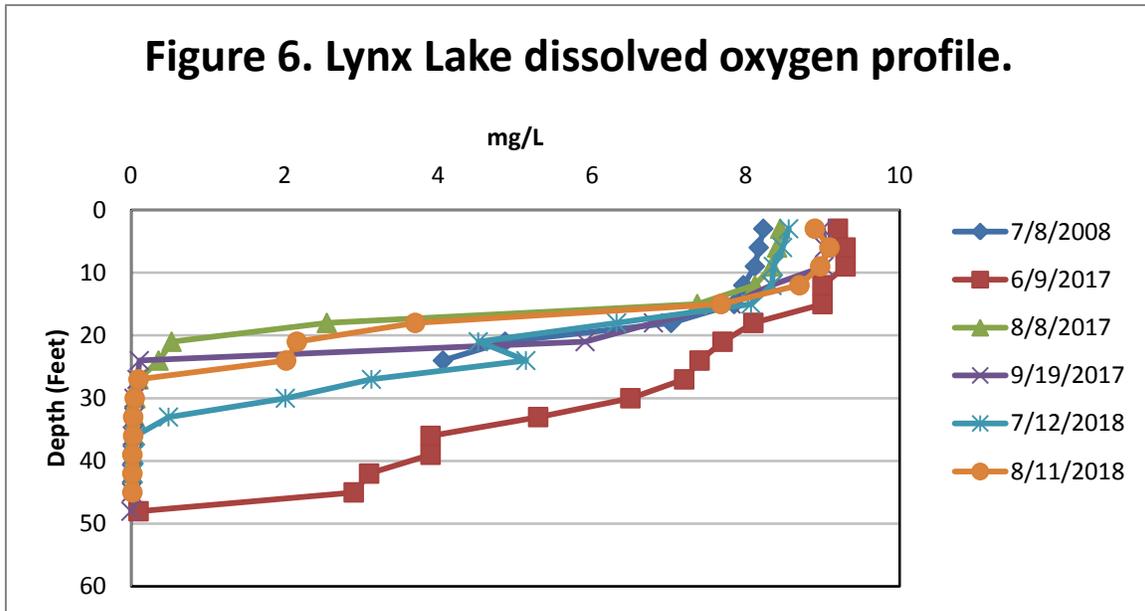
The dissolved oxygen (D.O.) content of lake water is vital in determining presence of fish species and other aquatic organisms. Dissolved oxygen also has a strong influence on the chemical and physical conditions of a lake. The amount of dissolved oxygen is dependent on the water temperature, atmospheric pressure, and biological activity. Oxygen levels are increased by aquatic plant photosynthesis, but reduced by respiration of plants, decomposer organisms, fish, and invertebrates. The amount of D.O. available in a lake, particularly in the deeper parts of a lake, is critical to overall health. Lynx Lake D.O. profiles for June (2017), July (2008 and 2018), August (2018), and September (2017) are displayed in Figure 6. D.O.

levels were between 8.23 and 9.2 mg/L from June to September at the surface (Figures 6). Depending on the time of season, D.O. levels (Figure 6) began to drop between 18 and 21 feet.

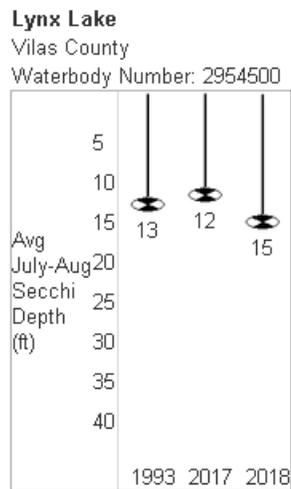
Figure 7. Lynx Lake Secchi depth averages (July and August only).

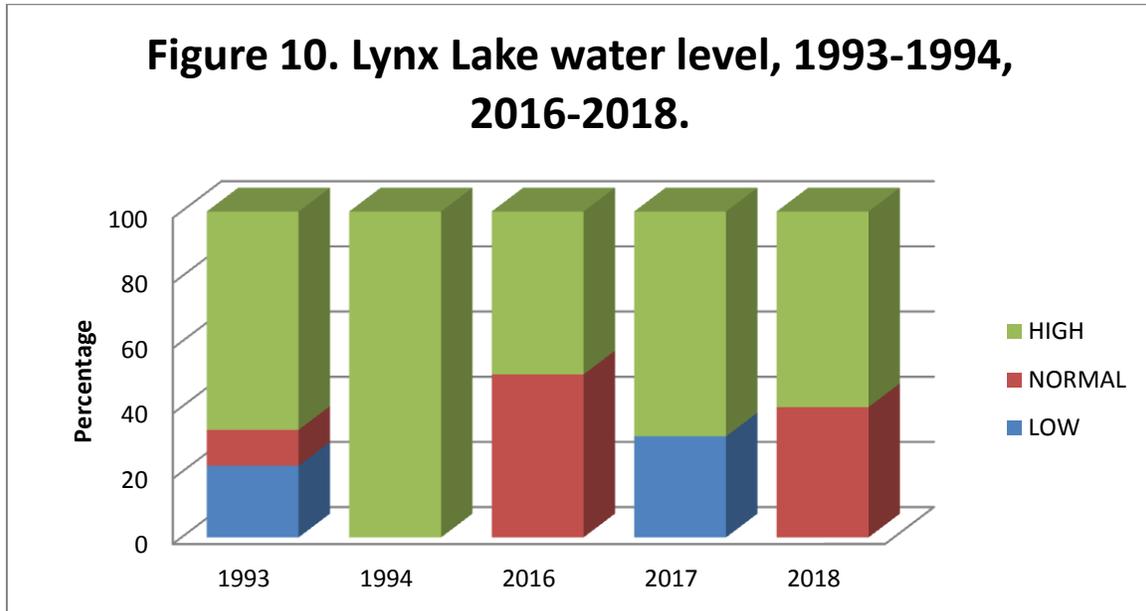
When CLMN volunteers collect Secchi depth readings, they also record the lake level as “high,” “normal,” or “low.” Figure 10 indicates that in 1994 the water level in Lynx Lake appeared “high.”

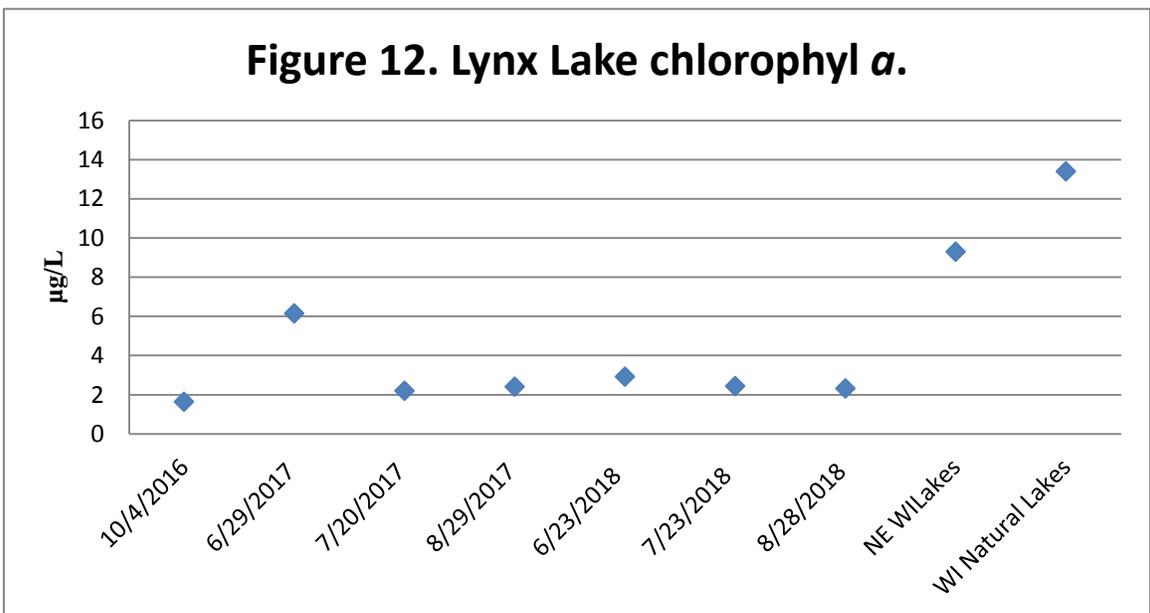
Chlorophyll *a* is the photosynthetic pigment that makes plants and algae green. Chlorophyll *a* in lake water is an indicator of the amount of algae. Chlorophyll *a* concentrations greater than 10 µg/L are perceived as a mild algae bloom, while concentrations greater than 20 µg/L are perceived as a nuisance. Chlorophyll *a* values were below nuisance levels and well below the average levels for Wisconsin natural lakes (Figure 12).

Figure 12. Lynx Lake chlorophyll *a*.

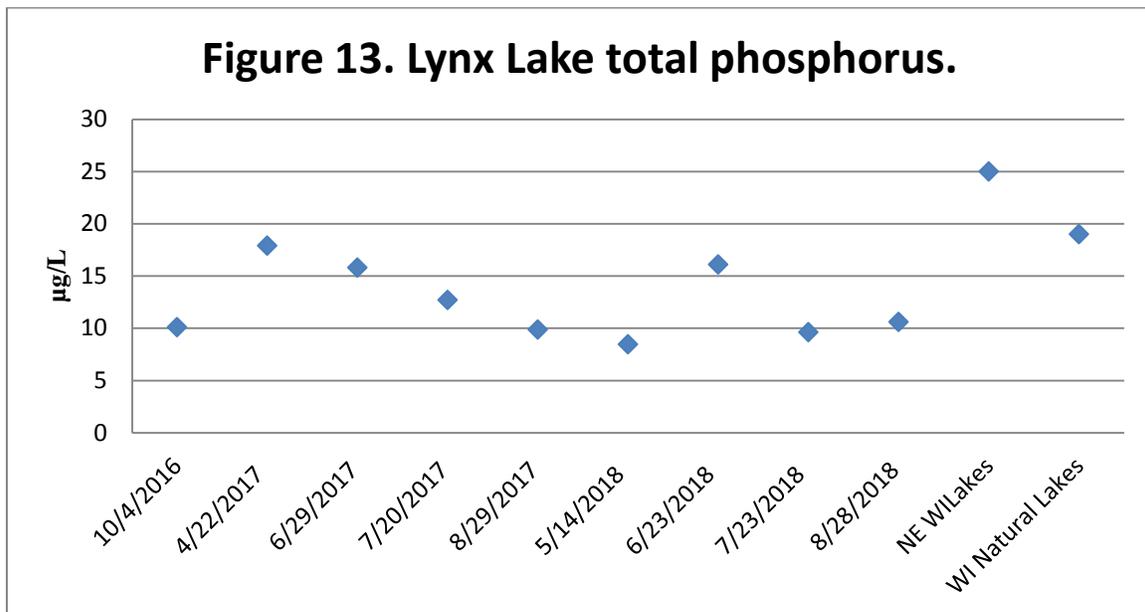
Lynx Lake total phosphorus values were considered "good" to "very good," (Figure 13) and are comparable to the region and state values (Figure 14).

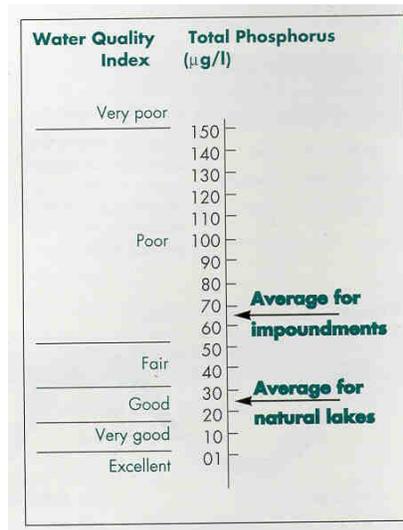
Figure 14. Total phosphorus concentrations for Wisconsin’s natural lakes and impoundments (Shaw et al., 2004).

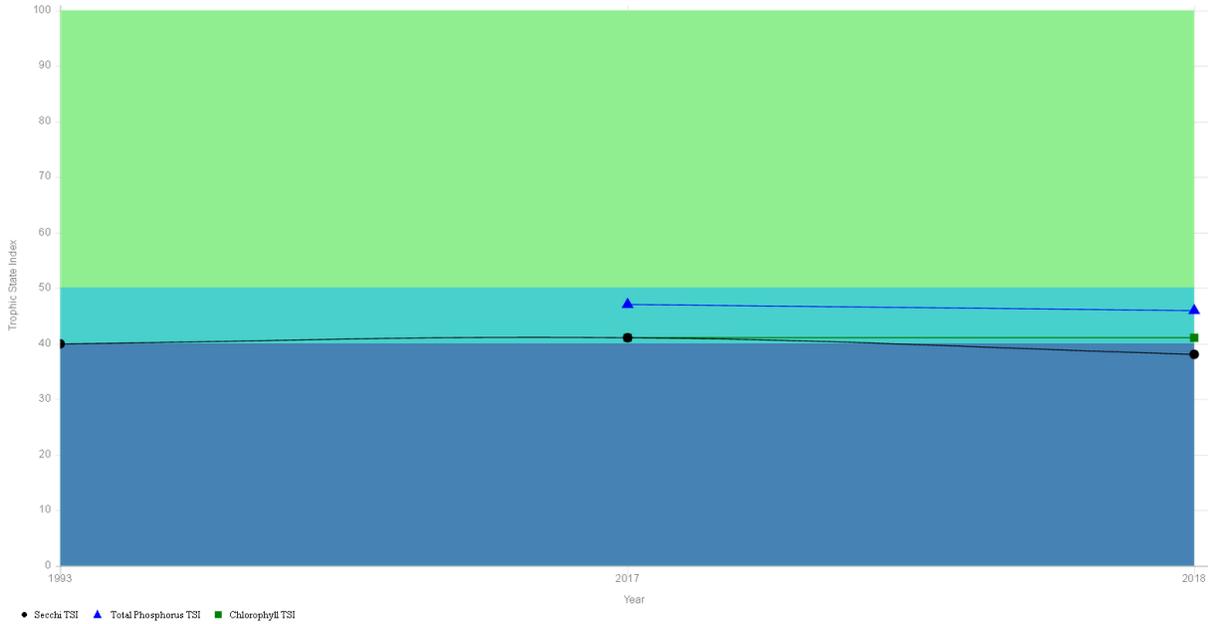
Trophic State Index Graph: Lynx Lake - Max Depth - Vilas County

Trophic state is another indicator of water quality (Carlson, 1977). Lakes are typically divided into three categories based on trophic state – oligotrophic, mesotrophic, and eutrophic. These categories reflect a lake’s nutrient and clarity levels (Shaw et al., 2004).

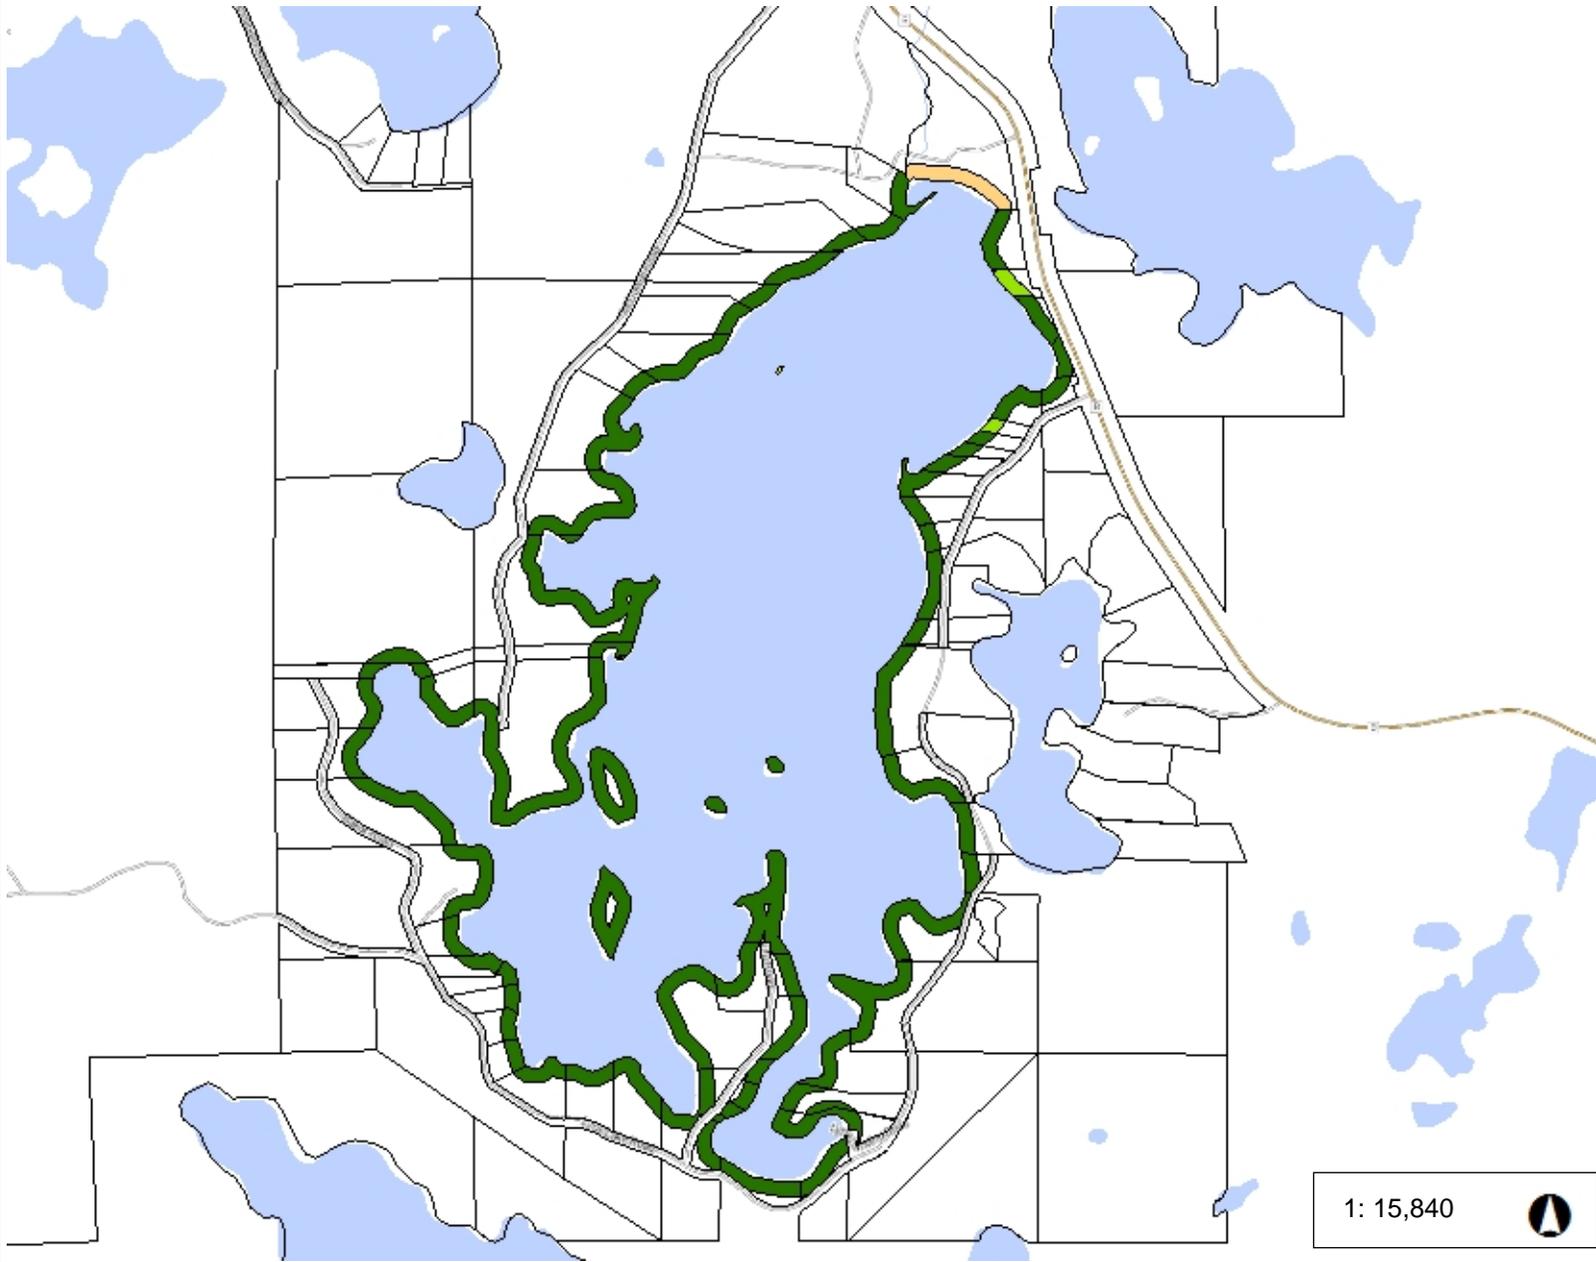
Exhibit 5. Lynx Lake Riparian Coverage - % Canopy - 2017

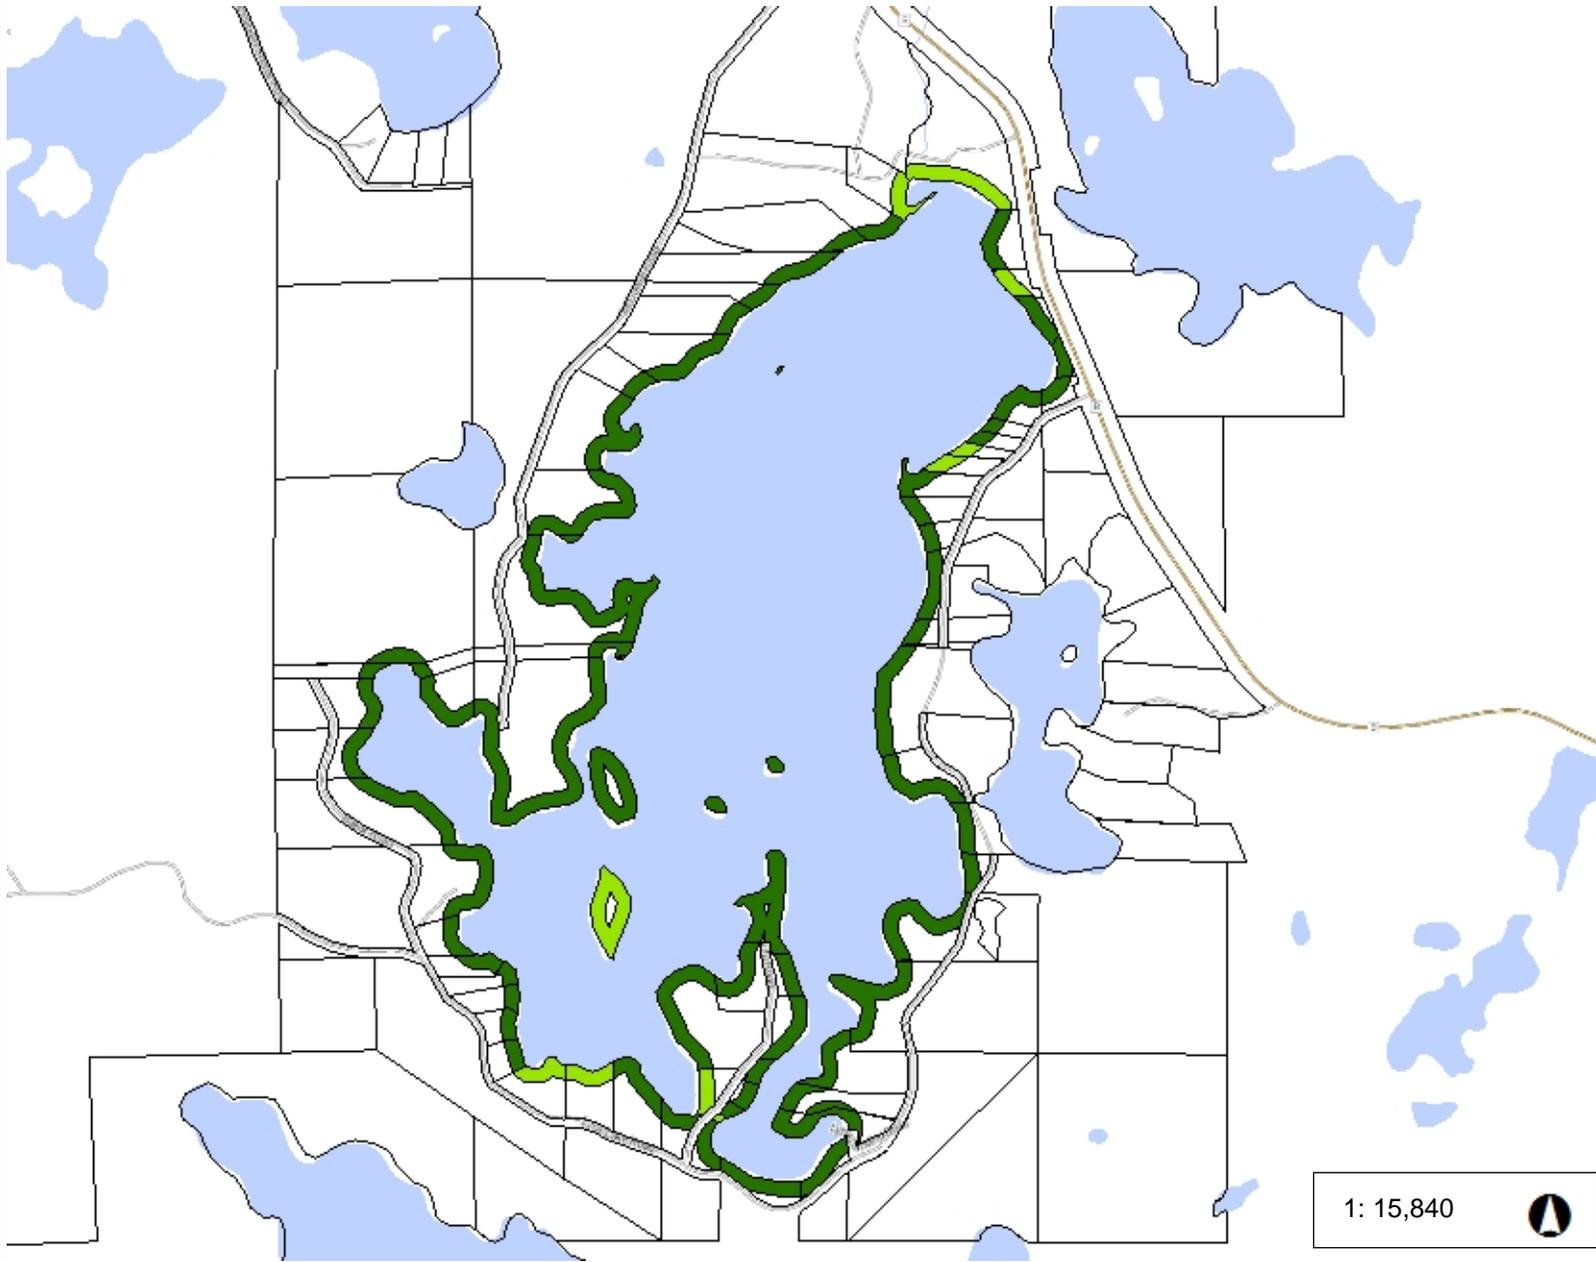
Exhibit 6. Lynx Lake Riparian Coverage - % Shrub Herbaceous - 2017
