Presque Isle Wilderness Waters Program

Aquatic Plant Management Plan – Lynx Lake

Date: March 2019

Cite as: Premo, Dean, Angie Stine, and Kent Premo. 2019. Presque Isle Wilderness Waters Program: Lynx Lake Aquatic Plant Management Plan. White Water Associates, Inc.

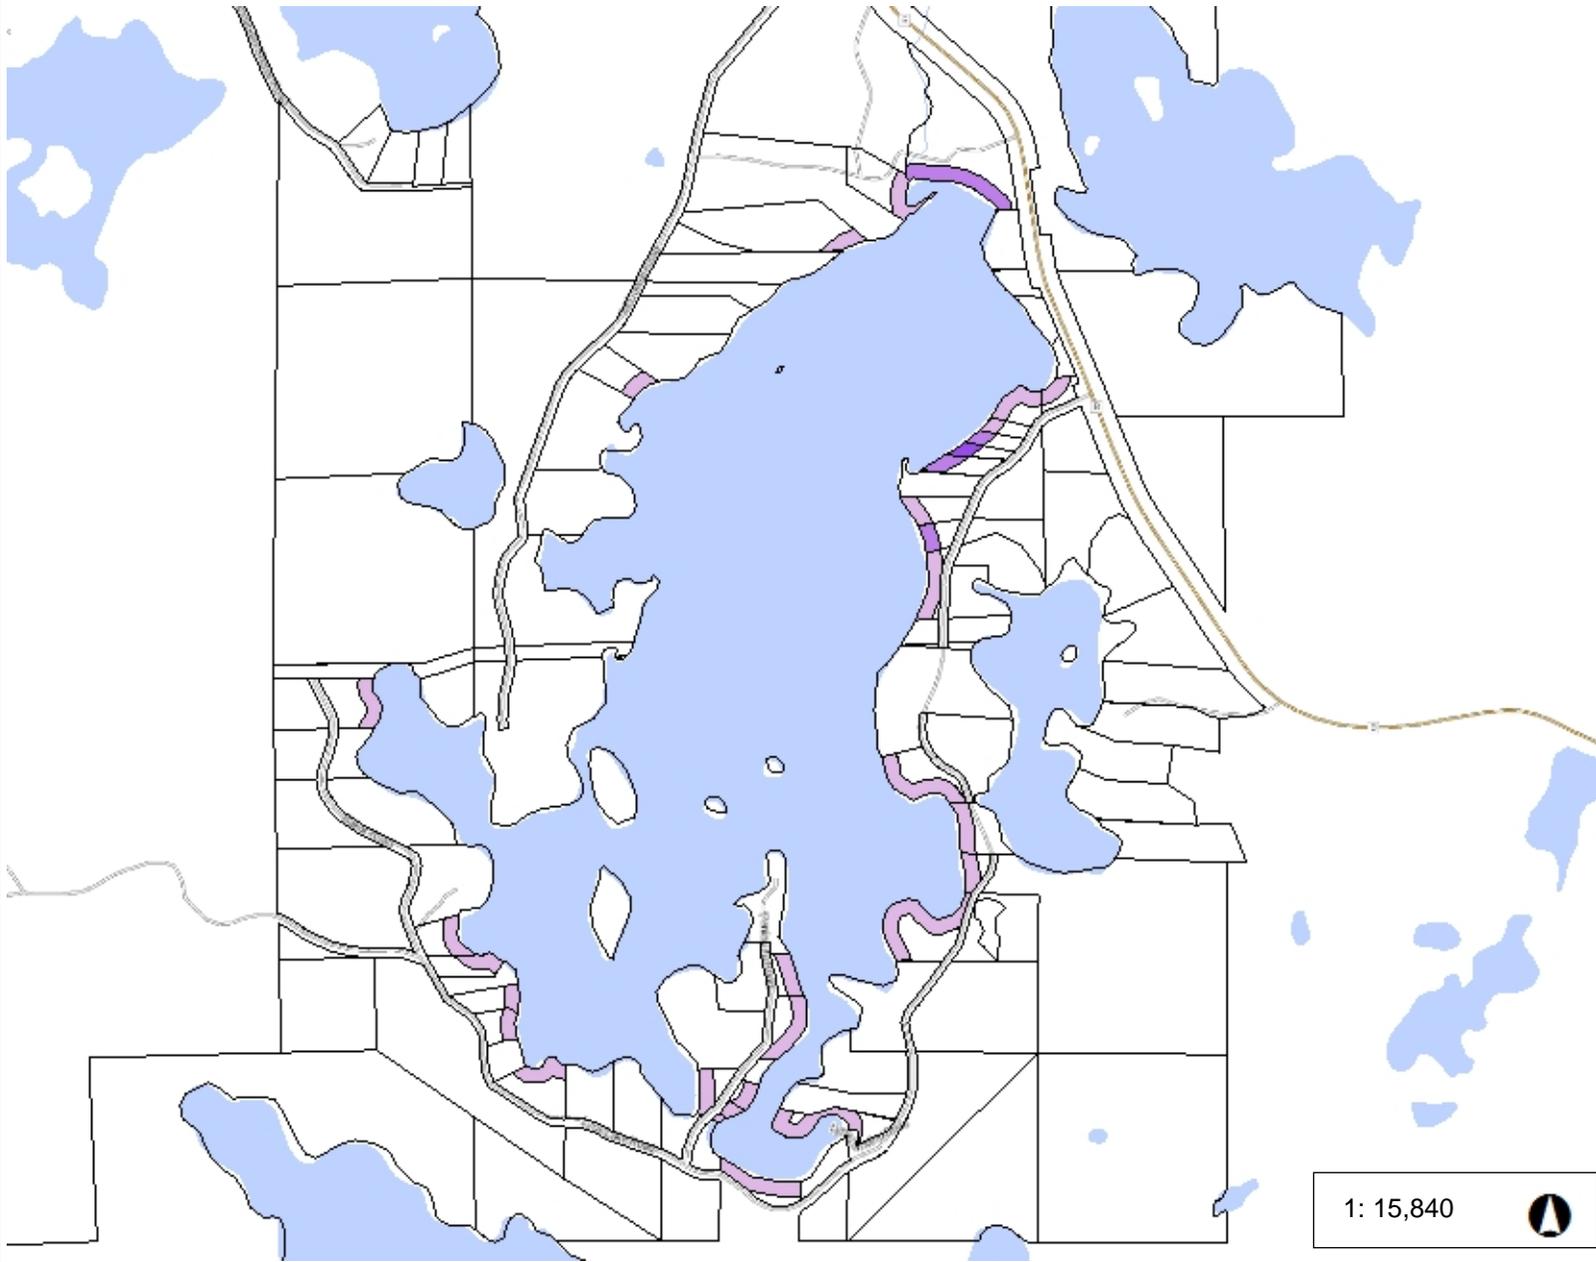
Exhibit 7. Lynx Lake Riparian Coverage - % Impervious - 2017

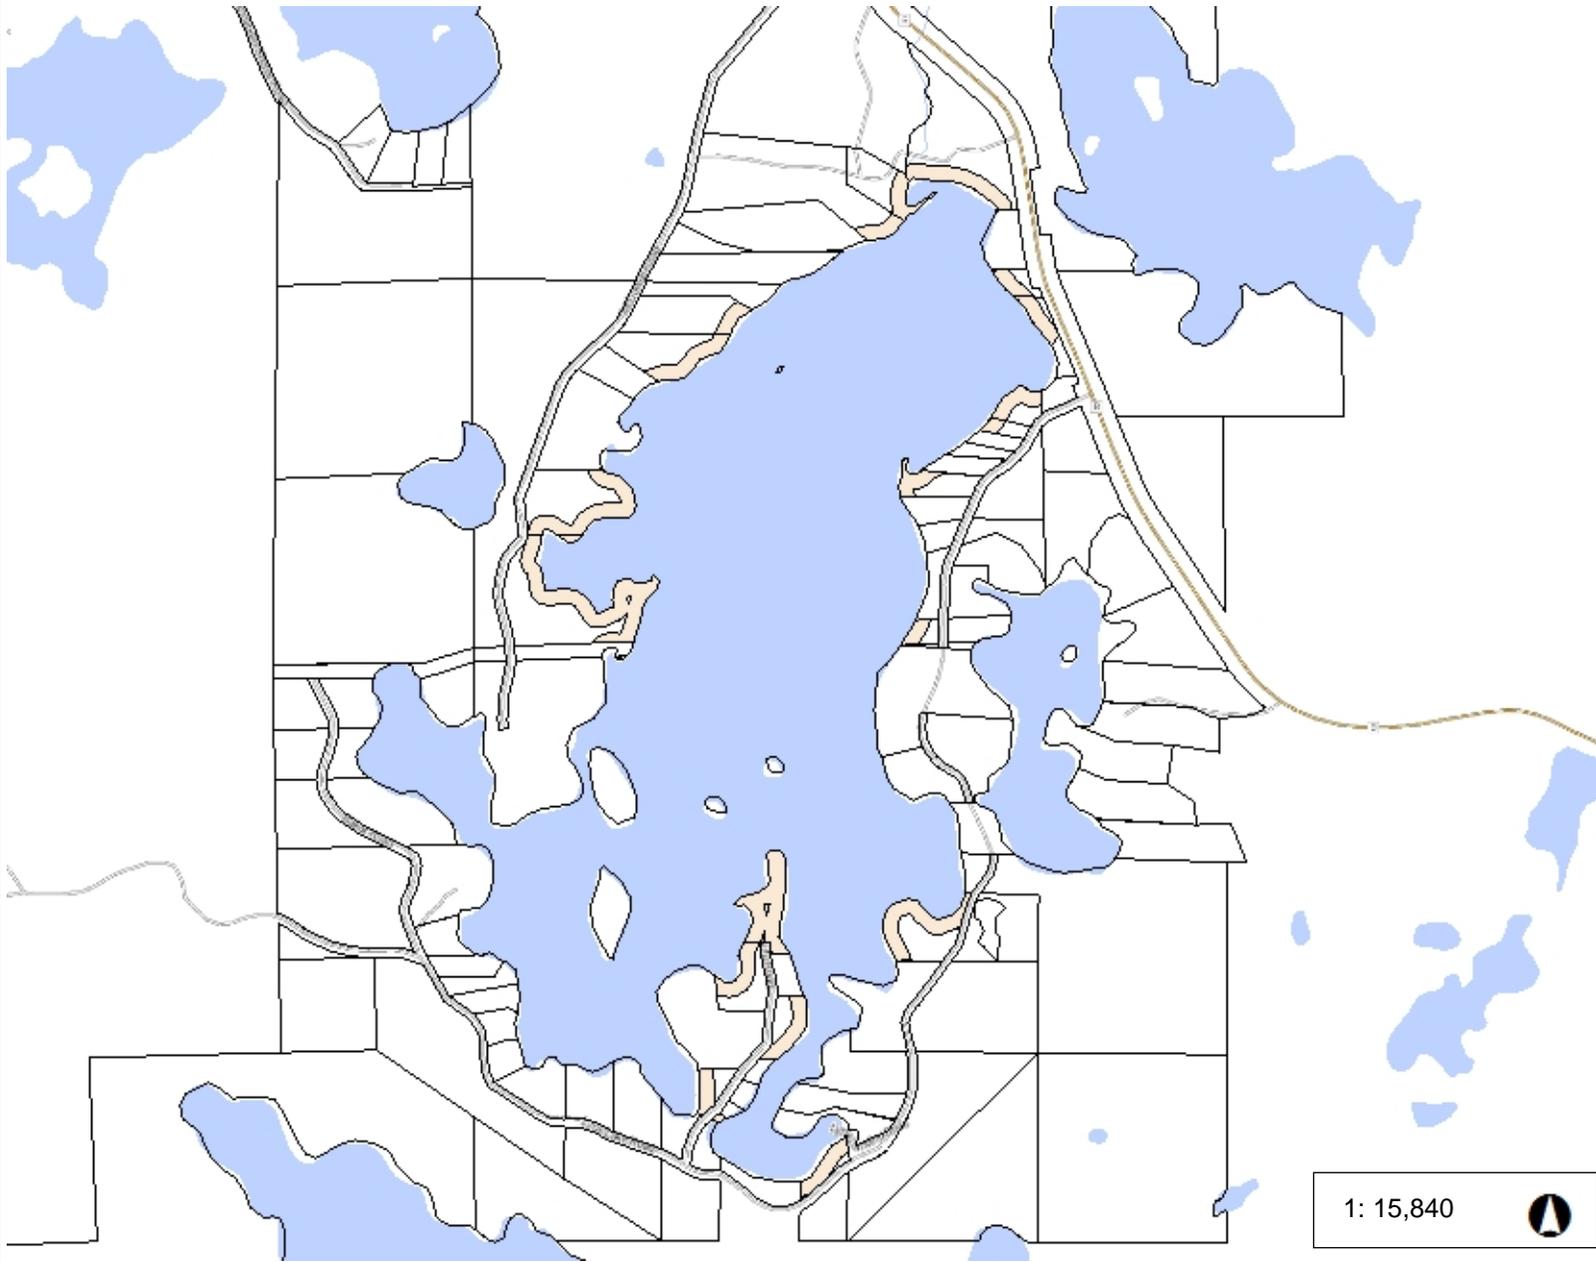
Exhibit 8. Lynx Lake Riparian Coverage - % Manicured Lawn - 2017

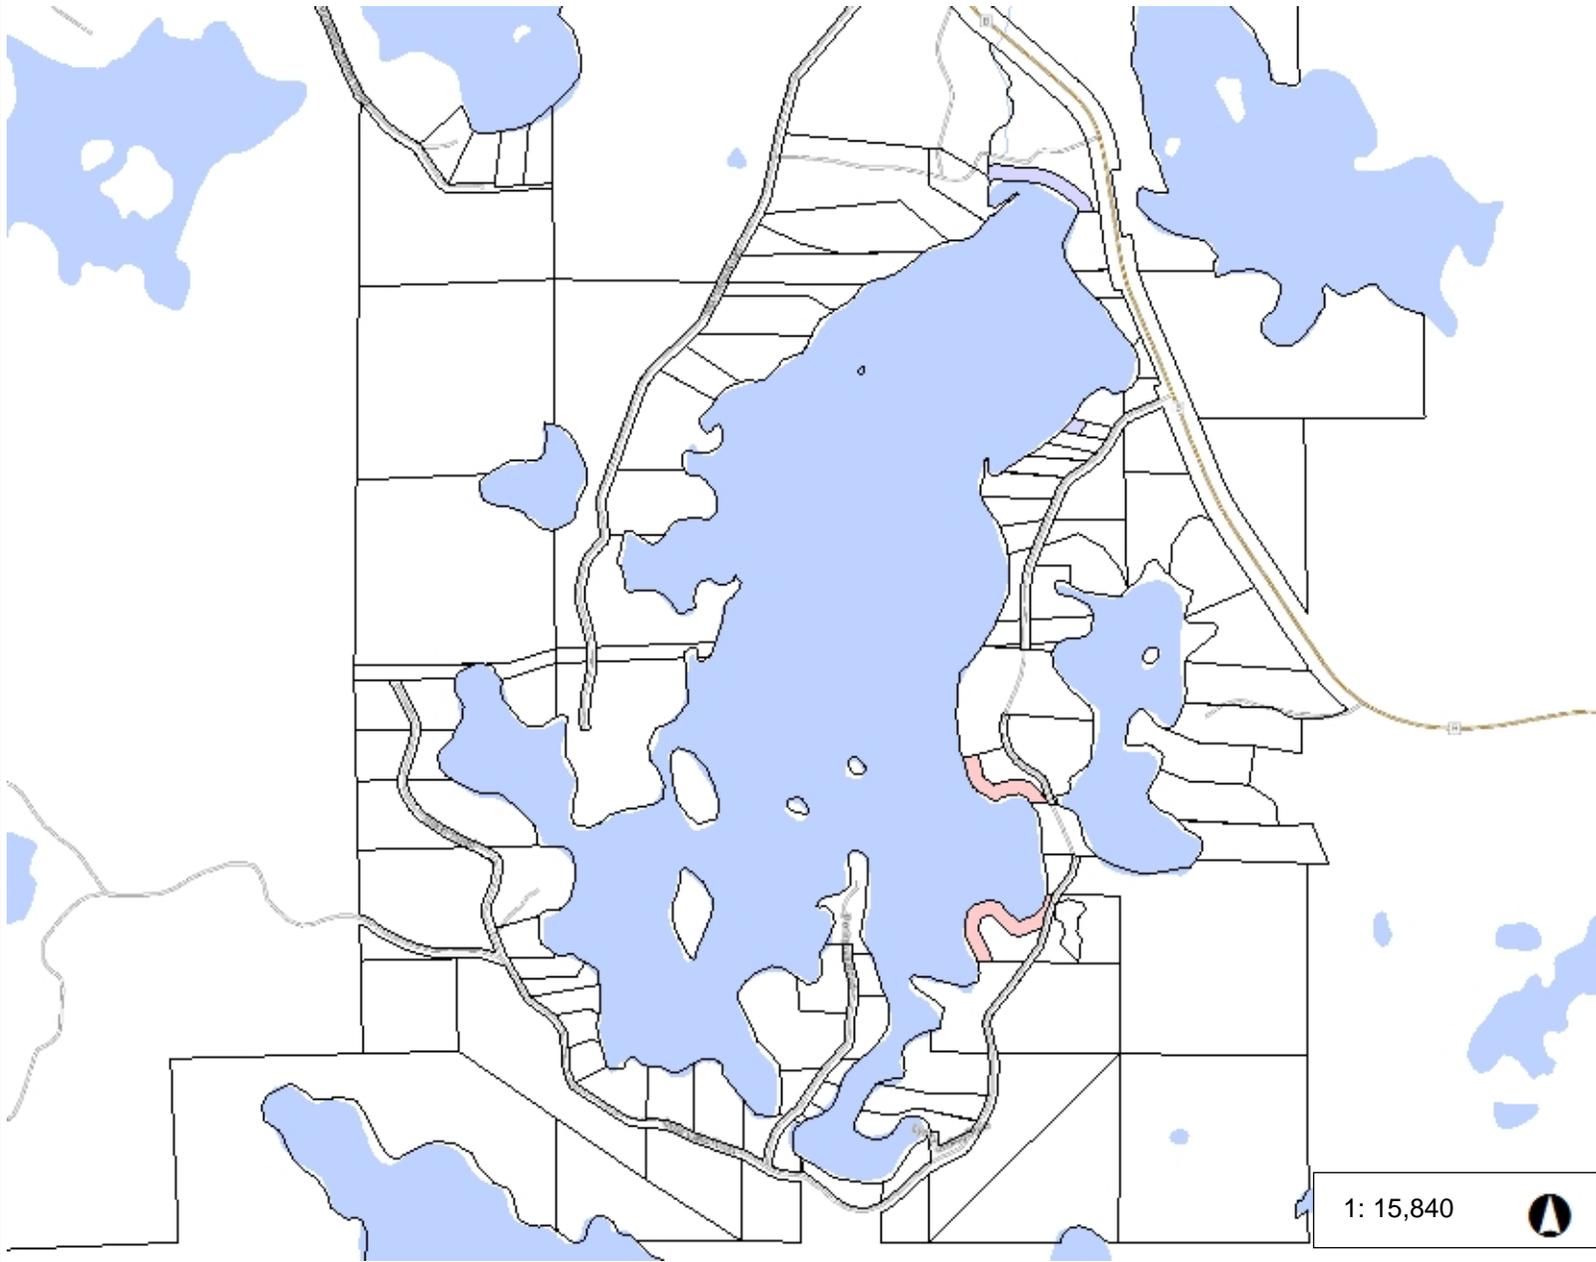
Exhibit 9. Lynx Lake Bank Erosion and Modifications - 2017

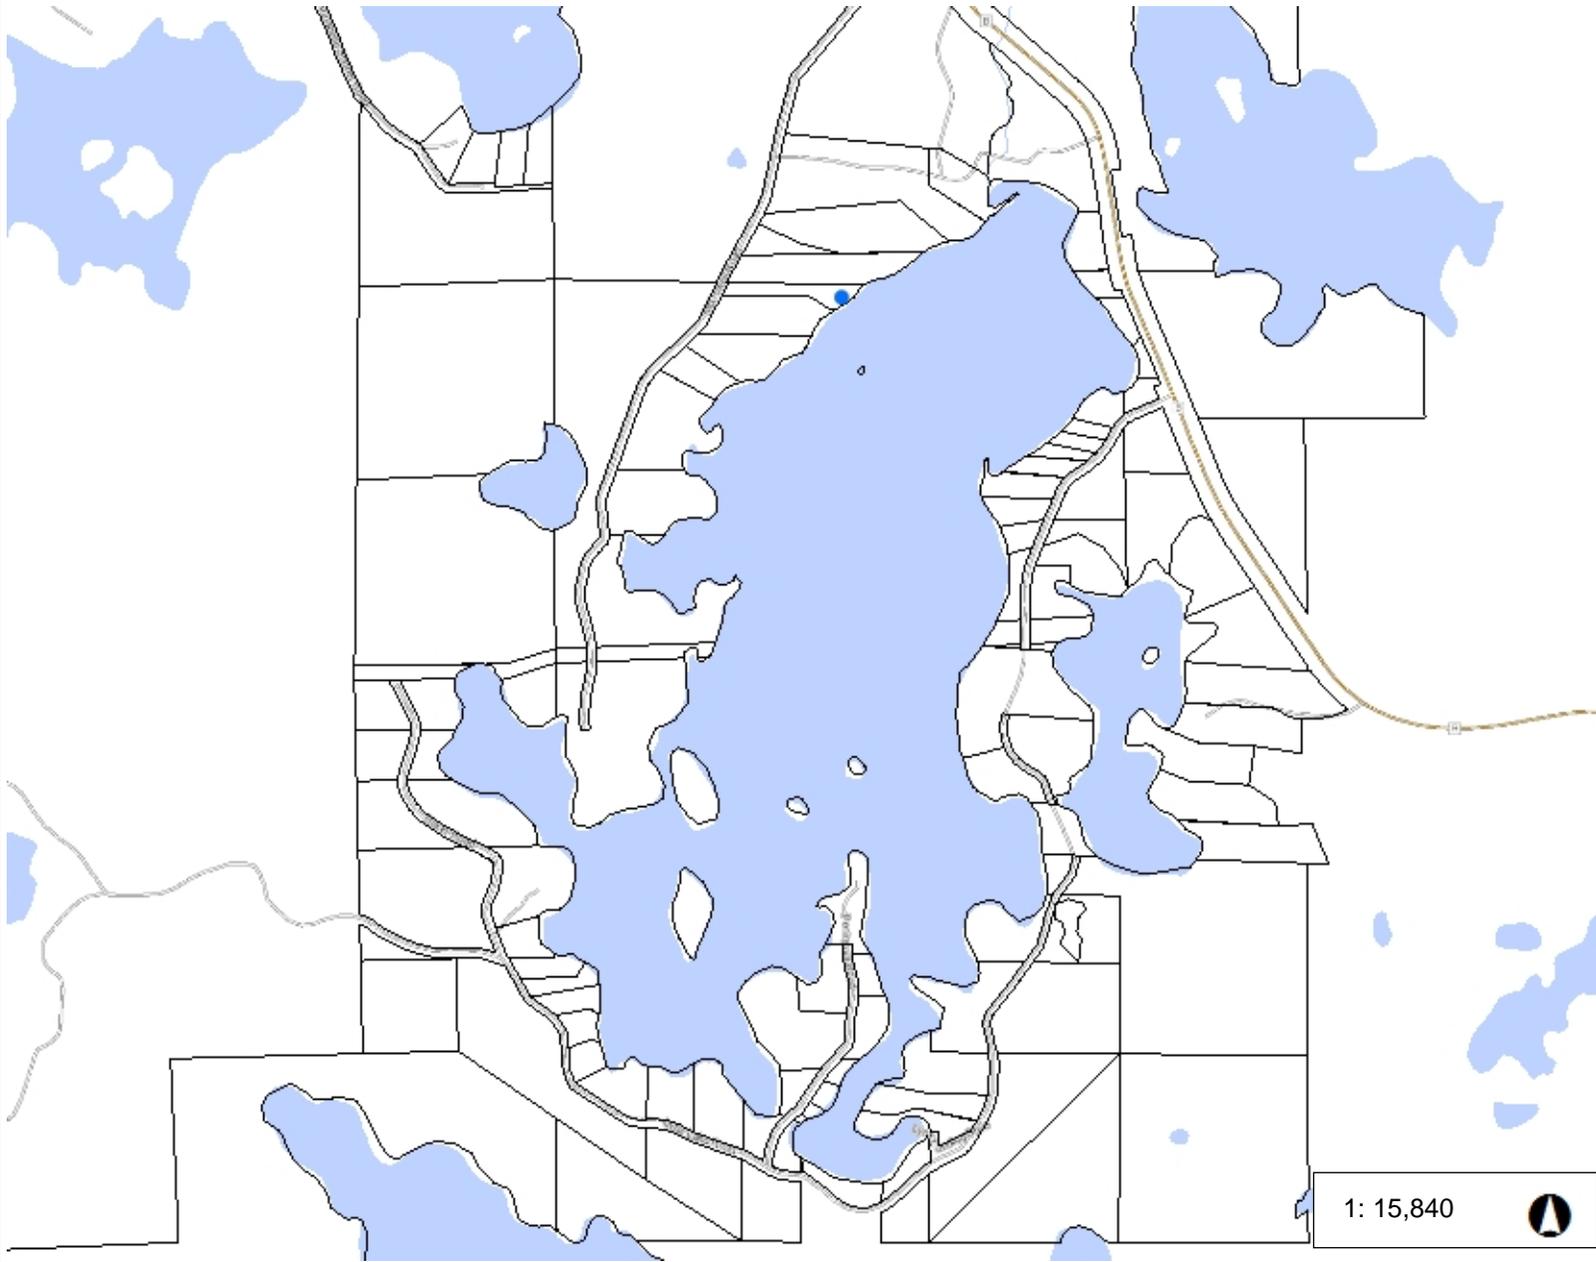
Exhibit 10. Lynx Lake Runoff Concerns - 2017

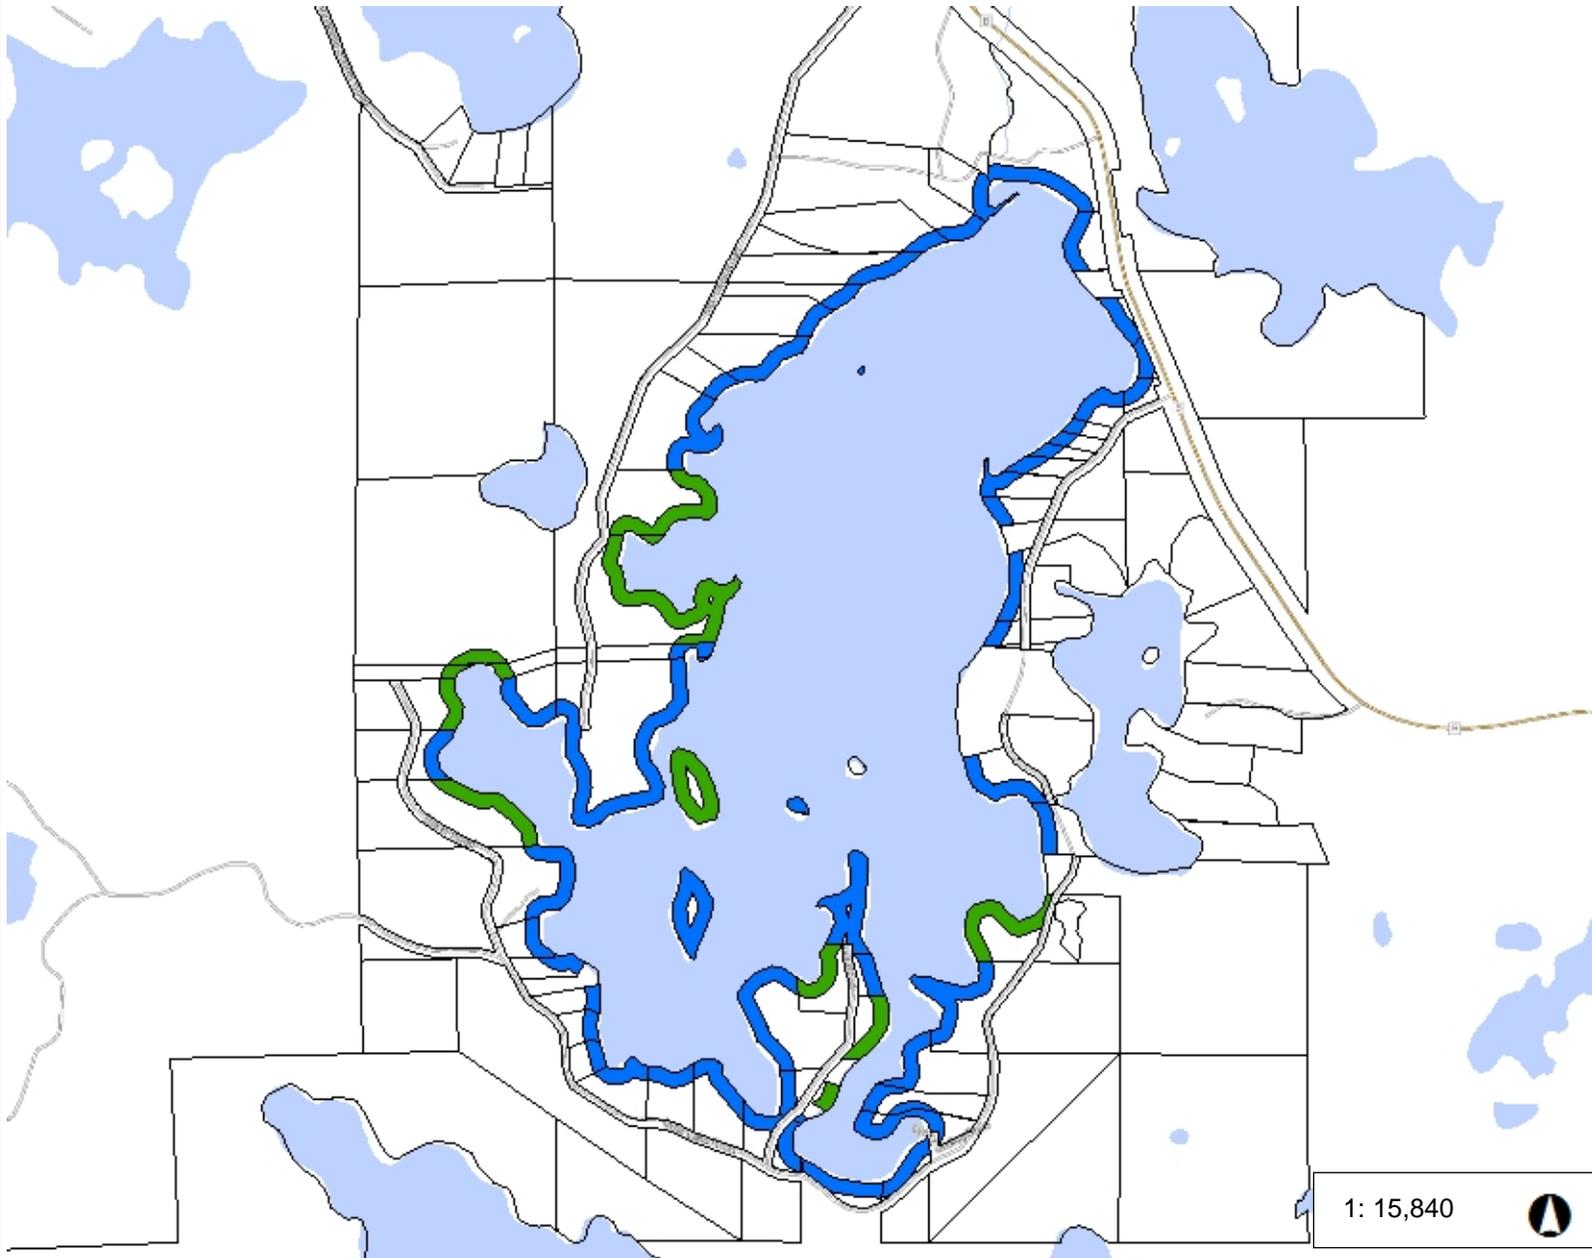
Exhibit 11. Lynx Lake Aquatic Plants - 2017

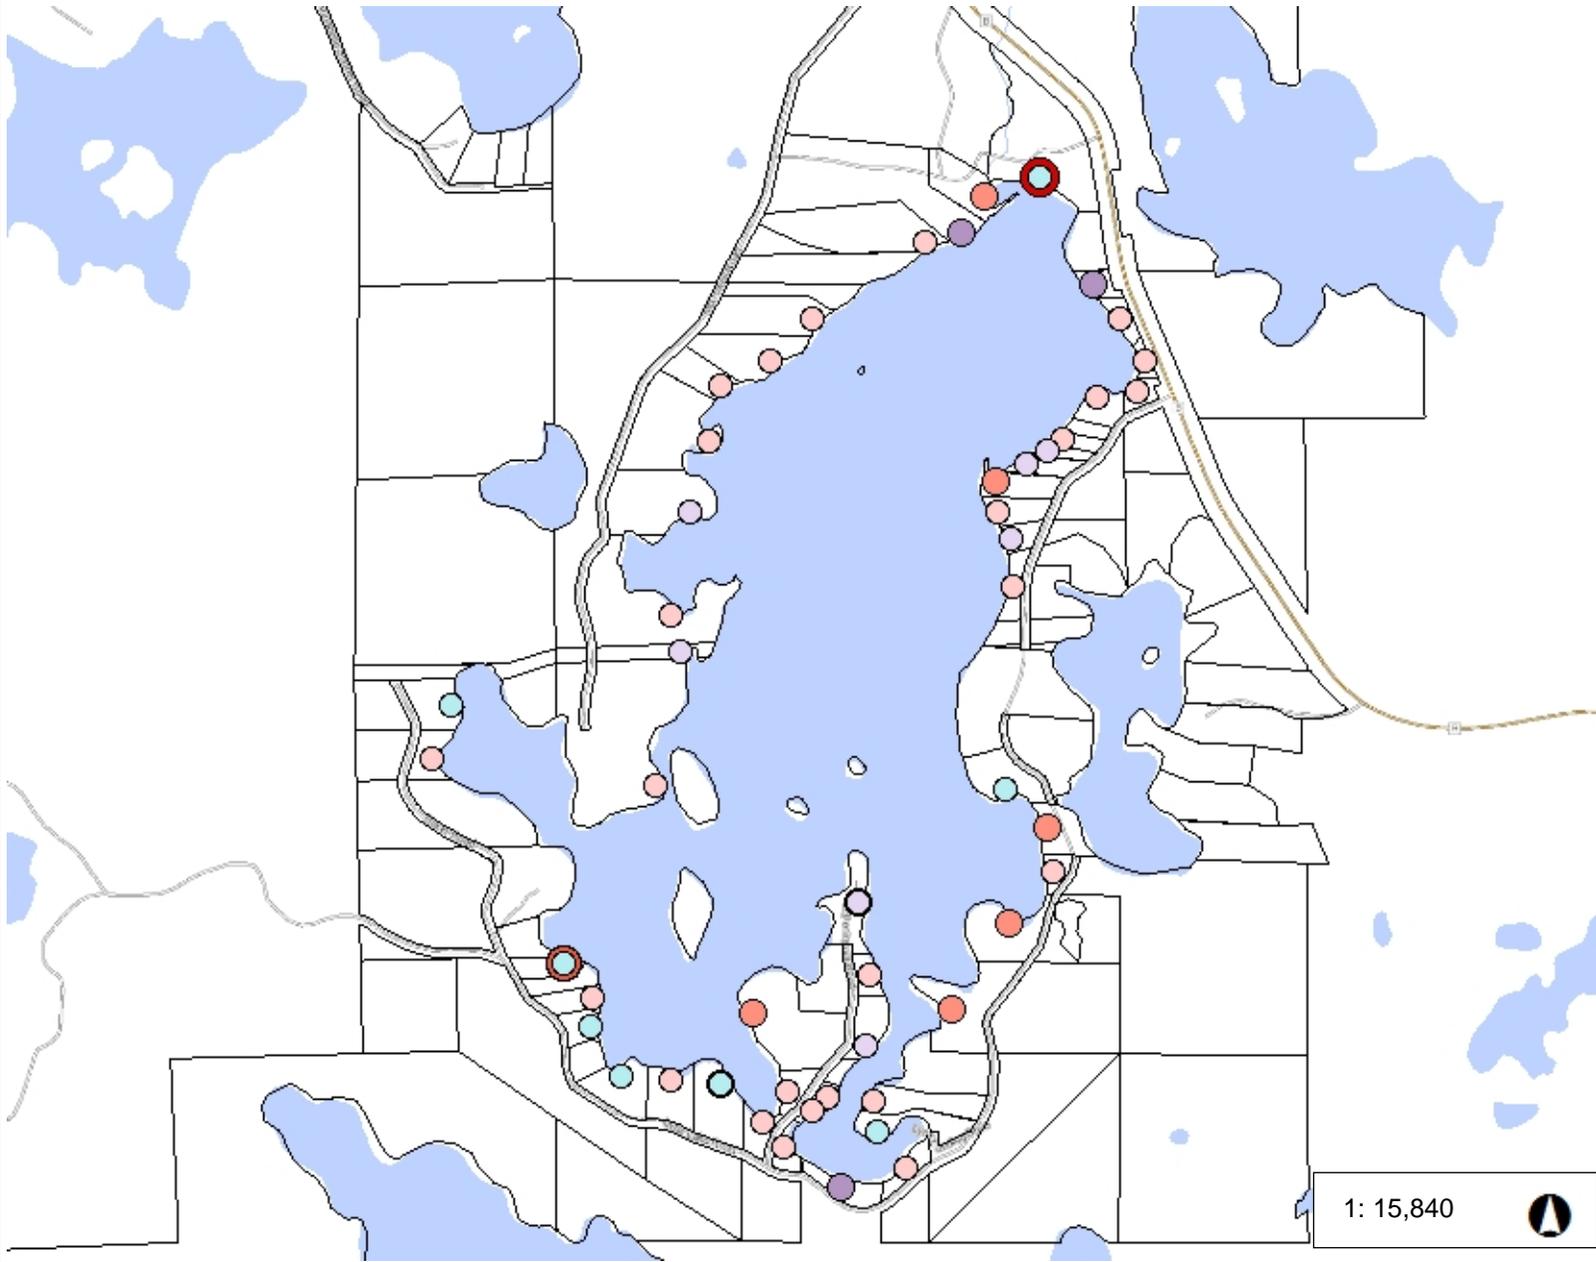
Exhibit 12. Lynx Lake Littoral Zone - Human Structures - 2017

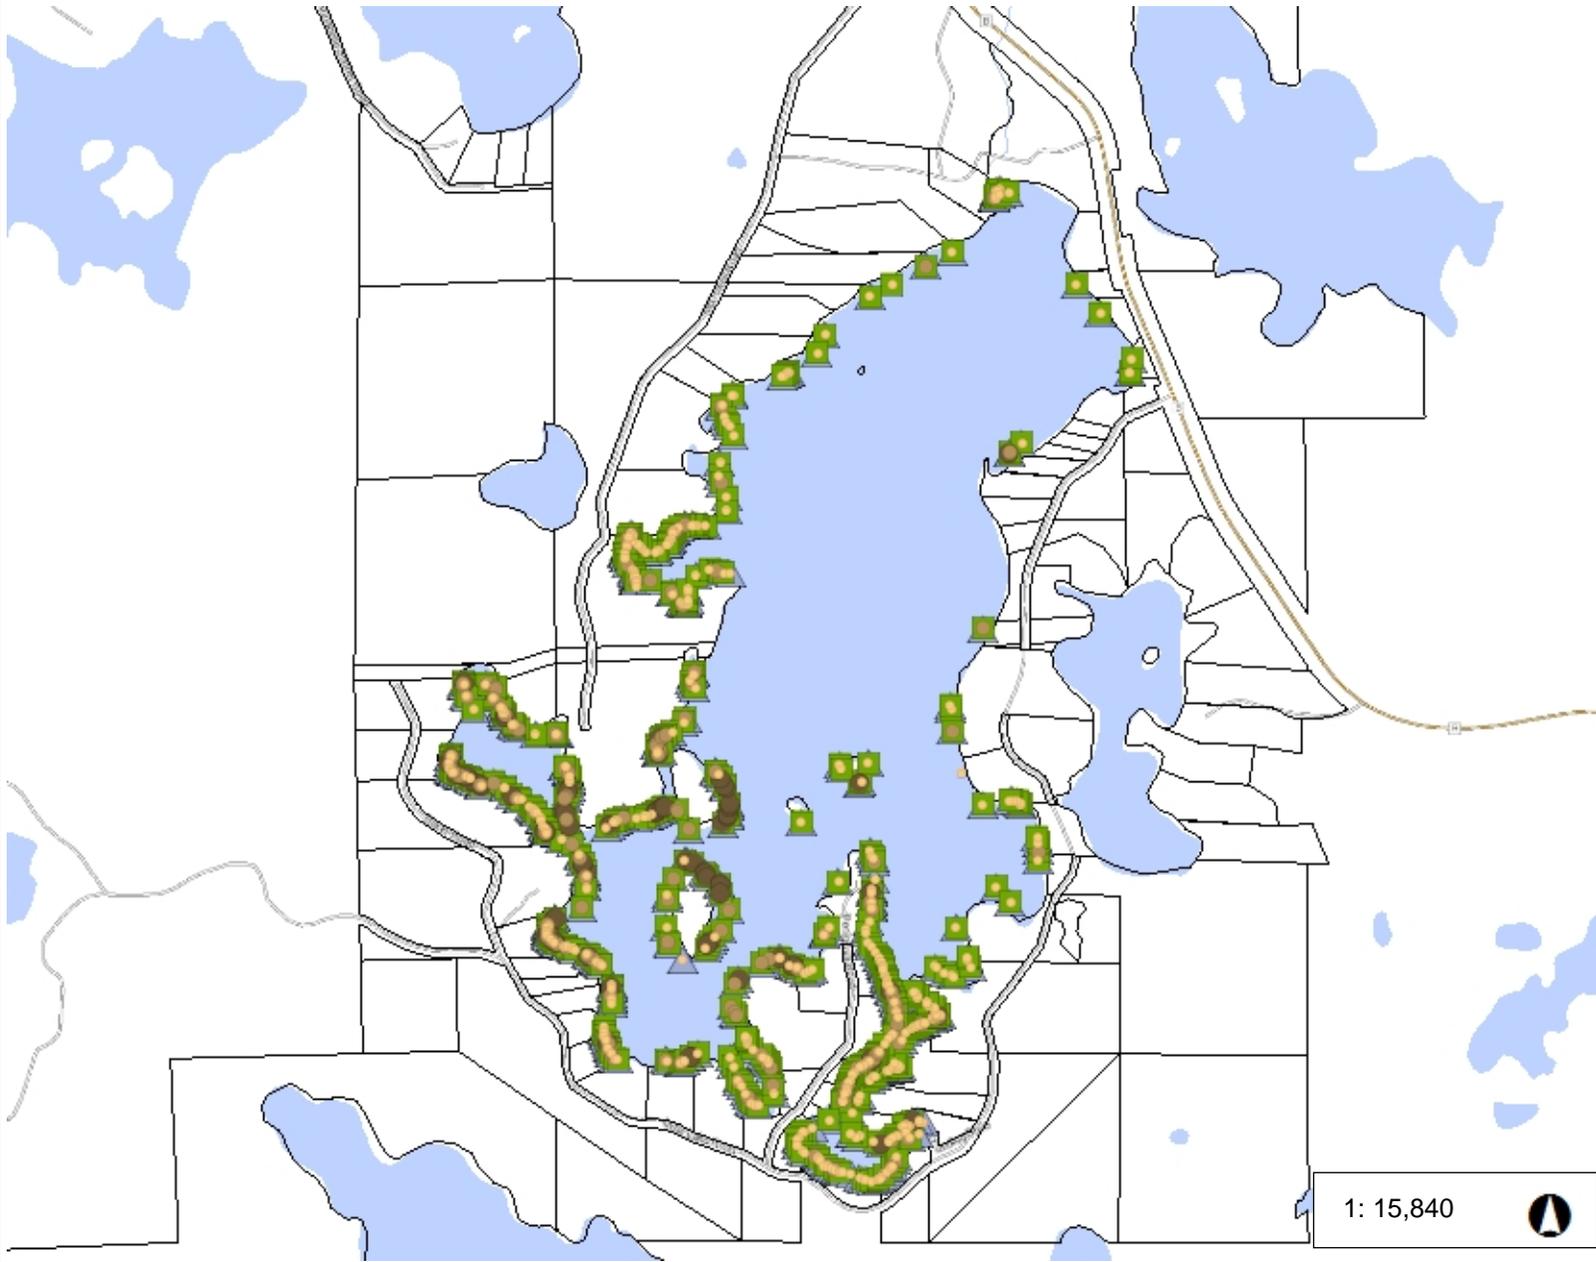
Exhibit 13. Lynx Lake Woody Habitat - 2017
