Presque Isle Wilderness Waters Program

Aquatic Plant Management Plan – Papoose Lake

Date: March 2019

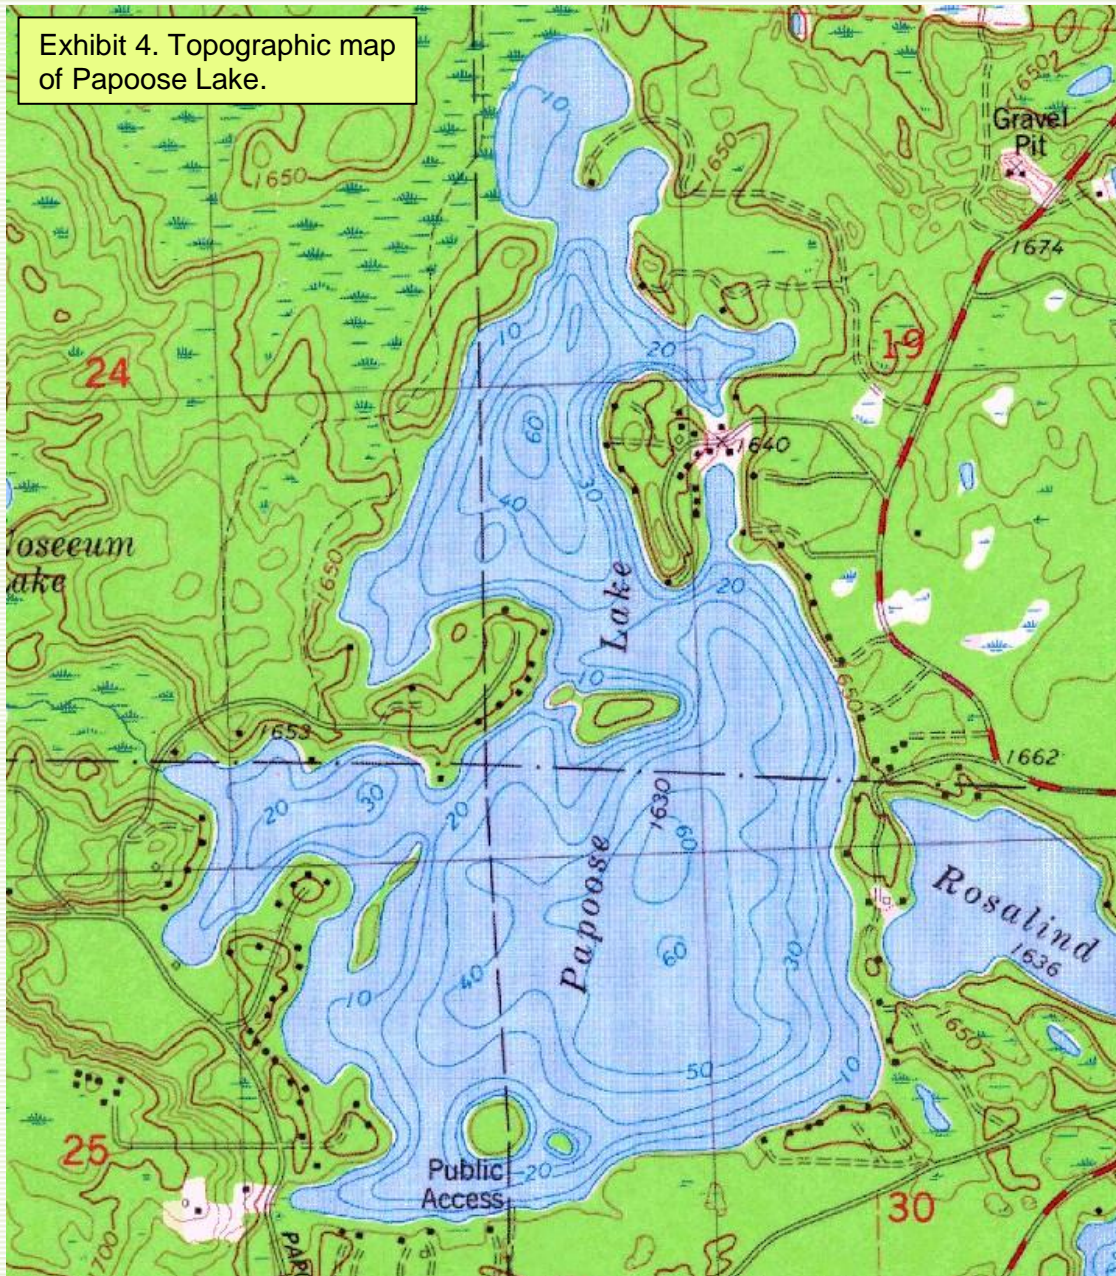
Papoose Lake has a public access site on the lake's south end. We observe a total of 89 piers on the shoreline of Papoose Lake from a recent aerial photograph or about 11.25 piers per mile of shoreline. The riparian area consists of both upland and wetland areas (Exhibit 4).

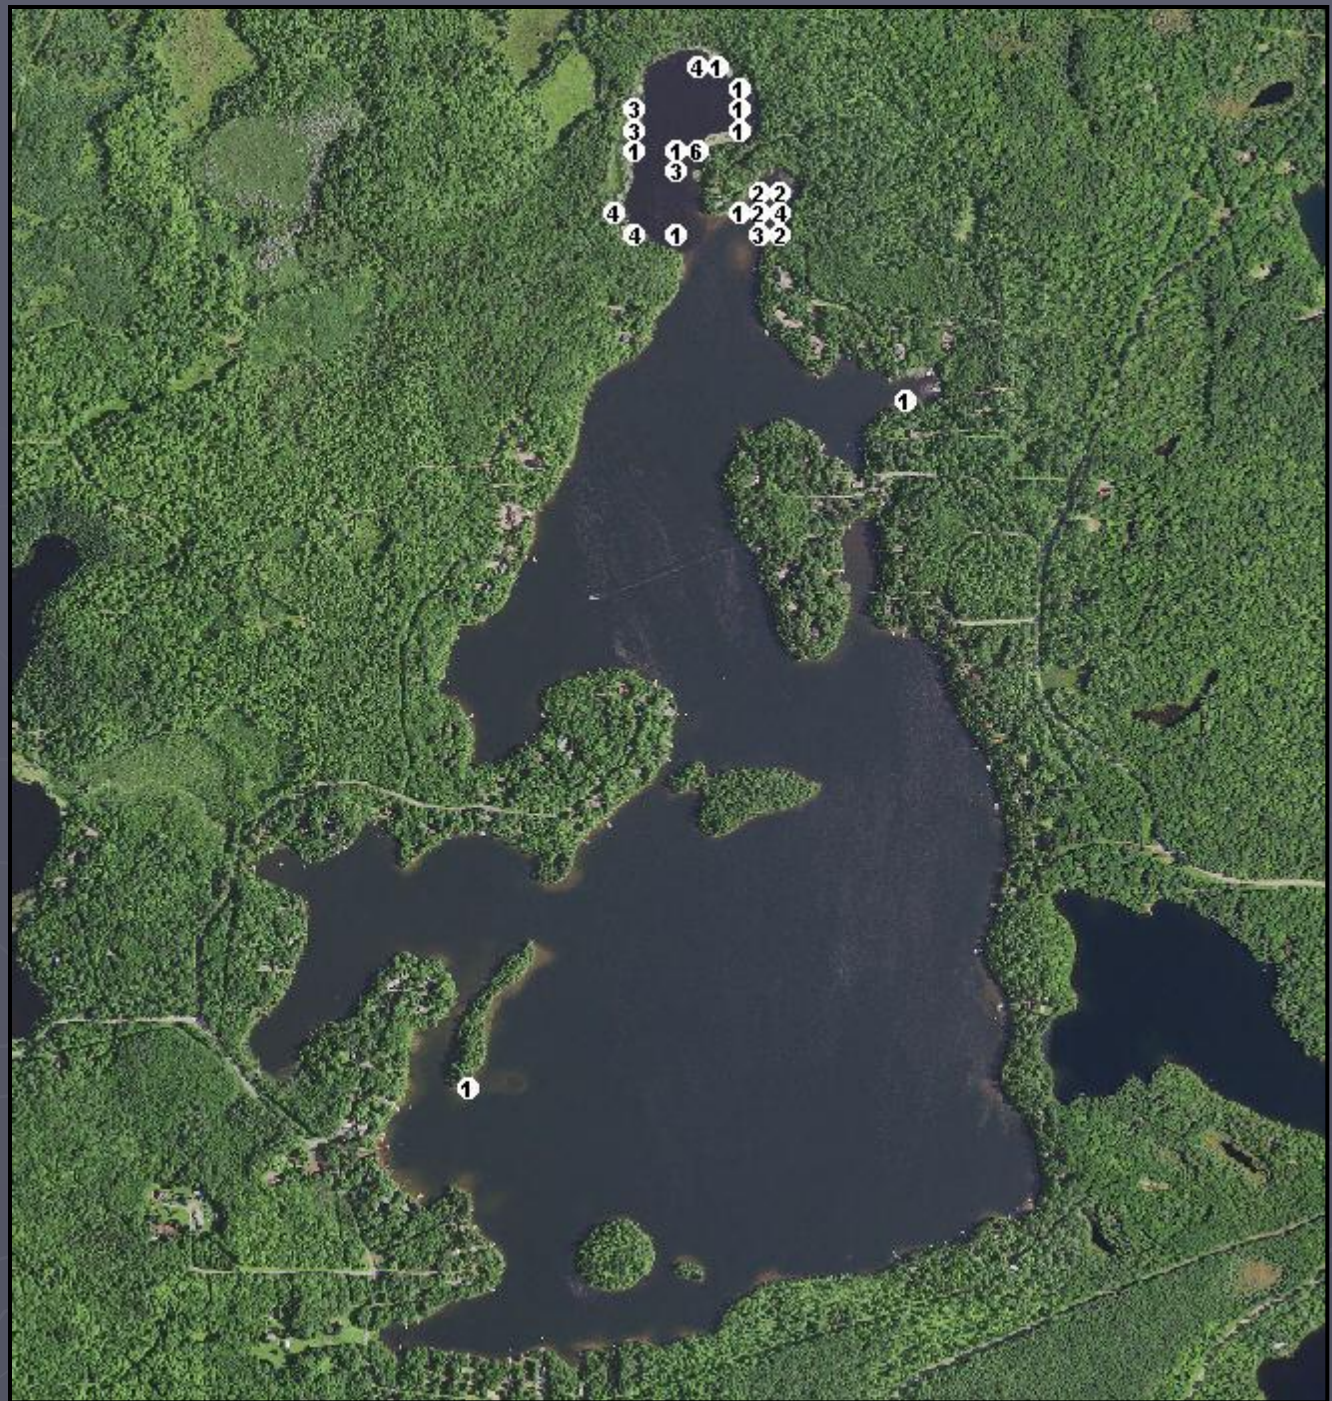
Figure 1. Number of plant species recorded at Papoose Lake sample sites (2017).

any given sample point ranged from 0 to 6 and 24 sample points were found to have aquatic vegetation present. The average number of species encountered at these vegetated sites was 2.29. The actual number of species encountered at each of the vegetated sites in 2017 is graphically displayed on Figure 1. Plant density is estimated by a “rake fullness” metric (3 being the highest possible density). These densities (considering all species) are displayed for each sampling site on Figure 2.

Figure 1. Number of plant species recorded at sample sites.

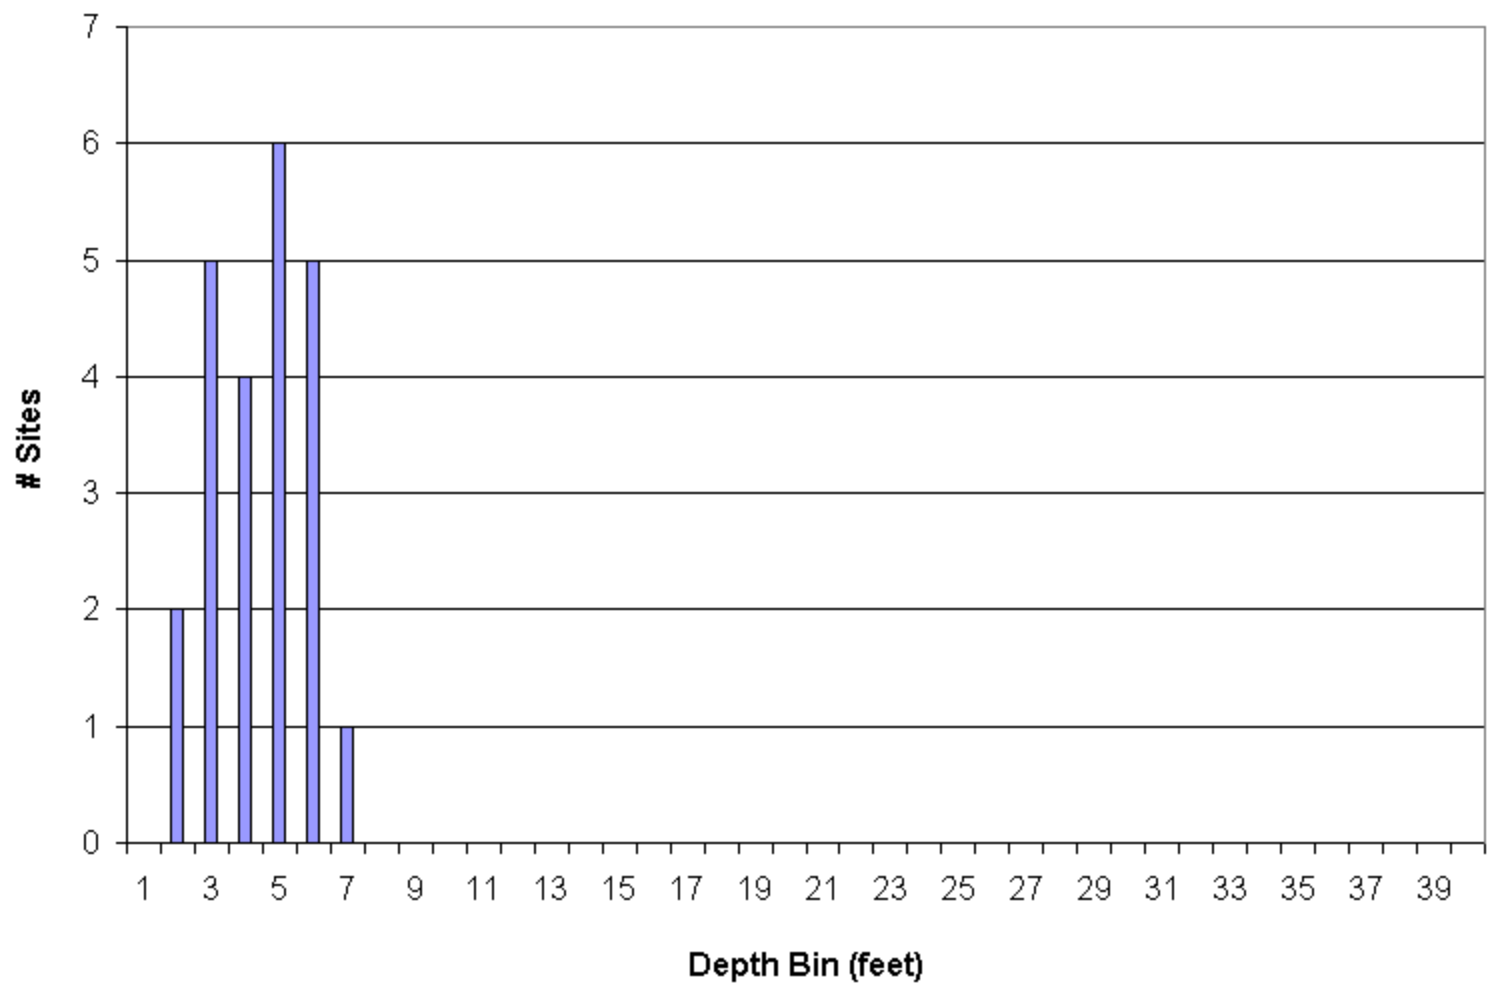
Figure 4. Papoose Lake sampling sites less than or equal to maximum depth of rooted vegetation (2017).

The maximum depth of plant colonization in 2017 was 6.5 feet (Table 1 and Figure 3). Rooted vegetation was found at 55 of the 299 sample sites with depth \leq the maximum depth of plant colonization (43.6% of sites). These sites are displayed as a black dot within a circle on Figure 4. This indicates that although availability of appropriate depth may limit the distribution of plants, it is not the only habitat factor involved. Substrate is another feature that influences plant distribution (e.g., soft substrate often harbors more plants than hard substrate). Figure 5 presents the substrates encountered during the aquatic plant survey (mud, sand, or rock).

- Site less than or equal to maximum depth of plant colonization (MDC).
- Plant find(s) at site less than or equal to MDC.

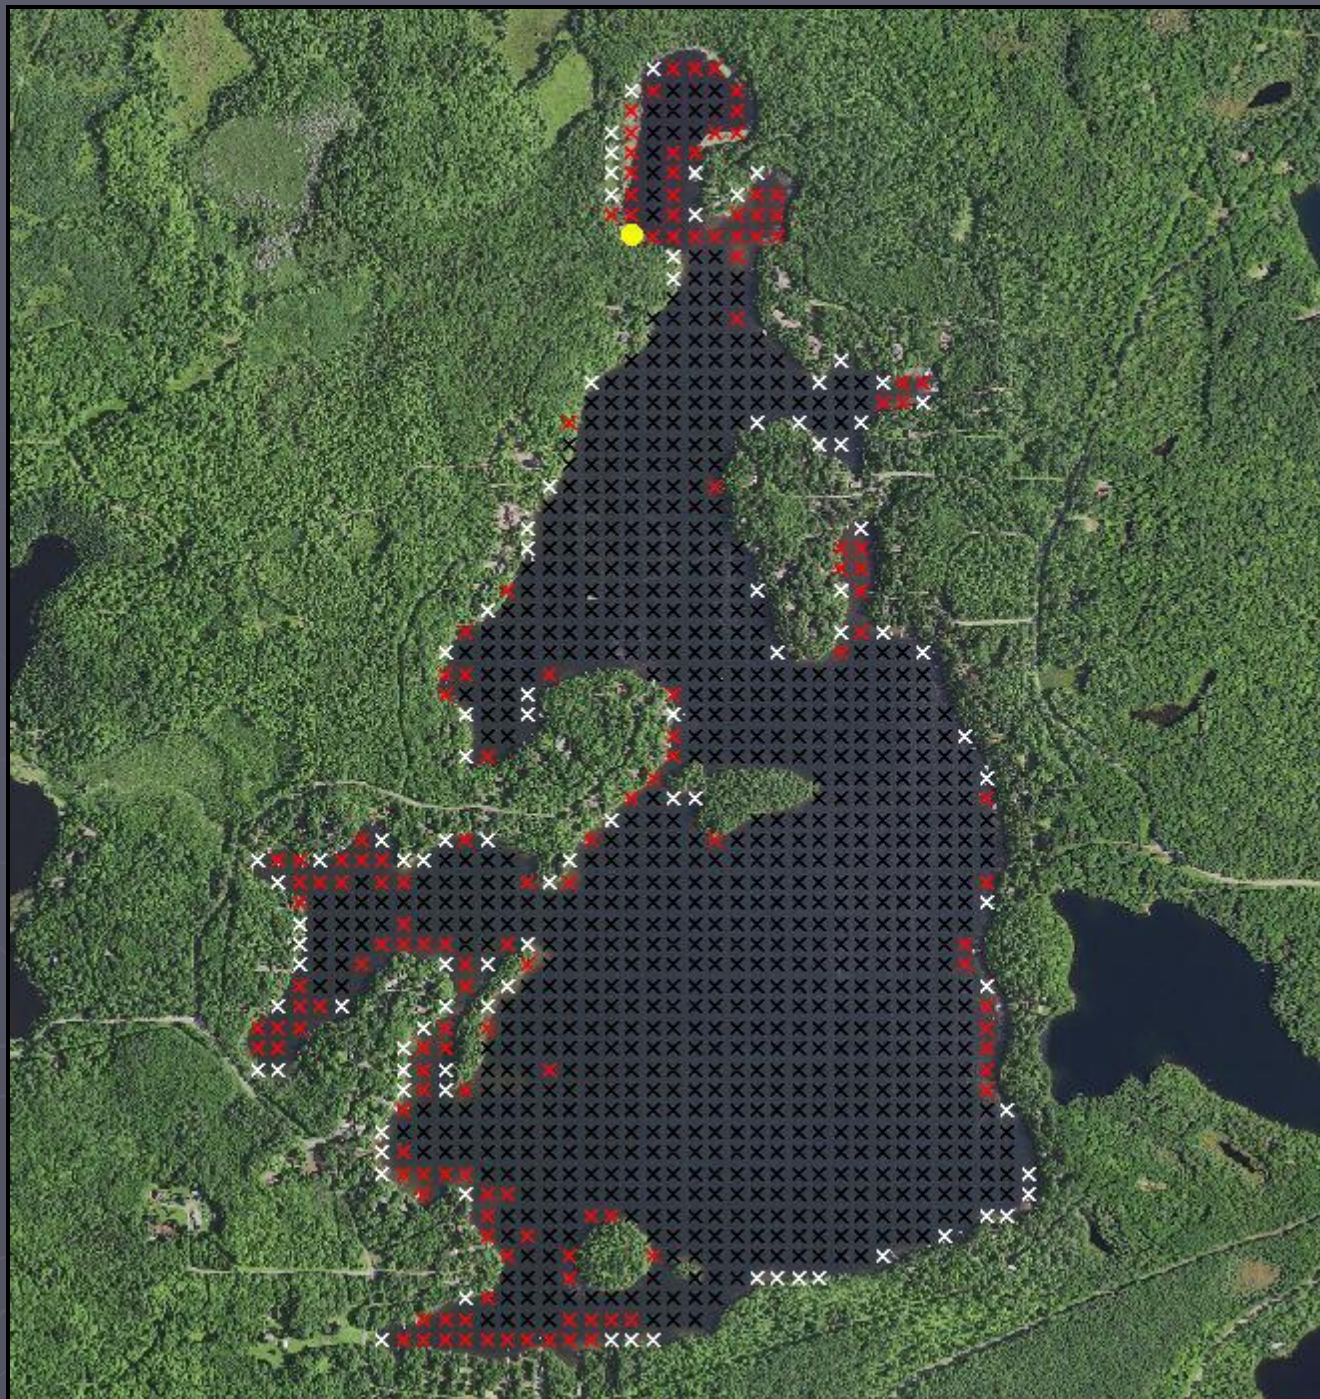
Figure 13. Distribution of plant species, Papoose Lake (2017).

Najas gracillima,
Northern naiad

-   1 (Rake fullness)
-   2
-   3
-   Visual
-   Not found
-   Unsampled (depth)
-   Non-navigable

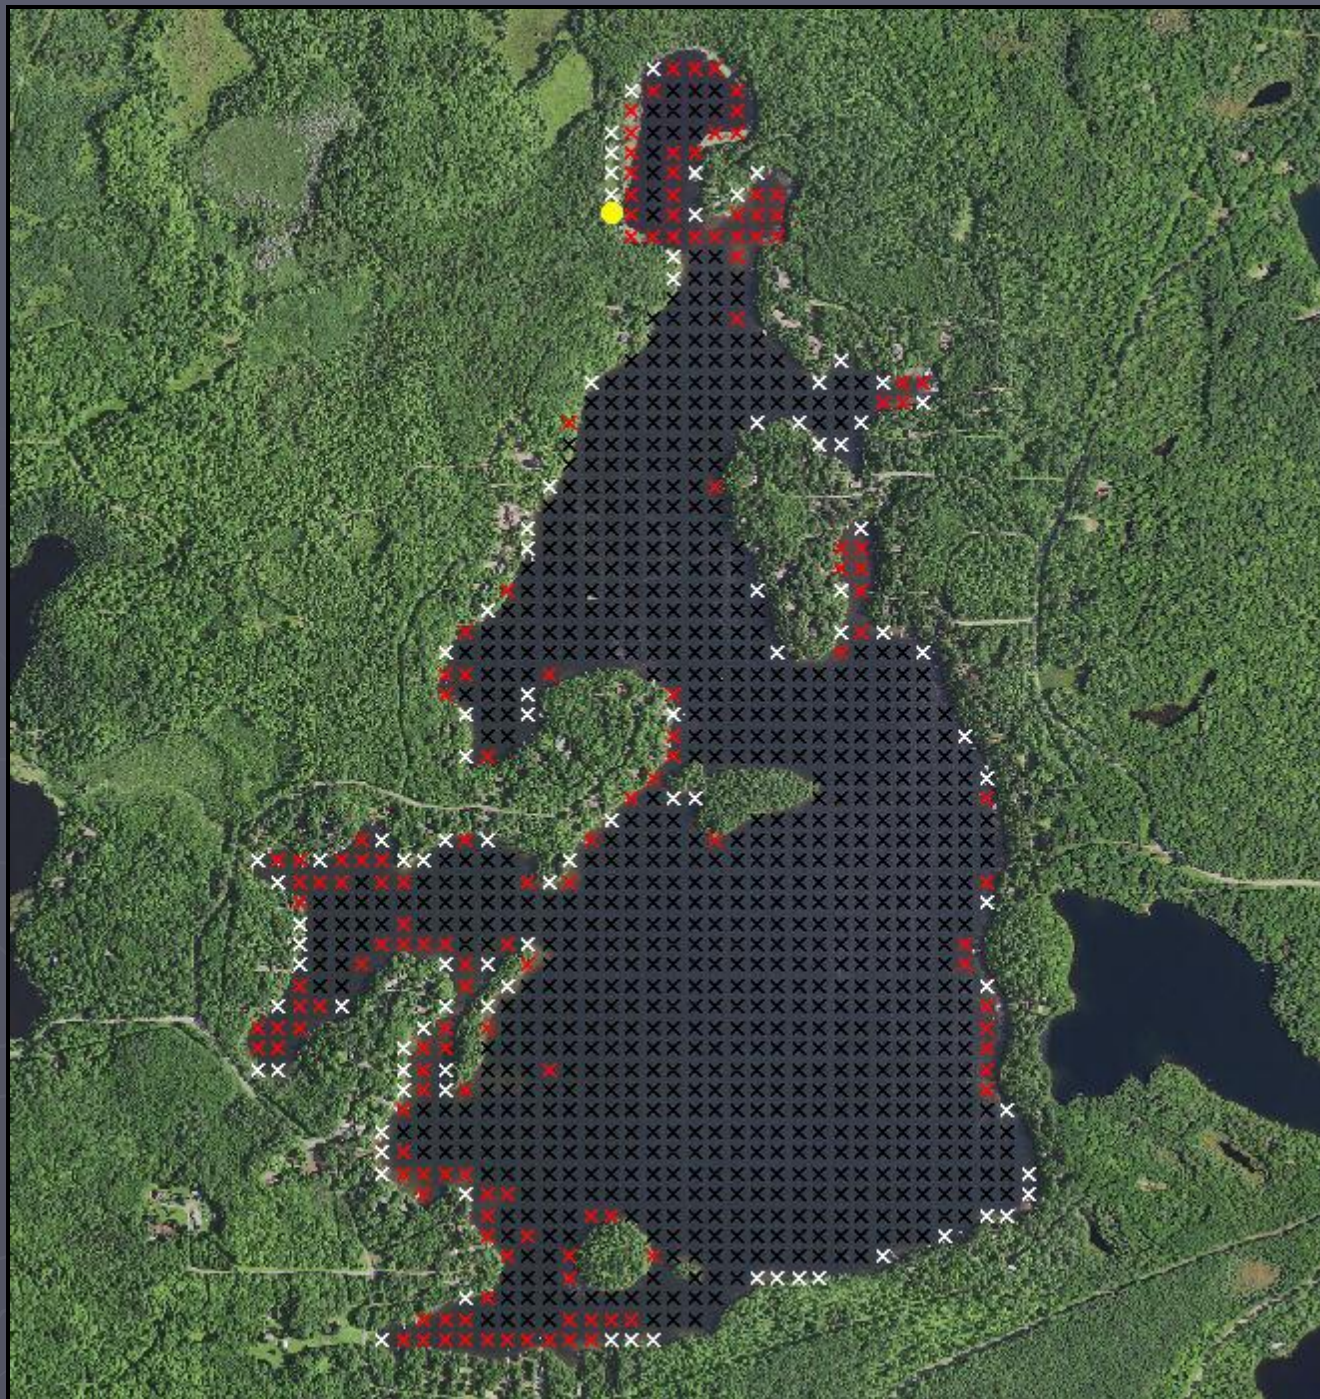
Figure 14. Distribution of plant species, Papoose Lake (2017).

Potamogeton obtusifolius, Blunt-leaf pondweed

-   1 (Rake fullness)
-   2
-   3
-   Visual
-   Not found
-   Unsampld (depth)
-   Non-navigable

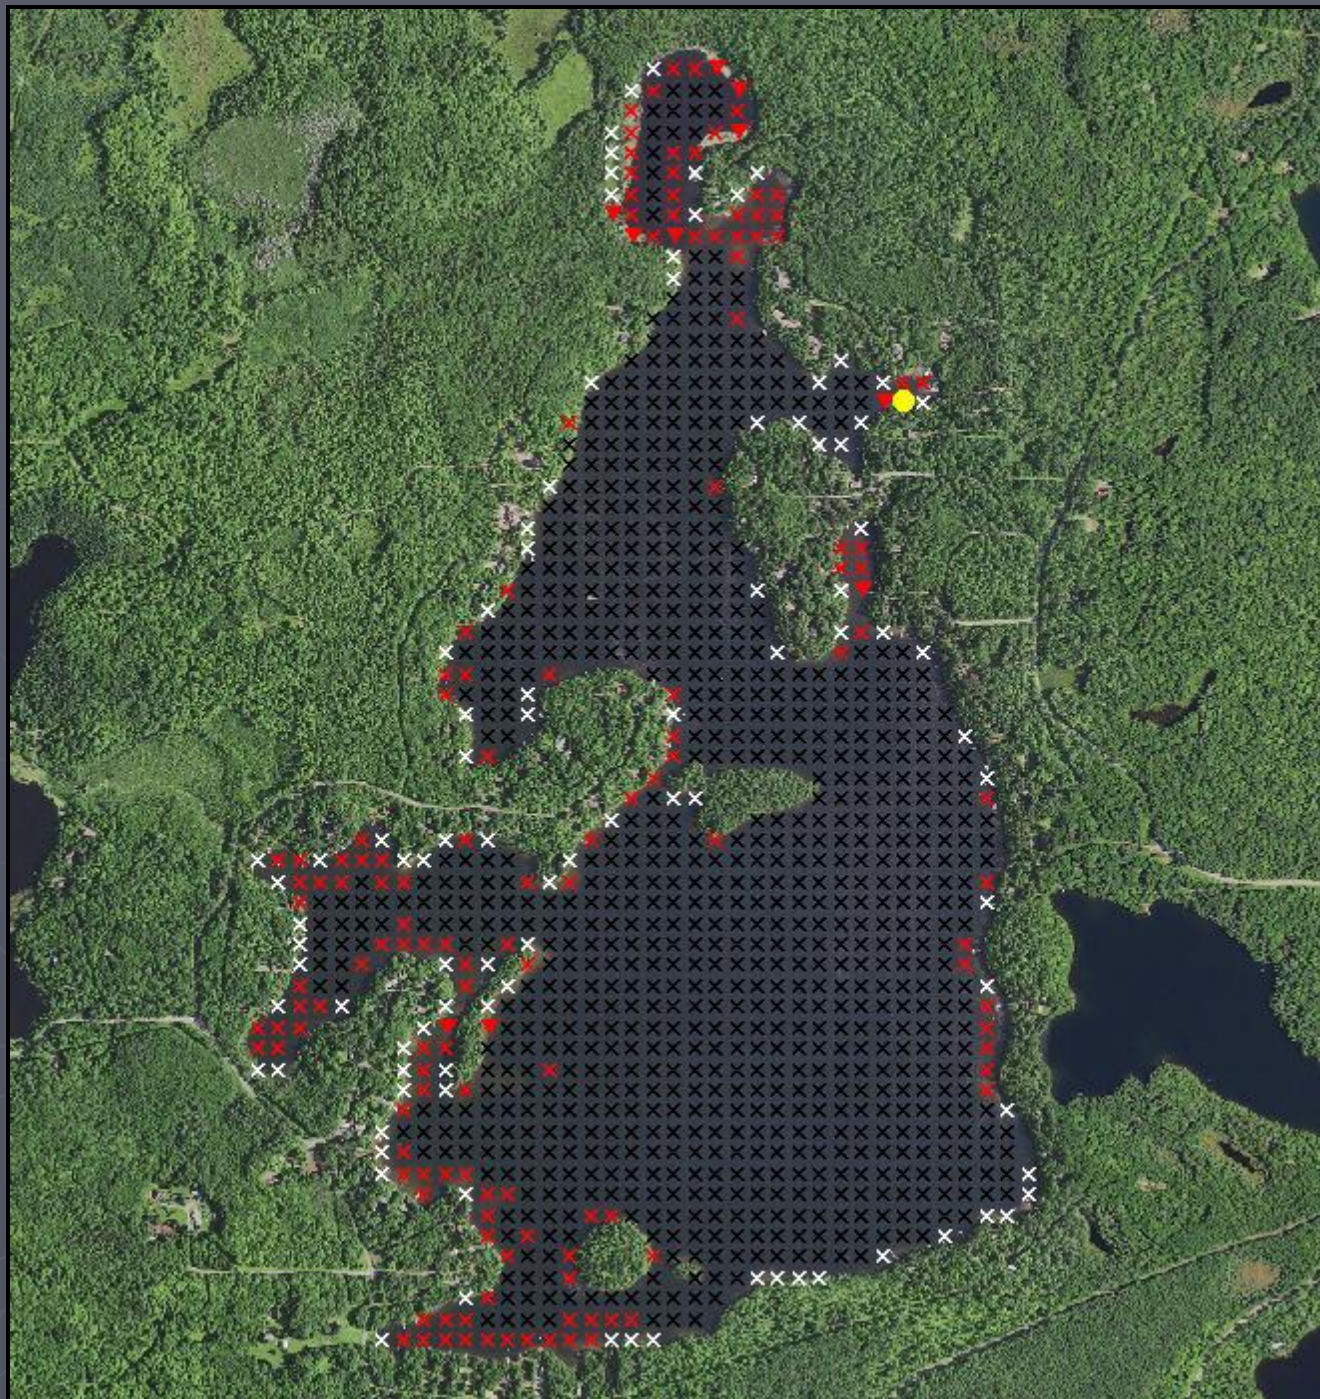
Figure 16. Distribution of plant species, Papoose Lake (2017).

2
-   3
-   Visual
-   Not found
-   Unsampld (depth)
-   Non-navigable

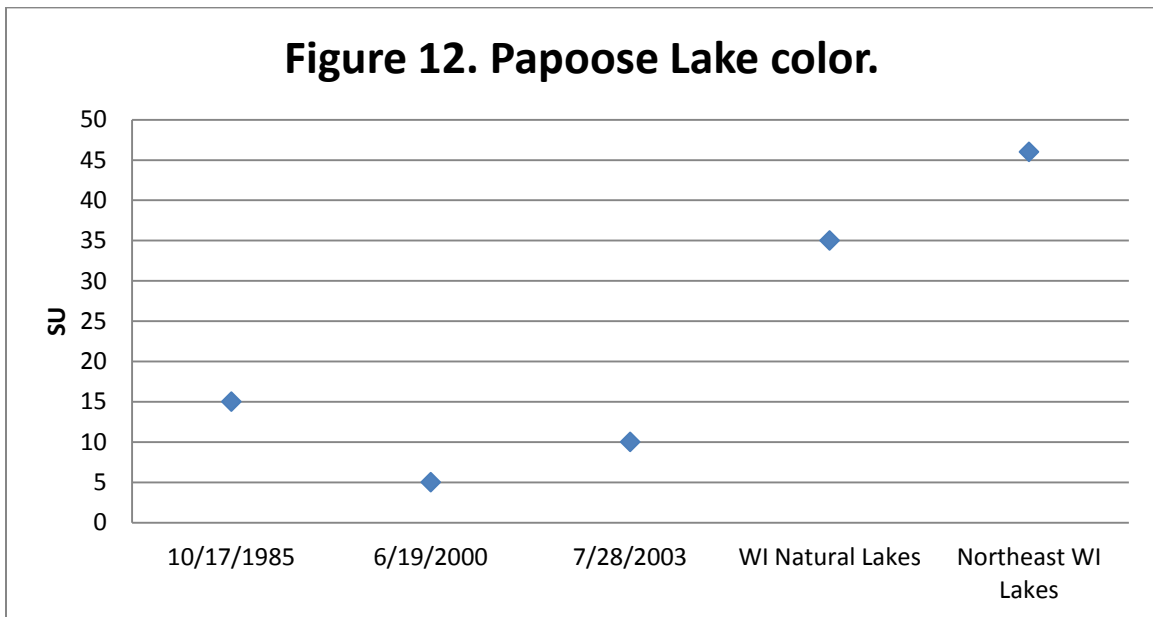
Figure 12. Papoose Lake color.

Color of lake water is related to the type and amount of dissolved organic chemicals. Its main significance is aesthetics, although it may also influence light penetration and in turn affect aquatic plant and algal growth. Many lakes have naturally occurring color compounds from decomposition of plant material in the watershed (Shaw et al., 2004). Units of color are determined from the platinum-cobalt scale and are therefore recorded as Pt-Co units. Shaw states that a water color between 0 and 40 Pt-Co units is low. Papoose Lake was analyzed for color levels and is shown in Figure 12. CLMN volunteers also recorded their perceptions of water color in Papoose Lake. Since 1991, 60% of volunteers indicated the water appeared “blue” in color (Figure 13).

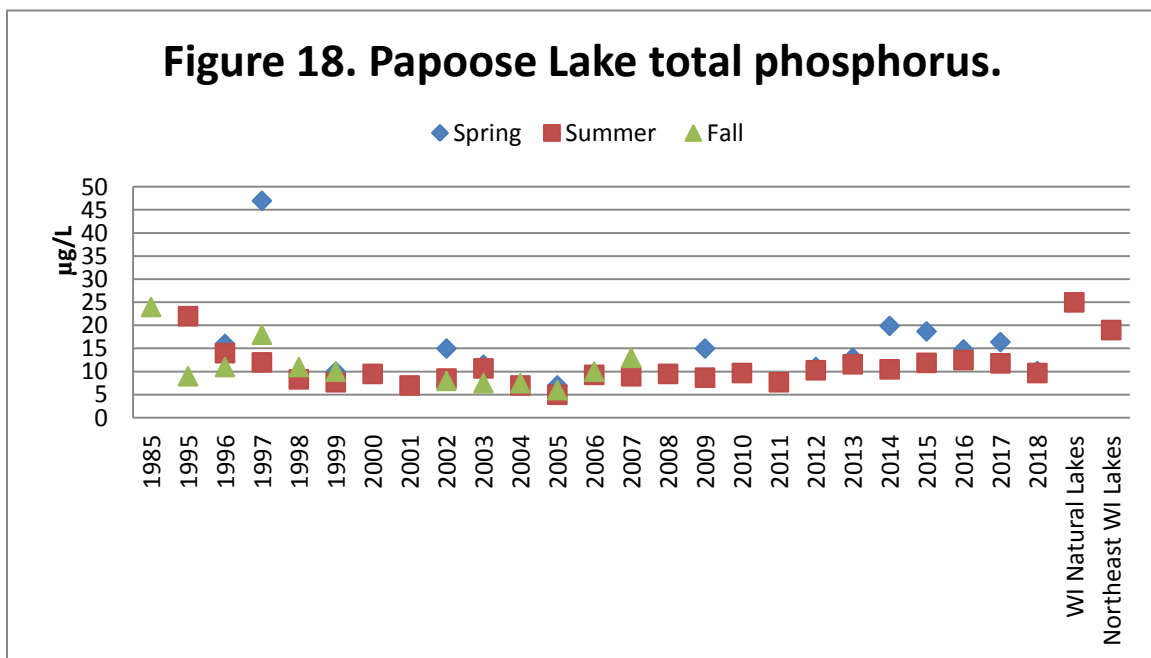
Papoose Lake's average total phosphorus (Figure 18) is below the average for northeast WI lakes and the average for WI natural lakes. This value can be considered "very good" with respect to total phosphorus (Figure 19).

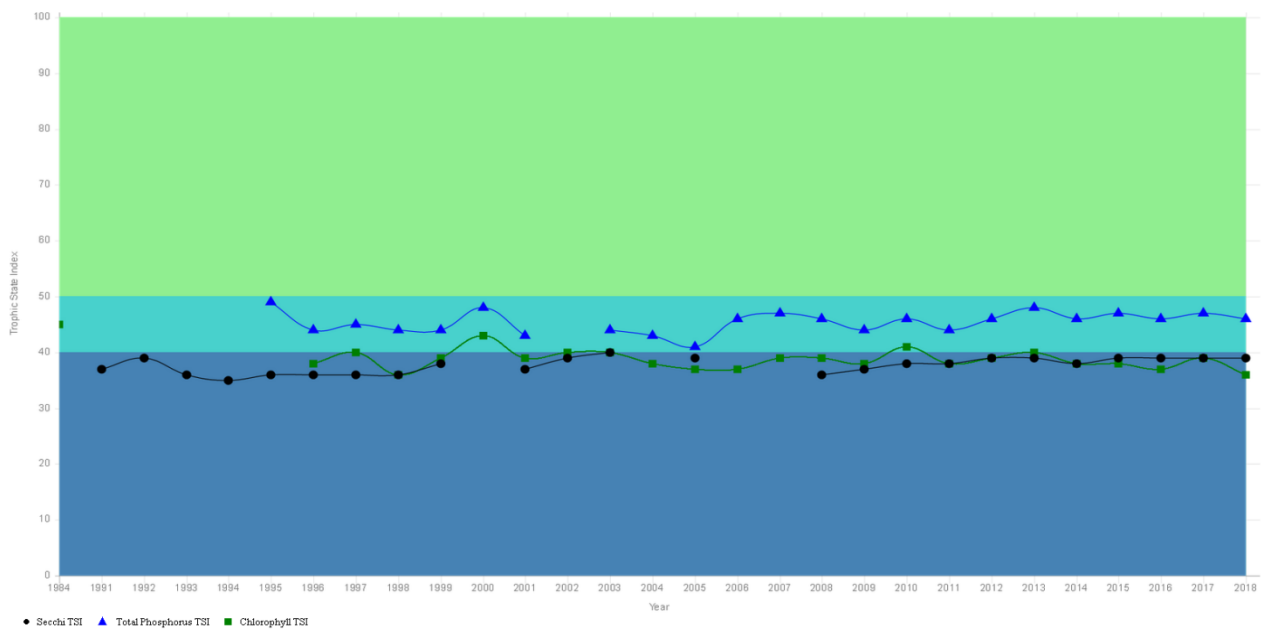
Trophic State Index Graph: Papoose Lake - Deep Hole - Vilas County

Trophic state is another indicator of water quality (Carlson, 1977). Lakes are typically divided into three categories based on trophic state – oligotrophic, mesotrophic, and eutrophic. These categories reflect a lake’s nutrient and clarity levels (Shaw et al., 2004). Trophic State Index (TSI) was calculated by the WDNR using Secchi measurements, chlorophyll *a*, and total phosphorus (Figure 20). Papoose Lake is classified as “oligotrophic” (Table 2).

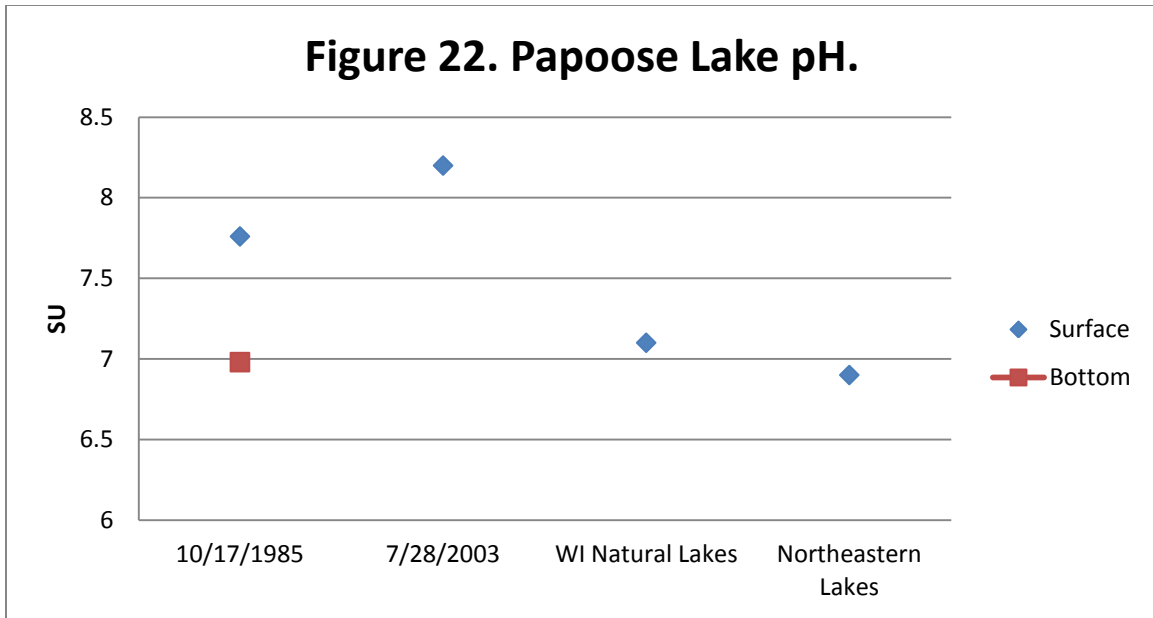
The acidity level of a lake's water regulates the solubility of many minerals. A pH level of 7 is considered neutral. The pH level in Wisconsin lakes ranges from 4.5 in acid, bog lakes to 8.4 in hard water, marl lakes (Shaw et al., 2004). Natural rainfall in Wisconsin averages a pH of 5.6. Some minerals become available under low pH (especially aluminum, zinc, and mercury) and can inhibit fish reproduction and/or survival. Mercury and aluminum are not only toxic to many kinds of wildlife, but also to humans (especially those that eat tainted fish). The pH scale is logarithmic, so every 1.0 unit change in pH increases the acidity tenfold. Water with a pH of 6 is 10 times more acidic than water with pH of 7. A lake's pH level is important for the release of potentially harmful substances and affects plant growth, fish reproduction and survival. A lake with neutral or slightly alkaline pH is a good lake for fish and plant survival. The pH of Papoose Lake is shown in Figure 22 indicating that the lake was neutral to slightly alkaline.

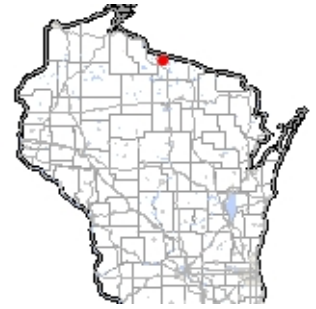
Exhibit 5. Papoose Lake Riparian Coverage - % Canopy - 2018

- Percent Canopy**
 - 0 - 20
 - 21 - 40
 - 41 - 60
 - 61 - 80
 - 81 - 100
- Shoreland Parcels
- County Boundary
- Municipality
- State Boundaries
- County Boundaries
- Major Roads**
 - Interstate Highway
 - State Highway
 - US Highway
- County and Local Roads**
 - County HWY
 - Local Road
- Railroads
- Tribal Lands
- Rivers and Streams
- Intermittent Streams
- Open Water
- Great Lakes

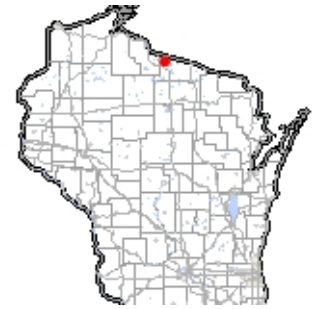
Exhibit 8. Papoose Lake Riparian Coverage - % Manicured Lawn - 2018

Percent Manicured Lawn

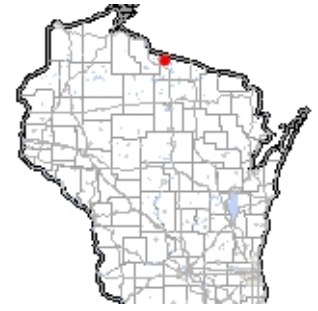
Exhibit 9. Papoose Lake Bank Erosion and Modifications - 2018

- Bank Erosion >1ft
- Bank Erosion <1ft

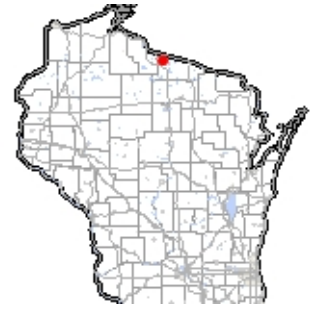
Exhibit 10. Papoose Lake Runoff Concerns - 2018

- Channelized Flow
- Point Source
- Shoreland Parcels
- County Boundary
- Municipality
- State Boundaries
- County Boundaries

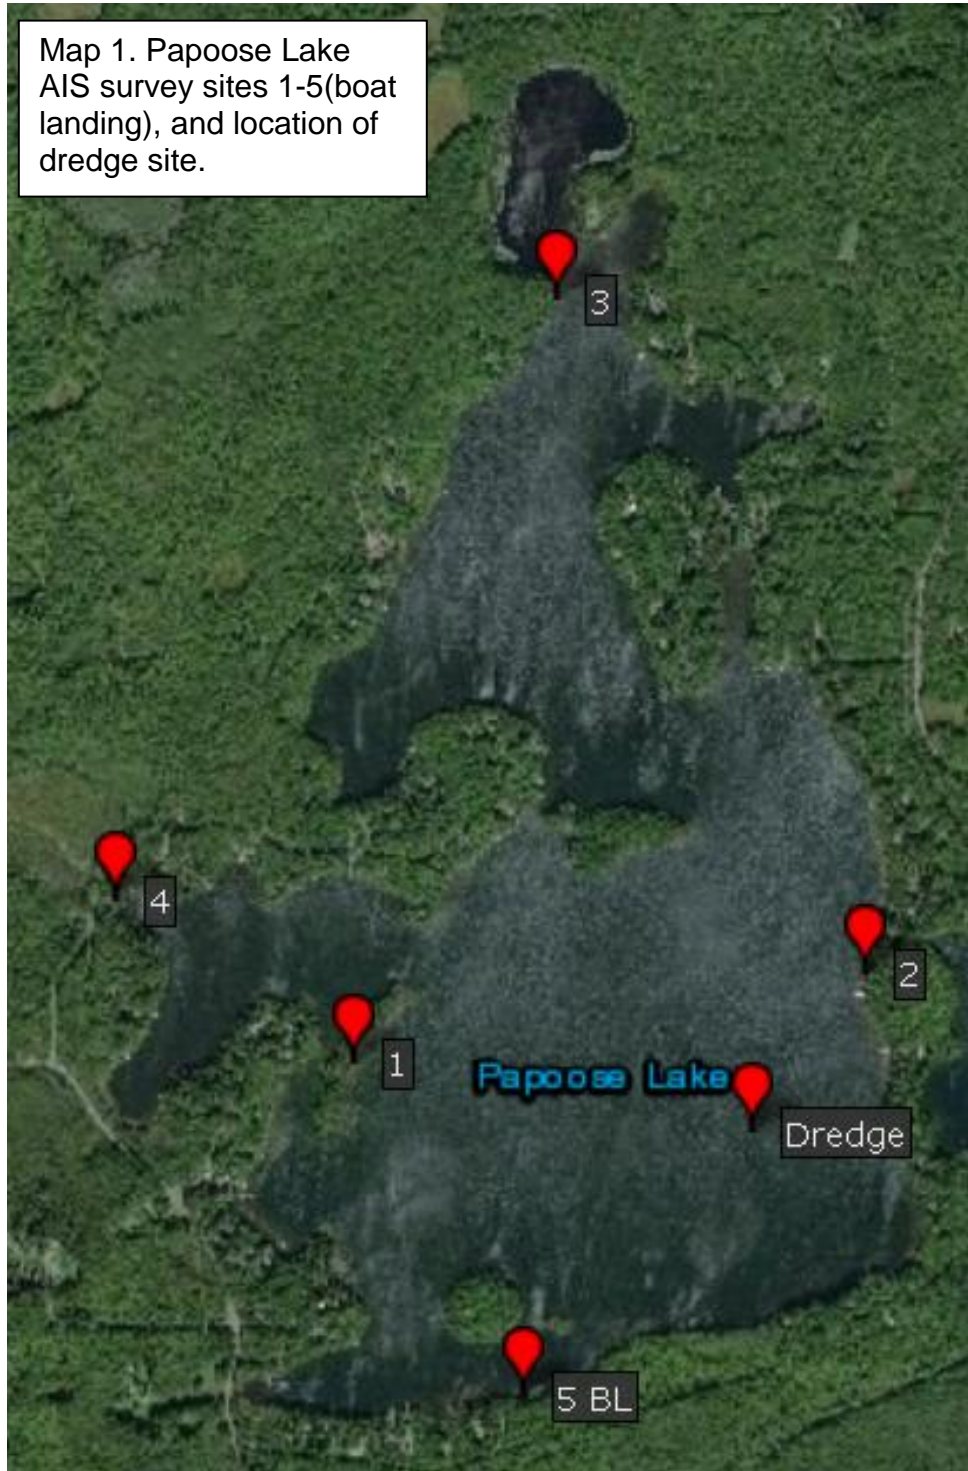
used to collect a sediment sample in the middle of the lake (Map 1 and Table 2). The sample was brought back to the lab and filtered to look for spiny water flea spines under magnification. No AIS were found.

Meander surveys found no additional invasive species.

Table 1. AIS Survey on Papoose Lake 5/23/2018.			
Site	Latitude	Longitude	Species found
1	46.18201	-89.807783	Rusty crayfish
2	46.183517	-89.795367	None
3	46.1948333	-89.802867	None
4	46.184750	-89.813583	Rusty crayfish
5 BL	46.176417	-89.803700	Rusty crayfish
