# Presque Isle Wilderness Waters Program

## Aquatic Plant Management Plan – Cathaline Lake

Date: March 2019

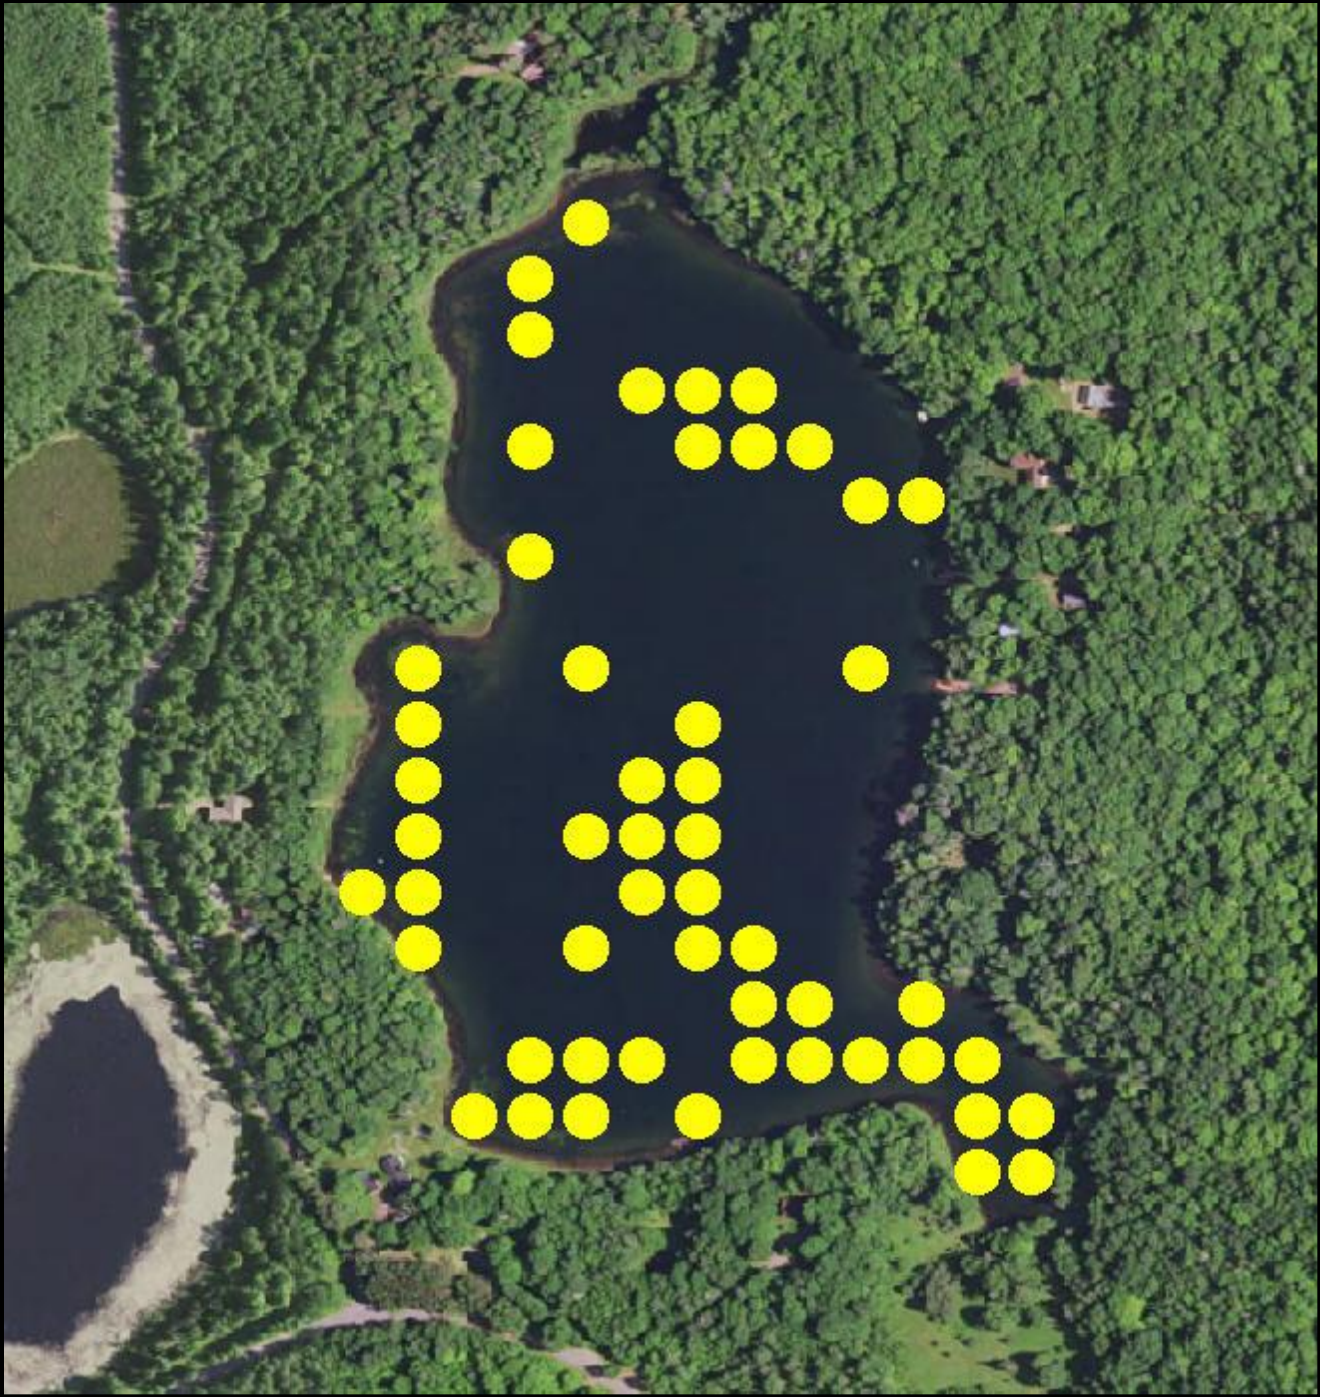
Figure 2. Rake fullness ratings for Cathaline Lake sample sites (2017).

- 1 (Yellow circle)
- 2 (Orange circle)
- 3 (Red circle)

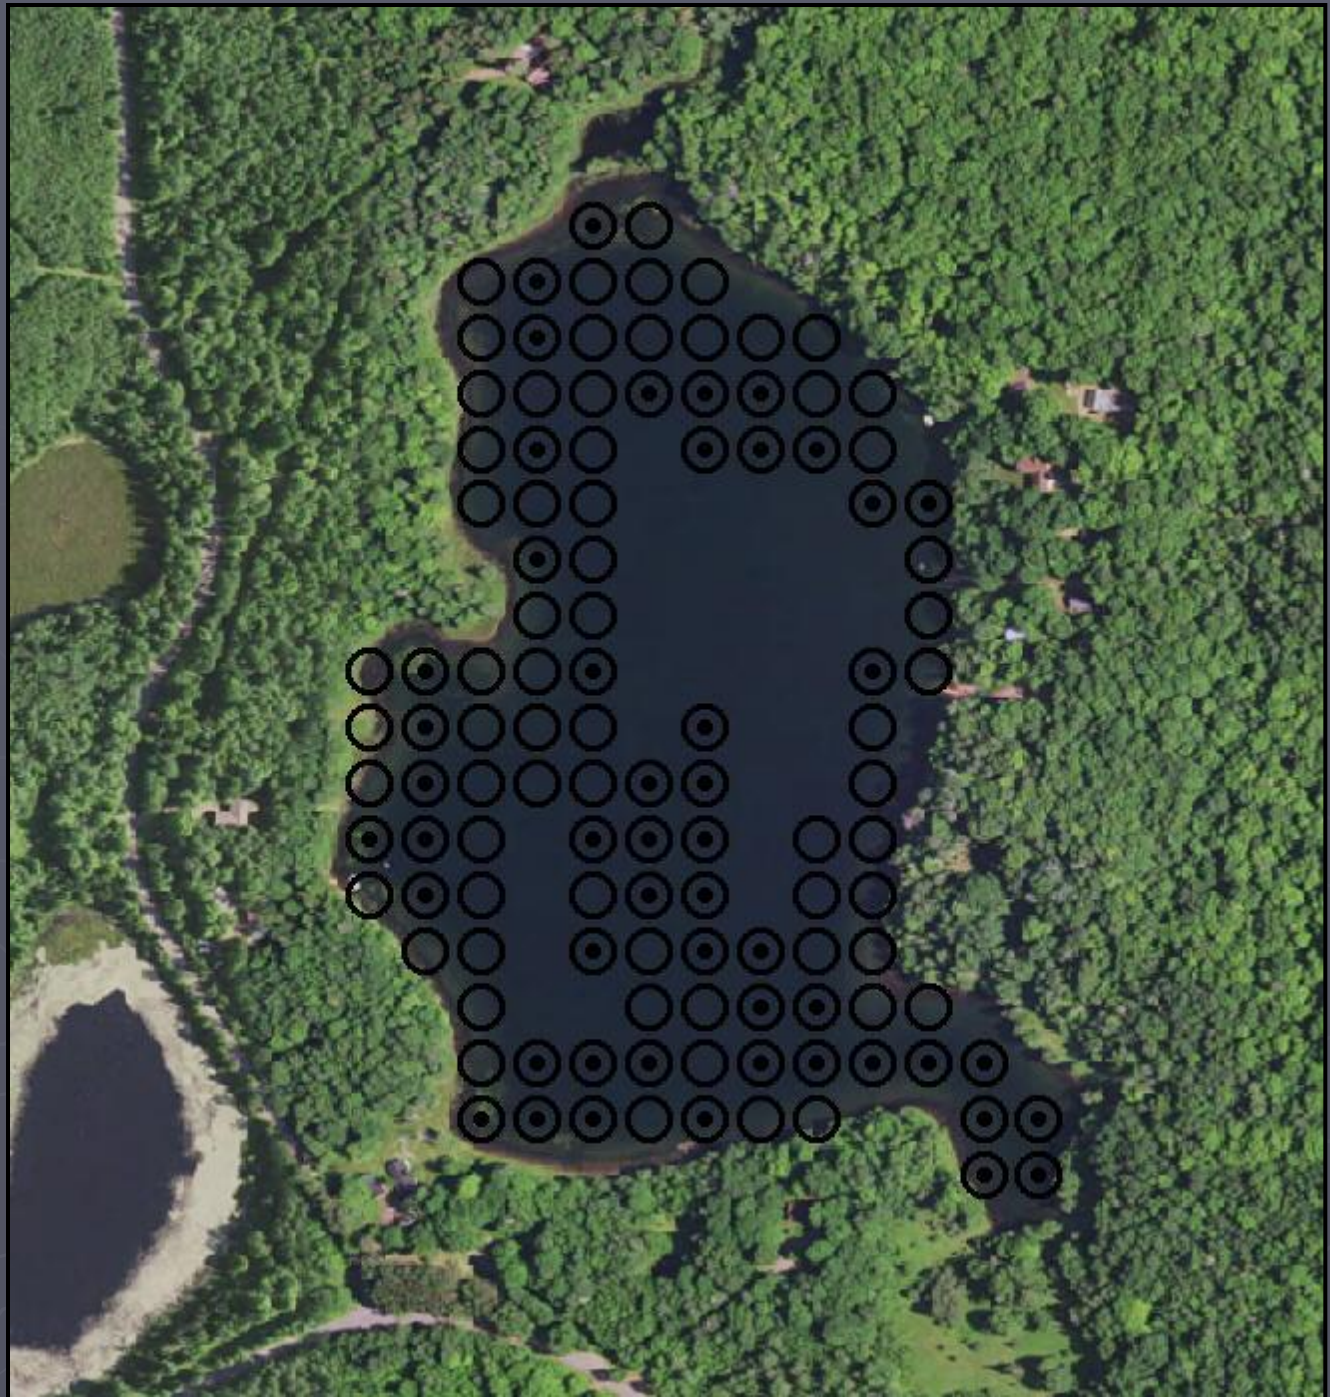
Figure 4. Cathaline Lake sampling sites less than or equal to maximum depth of rooted vegetation (2017).

- Site less than or equal to maximum depth of plant colonization (MDC).
- Plant find(s) at site less than or equal to MDC.

The maximum depth of plant colonization in 2017 was 29.0 feet (Table 1 and Figure 3). Rooted vegetation was found at 50 of the 114 sample sites with depth  $\leq$  the maximum depth of plant colonization (43.9% of sites). These sites are displayed as a black dot within a circle on Figure 4. This indicates that although availability of appropriate depth may limit the distribution of plants, it is not the only habitat factor involved. Substrate is another feature that influences plant distribution (e.g., soft substrate often harbors more plants than hard substrate). Figures 5 presents the substrates encountered during the aquatic plant survey (mud, sand, or rock).

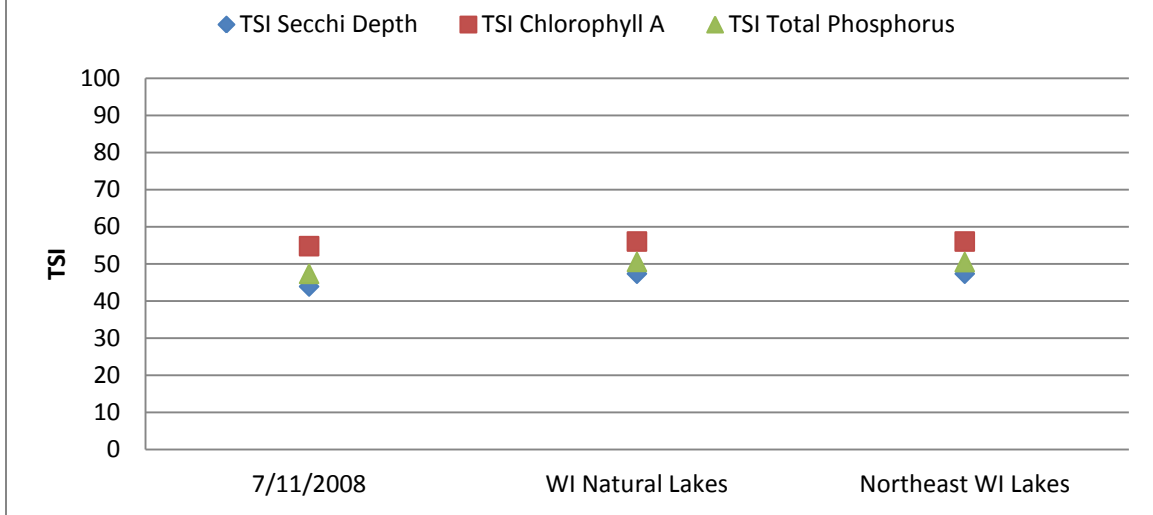
**Figure 5. Cathaline Lake Trophic State Index.**

Trophic state is another indicator of water quality (Carlson, 1977). Lakes are typically divided into three categories based on trophic state – oligotrophic, mesotrophic, and eutrophic. These categories reflect a lake’s nutrient and clarity levels (Shaw et al., 2004). Trophic State Index (TSI) can be calculated by the WDNR using Secchi measurements, chlorophyll *a*, and total phosphorus (Figure 5). Cathaline Lake is classified as being “mesotrophic” (Table 2).

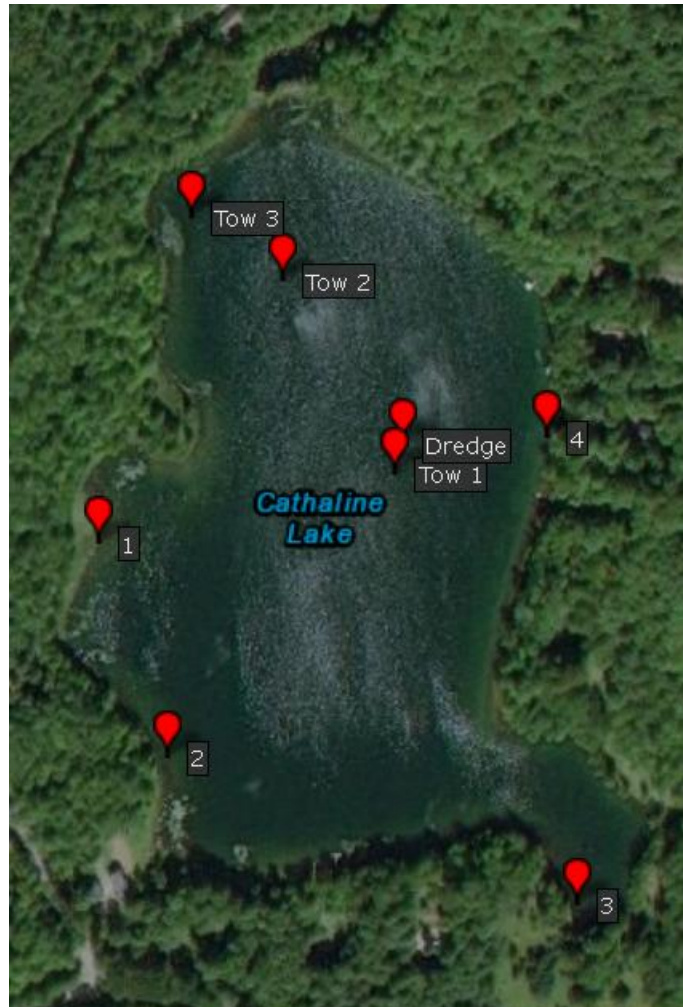
Map 1. Cathaline Lake AIS survey sites 1-4, plankton tows 1-3, and location of dredge site.

<b>Table 1. AIS Survey on Cathaline Lake 5/15/2018.</b>			
<b>Site</b>	<b>Latitude</b>	<b>Longitude</b>	<b>Species Found</b>
1	46.24992	-89.79296	None
2	46.24860	-89.79235	None
3	46.24769	-89.78868	None
4	46.25057	-89.78896	None

<b>Table 2. Spiny Water Flea Sample from Cathaline Lake</b>			
<b>Date: 5/15/2018</b>	<b>GPS Coordinates</b>		<b>Depth of sample (feet)</b>
Site 1	46.25035	-089.79031	30
Site 2	46.25154	-89.79132	30
Site 3	46.25193	-89.79213	25
Dredge Site	46.25053	-89.79025	40
