**Eurasian Water-milfoil (*Myriophyllum spicatum*)
Boat Landing and Meandering Littoral Zone Surveys
Pipe/North Pipe Lakes - WBIC: 2490500 and 2485700
Polk County, Wisconsin**

Pipe Lakes Protection and Rehabilitation District and the
Wisconsin Department of Natural Resources

Endangered Resource Services, LLC
Matthew S. Berg, Research Biologist
St. Croix Falls, Wisconsin
June-late September, 2019

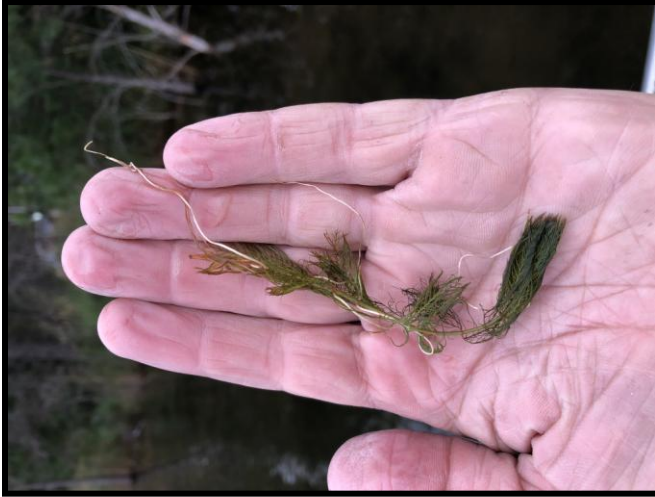
Floating Eurasian water-milfoil fragment with white roots on a nearby lake (Berg 2019)

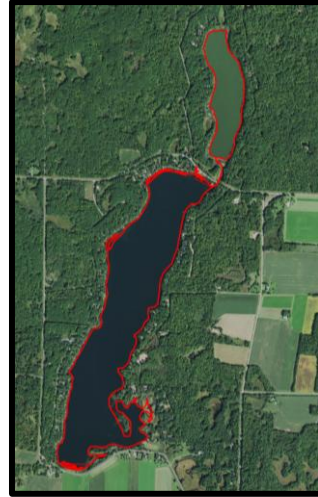
Aerial with Survey Tracks 9/28/19

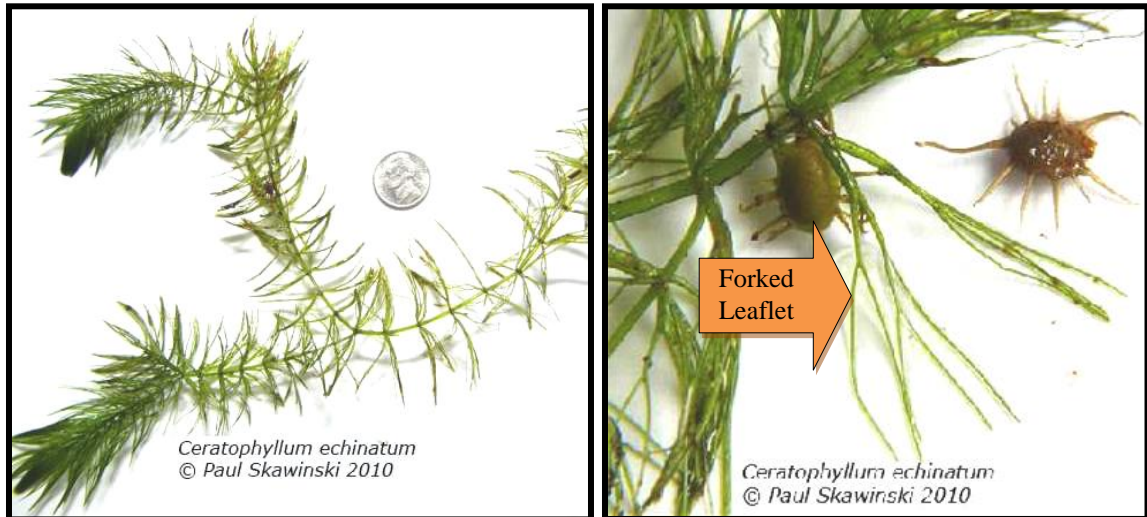
Figure 6: Spiny Hornwort Identification (Skawinski 2010)

We also noted two other beneficial native species that could potentially be confused with Eurasian water-milfoil: Spiny hornwort (*Ceratophyllum echinatum*) (Figure 6) and Common bladderwort (*Utricularia vulgaris*) (Figure 7). Both species are relatively common in the lakes' bays where they primarily occur in water <1.5m over organic muck substrates. Hornwort can be told from the milfoils as it has leaflets that fork repeatedly, while bladderworts have tiny "bladders" along their forked leaflets where these carnivorous plants trap and digest minute aquatic animals like mosquito larvae.

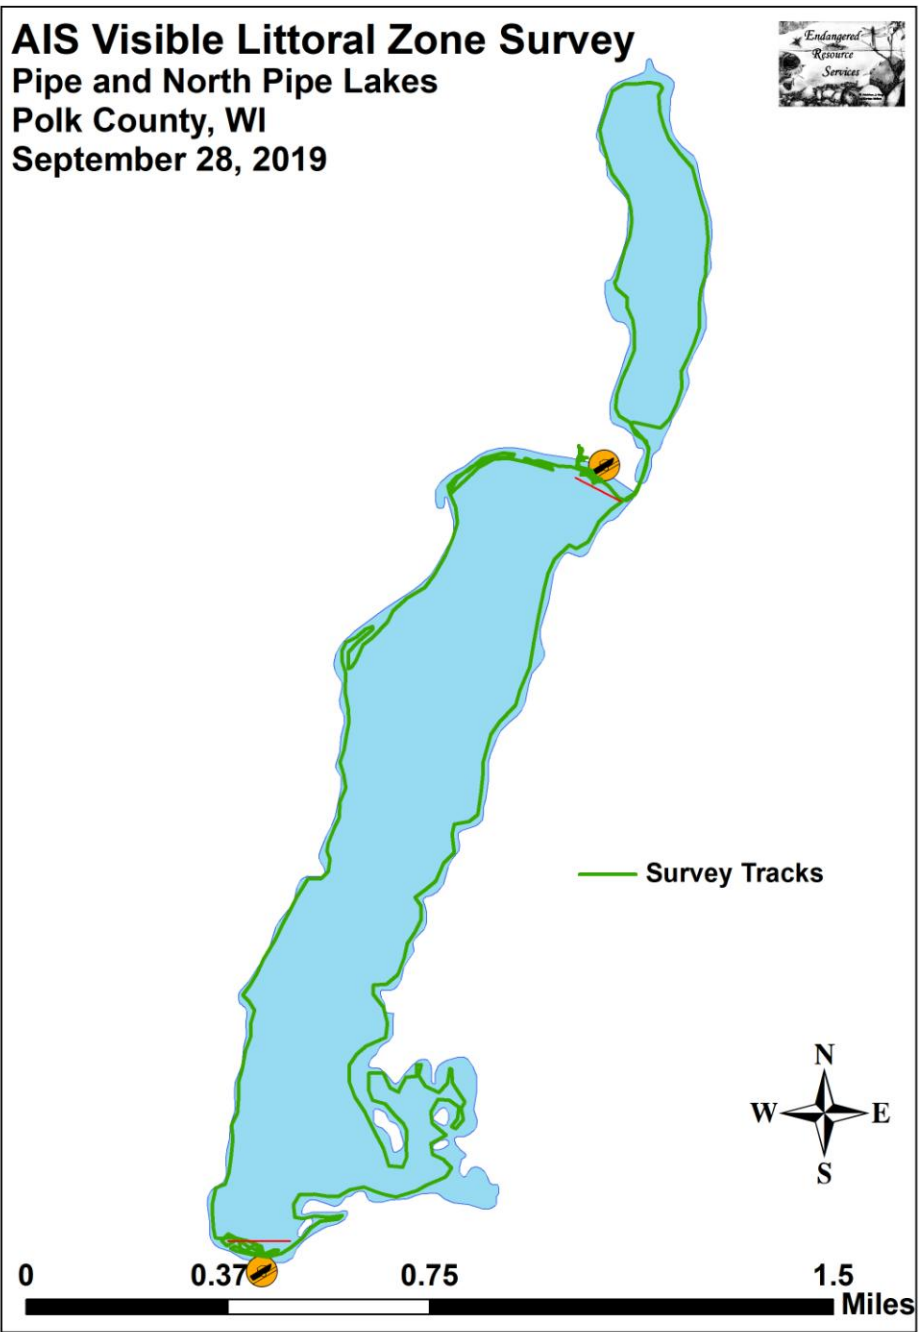
Appendix I: Pipe Lakes Fall Survey Tracks

AIS Visible Littoral Zone Survey
Pipe and North Pipe Lakes
Polk County, WI
September 28, 2019
