**Eurasian Water-milfoil (*Myriophyllum spicatum*)
Manual Rake and SCUBA Removal and
Fall Bed Mapping Surveys
Echo Lake – WBIC: 2630200
Barron County, Wisconsin**

Surveys Conducted by and Report Prepared by:

Endangered Resource Services, LLC
Matthew S. Berg, Research Biologist
St. Croix Falls, Wisconsin

June 23, July 27, and September 24, 2017

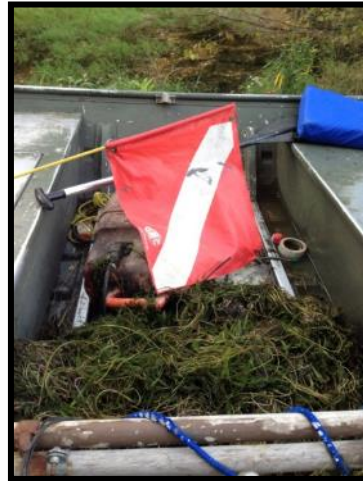
Eurasian water-milfoil (Berg 2007)

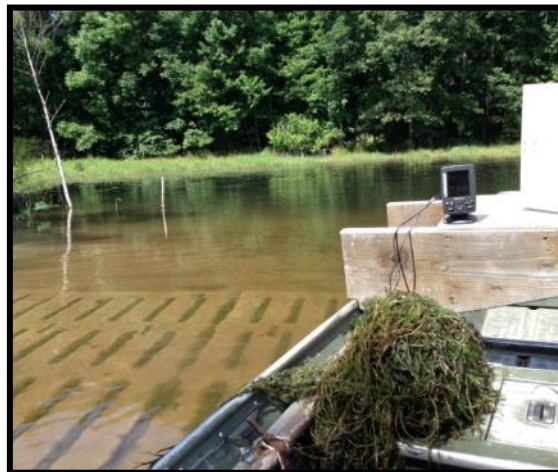
Eurasian Water-milfoil Removed 7/27/17

During the July survey, we covered 26km (16.2 miles) of transects on the lake (Figure 3). Unfortunately, we documented a sharp uptick in EWM growth as we found and removed 45 plants – 24 in the northeast bay and 21 in the southeast finger bay. No plants or floating fragments were seen anywhere else on the lake despite paying special attention to areas that have supported EWM growth in the past. All EWM plants were again located in water <5ft deep and were easily removed with a rake as they were again single-stemmed and appeared to be recently established.

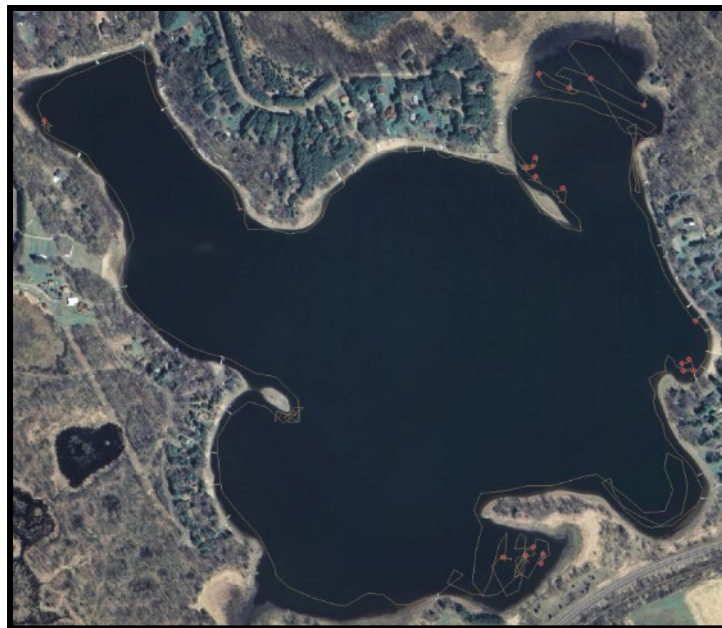
Figure 4: Shoreline Transect Survey Tracks/EWM Plants – 9/21/17

A September 21, 2017 survey by Dave Blumer and Mike Clohisy identified several new areas with Eurasian water-milfoil (Figure 4). Although they removed approximately 20 EWM plants, the majority of plants were left for later dive removal; especially when they were in water >5ft deep or were growing in clusters.
