Soft Maple and Hay Creek Targeted Watershed Assessment: A Water Quality Plan to Protect Wisconsin Watersheds 2020

A Clean Water Act Water Quality Monitoring Report by the Bureau of Water Quality

*Soft Maple and Hay Creeks (UC17)
HUC12: 0705000107, Monitored in 2015*

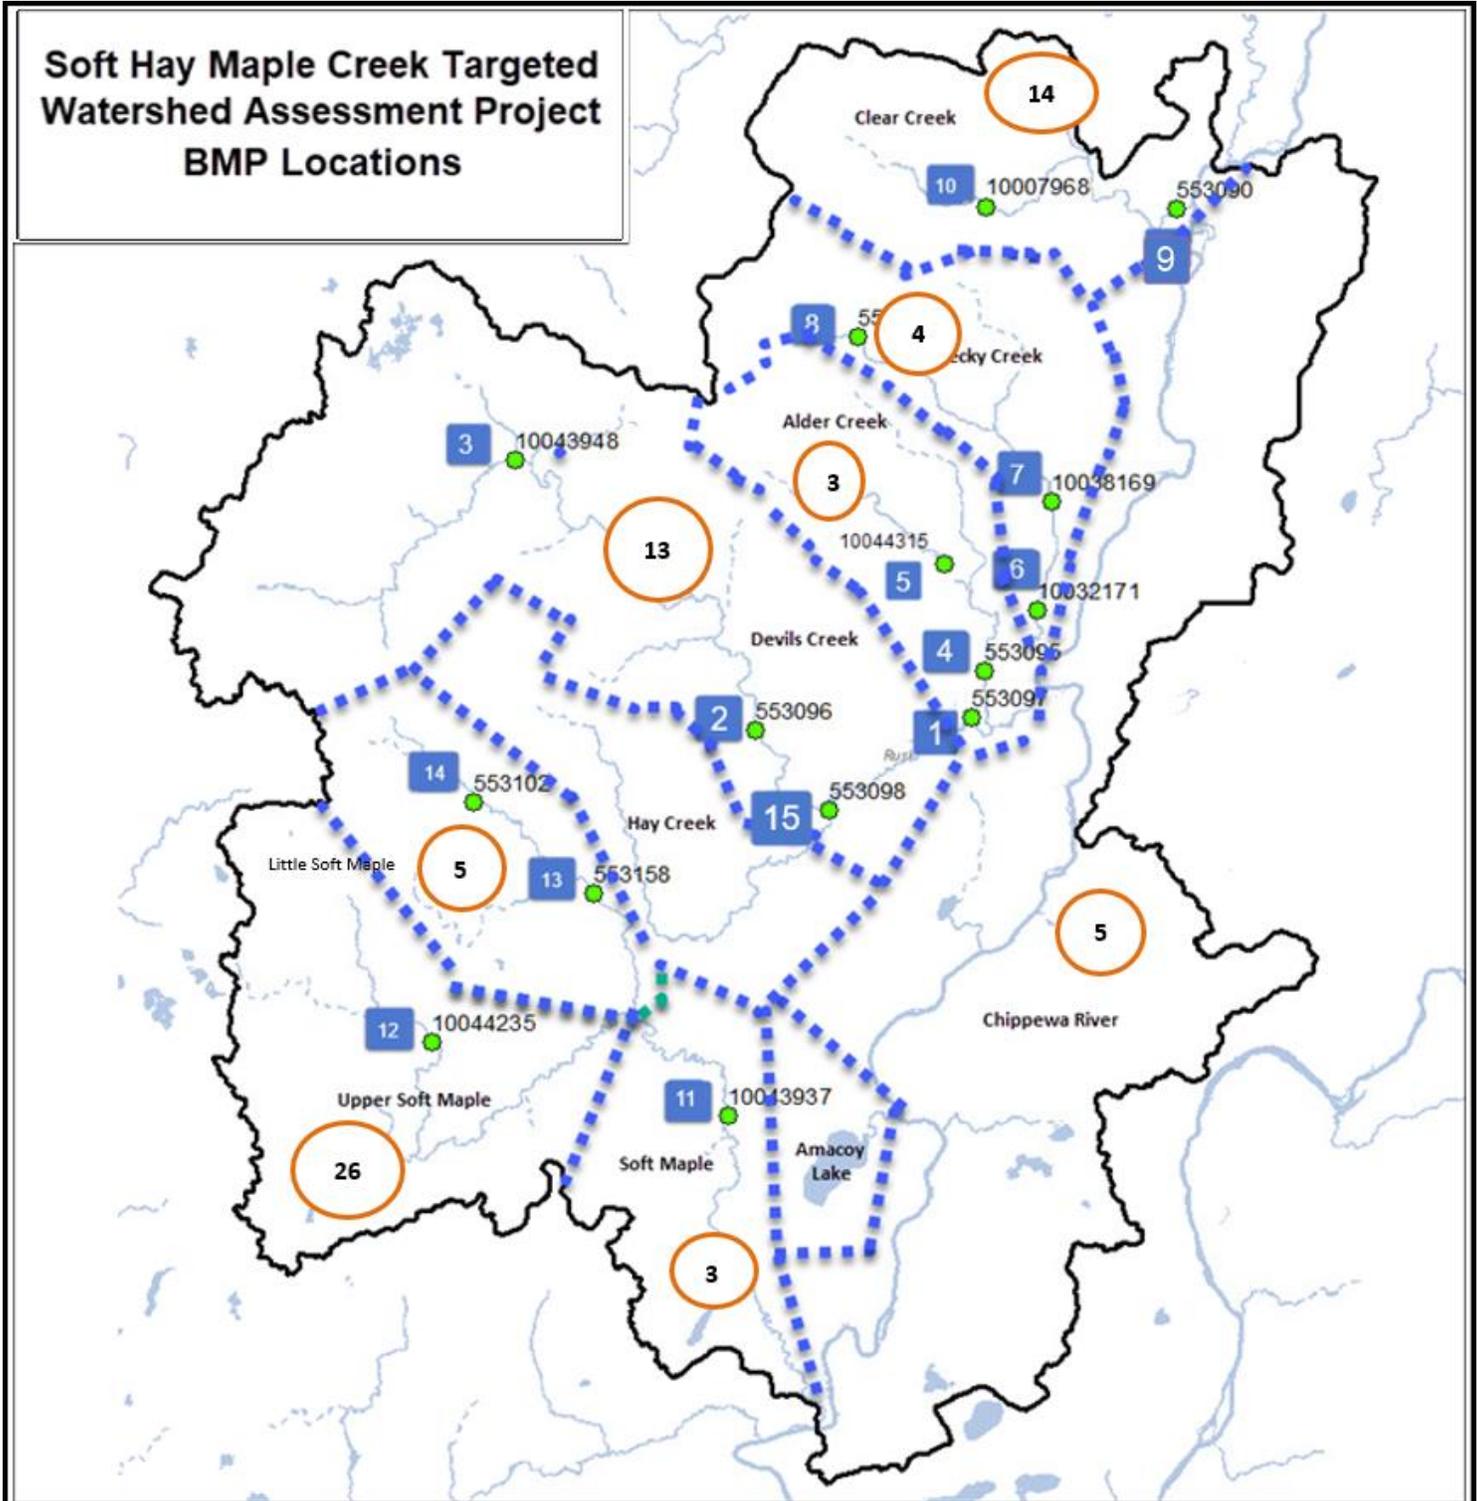
Figure 3. Number of best management practices implemented in each subwatershed
The circled number indicates how many practices were implemented in that subwatershed from 1996-2007.

Rusk County LCD staff reported to the WDNR the name of property owners, site location and types of BMP implemented over the project's lifetime. A total of 68 BMPs were reported installed by 35 different property owners. There were 19 named practices installed in 10 sub-watersheds with named waterways (Table 1). The Big Soft Maple and Devils Creek sub-watersheds had the most BMPs installed with 26 and 13 practices, respectively. The BMPs nutrient management and streambank shore protection-riprap were the most common practices with 12 and 8 installations respectively (Table 1, Figure 3).

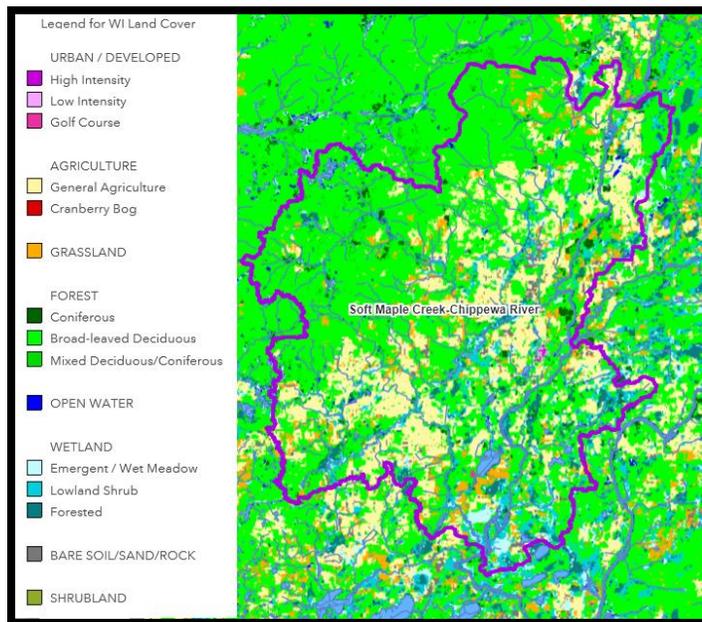
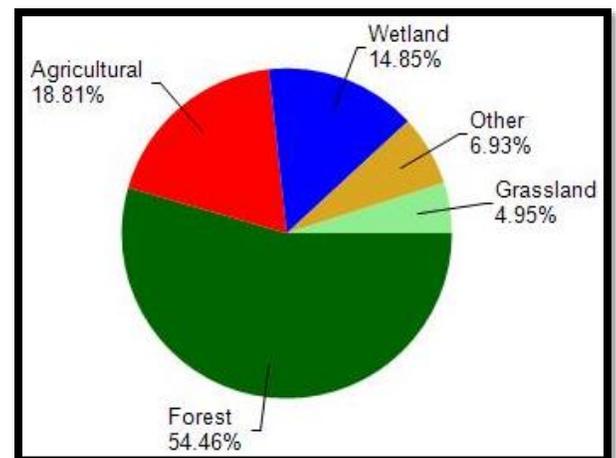
Figure 4. Wisconsin Land Cover Data in the Soft Maple and Hay Creeks Watershed (NLCD, 2016)

The Soft Maple and Hay Creek Watershed is located in Rusk County, which had a population of 14,147 in 2019; the county population has decreased by 3.96% since 2010. The major municipalities in the watershed are the Villages of Weyerhauser and Bruce. Forested areas are in the headwaters of the watershed, while agricultural activities are concentrated near the Chippewa River, in the lower reaches of the watershed (Figure 4).

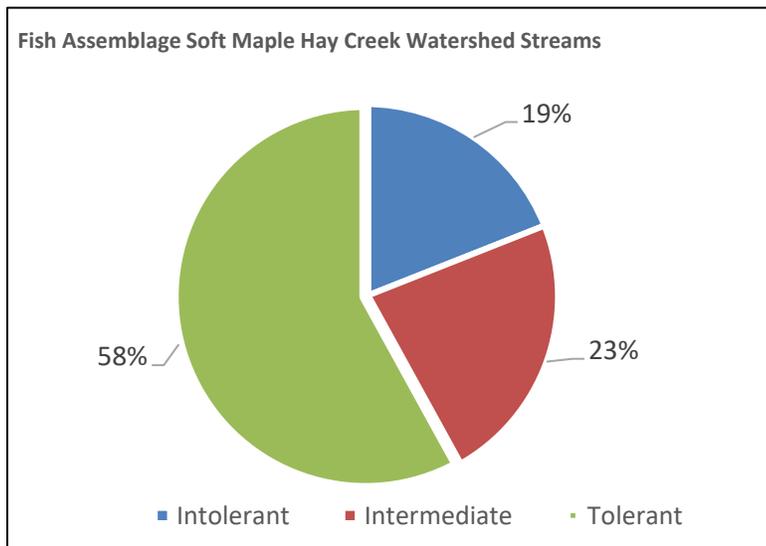
Figure 6. Fish Assemblage Tolerance Percentages Soft Maple Hay Creek Watershed

There are 6 trout streams in the watershed (Table 5). Brook trout were captured in 5 of these 6 waterways. Trout were captured at all sites on Devils, Alder, Clear, and Little Soft Maple Creeks. No trout were captured in Big Soft Maple Creek, a class III trout water. Trout were only captured at the headwater site on Becky Creek. Clear Creek had the highest number of trout captured at both its downstream and upstream sites with 140 and 144 individuals, respectively.

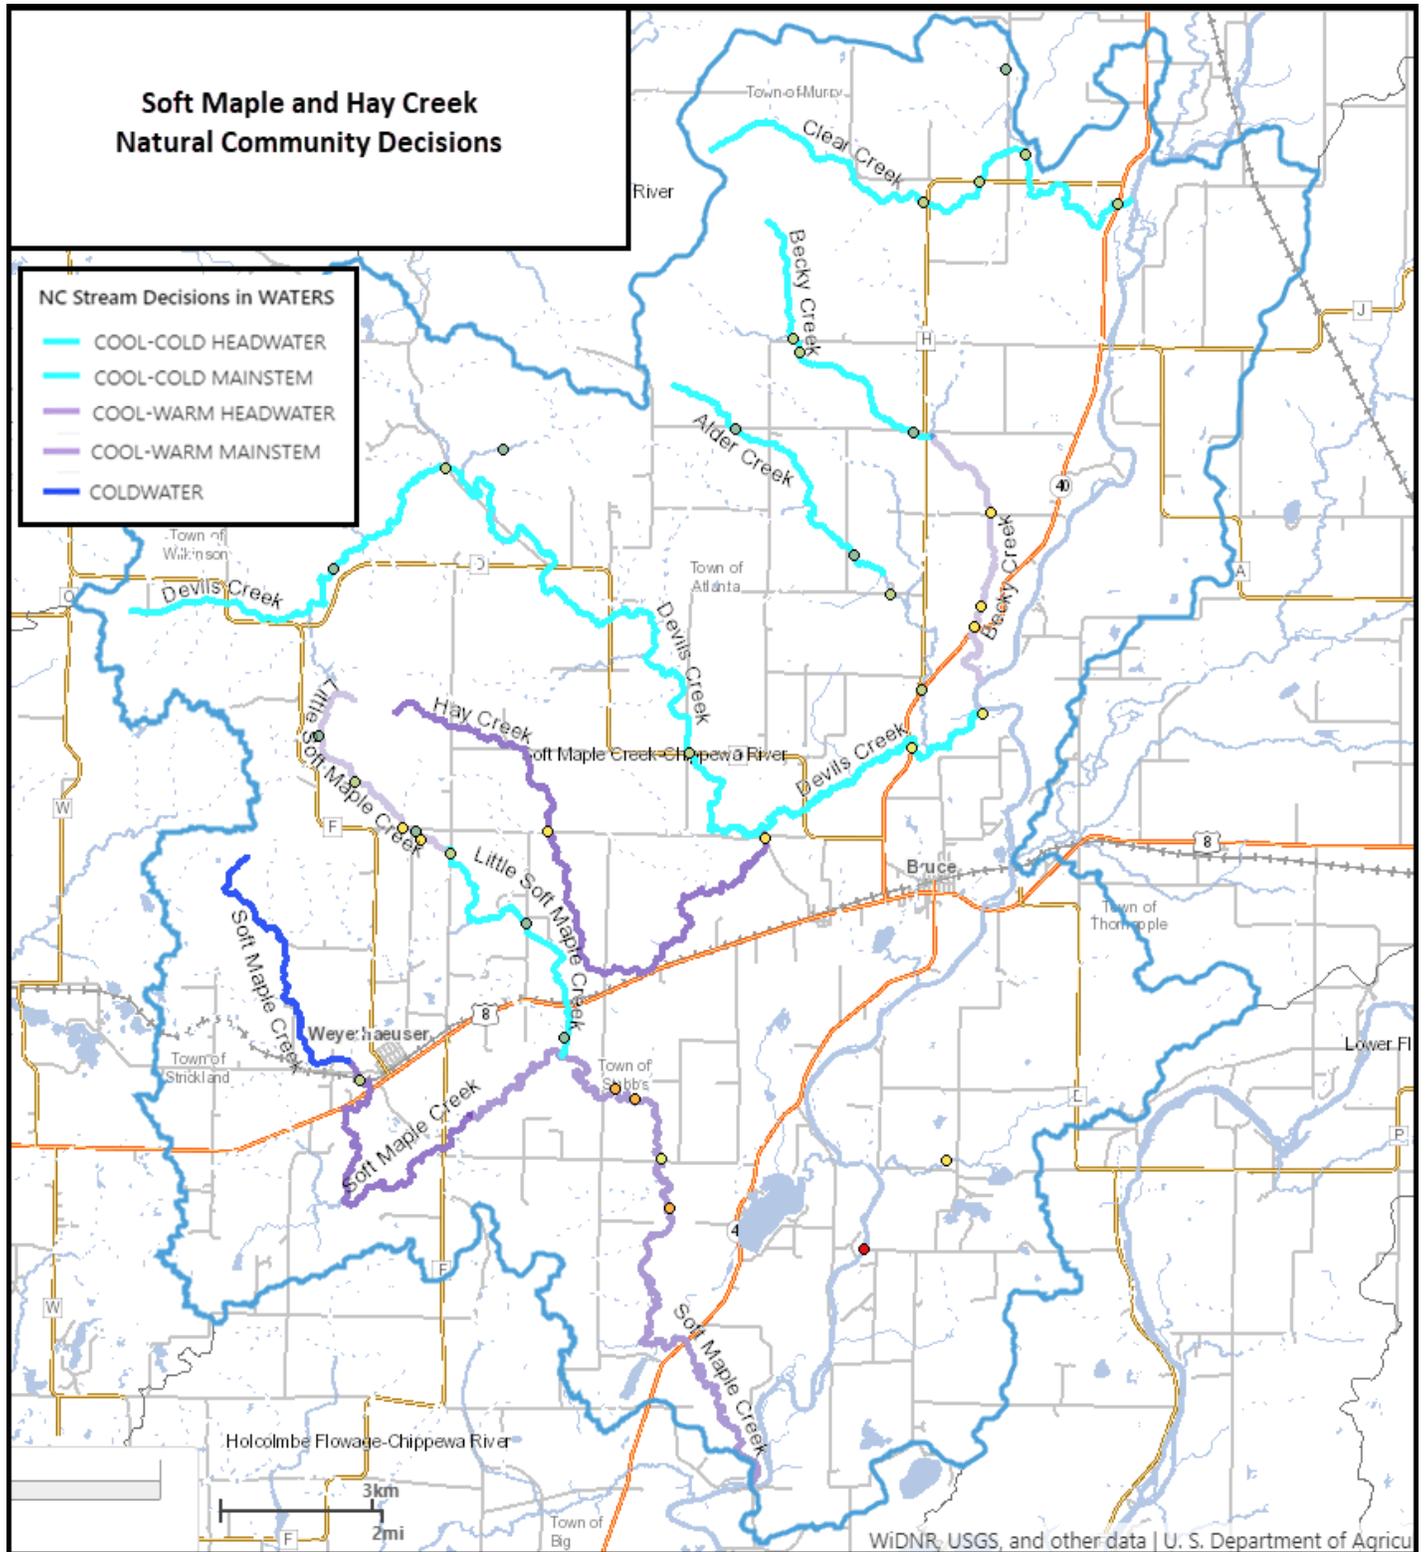
Figure 7. Natural Community Determinations, Soft Maple and Hay Creek Watershed

All available fish survey data and stream temperature data for each waterway was used to review the natural community of each watershed stream surveyed in 2015 (Table 7 and Table 8, Figure 7). These data were reviewed to assess the natural community for the entire stream length following the verification methodology, best professional judgment, and knowledge of the watershed. The predicted natural communities varied from coldwater to cool-cold and cool-warm headwaters and mainstems depending on the waterway and stream reach. There were several streams and reaches where the observed natural community was different than the modeled community and changes are recommended. The recommended natural community is shown in Table 8. In general, the streams tended to be warmer than predicted by the model. Some stream reaches did not have enough survey information available to assess the natural community. Other reaches had conflicting survey results, and in those cases, the predicted natural community was retained.

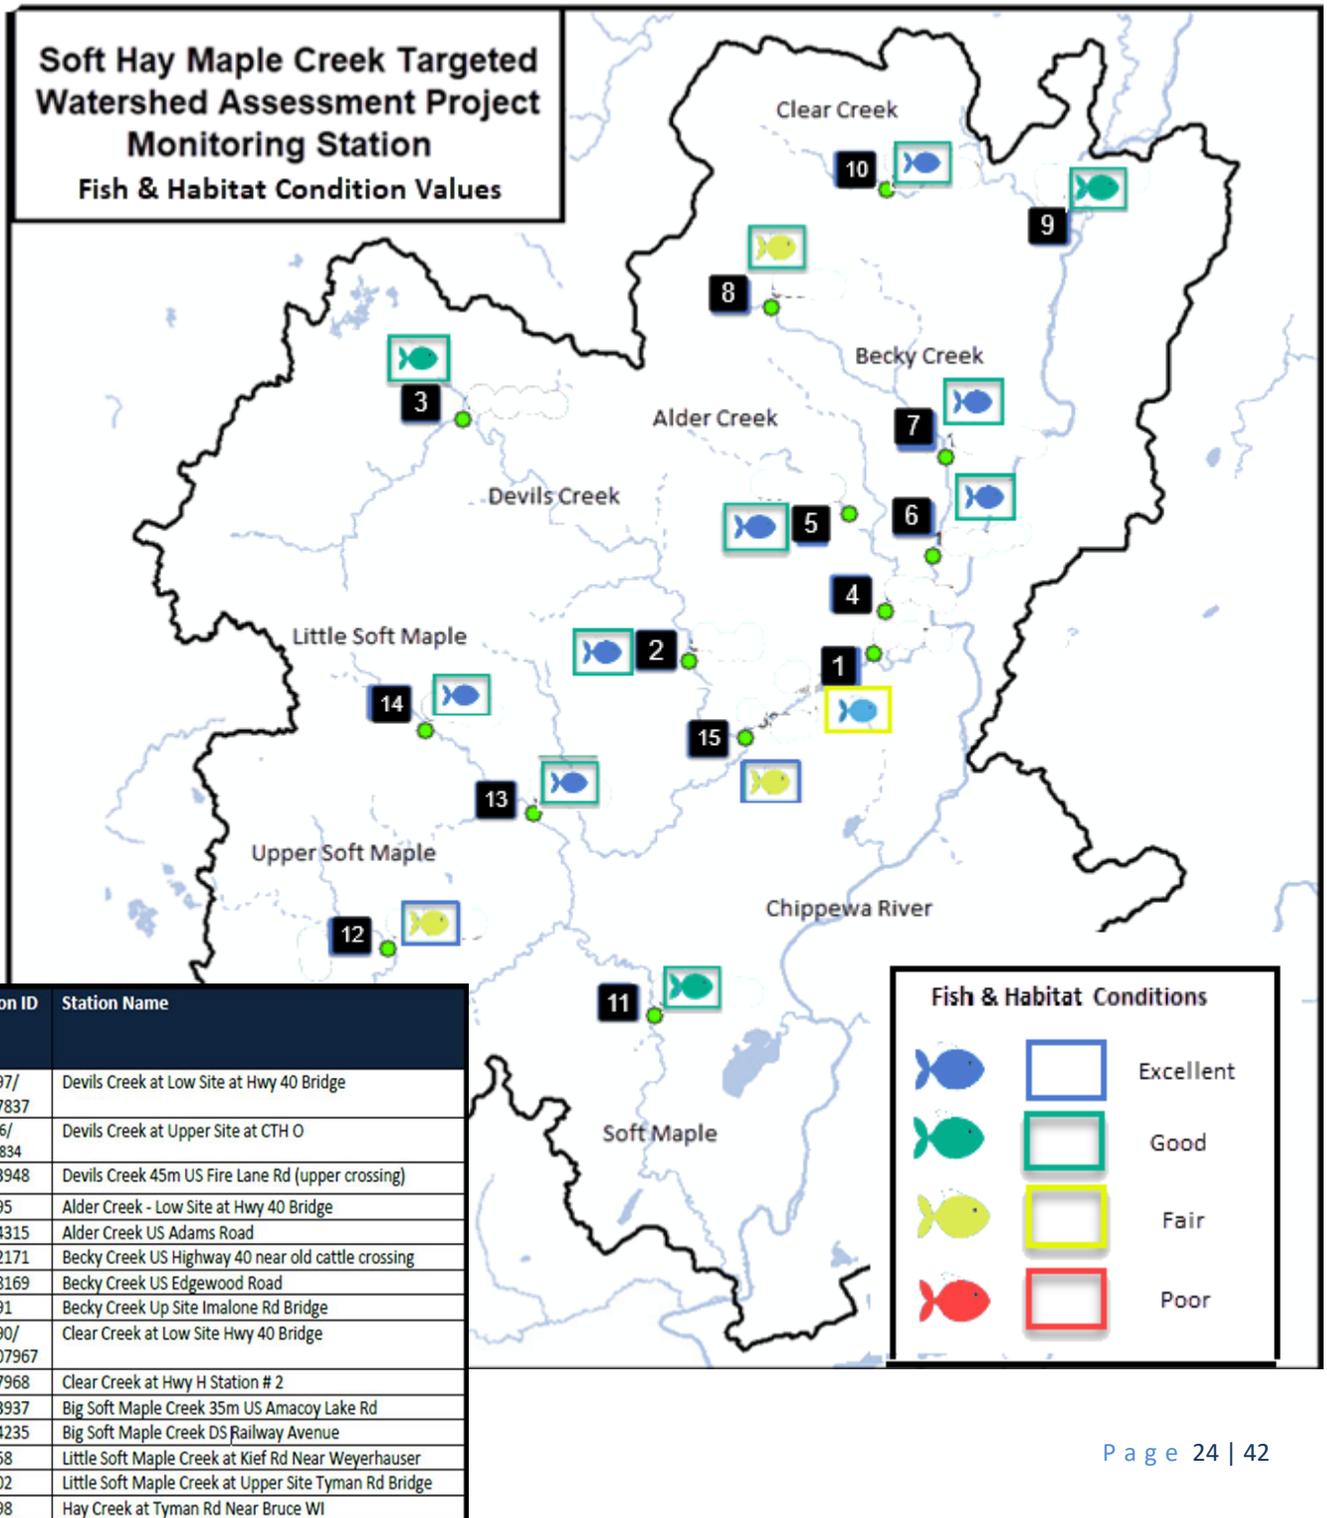
Figure 8. Fish Biological Integrity and Habitat Condition

The indexes of biological integrity were applied to the 2015 fish surveys based on the stream segments assigned natural community according to WisCALM 2018. The Warm Transitional and Cool Transitional IBIs were applied to the mainstem sites on Big Soft Maple and Devils Creeks respectively; the small stream (intermittent) IBI was applied to all headwaters. Fish IBI scores ranged from fair to excellent. Of the 15 sites surveyed, 9 scored excellent, 3 good and 3 fair (Table 9, Figure 8 and Table 10, Figure 9).

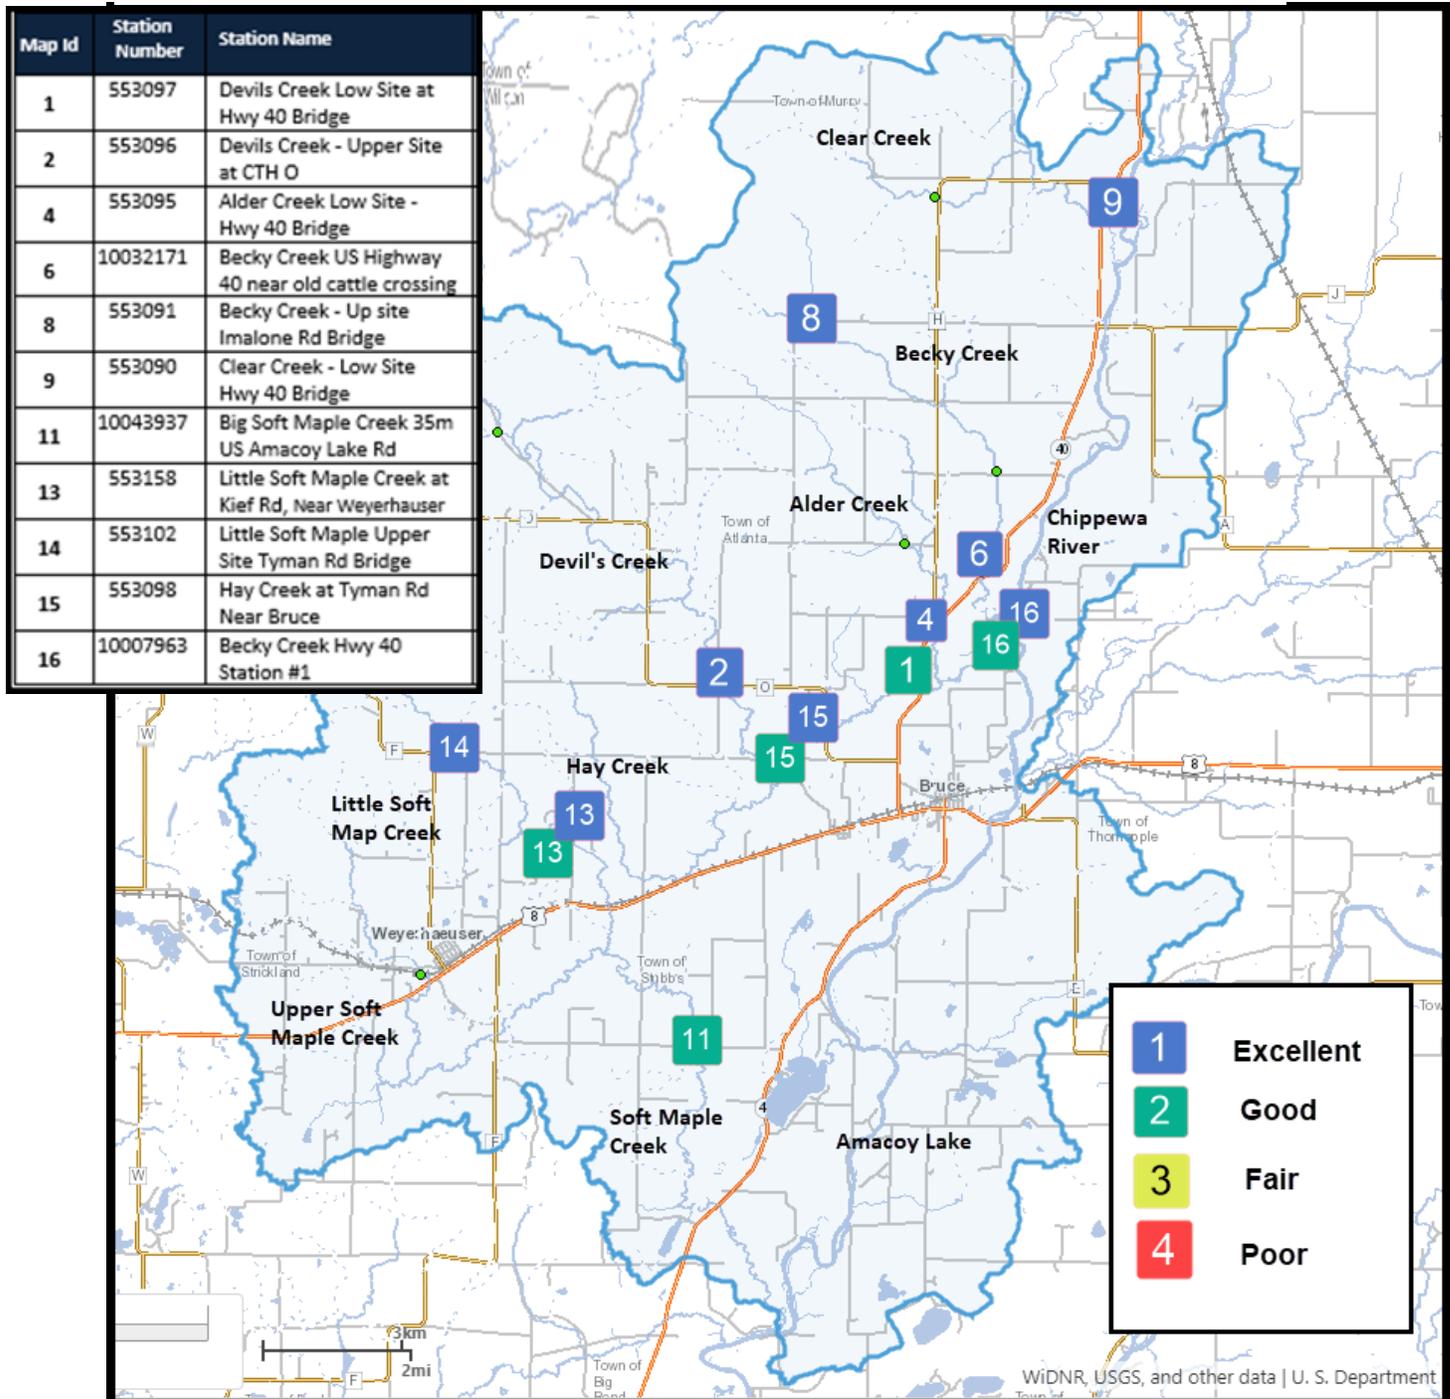
Figure 9. Macroinvertebrate Biological Integrity (mIBI)

Species Richness, % chironomidae individual, and EPT % individual for sample location in the Soft Maple Hay Creek watershed.

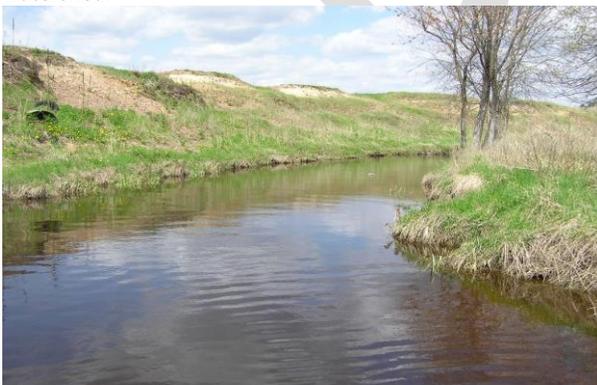
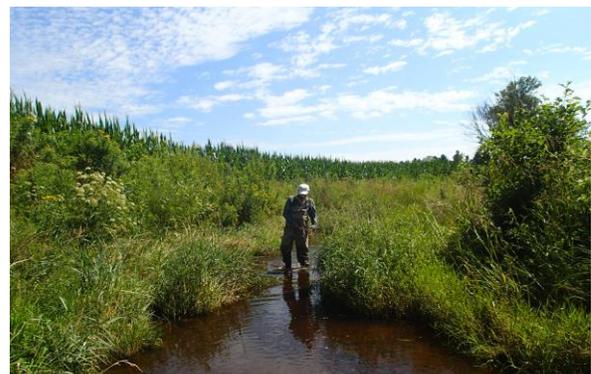
Becky Creek US STH 40, April 2010. Photo by Craig Roesler DNR.

Becky Creek US STH 40, July 2015. Photo by Jon Kleist, DNR.

The STH 40 site continued to recover from unlimited cattle access and streambank pasturing since 2010. Row crop fields of corn were observed in the riparian area and near the top of the stream bank in places along the survey station but were not continuous. The stream banks and the near bank area had sloughed to narrow the channel and form a terrace for a floodplain. These areas were well vegetated, consisting of wetland grasses and sedges. Areas of dense reed canary grass were also present. The stream channel still appeared to be changing and narrowing, areas of mid channel sediment islands were well vegetated and trapping sediment and slowly reconnecting to the stream banks. The stream bed was mainly rock and gravel, with soft sediments confined to the stream banks and in pools.

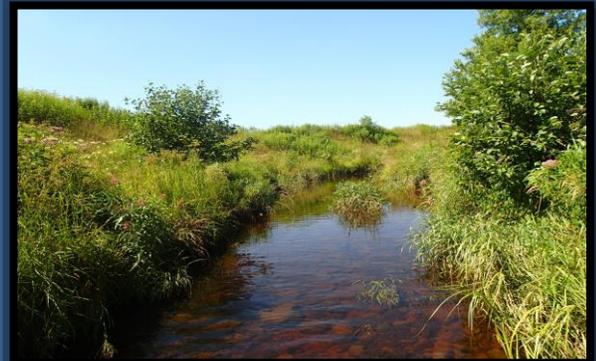
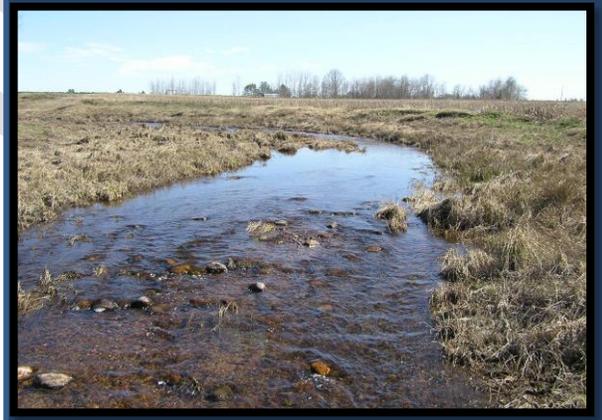
Becky Creek US of STH 40, July 2015 (top) and April 2010 (bottom).

Photos below show two locations that are not the same site, but are similar representative reaches of the stream at this monitoring station. The stream banks are currently well vegetated and woody cover is continuing to establish itself since the discontinuation of cattle pasturing.

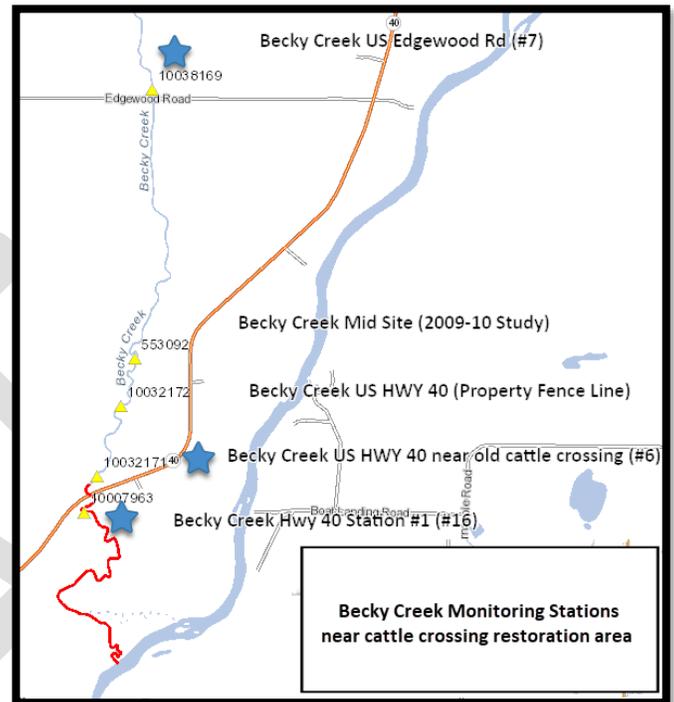
Figure 11. Lower Becky Creek Monitoring Stations

The total phosphorus sample results in 2015 were 44 µg/L at Imalone Road and 138 µg/L US of STH 40. A sample was not collected at the Edgewood Road site. The values referenced from the watershed appraisal report included runoff values and are not directly comparable.

Phosphorus concentrations are declining in Becky Creek. However, Becky Creek still has elevated phosphorus values greater than the 75 µg/L state standard listed in NR 102 Wis. Adm Code US of STH 40.

In 2018, Becky Creek from the STH 40 crossing to its headwaters was assessed using new biological data (fish Index of Biotic Integrity (IBI) scores and the MIBI) which were part of this study. These assessments showed that Fish and Aquatic Life water quality designated use is supported. This water is considered in "good" condition and should be removed from the impaired waters list. Becky creek, while a trout water, is not a coldwater stream and the coldwater IBI should not be used to assess the condition of the fish community assemblage. The impacted areas of Becky Creek continue to recover from cattle pasturing and barnyard runoff. Phosphorus and other nutrients remain elevated in the lower reaches of Becky Creek. These should continue to be monitored. It will take years and possibly more BMP work in the watershed to bring TP values below 75 µg/L.

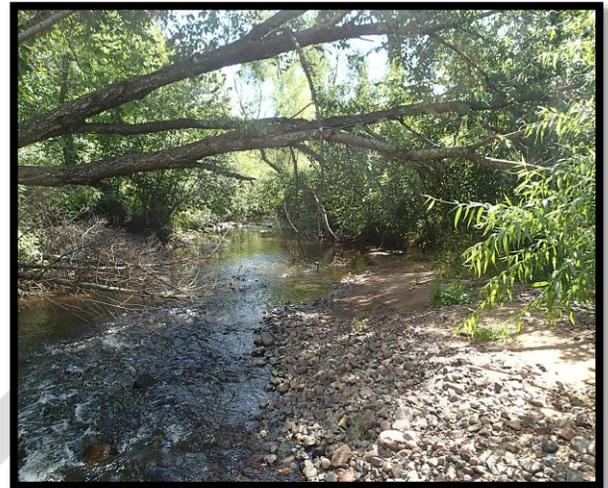
Devils Creek DS CTH O. Photo by Jon Kleist, DNR.

Past descriptions in WDNR files states water quality showed significant impacts from nonpoint sources at both the upper and lower site. The locations are not specifically located in any reports. The upper site drainage area is described as less than 10 percent developed land, therefore was likely at one of the two upper crossings of CTH O. The upper site total phosphorus reportedly exceeded background levels (of 50 µg/L) by 130 percent or around 115 µg/L at the upper site and by 70% or around 85 µg/L at the lower site in the 1990s. These samples were collected during runoff and baseflow and may not be directly comparable to total P values in this study which were around 60 µg/L at both (US and DS) sites. The current total P values were below the state standard of 75 µg/L. In the 1990s, erosion from gravel roads was described as a very substantial source of suspended solids for the stream. At that time, severe erosion of roads was observed after heavy rains, and the re-channelization of a short segment of a Devils Creek tributary was observed which added suspended solids. Based on observations during this study, the gravel roads in the upper reaches of the watershed remain sources of suspended solids in the watershed. The influence of agriculture is present in the watershed especially in the lower portions of the watershed. A crop field was visible from Devils Creek at the lower site, US of STH 40 during the fish survey and habitat evaluation. There were several areas observed, where channelized runoff from the crop fields entered Devils Creek.

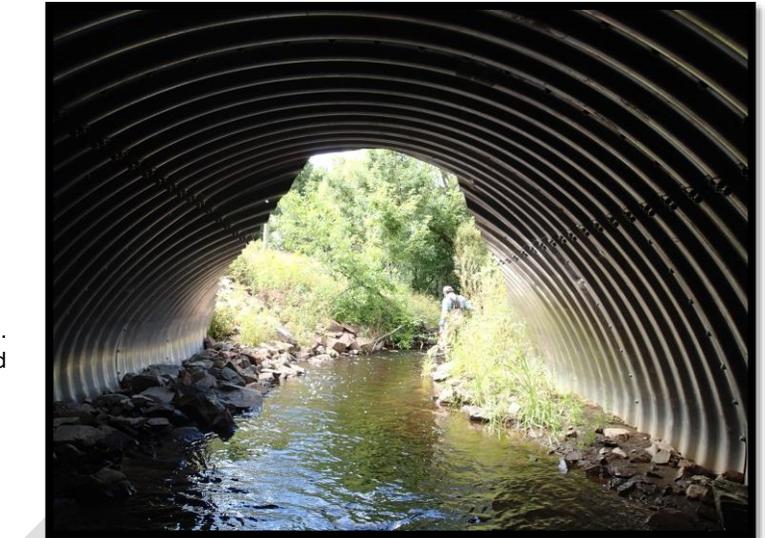
The road culvert at Kief Road was replaced by an arched culvert as a conservation practice through a cost sharing agreement by the local land conservation department and the township to allow for aquatic life passage. The project was successful, and a natural stream bed was observed within the arched pipe during the fish survey.

Arched Pipe at Kief Road, Little Soft Maple Creek. Photo by Jon Kleist, DNR.
