## *A 2016 Evaluation of the Koshkonong Creek Watershed Dane and Jefferson Counties*

*Targeted Watershed Evaluation Project: South TWA 2016, HUC 0709000204*

*Jim Amrhein and Michael Sorge,  
Investigators and Authors  
Water Quality Biologists  
South District Water Resources  
Department of Natural Resources  
May 2018*

EGAD #3200-2018-52

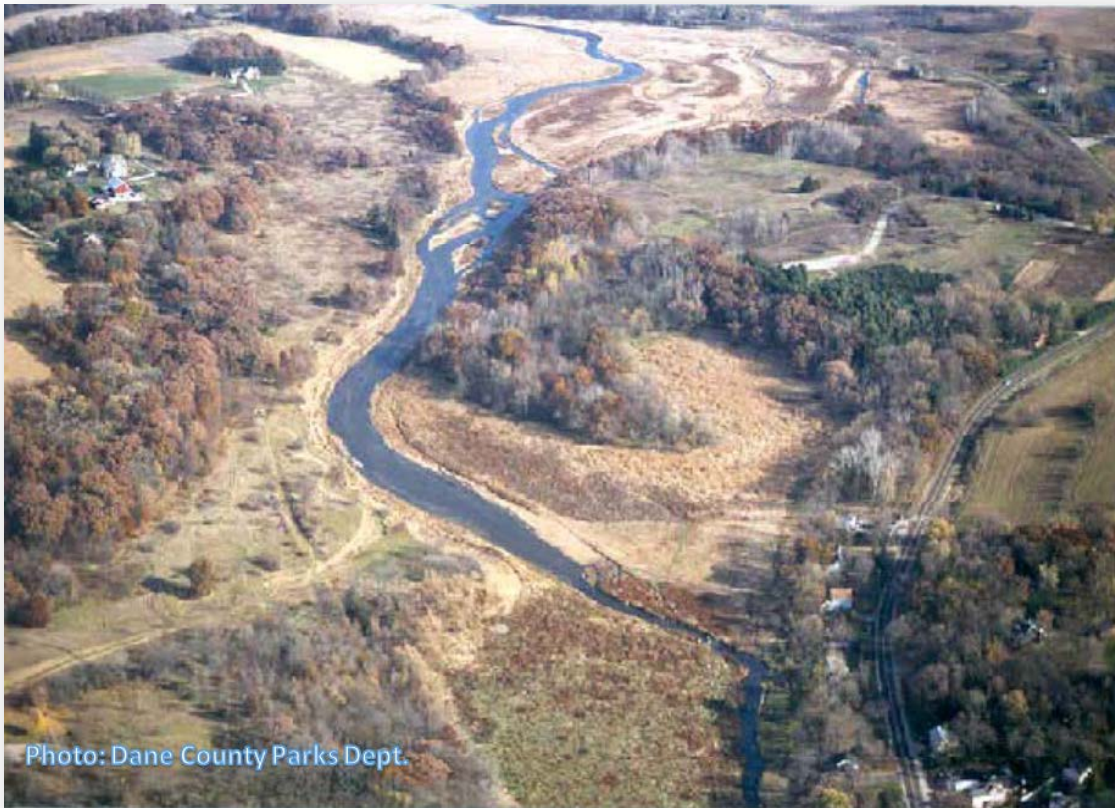
***Koshkonong Creek: Newly formed stream channel in what was once an impoundment***

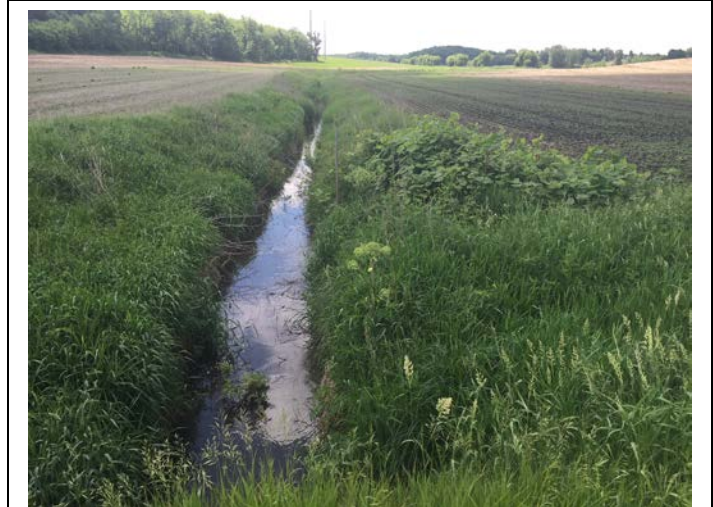
*This unnamed tributary (5036882) is typical of those in the watershed: channelized, entrenched, with a de facto buffer and well vegetated banks*

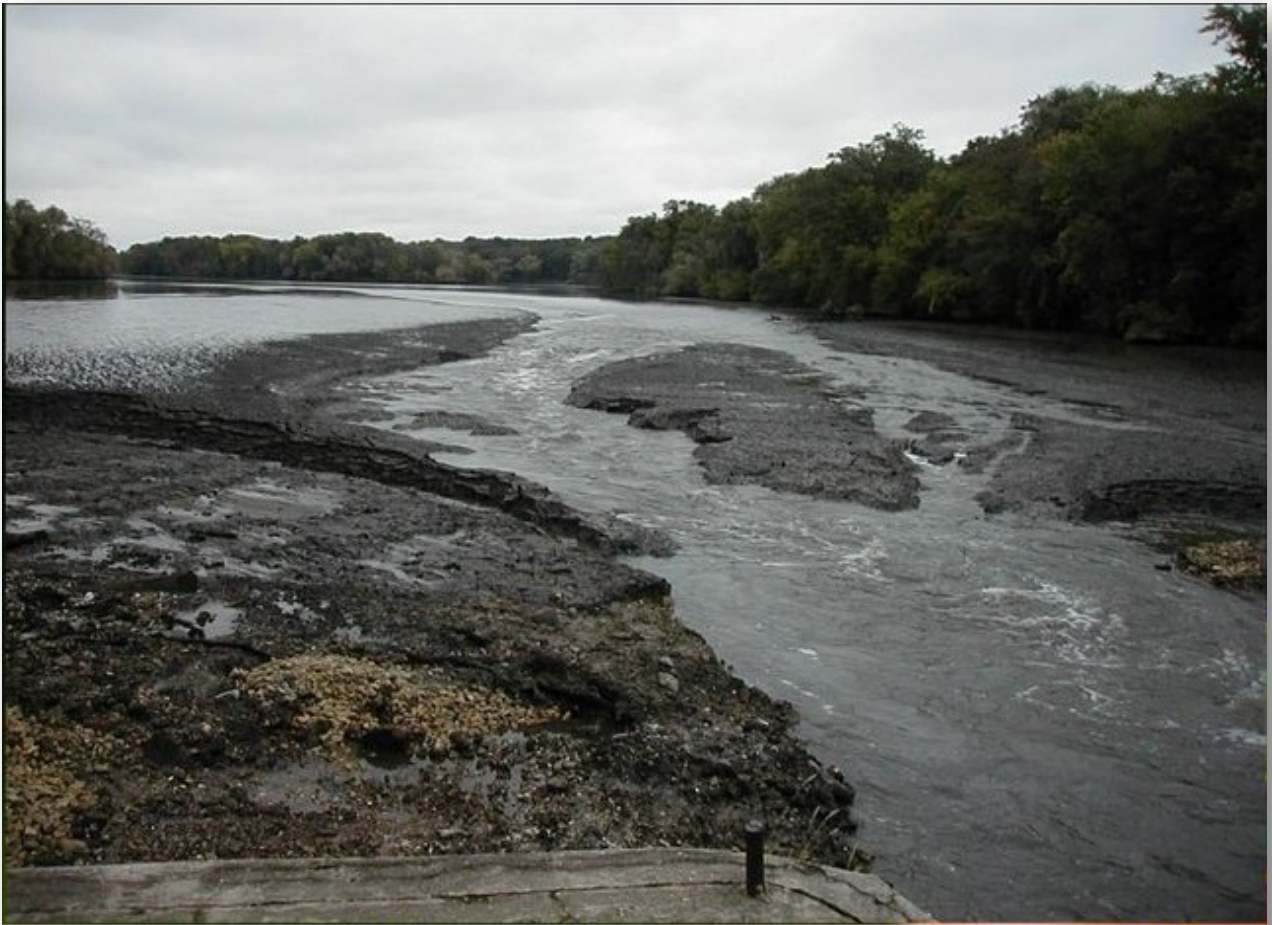
On September 12, 2000, the Rockdale Dam on Koshkonong Creek was breached to grade (see above photo). The remainder of the structure (i.e., the lateral portion) was removed during late June 2001. A team of researchers subsequently studied the effects of dam removal on sediment and nutrient transport as well as biota.

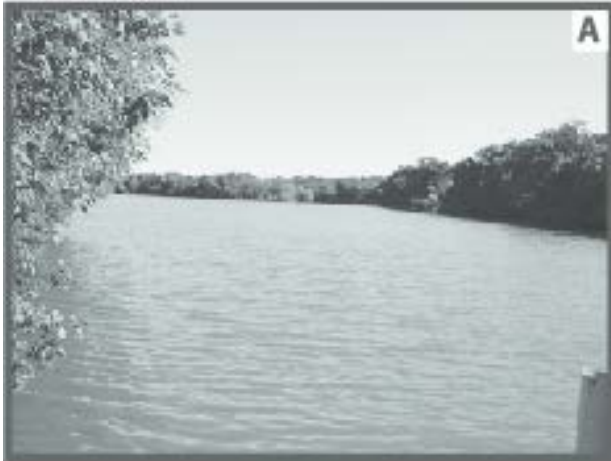
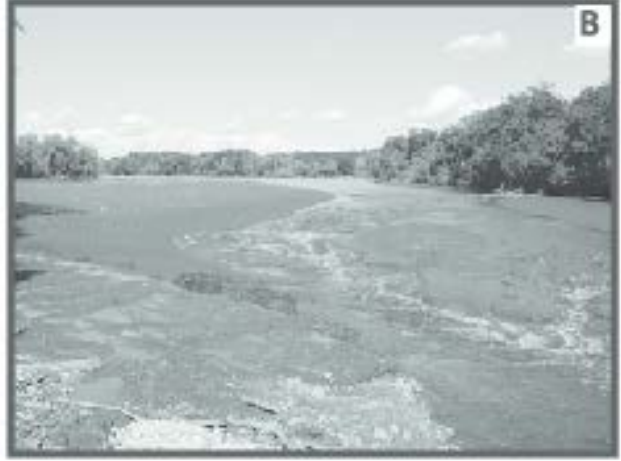
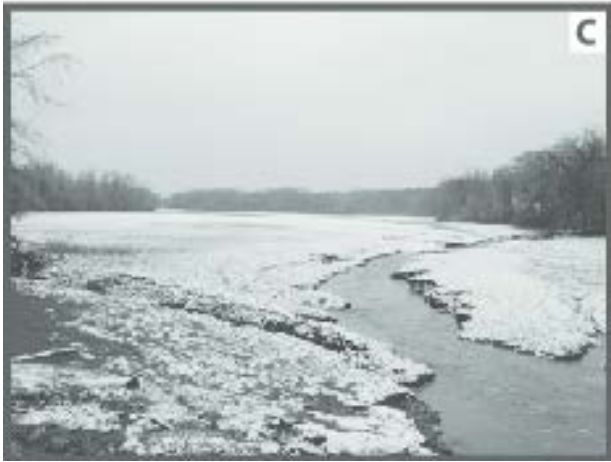
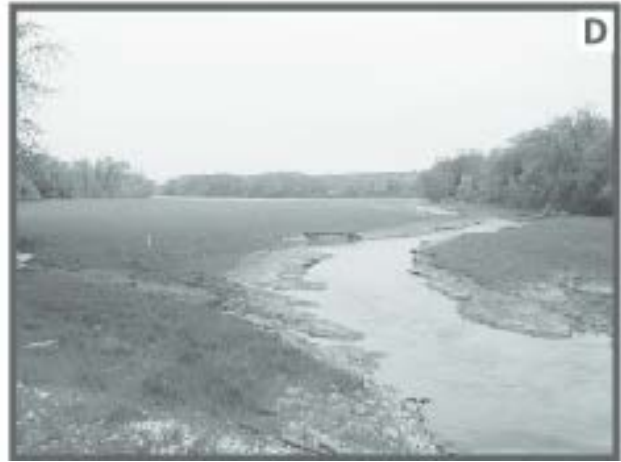
Rockdale Dam on the Koshkonong River. (a) Rockdale reservoir pre-removal; view is facing upstream from dam, September 2000. (b) Rockdale reservoir, 24 hours post-removal. (c) Rockdale reservoir, November 2000. (d) Rockdale reservoir, May 2001. From: Doyle, et. al., 2003.

Doyle et. al. (2003) found prior to dam removal, the reservoir was a sediment sink that had accumulated 287,000 m<sup>3</sup> of sediment. Sediment within the reservoir varied from 1 to 2 m thick. There was a distinct difference between the fine sediment at the surface and the underlying coarser sediment. Fine sediments also covered the channel upstream of the reservoir to a depth of 10-20 cm. Once the dam was removed, researchers noted a net export of fine sediment from the old reservoir. Initial fine sediment export was substantial, but had little effect on channel formation. Channel development was instead in the form of head cutting, which was significant within the 1<sup>st</sup> day, but decreased dramatically during the ensuing week. The sediment surface upstream of the head-cut remained undisturbed after the initial flush, while the channel downstream of the head cut changed substantially. There was very little in-channel

deposition downstream of the former dam; however, vegetation colonized some of the soft sediment deposits up to 2600 m downstream and were not eroded by subsequent flows. In some cases, this sediment deposition coupled with rapid vegetation establishment narrowed the channel, which caused deepening of the thalweg. There was little downstream sedimentation through time due to limited reservoir sediment erosion.

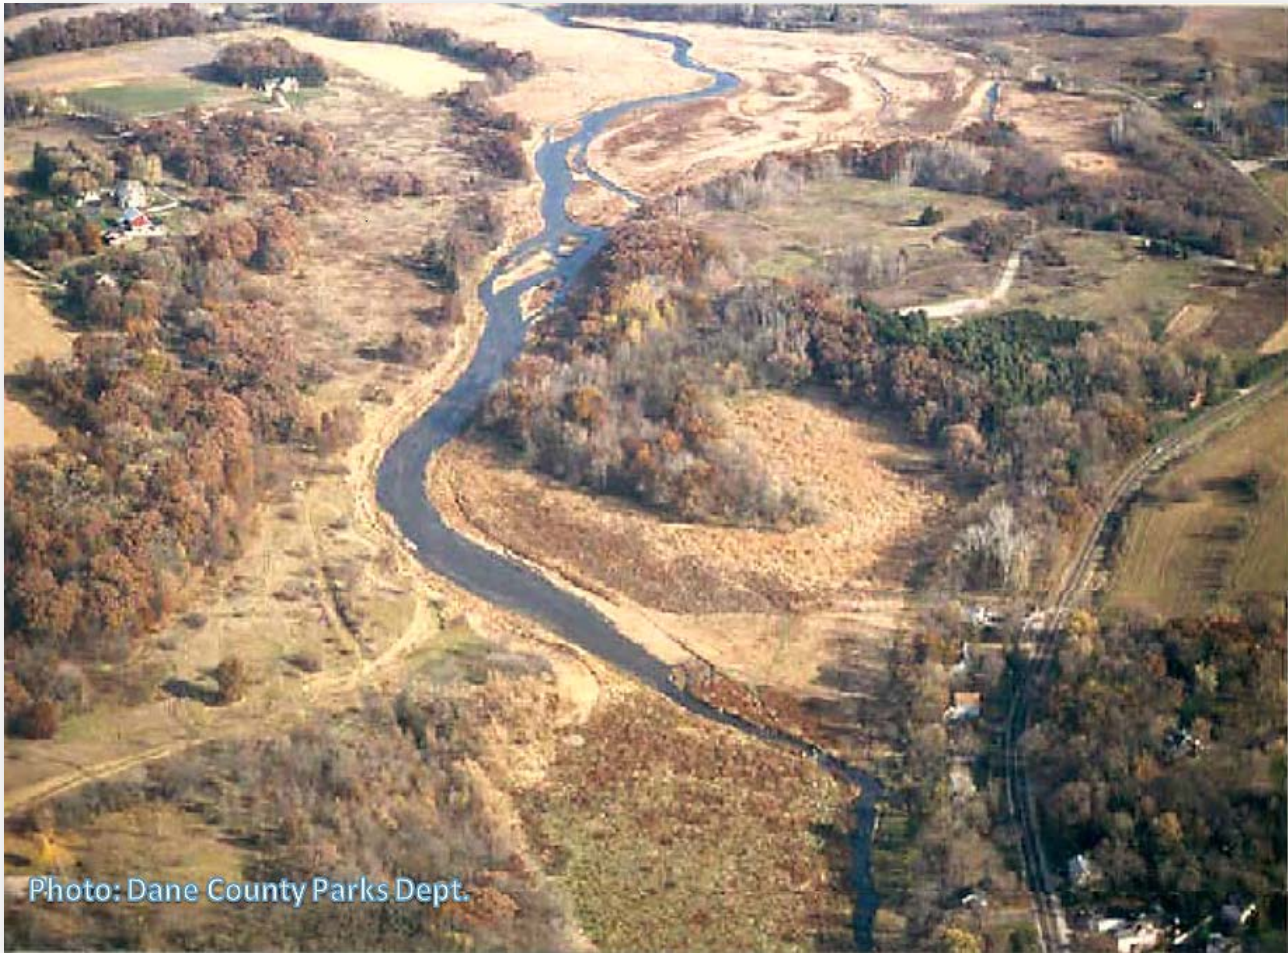
***Koshkonong Creek: Newly formed stream channel in what was once an impoundment***
