Koshkonong Creek Targeted Watershed Assessment: A Water Quality Plan to Protect Wisconsin Watersheds, 2020

*Lower and Upper Koshkonong Creek
(LR11 and LR12)*

*Watershed Report by the
Bureau of Water Quality
in support of the Clean
Water Act.*

EGAD # 3200-2020-05
Water Quality Bureau
Wisconsin DNR

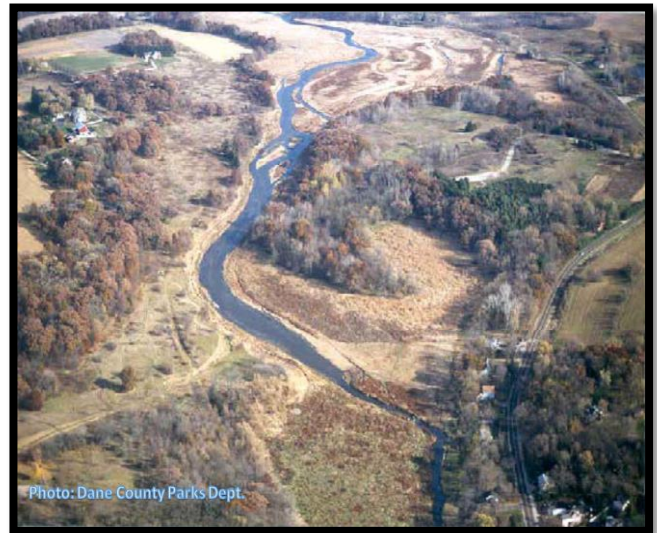
Koshkonong Creek: Newly formed stream channel in what was once an impoundment

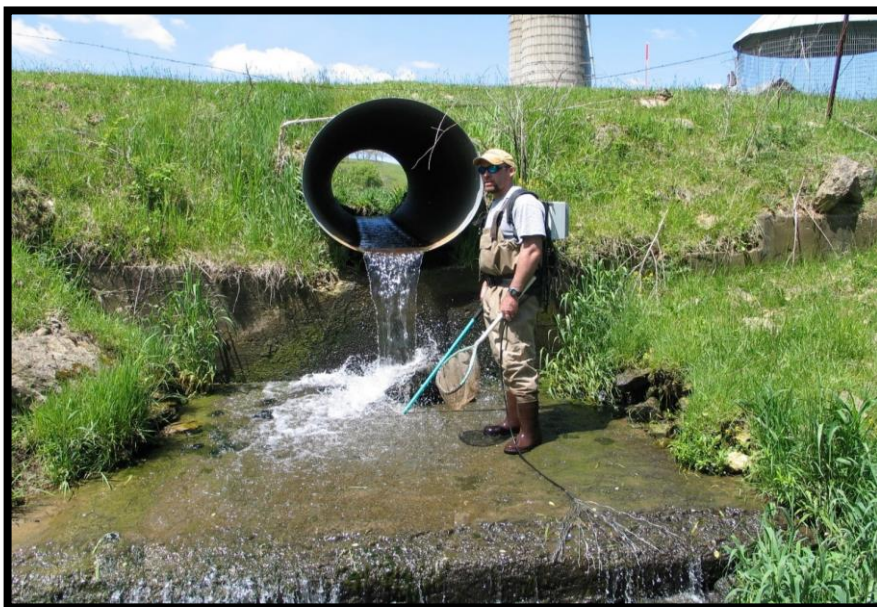
Perched Culvert
