Sweeny Lake

Page 1: May 31, 2020 Aquatic Invasive Species Boat Launch and
Shoreline Surveillance Monitoring Report

Page 3: July 12, 2017 Aquatic Invasive Species Monitoring and Water Clarity Report

Page 7: August 13, 2014 Aquatic Invasive Species Monitoring and Water Clarity
Report

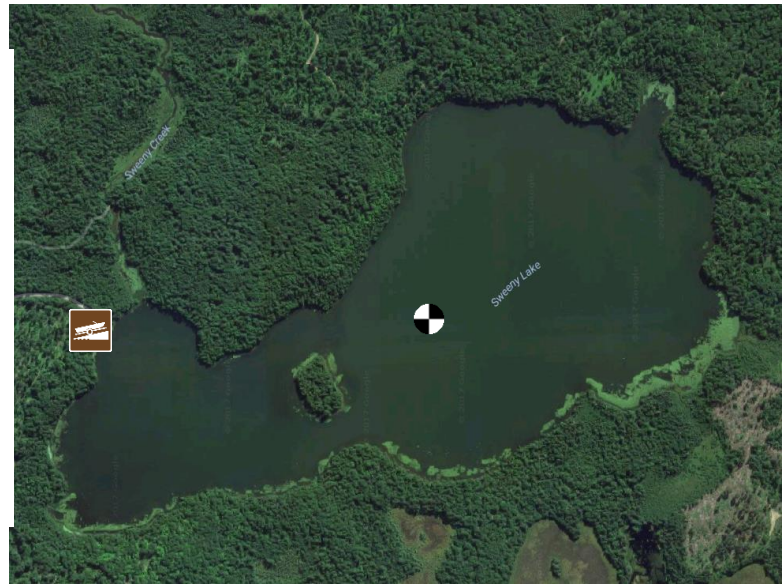
Figure 2. Map of Sweeny Lake with the boat landing and location of Secchi disk readings labeled.

Secchi: The Secchi reading on this lake was 8 feet out of an 18 foot maximum depth. The water color was a greenish color, and appeared murky when glancing across the lake.

Public boat landing
 -

Deep hole & location of Secchi disk reading
- Secchi Disk Readings:
Hemlock Lake - Deep Hole
Coordinates - Not Available

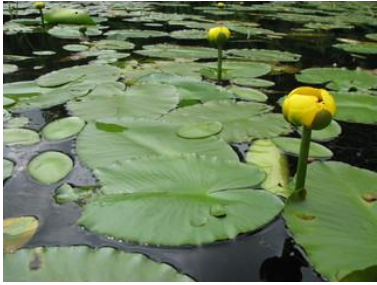
<p>Bullhead Pond Lily (Spatterdock)</p> <p><i>Nuphar variegata</i></p>	<p>An aquatic plant with heart-shaped leaves that can grow to be 15 inches long. This plant also has a yellow, cup-shaped flower. This plant is native.</p>

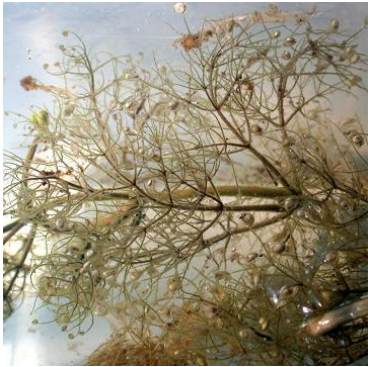
<p>Large Purple Bladderwort</p> <p><i>Utricularia purpurea</i></p>	<p>An aquatic plant with leaves containing small sacks that trap small invertebrates. This plant usually has unrooted stems that easily tangle with other plants. In the water, this plant tends to look cloudy or slimy. This plant is native.</p>
