WETLAND DELINEATION REPORT

**HICKORY HILL FARMS, INC., PROPERTY
N67 W25913 SILVER SPRING DRIVE**

**SW and SE Quarters, Section 21
NW Quarter, Section 28
T8N, R19E
VILLAGE OF SUSSEX,
WAUKESHA COUNTY,
WISCONSIN**

Report completed: January 17, 2020

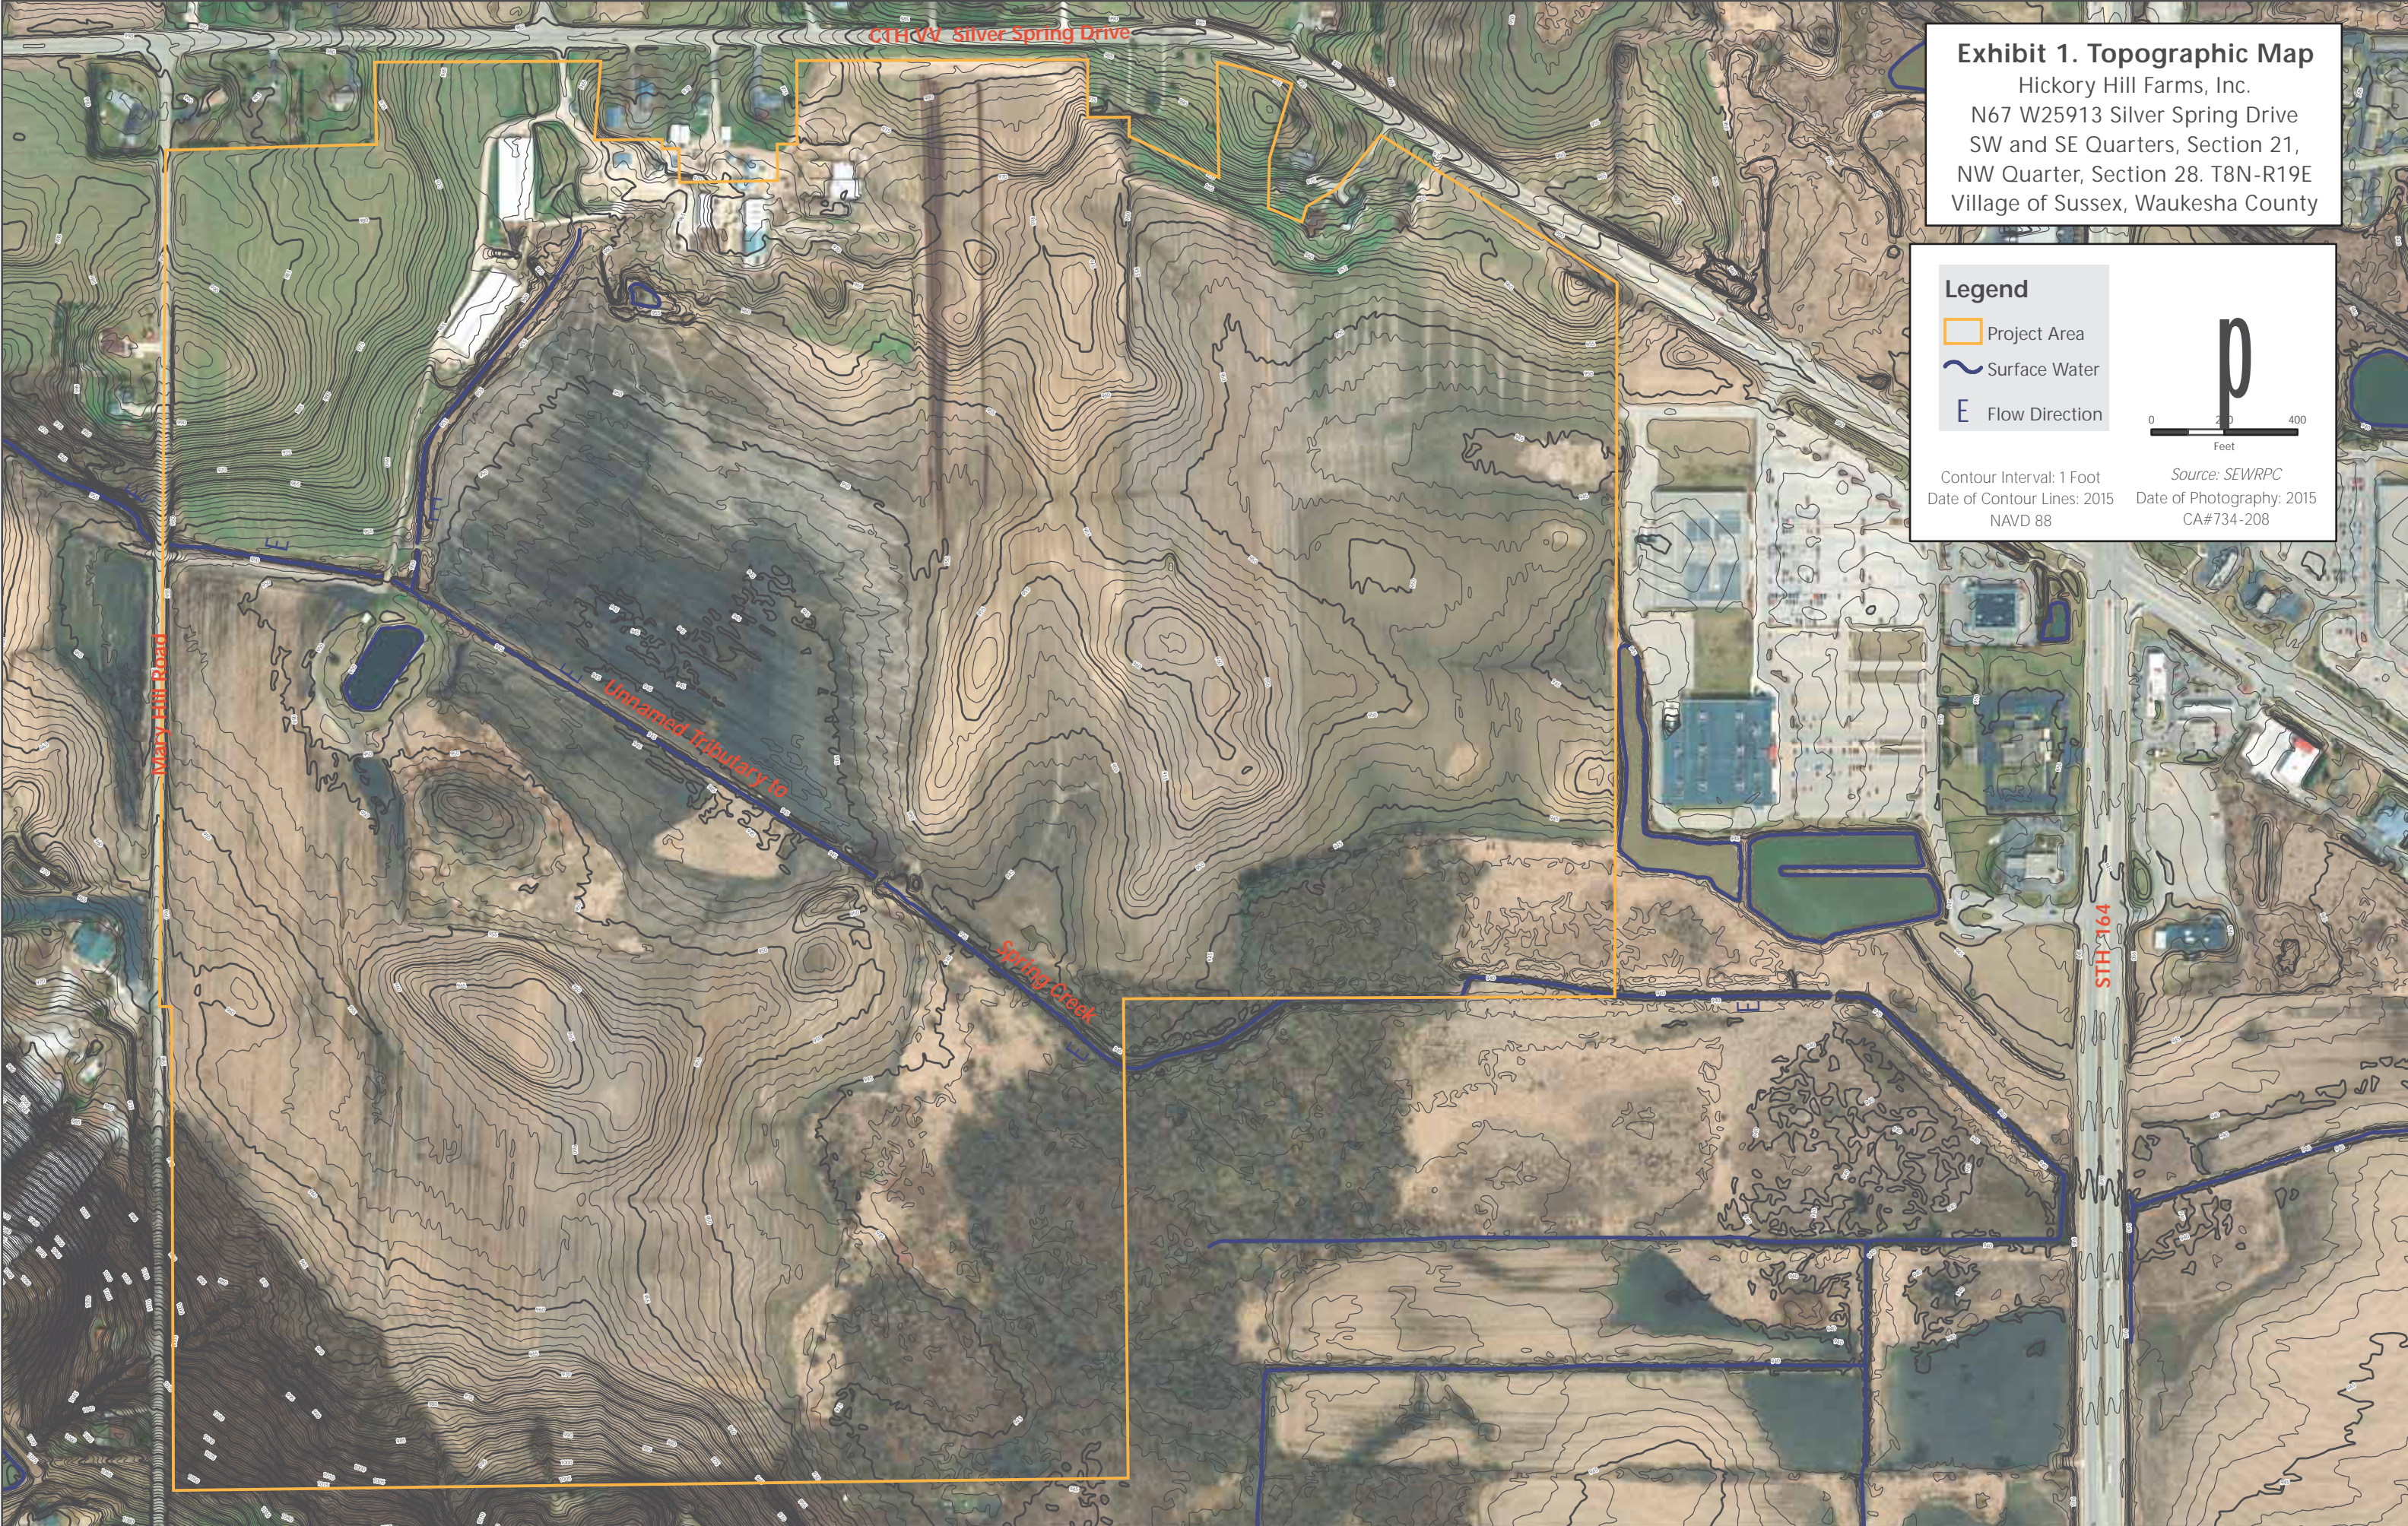
Exhibit 1. Topographic Map

The Waukesha County topographic mapping (Exhibit 1) depicts a project area with significant topographic relief. Steep east- and south-facing slopes are present in the northwest part of the property while steep north-facing slopes are also present on the south part. Elevations range from a high of 1063 feet above North American Vertical Datum, 1988 adjustment (NAVD 88), on a steep hillside at the southwest corner of the property to a low of 940 feet along the banks of the unnamed tributary to Spring Creek where it flows off the property at the eastern edge. The unnamed tributary to Spring Creek enters the western edge of the property via culvert under Mary Hill Road before flowing in a southeasterly direction across the central part of the property. A small ditched waterway flows in a southerly direction from the north part of the property before draining into the unnamed tributary to Spring Creek. Other surface waters include two excavated ponds. One is located just south of the main tributary waterway while the other is east of the small waterway.
