Lake Management Plan for Lower Turtle Lake, Barron County, Wisconsin

December 2005

Prepared by Steve McComas, Blue Water Science
with contributions from Wisconsin Department of Natural Resources
and the Lower Turtle Lake Association

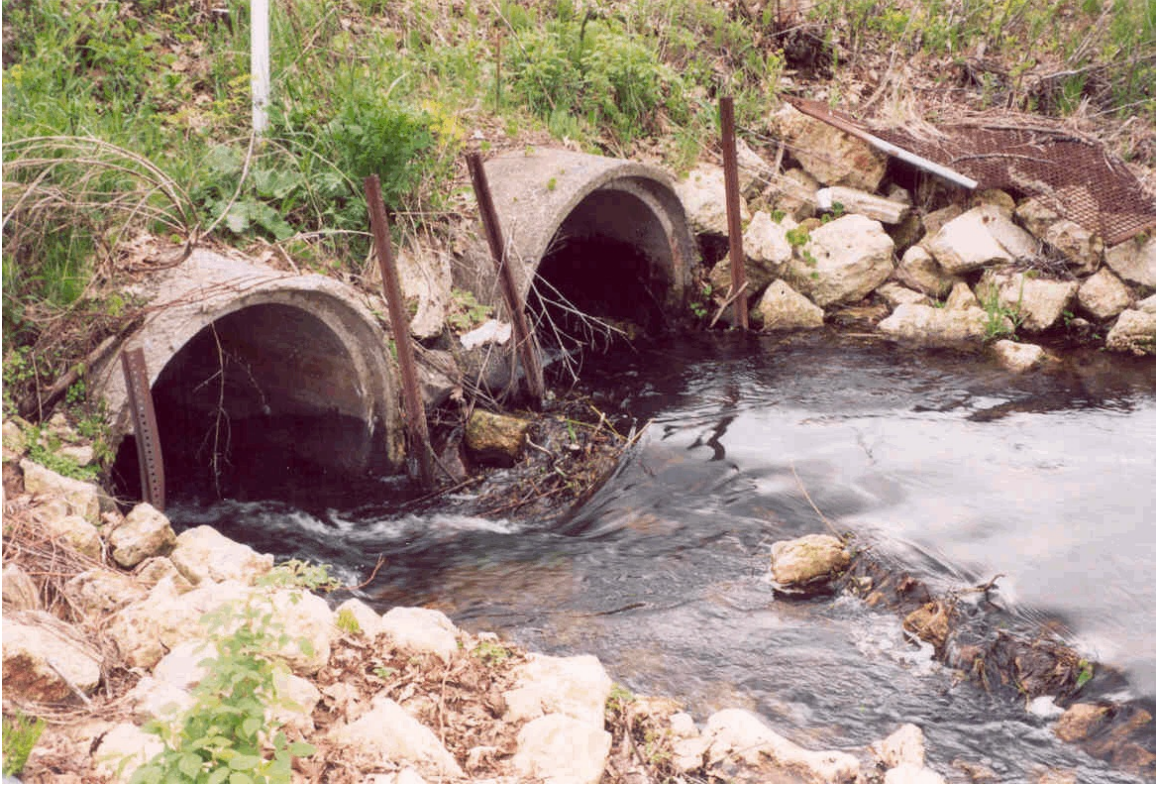
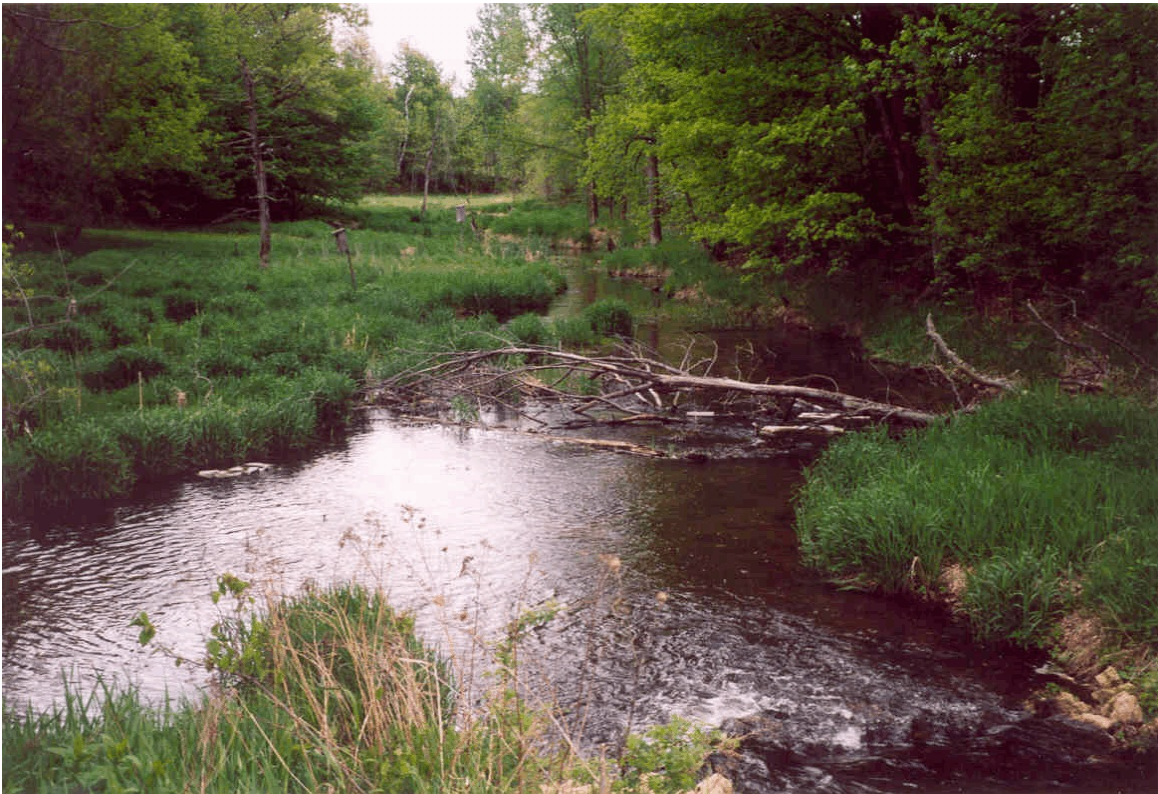
Figure 6. (top) Culverts leaving Upper Turtle Lake that feed the stream that flows into Lower Turtle Lake.

(bottom) A stretch of the stream that leaves Upper Turtle Lake. This stream does not appear to be a large nutrient source for Lower Turtle Lake.

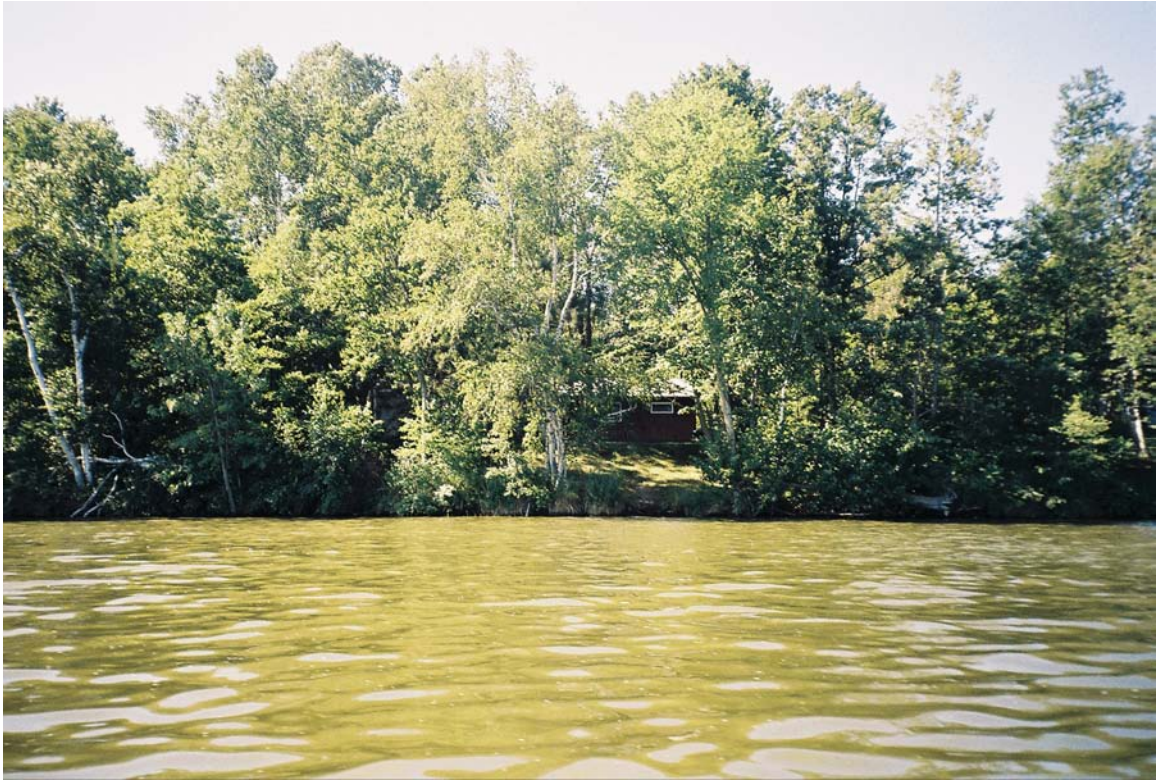
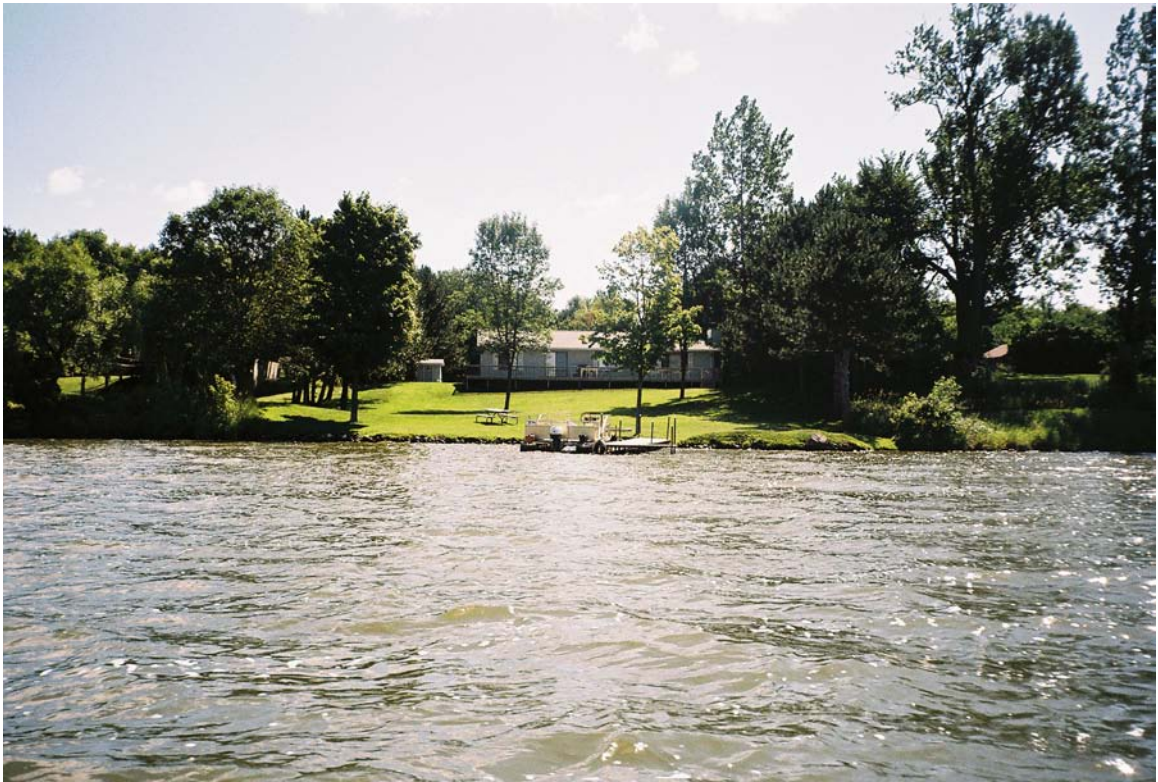
Figure 7. Both of the pictures are from Lower Turtle Lake. [top] This parcel would rate as having a shoreline with a buffer greater than 50% of the lot width and an understory with greater than 50% natural cover.

For each photograph we looked at the shoreline and the upland condition. Our criteria for natural conditions were the presence of 50% native vegetation in the understory and at least 50% natural vegetation along the shoreline in a strip at least 15 feet deep. We evaluated shorelines and uplands at the 75% natural level as well (Figure 7 illustrates the methodology).

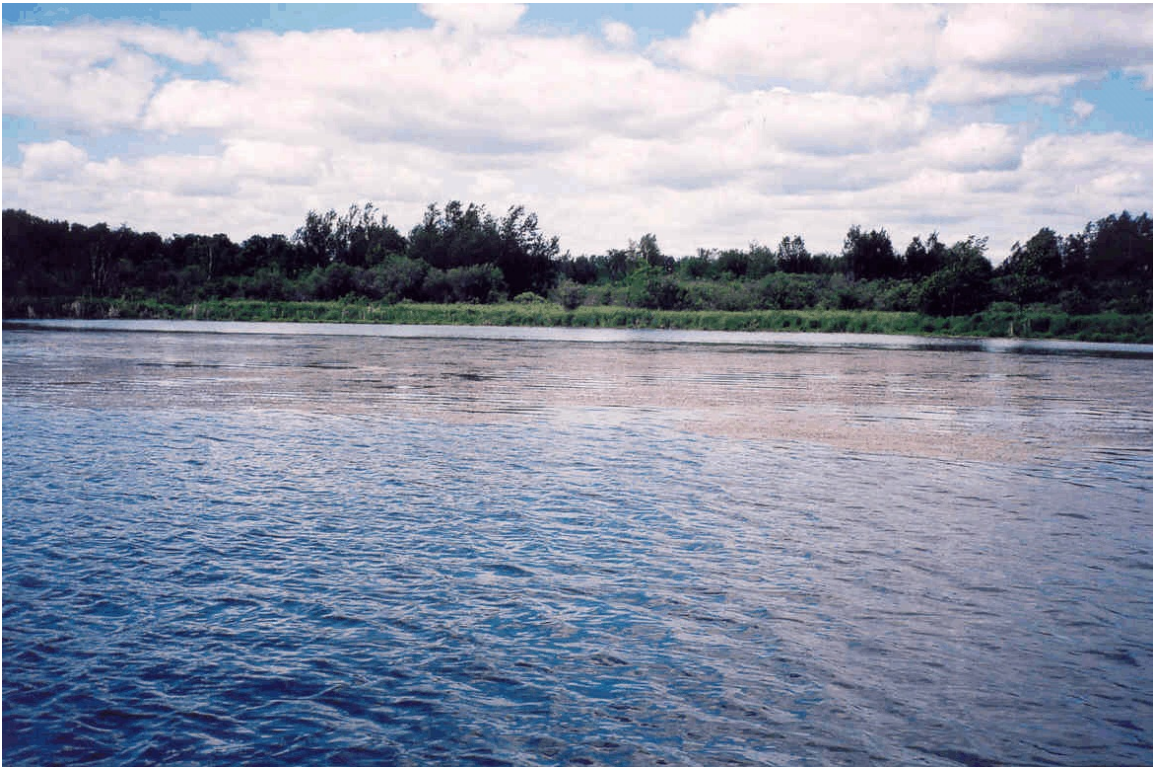
Figure 12. In the southern end of Lower Turtle, aquatic plants were growing close to the lake surface in June, 2004.

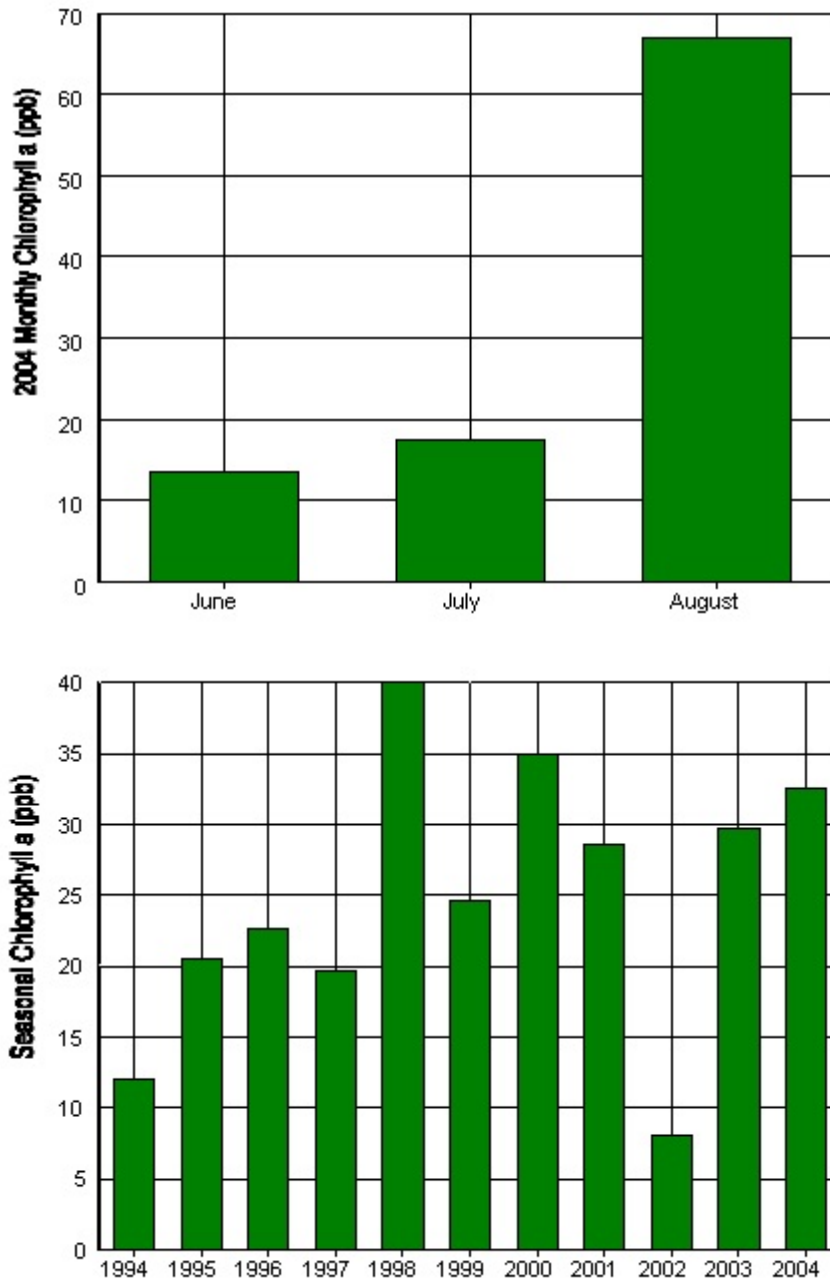
Figure 16. [top] Monthly summer chlorophyll a readings for Lower Turtle Lake in 2004. [bottom] Seasonal chlorophyll a concentrations from 1994-2004.

Algae are small green plants, often consisting of single cells or grouped together in filaments (strings of cells). Algae blooms occur in Lower Turtle Lake nearly every summer. Algae are commonly characterized by measuring the chlorophyll content in lake water. In June and July chlorophyll was low and then increased in August. This is a common pattern for lakes like Lower Turtle Lake. Chlorophyll results from 1994 - 2004 are shown in Figure 16. Except for 2002, seasonal chlorophyll levels are elevated.

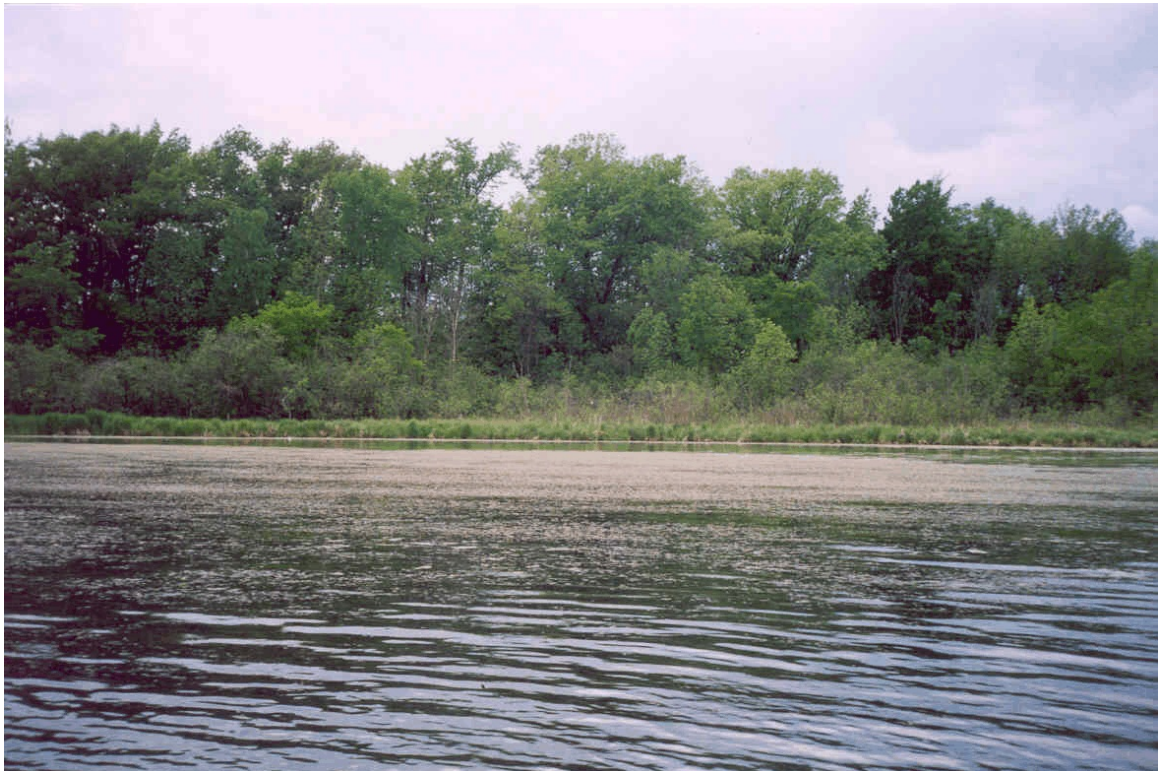
Figure 20. Curlyleaf pondweed, June 5, 2004.

Curlyleaf pondweed (*Potamogeton crispus*) is an exotic plant found in Lower Turtle Lake.

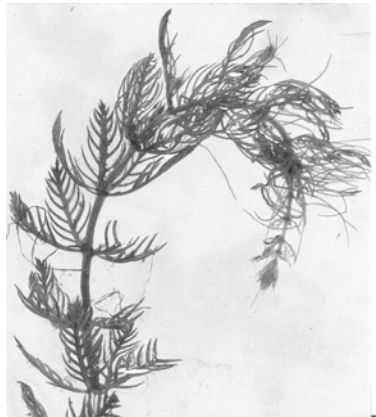
Northern watermilfoil (*Myriophyllum sibiricum*) is found in water depths to 8 feet.

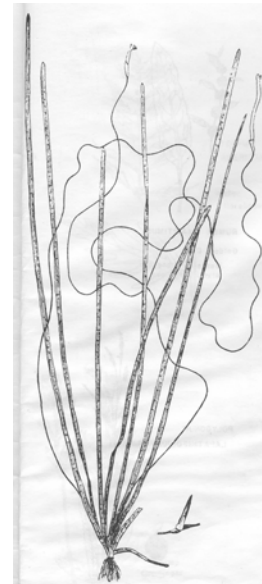
Water celery (*Vallisneria americana*) is found in water depths to 8 feet.

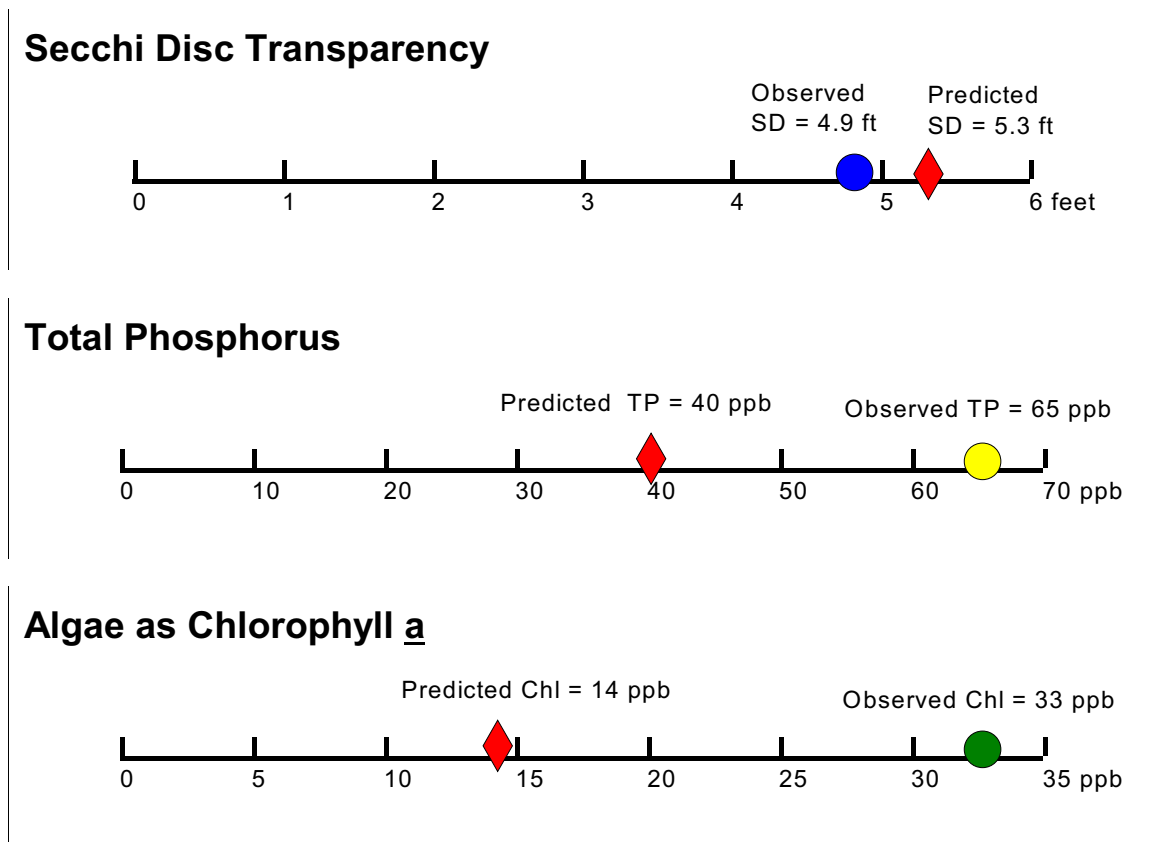
Figure 24. Comparison of water clarity, total phosphorus, and chlorophyll conditions for Lower Turtle Lake in 2004 to predicted conditions for a lake the size of Turtle Lake situated in the Central Hardwood Forest (CHF).

Lake phosphorus models were run using this information. It is estimated that between 1,000 - 1,500 pounds of phosphorus enter Lower Turtle Lake on an annual basis. Results of the model predictions are summarized in Figure 24. It is predicted that Lower Turtle Lake could maintain a phosphorus concentration of around 40 ppb, and should also have slightly better summer water clarity.

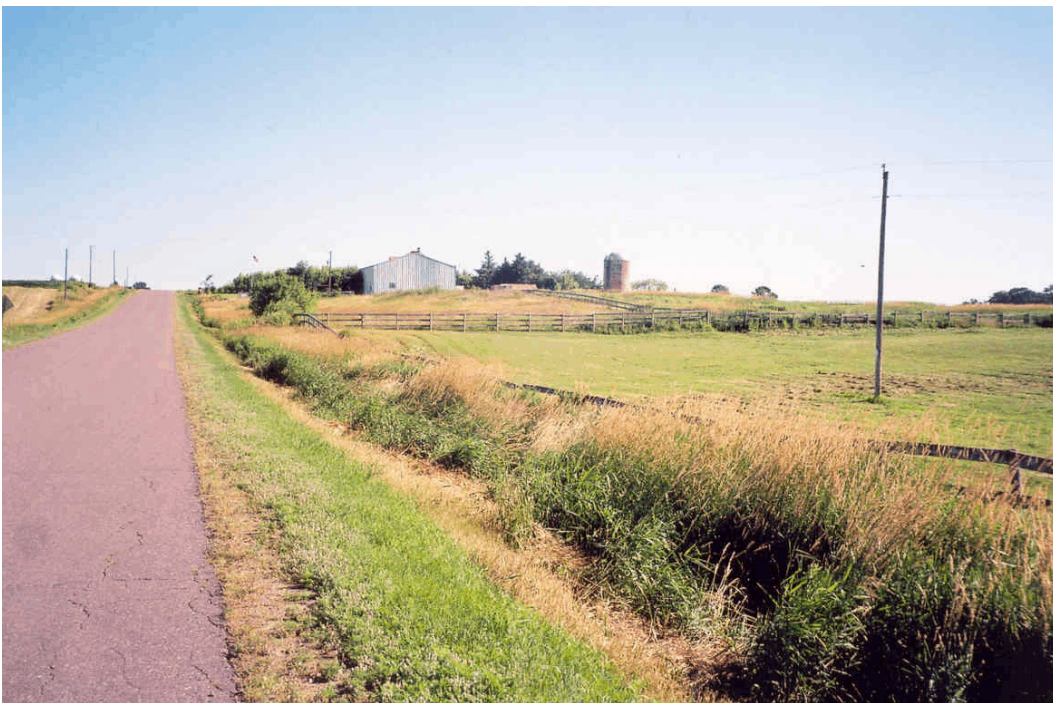
Figure 25. Some agricultural land to the north of Lower Turtle Lake is idle these days. The largest phosphorus contribution to Lower Turtle Lake comes from the western subwatersheds.

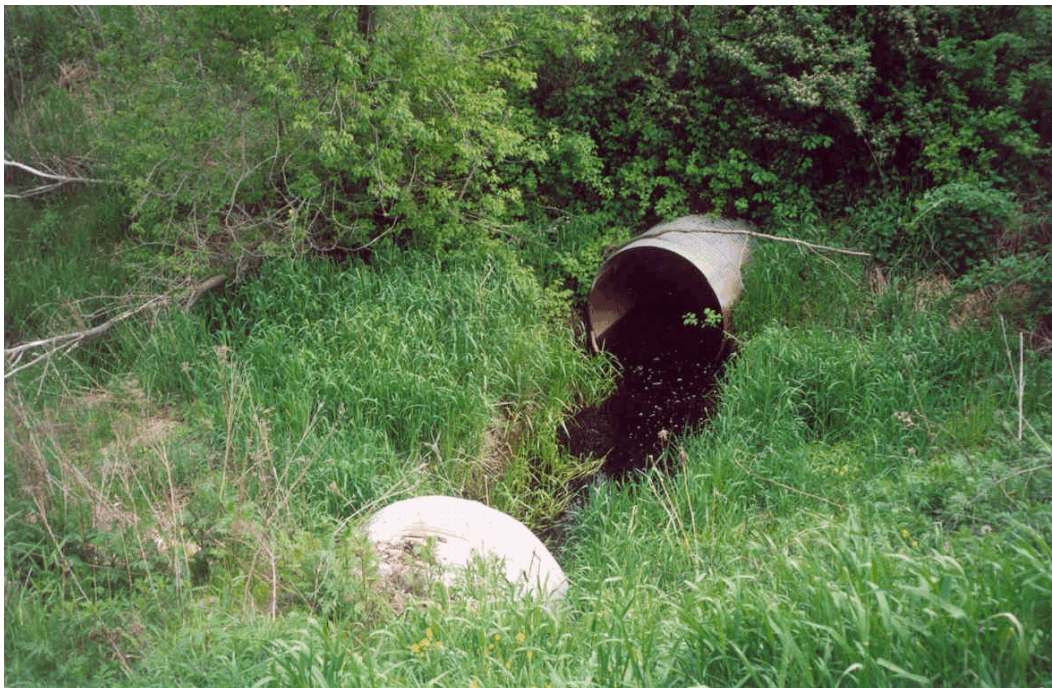
Figure 26. This stream at the 3rd Street culvert delivers high phosphorus loads to Lower Turtle Lake.

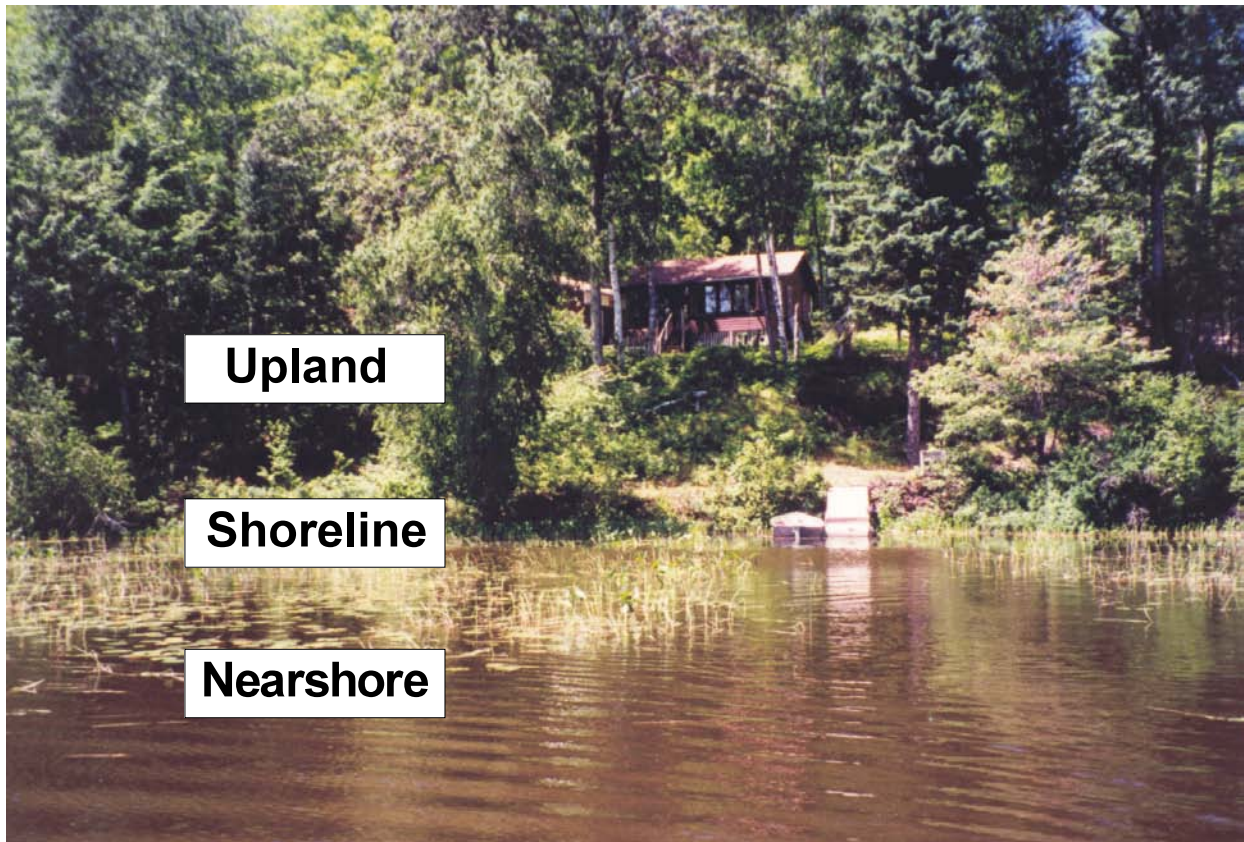
Figure 27. Cross section of the lake shoreland habitat.

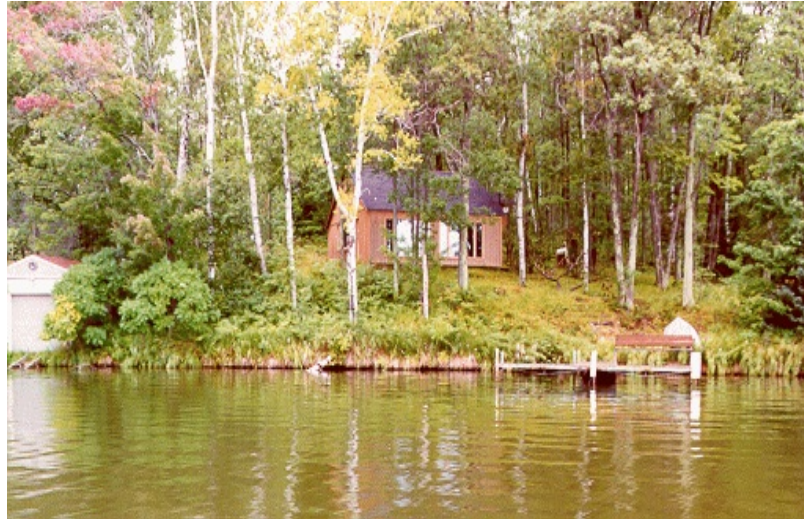
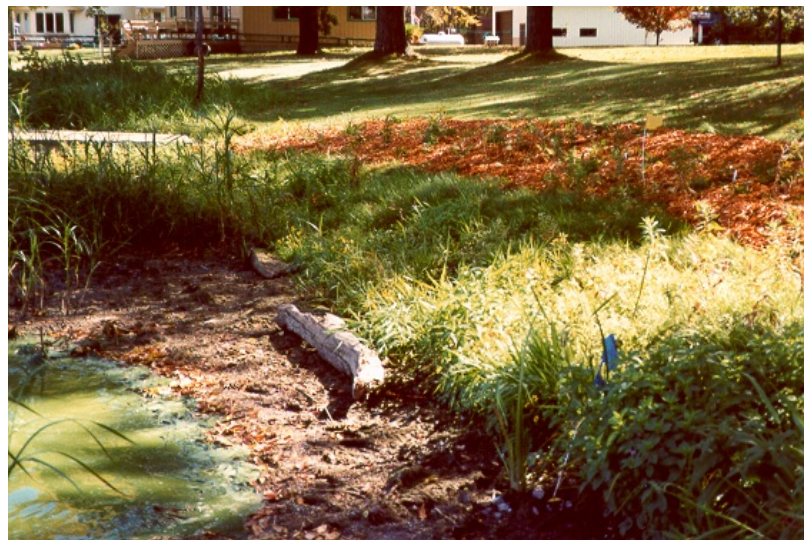
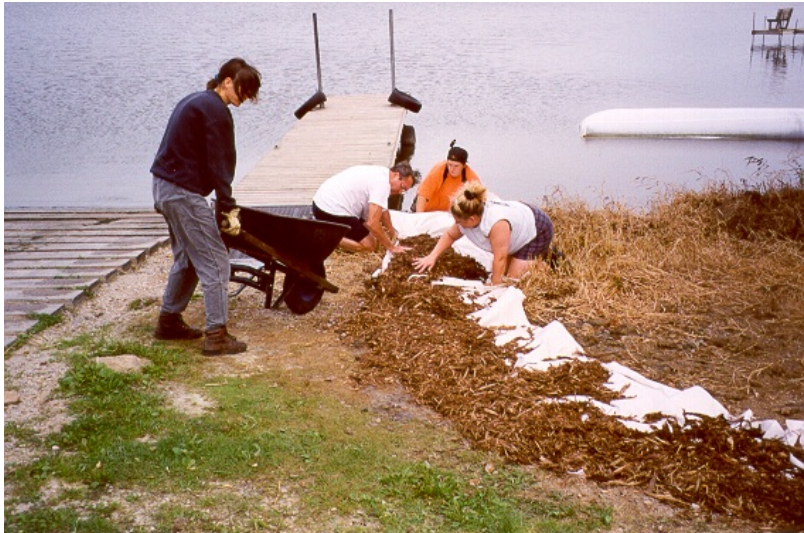
Figure 28. Examples of three shoreland management options.

2. Accelerated Naturalization: To accelerate the naturalization, plant shrubs, wild flowers, or grasses into a shoreland area.

3. Restoration: This involves removing existing vegetation through the use of paper mats and/or mulching and planting a variety of native grasses, flowers, and shrubs into the shoreland area.

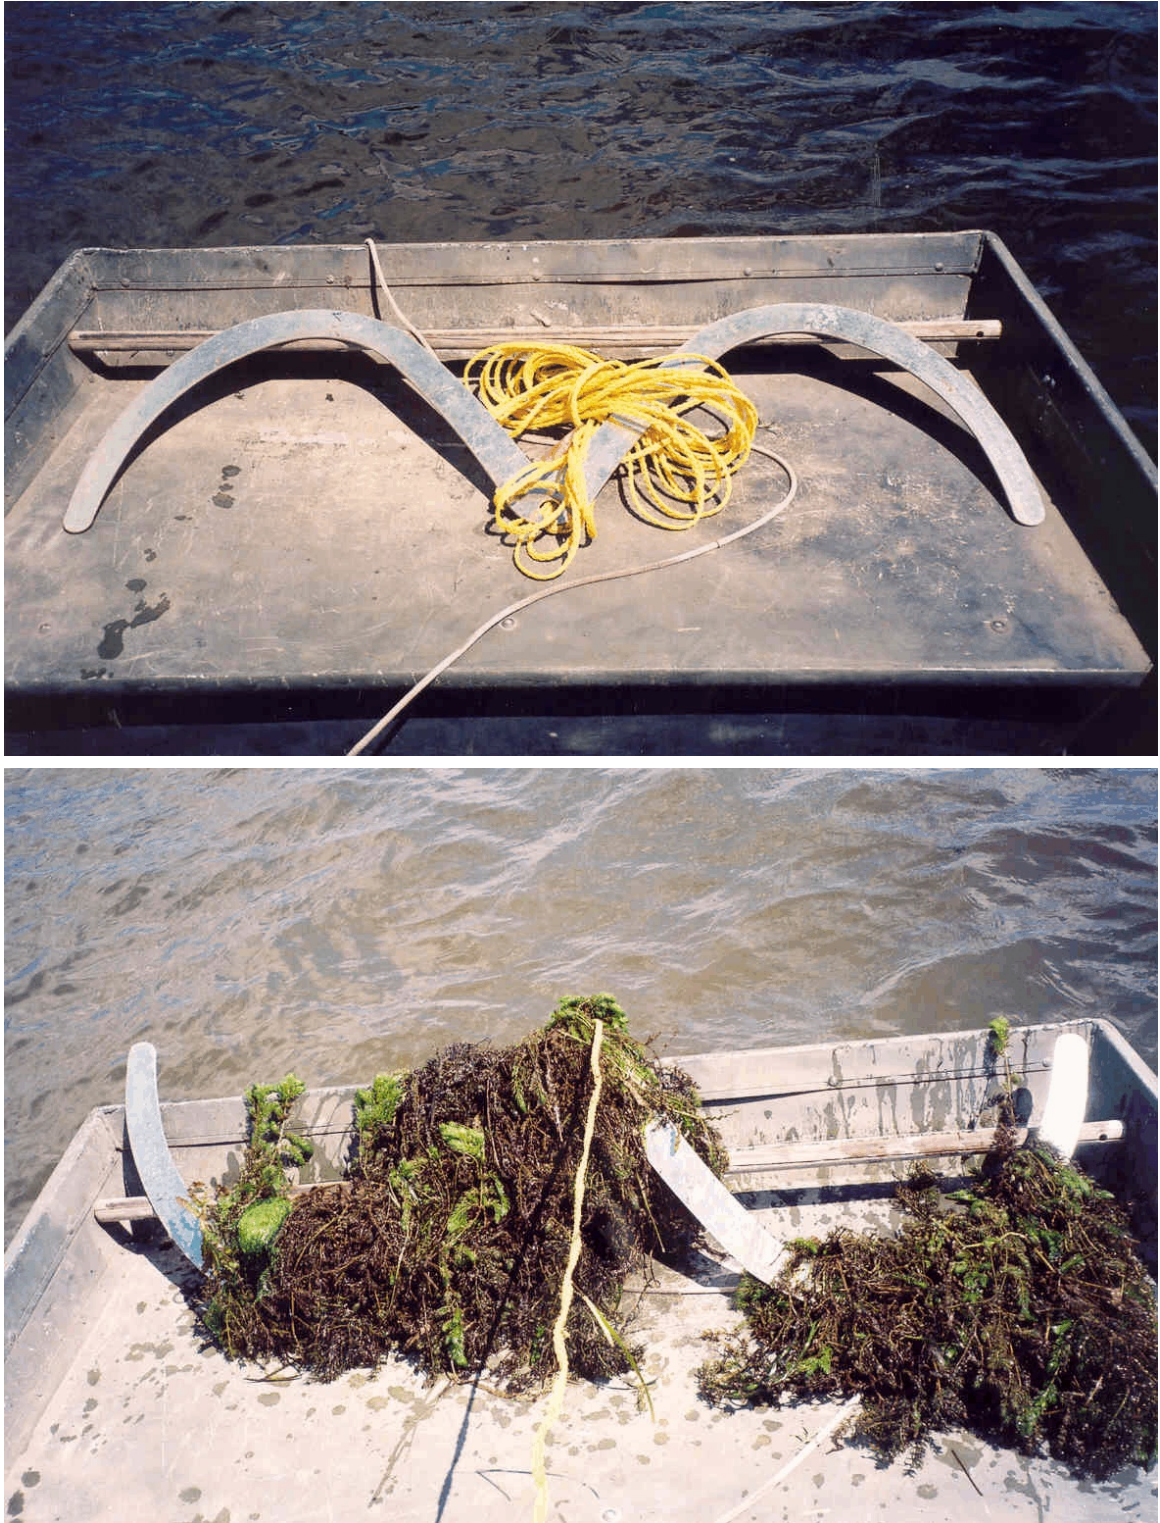
Figure 30. Small-scale removal efforts are one option for controlling nuisance growth of curlyleaf pondweed. The use of a herbicide, Aquathol K, is another option.

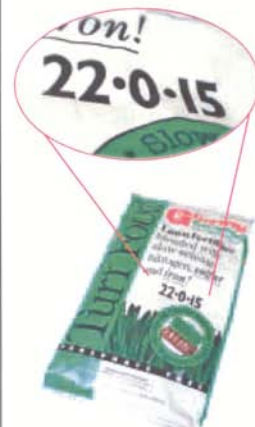
On any bag or box of fertilizer, there is a string of three numbers. The middle number indicates phosphorus content and should read "0" in the Twin Cities seven-county metropolitan area, and "3" or less in Greater Minnesota.
