# Lake Management Plan for Kimball Lakes, Washburn County, Wisconsin

Revised November 2005

Prepared by **Steve McComas, Blue Water Science**  
with contributions from **Wisconsin Department of Natural Resources**  
and the **Kimball Lakes Association**

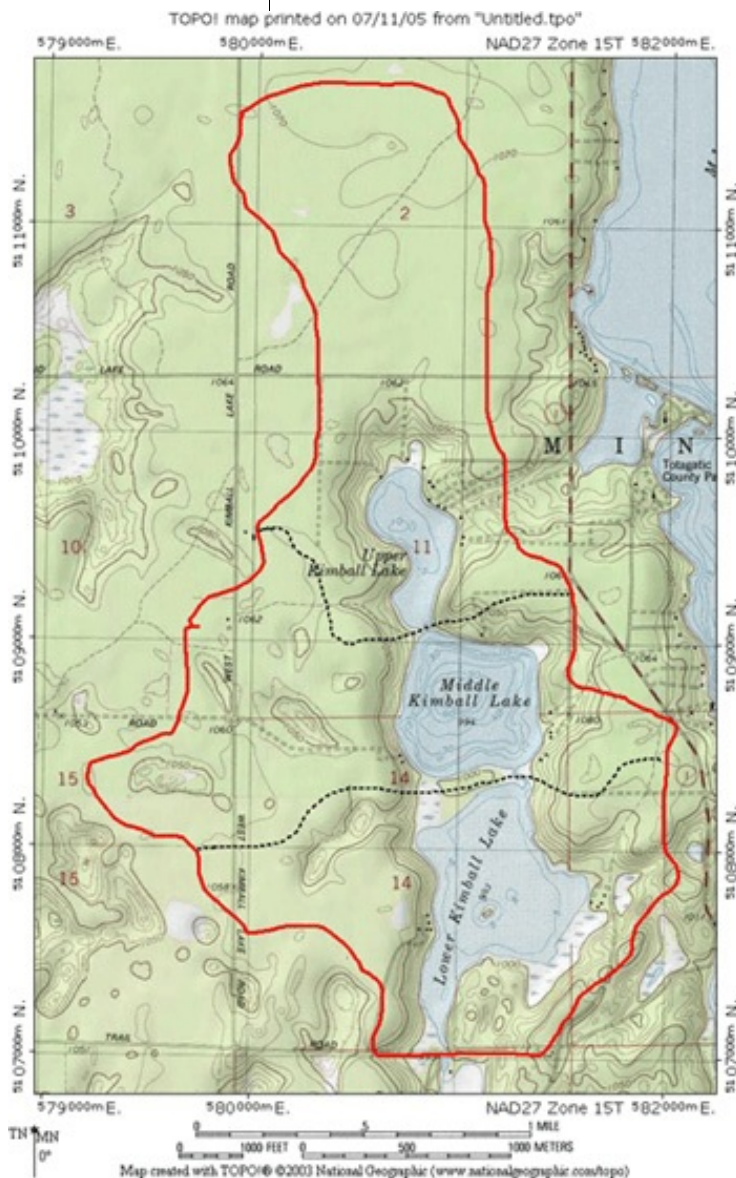
The watershed drainage area to the Kimball Lakes is about 1,314 acres and is outlined in red.

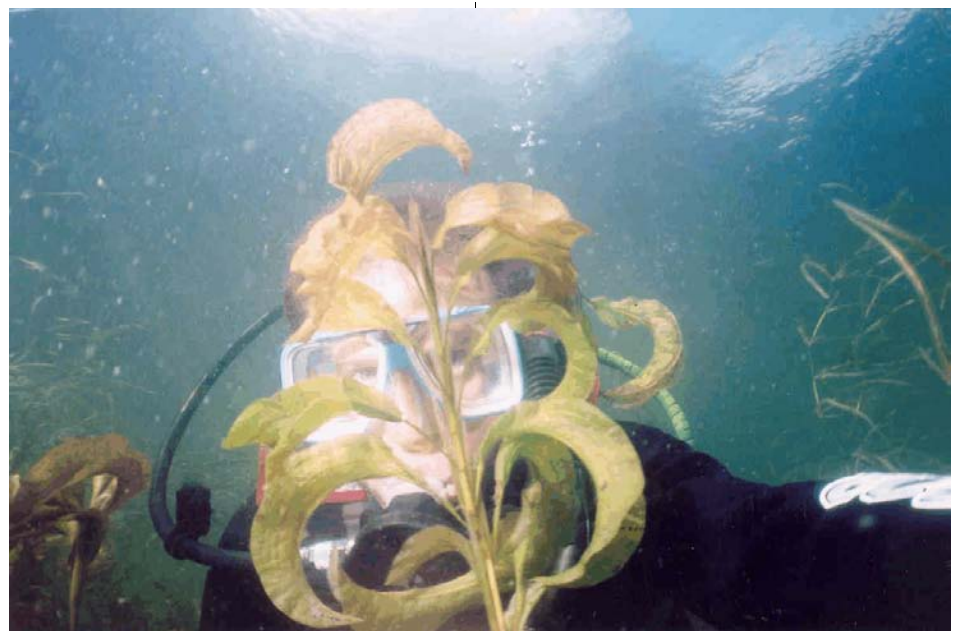
Here is a picture of broadleaf pondweed from Middle Kimball Lake. This is a desirable aquatic plant species. All three lakes have relatively good aquatic plant diversity and should promote good water clarity.

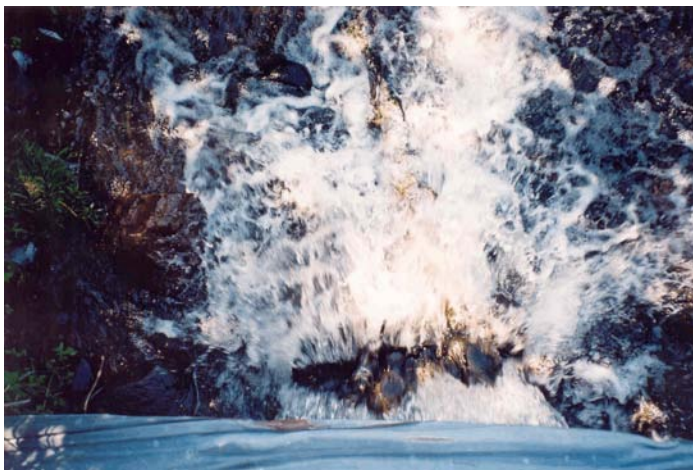
**Figure 5. Outlet at Lower Kimball Lake. Outflow averages about 1.4 cubic feet per second.**

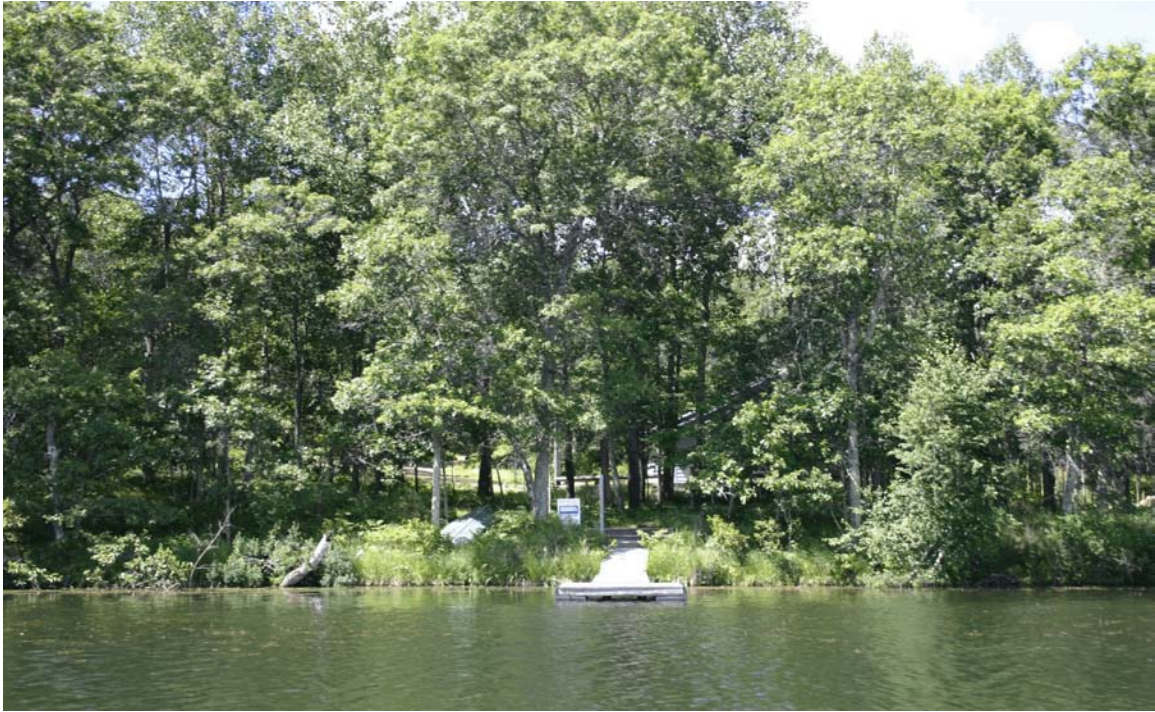
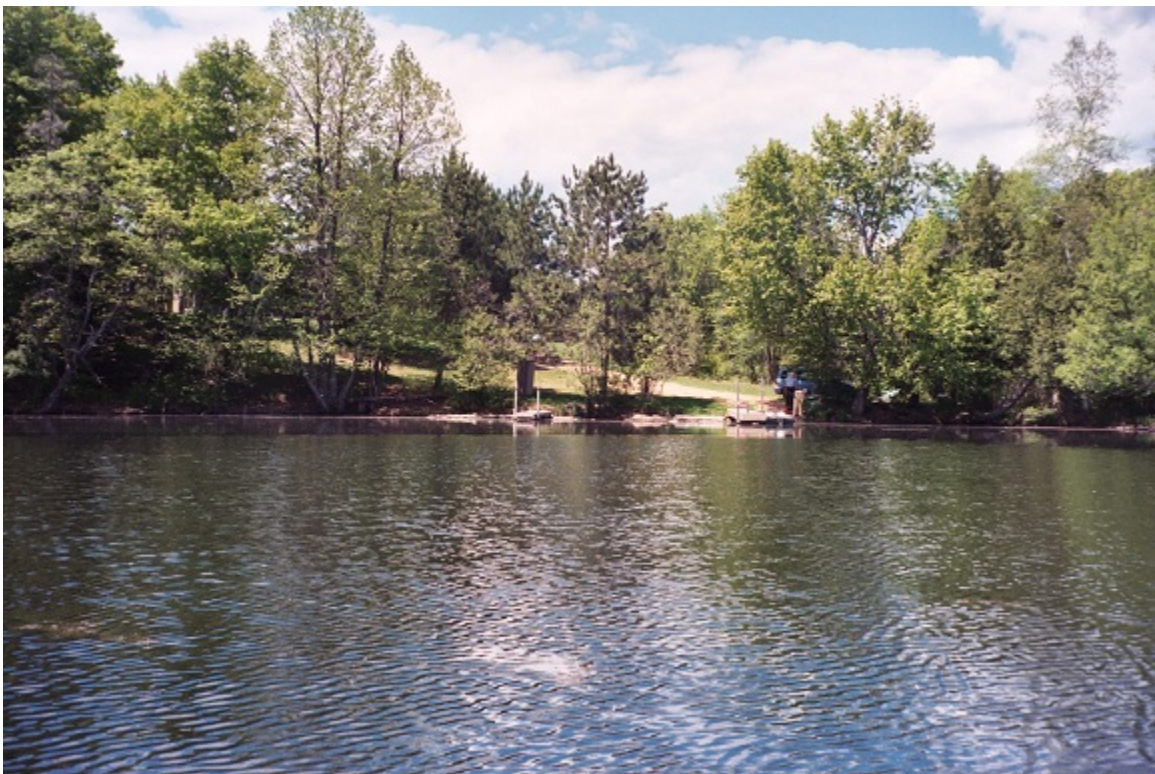
**Figure 6. [top] This parcel would rate as having a shoreline with a buffer greater than 50% of the lot width and an understory with greater than 50% natural cover.**

**[bottom] This parcel, from another lake, would not qualify as having a natural shoreline buffer greater than 50% of the lot width. Also the understory in the upland area would be rated as having less than 50% natural cover.**

For each photograph we looked at the shoreline and the upland condition. Our criteria for natural conditions were the presence of 50% native vegetation in the understory and at least 50% natural vegetation along the shoreline in a strip at least 15 feet deep. We evaluated shorelines and uplands at the 75% natural level as well (Figure 6 illustrates the methodology).

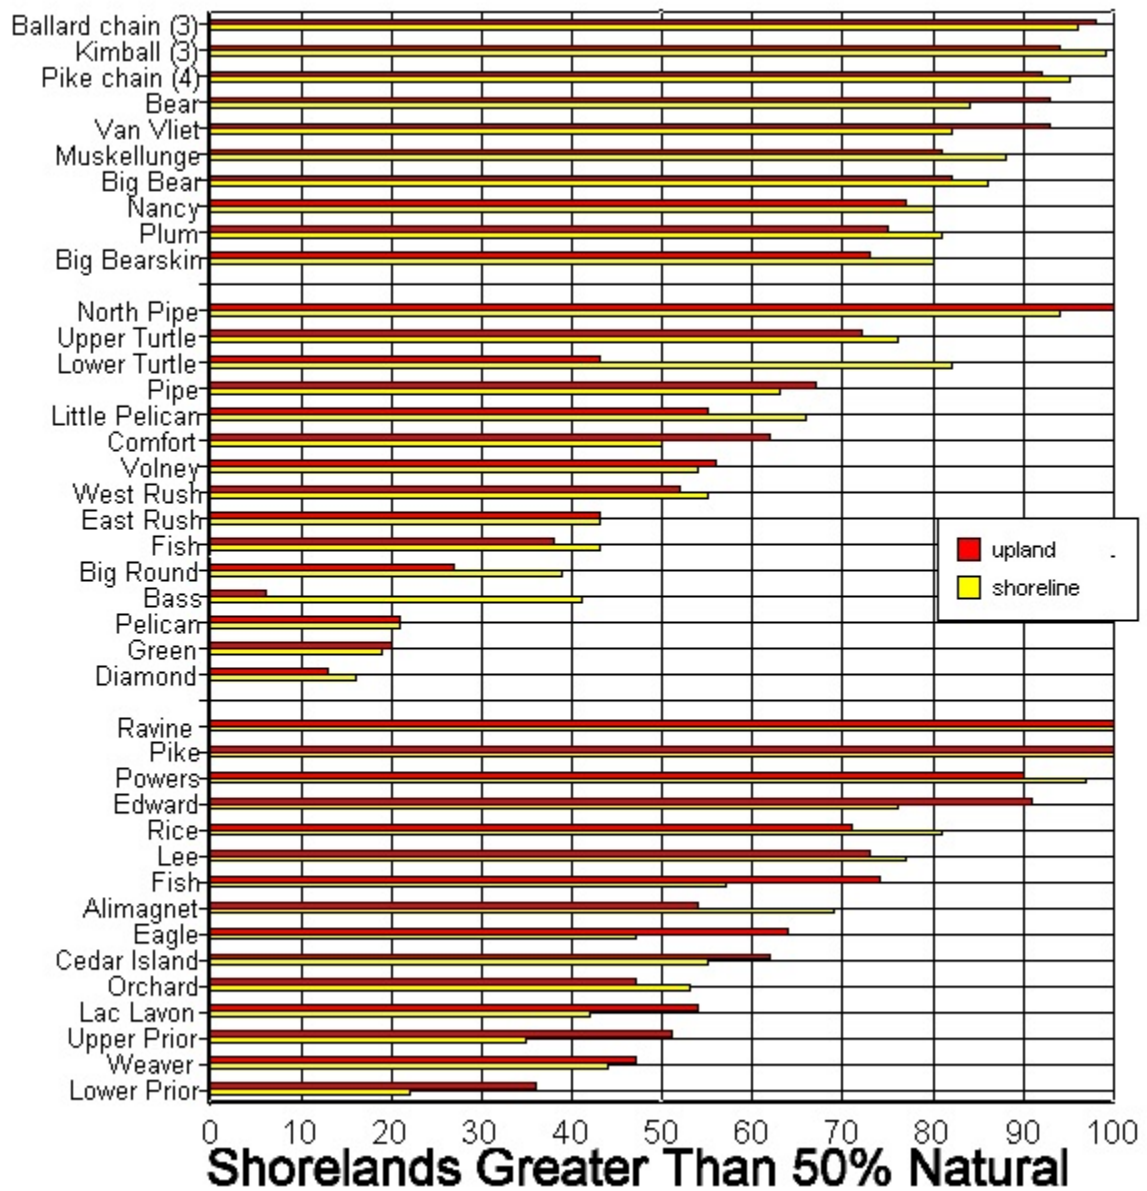
Figure 7. A summary of shoreland inventory results for lakes using an evaluation based on shoreland photographs. For each lake the percentage of shoreline and upland conditions with greater than 50% natural conditions is shown. The first tier of lakes are located in northern Wisconsin which are 4 to 5 hours from a major metropolitan area. The middle tier of lakes are about an hour's drive from the Twin Cities, and are considered to be "country" lakes. The lower tier of lakes are in the Twin City Metropolitan area and are categorized as urban lakes. Several lakes of the "urban" lakes have most of their shoreland owned by the city and there is a high percentage of natural conditions.

Kimball Lakes is considered a northwoods lake for this inventory. Natural shoreland conditions for Kimball Lakes are about average compared to the other northern Wisconsin lakes.

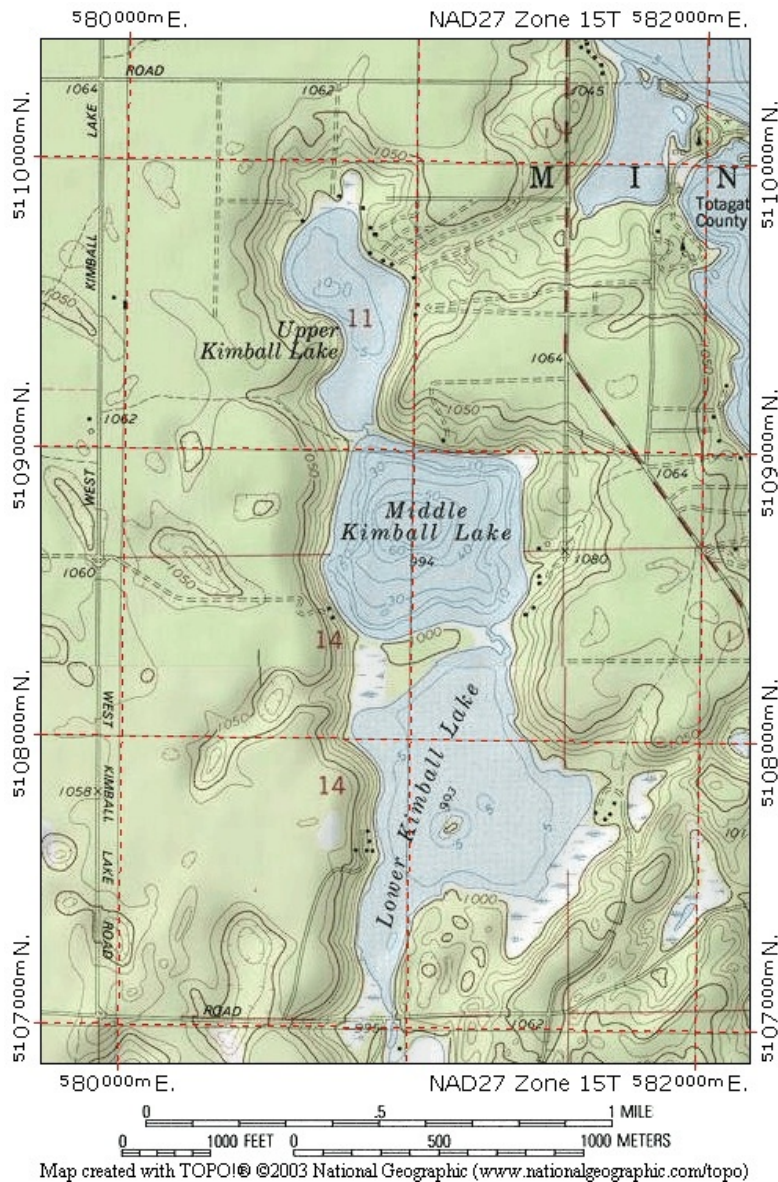
Figure 9. Kimball Lake, Washburn County, Wisconsin.

With all three basins combined, the Kimball Lakes are approximately 271 acres in size, with a watershed of 1,456 acres. The average depth of Upper, Middle, and Lower Kimball Lakes are 1.5, 9.4, and 1.2 meters (5, 31, 4 feet) respectively. The maximum depth of the three lakes are 3.3, 23.3, and 1.8 meters (11, 77, 6 feet) (Table 7). A lake contour map is shown in Figure 9. The Kimball Lakes are located in an area of Wisconsin that is dominated by forests and wetlands.

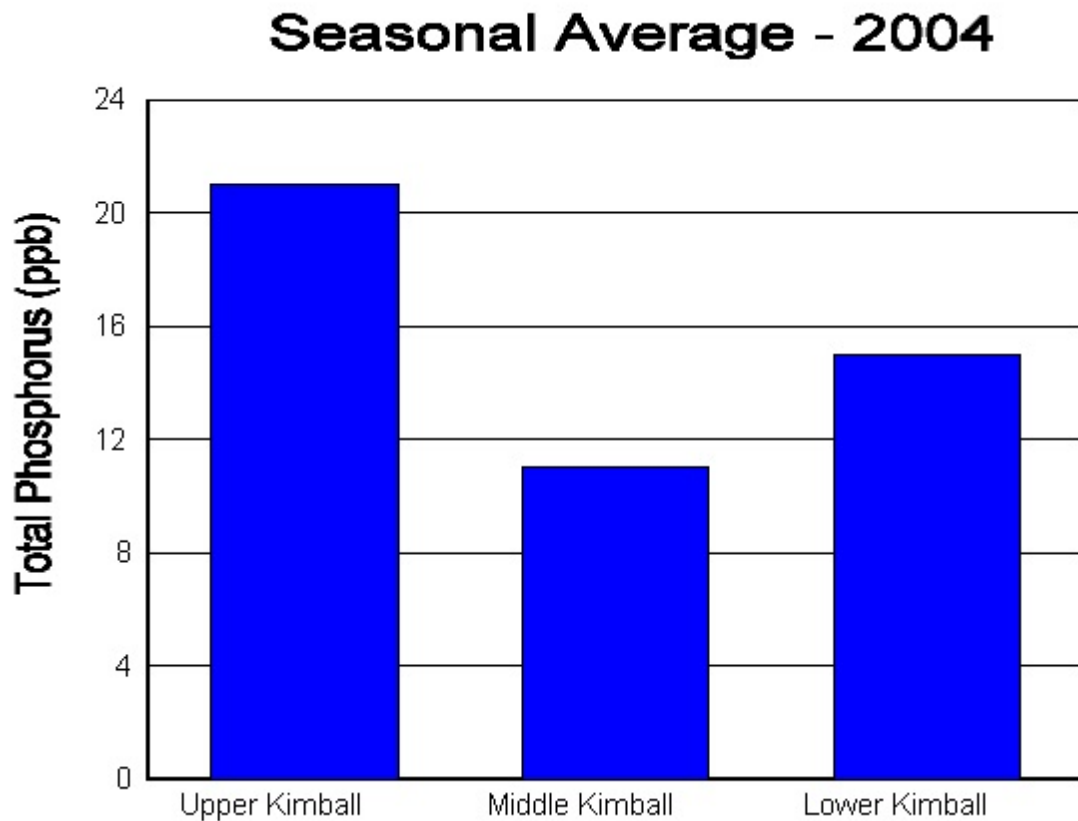
Figure 13. Seasonal average total phosphorus for Kimball Lakes in 2004.

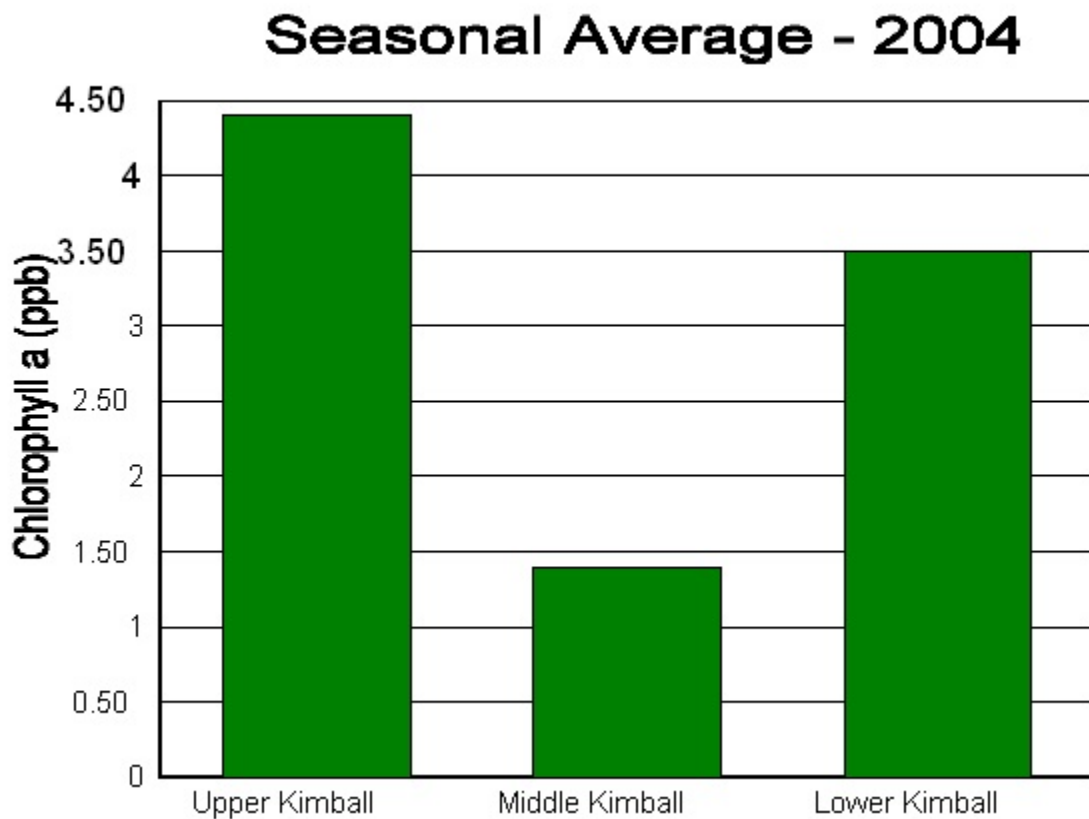
Figure 14. Seasonal average chlorophyll concentrations for Kimball Lakes in 2004.

Algae are small green plants, often consisting of single cells or grouped together in filaments (strings of cells). If algae are too abundant, the resulting algae blooms create greenish turbid water. Low amounts of algae in the lake will result in clear water. The amount of algae can be characterized by measuring the chlorophyll content in lake water. Chlorophyll results in 2004 are shown in Figure 14. Chlorophyll concentrations are low.

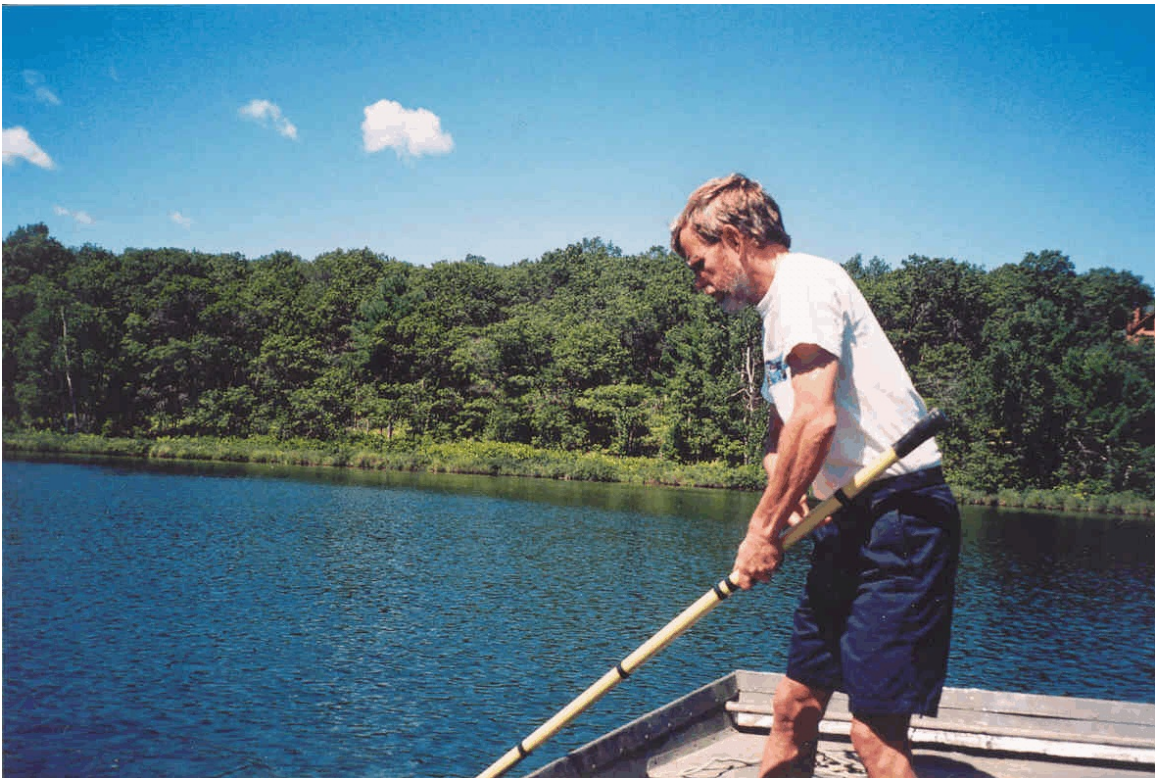
**Figure 18. Lake resident volunteers helped with the aquatic plant survey.**

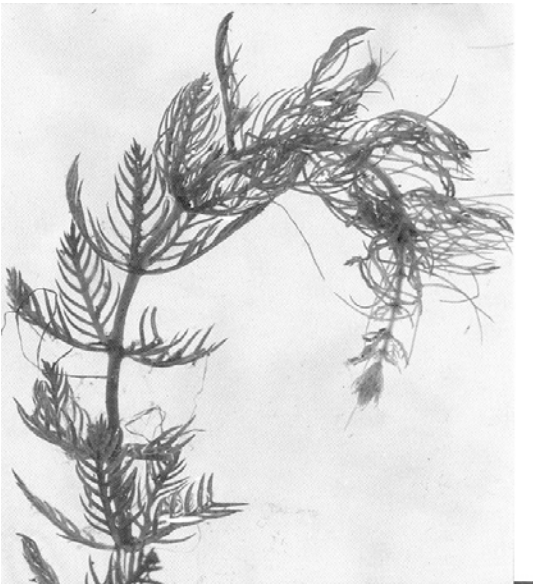
Northern watermilfoil (*Myriophyllum sibiricum*) is found in water depths to 10 feet.

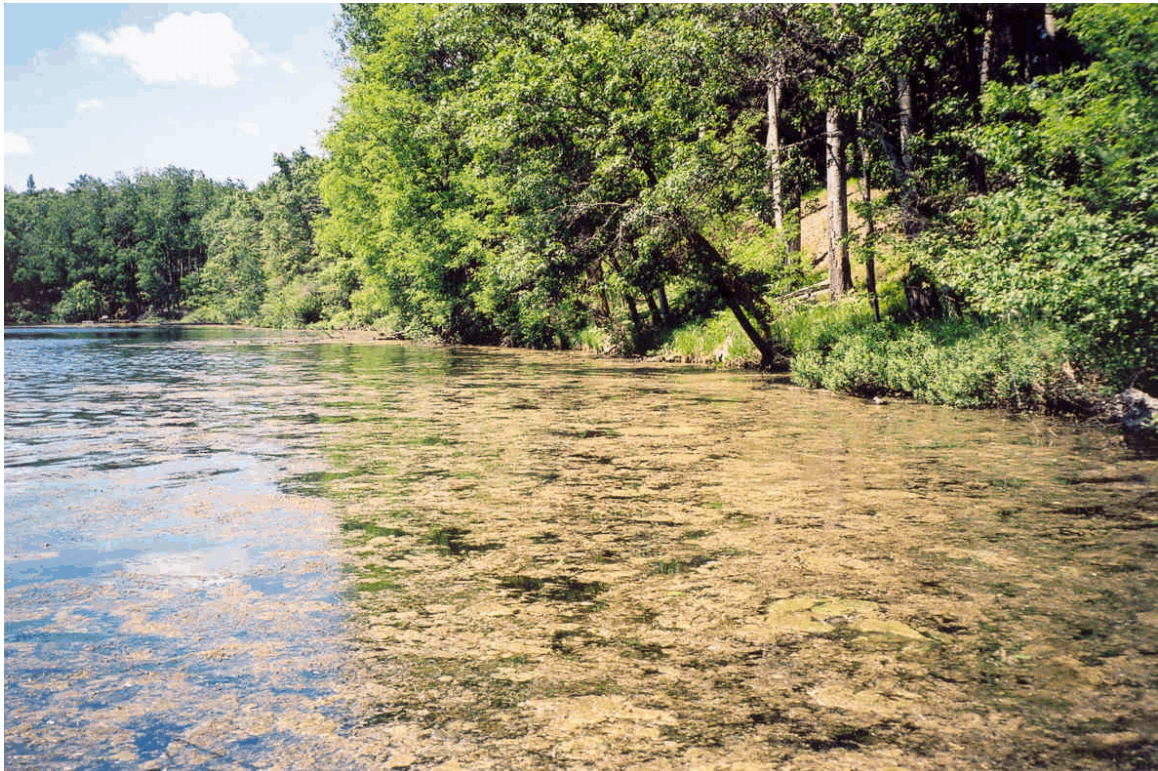
**Figure 19. Only one area in the Kimball Lakes has nuisance plant growth. The plant is filamentous algae and it is at the north end of Upper Kimball Lake.**

Filamentous algae was present at one end of the Upper Kimball Lake.

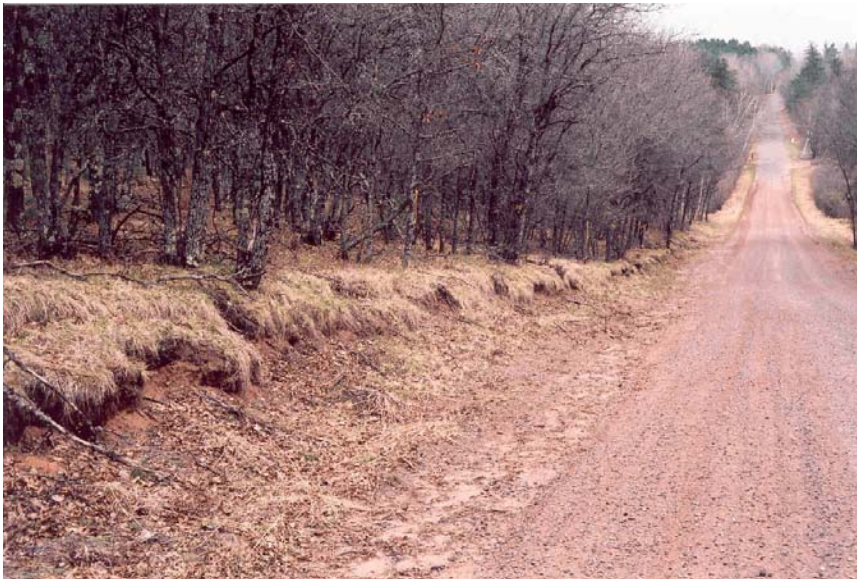
Figure 22. Potential sediment sources to the Kimball Lakes comes from road shoulders.

Currently, a majority of the watershed is forested. However, some sources of erosion exist in the watershed. Area residents should watch for excessive erosion that can come from roadside shoulders and from logging in harvested areas. Revegetation should be ongoing for these areas.

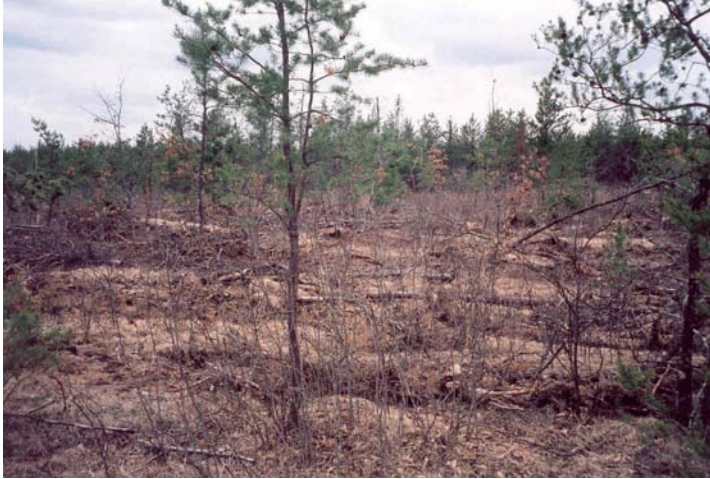
Figure 23. Revegetation in forest harvest areas minimizes excessive erosion from these sites.

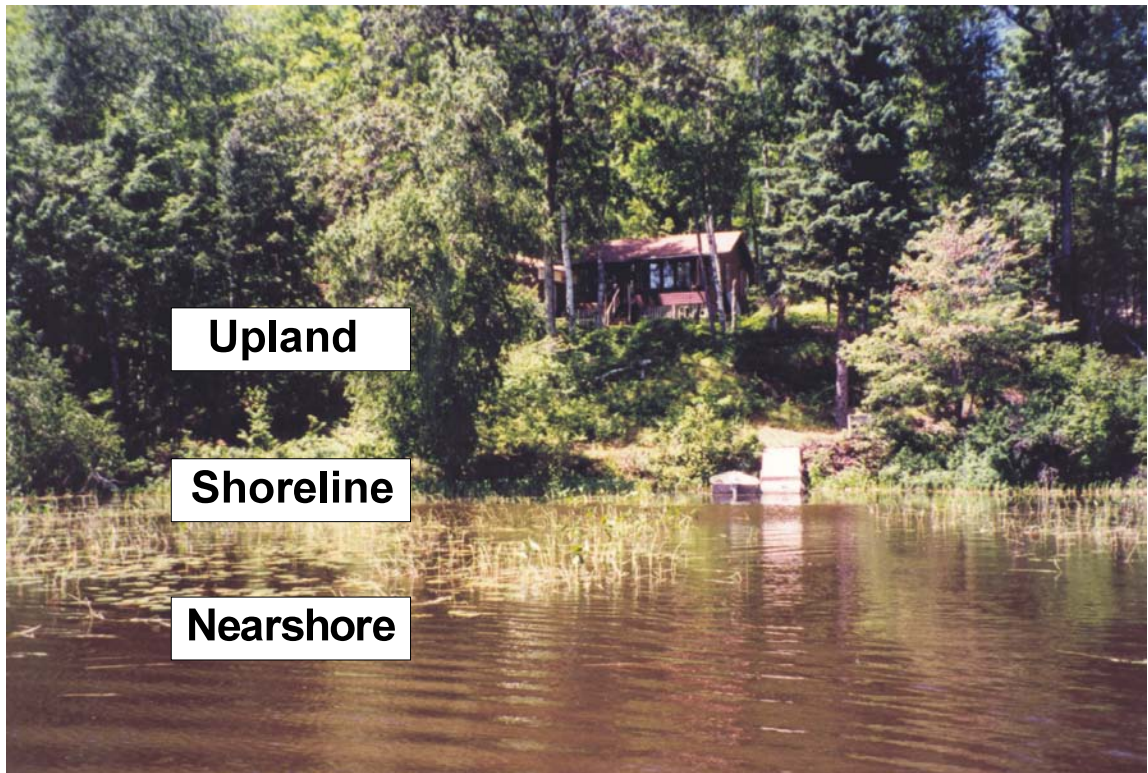
**Figure 24. Cross section of the lake shoreland habitat.**

The shoreland area is valuable for promoting a natural lake environment and a natural lake experience for lake users. The shoreland is defined as the upland area about 300 to 1,000 feet back from the shoreline, and out into the lake to about the end of your dock (Figure 24). A shoreland with native vegetation offers more wildlife and water quality benefits than a lawn that extends to the lake's edge. A summary of attributes and functions of native plants in the shoreland area is shown in Table 21.

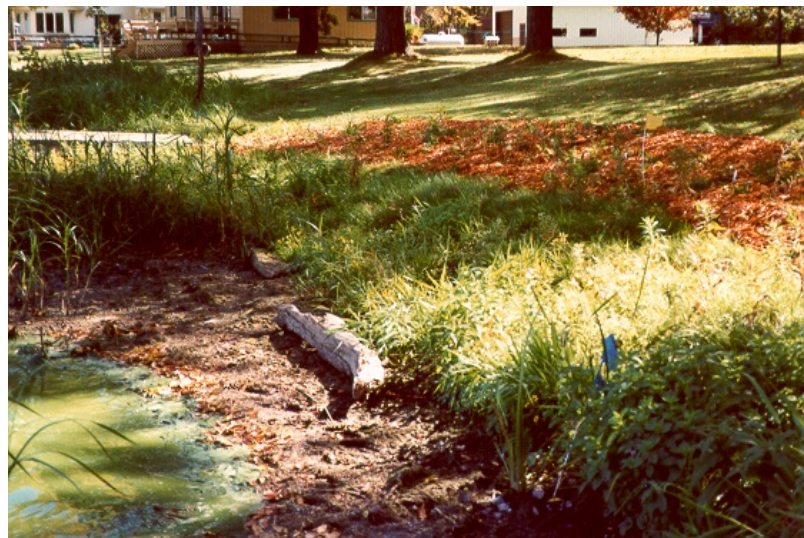
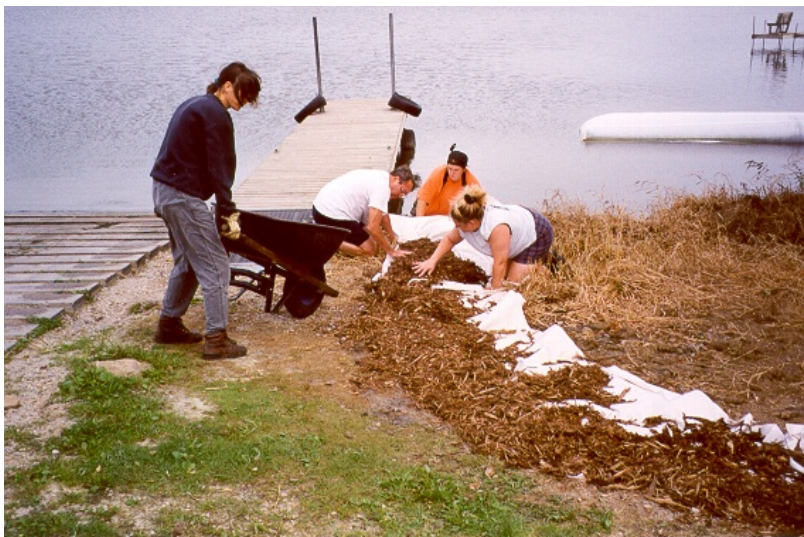
**Figure 25. Examples of three shoreland management options.**

**1. Naturalization:** The easiest way to implement a natural shoreline setting is to select an area and leave it grow back naturally.

**2. Accelerated Naturalization:** To accelerate the naturalization, plant shrubs, wild flowers, or grasses into a shoreland area.

**3. Restoration:** This involves removing existing vegetation through the use of paper mats and/or mulching and planting a variety of native grasses, flowers, and shrubs into the shoreland area.

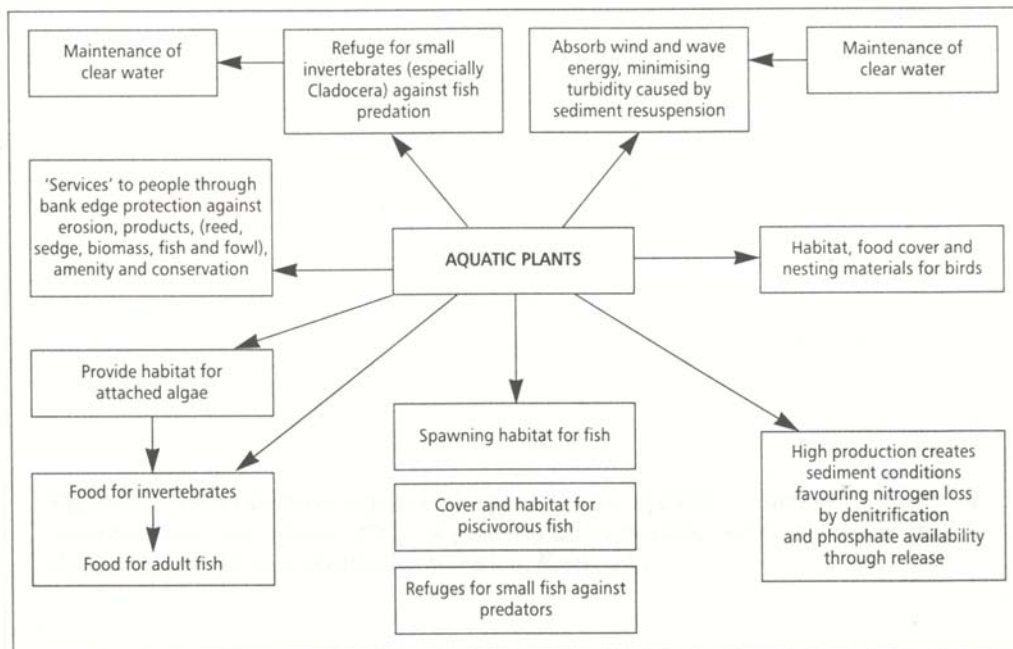
Figure 26. Links between aquatic plants and other organisms, including ourselves (source: Moss and others. 1996. A guide to the restoration of nutrient-enriched shallow lakes. Broads Authority Norwich, England).
