East Alaska Lake, Wisconsin

The Path to a Successful Lake Restoration

Beginning the Process with Baseline Studies and Creating a Management Plan

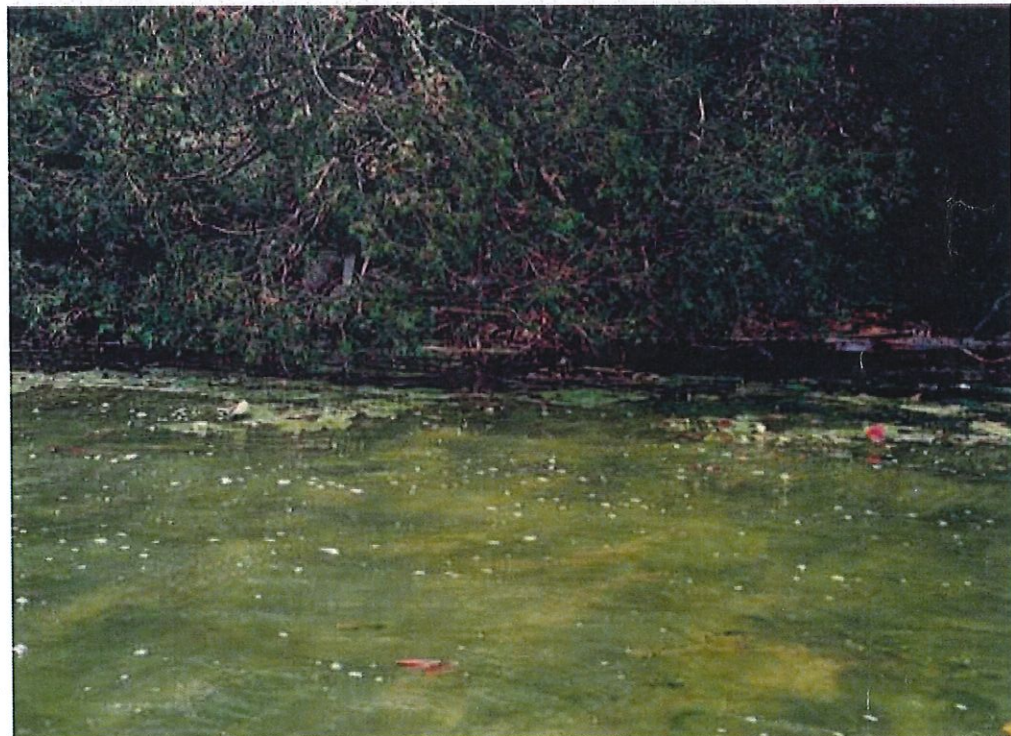
Figure 1. Algae bloom on East Alaska Lake. Photo by Patrick Robinson.

The studies associated with that first planning project confirmed the concerns over poor water quality raised by East Alaska Lake stakeholders, including eutrophic conditions brought on by high nutrient levels that resulted in frequent pelagic and filamentous algae blooms (Figure 1). Documentation of the lake's poor water quality conditions continued into the 2000s with summer phosphorus levels often exceeding 0.030 mg/L, which is higher than the median value of 0.017 mg/L for deep, headwater drainage lakes in Wisconsin (WDNR 2009).

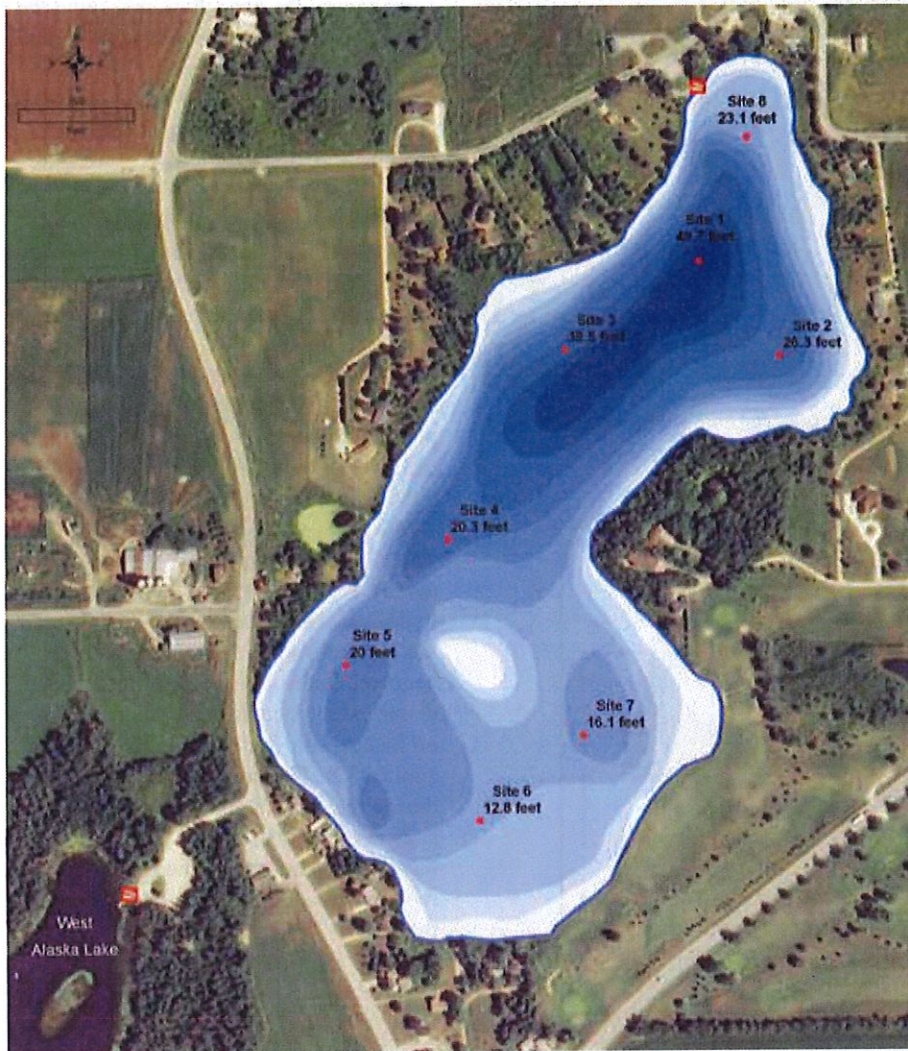
Figure 2. Sediment coring sites at East Alaska Lake. The results of the phosphorus fraction analysis on the core samples lead to the determination of the alum dose used to restore the lake.

During the summer of 2010, Wisconsin Department of Natural Resource (WDNR) researchers extracted sediment cores from eight locations within East Alaska Lake (Figure 2). The sediment cores were delivered to Bill James of the U.S. Army Corps of Engineers Eau Galle Aquatic Ecology Laboratory in Spring Valley, Wisconsin and were analyzed for different fractions of sediment phosphorus. The core analysis results indicated that under anaerobic conditions, all of the sites released phosphorus to the overlaying water with the rates ranging from 0.7-11.5 mg/m²-day. The sediments from the northern basin had the greatest release rates, yet the sites in the southern basin also exhibited significant release. The alum treatment would target two fractions of phosphorus found within the sediment: loose-P, and Fe-P. Loose-P is essentially phosphorus that is loosely bound to other chemicals or particulate matter. Fe-P is iron-bound phosphorus. Together, these two phosphorus fractions are considered Redox-P, or the phosphorus fraction that is susceptible to being released from the sediment into overlaying waters during anoxia.

Based upon the sediment core analysis, the application plan was to dose the areas of the lake with depths equal to and greater than 10 feet (33.0 acres) at a rate of 132 g/m² Al. Following advice provided by Sweetwater Technologies, the contractor chosen to complete the alum application, the treatment area was expanded to include the bottom area between the depths of 5-10 feet (7.6

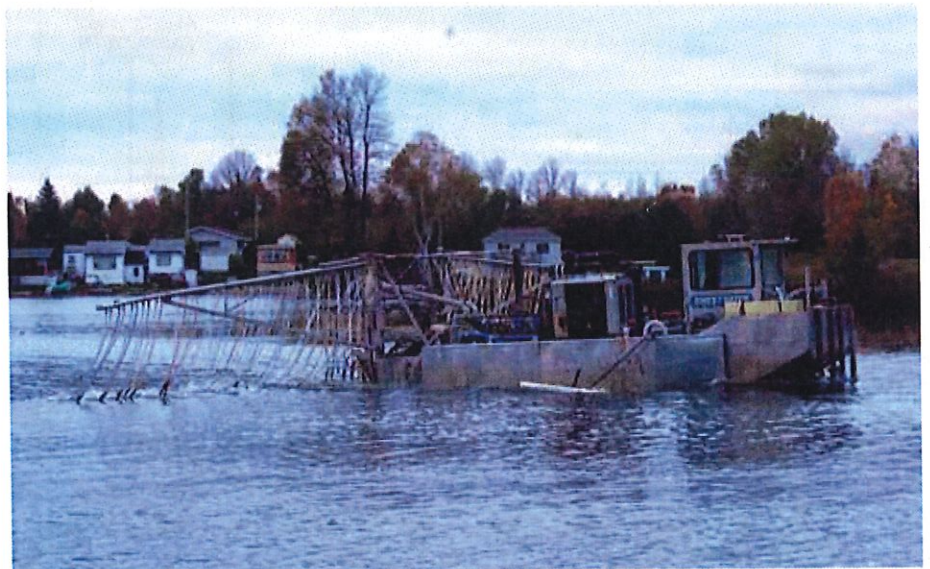
Figure 3. Barge applying alum to East Alaska Lake during October 2011.

After 20-plus years of study and planning, the East Alaska Lake alum treatment was implemented in mid-October 2011 and included the application of nearly 84,000 gallons of aluminum sulfate over a two-day period (Figure 3). It is quite a spectacle to have a 24-foot stainless steel barge with a 60-foot boom span sweep back and forth across a 53-acre lake. Add in a constant convoy of tanker trucks bringing aluminum sulfate to the lake's small landing and the characteristic milky turquoise appearance of the lake water during application (Figure 4) and you have something people are likely to go out of their way to see.

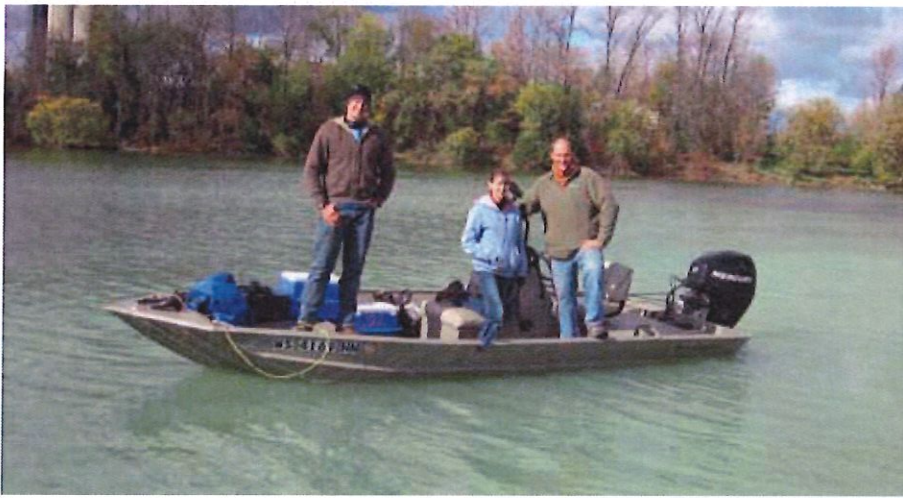
Figure 4. Treatment monitoring crew on East Alaska Lake. Notice the milky turquoise water resulting from the alum treatment occurring that day.

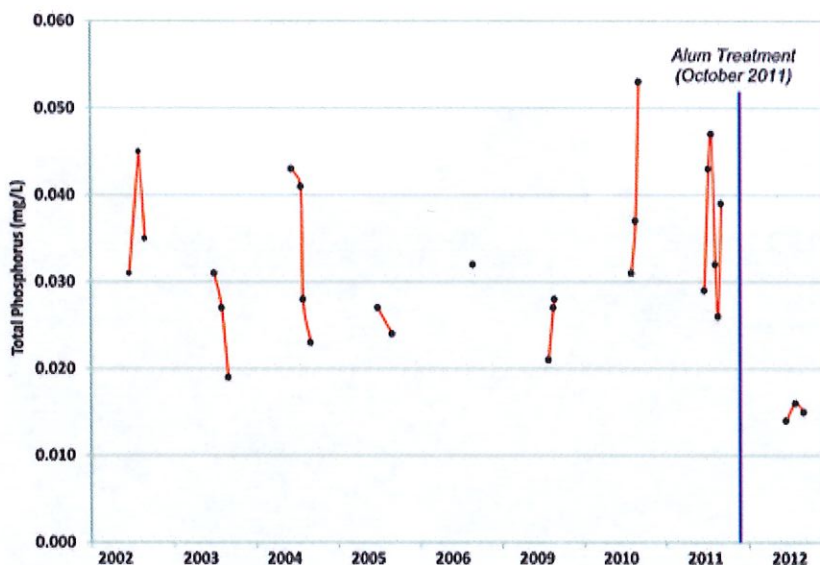
Figure 6. East Alaska Lake summer (June, July, and August) near-surface total phosphorus concentrations from 2002-2012. The alum treatment occurred during October 2011.

A single growing season's data have been collected at East Alaska Lake post alum treatment. Casual observations throughout the summer were positive as no filamentous algae was noted and near surface total phosphorus values were lower than previously measured (Figure 6). During early fall 2012, a core was extracted from the deep hole where the full dose rate of 132 g/m² was applied, a distinct layer was found near the surface of the sediment, indicating a substantial barrier to sediment phosphorus flux had been created (Figure 7). A phosphorus profile collected during the same October visit is also strong evidence of the success of the treatment, especially when compared to profiles collected the two previous years (Figure 8). During the two years prior to the treatment, total phosphorus concentrations in the anoxic hypolimnion ranged from 0.1 to 1.24 mg/L, while the post treatment samples spanned from 0.040 to 0.088 mg/L.

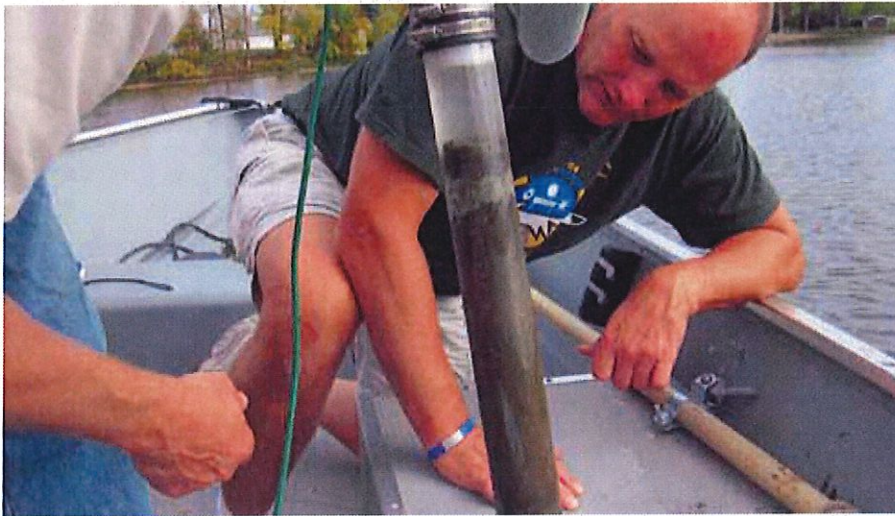
Figure 7. Bottom core extracted from the deepest location in East Alaska Lake approximately one year after the alum treatment. The white section is the alum layer that has settled approximately two inches into the soft bottom sediments.

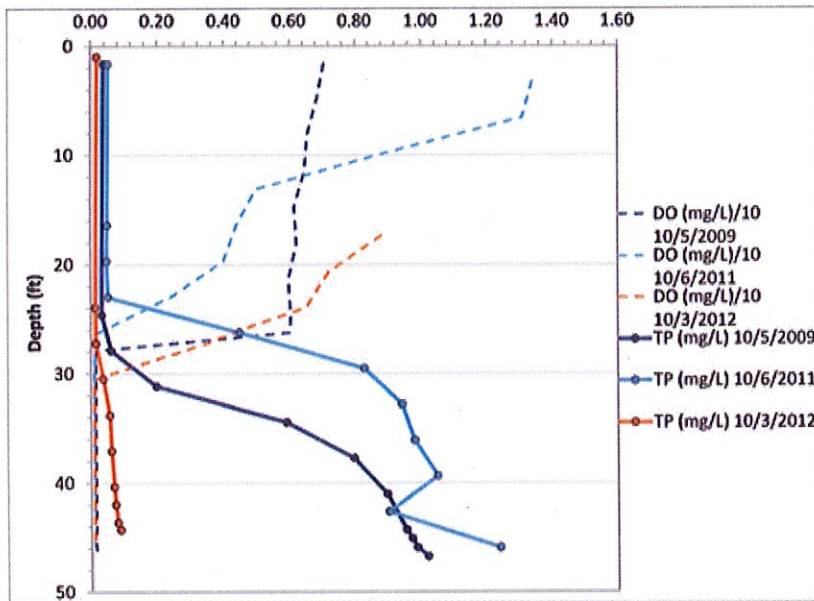
Figure 8. Total phosphorus and dissolved oxygen profile results from October 2010, 2011, and 2012. The alum treatment occurred after the October 2011 samples were collected.
