SAND LAKE, BARRON COUNTY

2018 AQUATIC PLANT MANAGEMENT
SUMMARY REPORT
WDNR WBIC: 2661100

Prepared by: Dave Blumer, Lake Educator

June 25, 2019

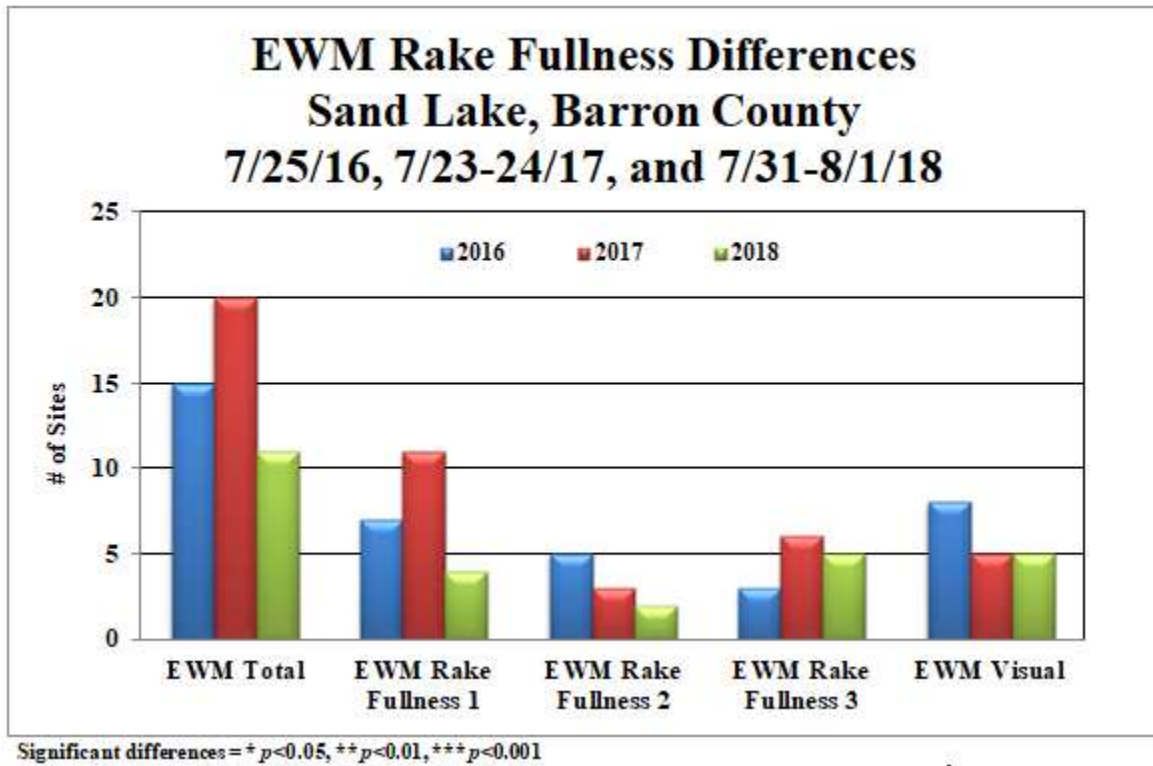
Figure 1: Comparison of EWM Density and significant changes from 2016, 2017, and 2018 (Berg, 2018)

In 2018, EWM was present at 11 points (2.32% of points with vegetation) and totaled just 0.59 of the total relative frequency. Five points rated a rake fullness of 3, two points a 2, and four points a 1 for a mean rake of 2.09. EWM was again recorded as a visual at five additional points. Similar to the changes noted in 2017, neither the increase in density nor the decline in distribution was significant (Figure 1).

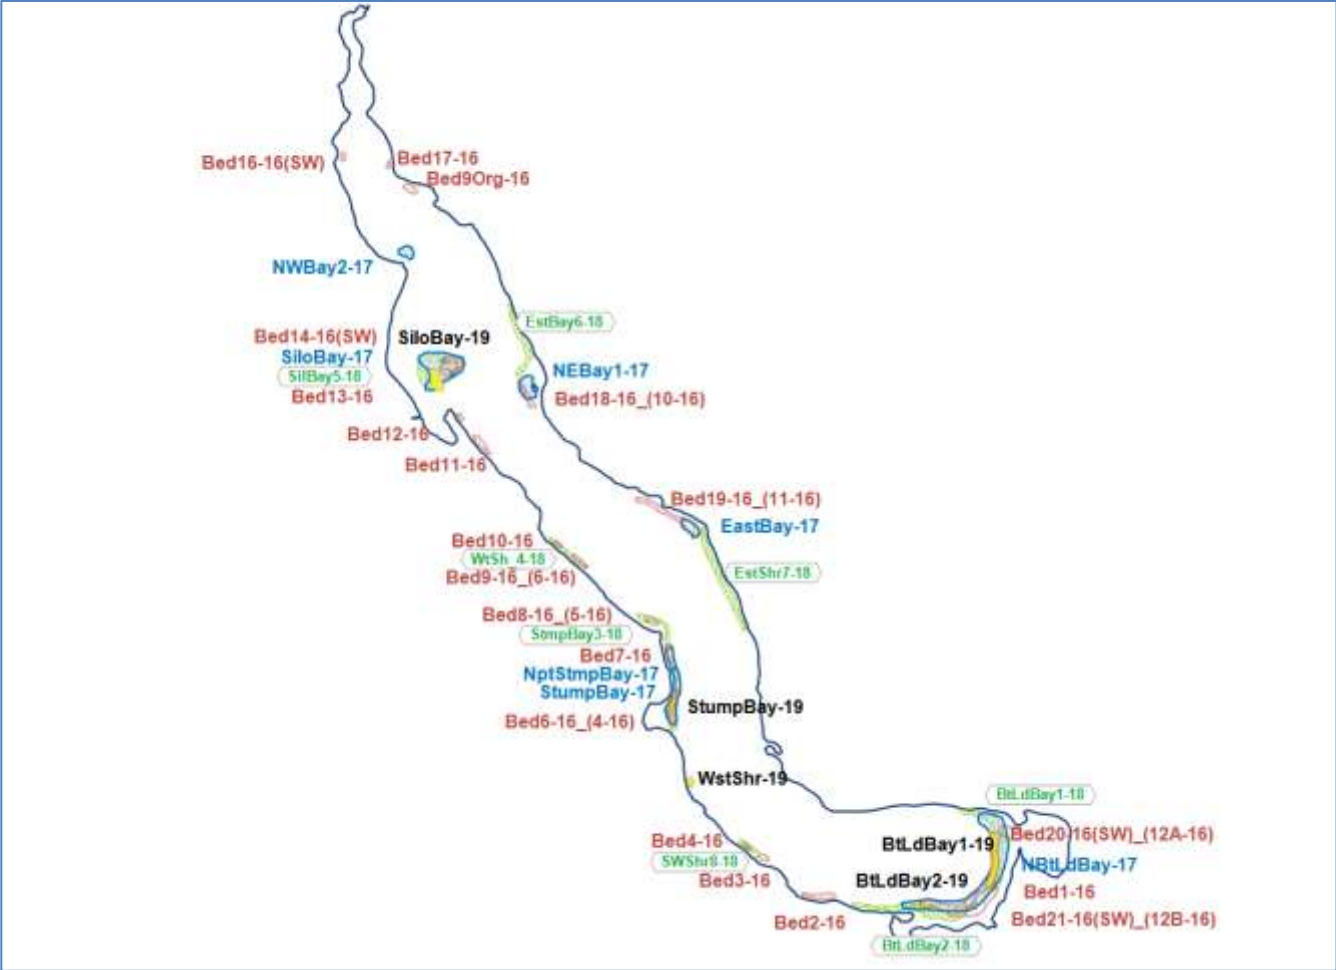
Figure 4: 2016, 2017, 2018, and 2019 chemical treatment areas

That said, EWM continues to be difficult to manage along the deep water edges of the littoral zone. It is these areas that are basically being treated every year (Figure 4).

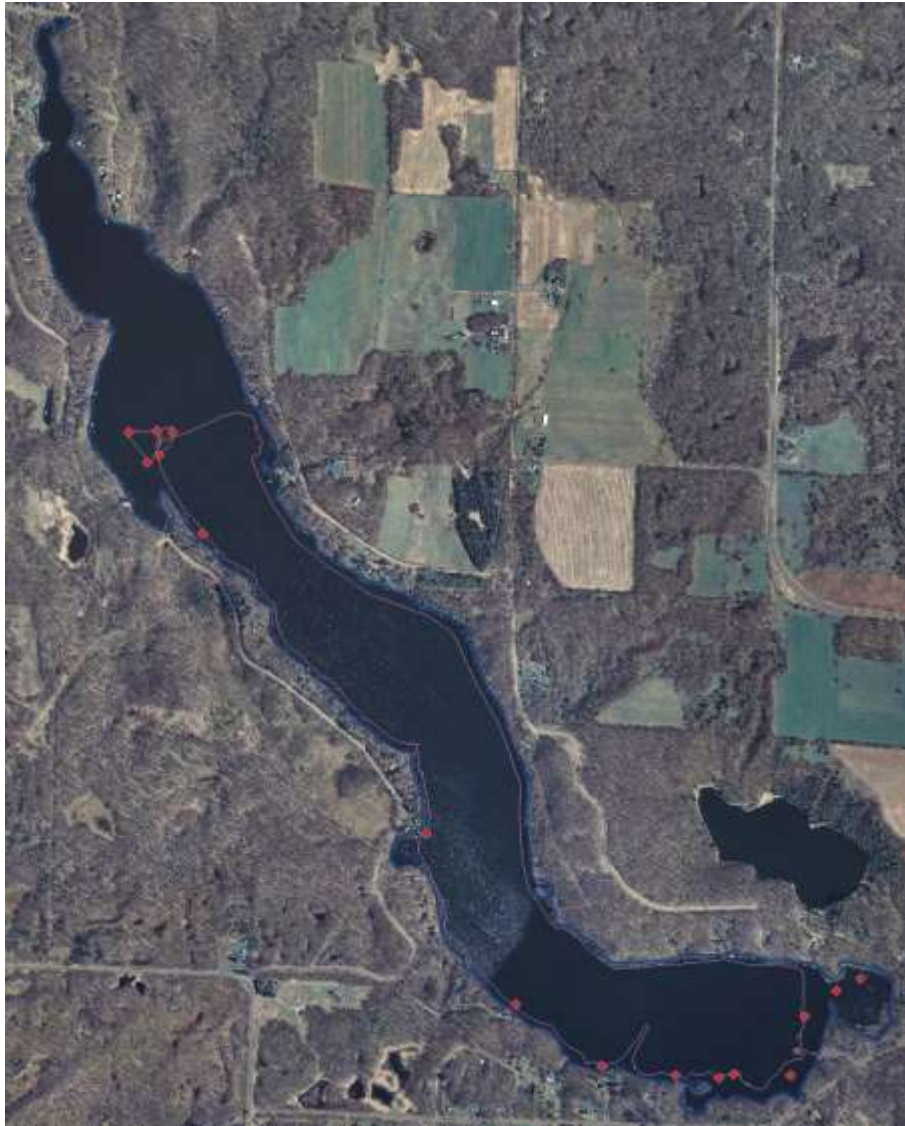
Figure 14: 2018 fall EWM meandering survey results (red dots =fall meandering survey points with EWM)

In the fall of 2018, LEAPS completed an informal meandering visual survey of EWM in Sand Lake. EWM was found at only a few locations and then only as individual plants or small concentrations of plants (Figure 14). This is substantially different than what was found in the fall of 2017 when EWM was well distributed and definitely bed forming. It has been anecdotally and formally documented that the amount of EWM through the summer of 2018 was nearly non-existent. Unfortunately, northern watermilfoil experienced a similar fate in 2018.
