2017 Aquatic Plant Survey Report

Lake Redstone Bays

Cardinal, South Chickadee, Eagle, Hummingbird, Killdeer
Martin-Meadowlark, Mockingbird, Mourning Dove,
Oriole, Quail, Swallow, Warbler, & Woodpecker
Sauk County, Wisconsin

Survey and report completed by:
Aquatic Plant & Habitat Services, LLC
Sara Hatleli
N4888 Beck Rd. Taylor, WI 54659
715-299-4604, Sarahatleli97@gmail.com

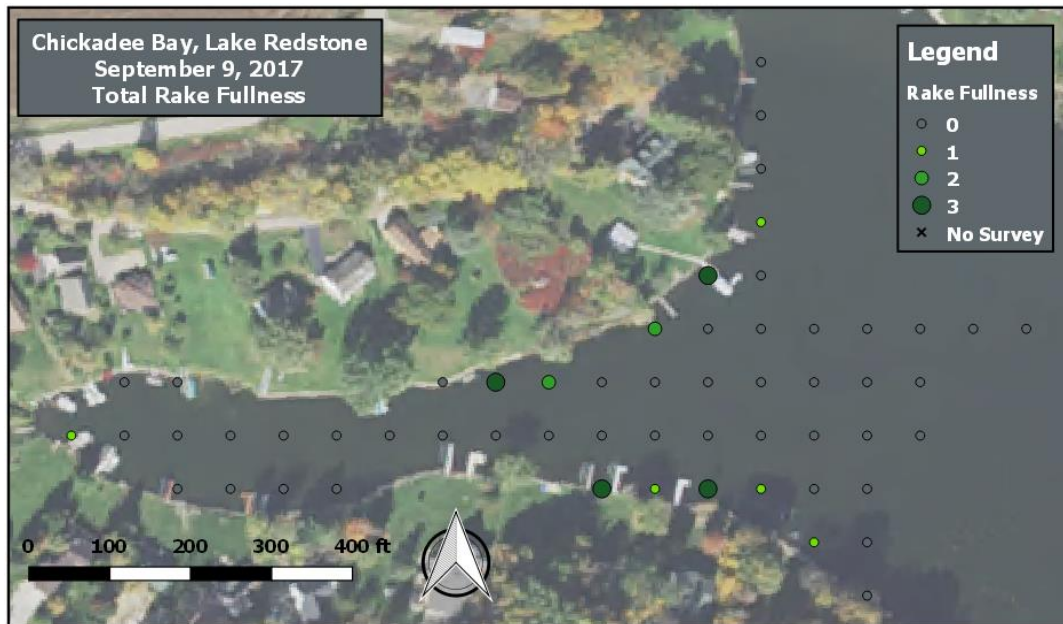
Figure 4 – South Chickadee Bay Total Rake Fullness Map

There were 56 points surveyed in South Chickadee Bay in 2017, 36 of which were the same depth or shallower than the maximum rooting depth of 5.5 feet. Only 11 sites had vegetation with an average number of 1.73 species found per site and the average rake fullness of 1.91 (Table 3). A total of 4 species of aquatic plants were found, one of which was “visual only” (i.e., within 6 feet of the survey point but not found on the rake). Filamentous algae is not counted as one of the 4 species. Eurasian watermilfoil and coontail were the most common species found at 28% and 22% of littoral survey points respectively (11% and 21% in 2016). Together they accounted for 95% of the total relative frequency (69% in 2016), indicating a highly homogeneous plant community in the bay (Table 5). Chi-square tests of all plant species revealed a statistically significant increase in Eurasian watermilfoil when compared to 2016. There were not statistically significant changes between the 2015 and 2017 data. Maps of plant species can be found in Appendix B. The Simpson Diversity Index for South Chickadee Bay was the much lower at 0.54 compared to 0.71 in 2016. The FQI only factors species raked at survey points and does not include visuals or aquatic invasive species. Therefore, 2 species were included in the calculation, yielding a low floristic quality of 4.2 and low average C value of 3 (Table 4).

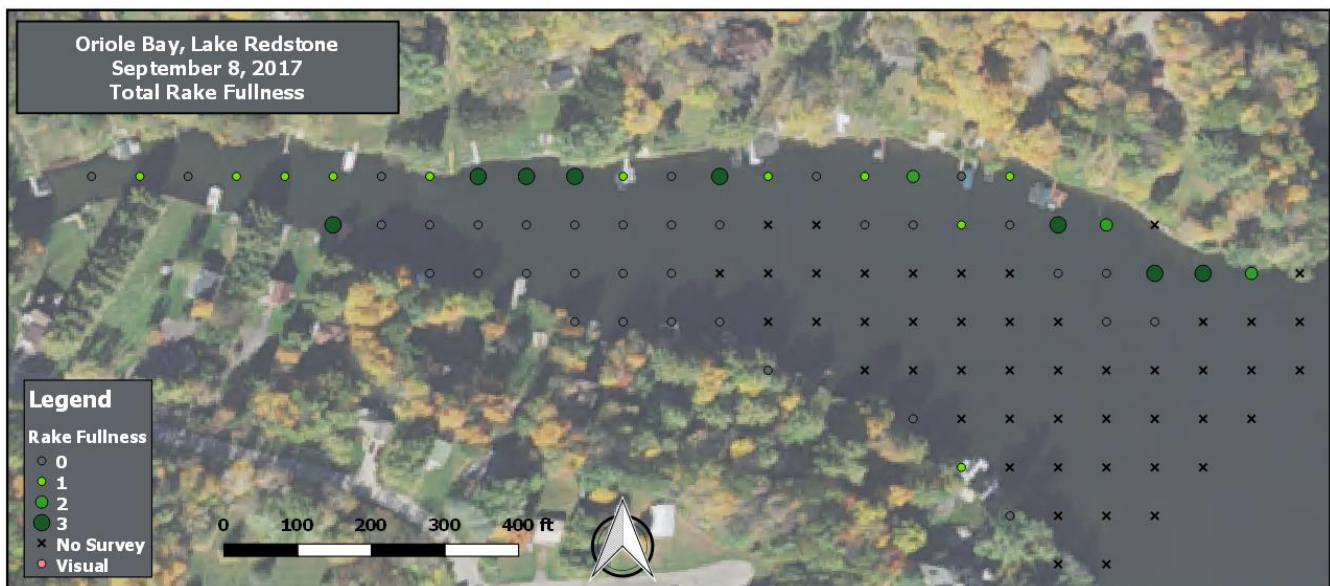
Figure 11 – Oriole Bay Total Rake Fullness Map

A total of 104 predetermined survey waypoints were attempted in Oriole Bay, 56 of which were actually surveyed because 48 points were deeper than 12 feet. The maximum rooting depth was 9.5 feet in Oriole Bay. There were 46 survey points ≤ 9.5 feet deep and 22 sites had vegetation. The average number of species found at the 28 sites with vegetation was 1.59 and the average rake fullness was 1.86 (Table 3). A total of 6 species of aquatic plants were found, one of which was “visual only” and not including filamentous algae. Coontail and Eurasian watermilfoil were the most common species found at 43% (45% in 2016) and 24% (14% in 2016) of littoral survey point, respectively. Together they accounted for 89% of the total relative frequency (65% in 2016), indicating the plant community in Oriole Bay is highly homogeneous (Table 6). Chi-square tests of all plant species revealed a statistically significant decrease in sago pondweed when compared to 2016 data. There were no statistically significant changes between the 2015 and 2017 data sets. All chi-square test results are in Appendix N. Maps of plant species can be found in Appendix I. The Simpson Diversity Index for Oriole Bay was 0.57 on a scale from 0 to 1. The FQI does not include aquatic invasive species. Therefore, 4 species were included in the calculation, yielding a floristic quality of 11.5 with an average C value of 5.8 (Table 4).

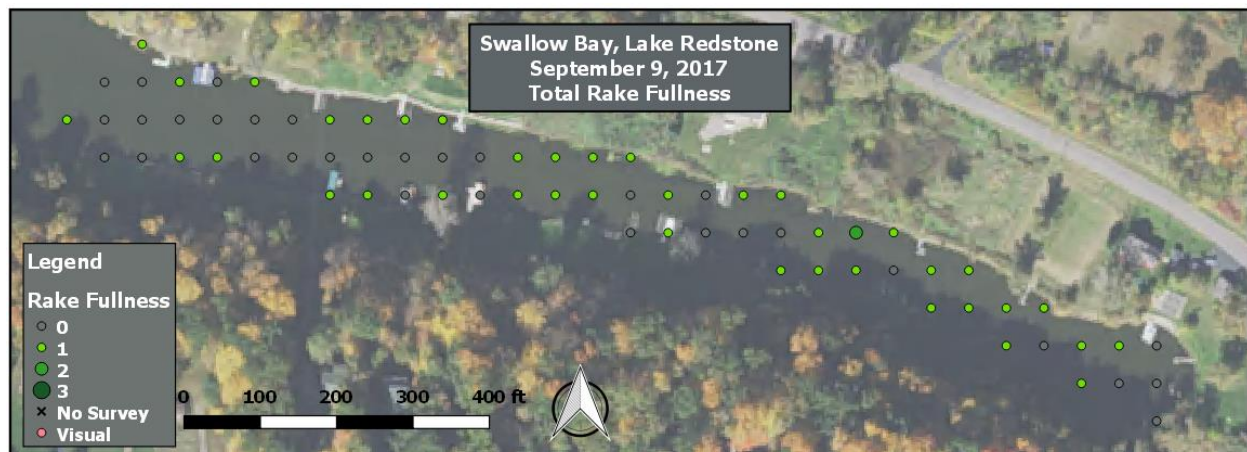
Figure 13 – Swallow Bay Total Rake Fullness Map

In Swallow Bay all 72 points were surveyed, 66 were shallower than the maximum rooting depth of 4 feet and 40 sites had vegetation. The average number of species found at vegetated sites was 2.15 and the average rake fullness was 1.03 (Table 3). A total of 8 species of aquatic plants were found in Swallow Bay, not including filamentous algae. White water lily and coontail were the most common species found at 36% and 33% of littoral survey points respectively (29% and 58% in 2016). Together they accounted for 53% of the total relative frequency indicating the plant community of Swallow Bay is somewhat heterogeneous (Table 7). Chi-square tests of all plant species revealed a statistically significant increase in small duckweed and Eurasian watermilfoil and a decrease in coontail when compared to 2016 data. Chi-square test of the 2014 data compared to 2017 revealed a statistically significant increase in small duckweed and decrease in coontail and filamentous algae (Appendix N). Maps of plant species can be found in Appendix K. The Simpson Diversity Index for Swallow Bay was 0.78 on a scale from 0 to 1. The FQI only factors species raked at survey points and does not include aquatic invasive species. Therefore, 6 species were included in the calculation, yielding a floristic quality of 13.1 with an average C value of 5.3 (Table 4).

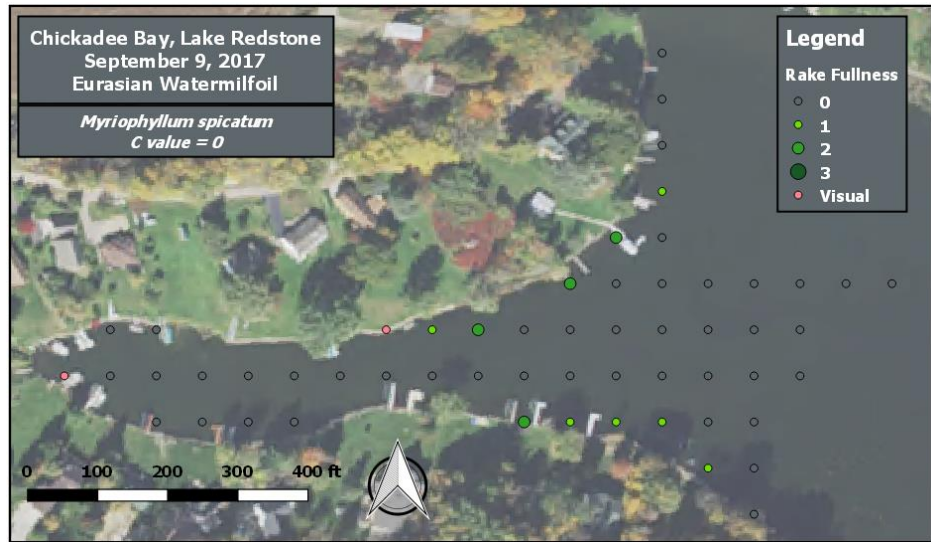
Figure 17– South Chickadee Bay EWM Map

EWM was the most common aquatic plant in 2017 and was found at 10 sites with rake fullness values of “2” at 4 of those sites. There were another two visual observations in the bay. There were only 3 sites total in 2016. EWM littoral frequency was 28% in 2017 and 11% in 2016 (Table 3). Herbicides were applied to the southern arm of Chickadee Bay in

spring of 2016 to combat EWM. A chi-square test of EWM presence in 2016 compared to 2017 revealed a statistically significant increase between the years. No statistically significant difference was detected between 2015 and 2016 nor was there a statistically significant difference between 2015 and 2017.

Only the south arm of Chickadee Bay was treated with herbicide for EWM control in spring 2016, so the post-treatment survey in 2016 and 2017 focused on this area only. The decrease of EWM from 6 sites (+1 visual) in 2015 to 3 sites (+0 visual) in 2016 was not statistically significant. The increase of EWM from 2016 to 2017 *was* statistically significant. However, much of the EWM was found concentrated near shore in relatively small patches that could be addressed using manual/mechanical means. Furthermore, the littoral frequency of EWM was 28% (below the 40% trigger, see above). Hand pulling

EWM in areas of higher abundance and close monitoring are recommended for 2018. South Chickadee is a designated sensitive area.

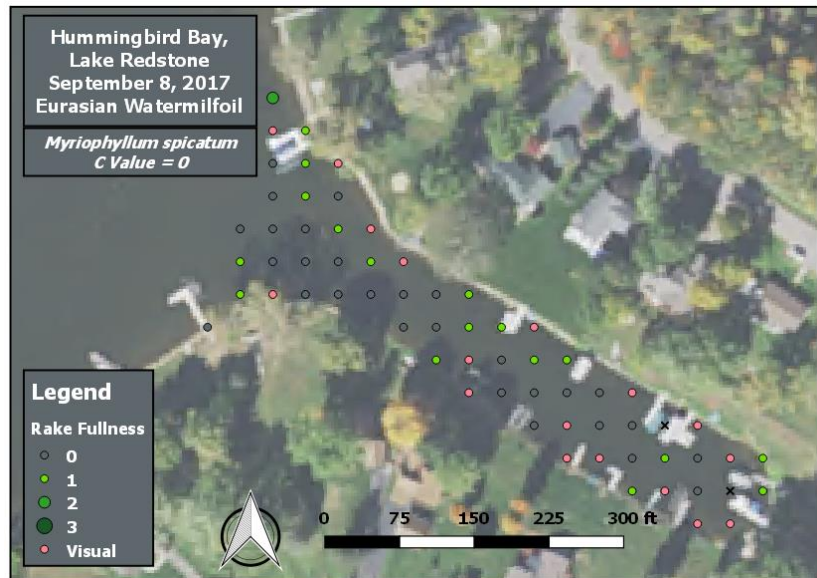
Figure 19 - Hummingbird Bay EWM Map

EWM was found at 18 survey points and another 17 visual observations (21 sites and 3 visual in 2016), making it the second most common plant species distributed throughout Hummingbird Bay. One site had a total rake fullness of “2.” EWM littoral frequency was 29% in 2017 and 36% in 2016. Herbicide treatment was conducted in Hummingbird Bay in spring 2017. There was no statistically significant difference in EWM between 2016 and 2017.

Herbicide treatment using 2,4-D occurred in Hummingbird Bay in early spring 2017 resulting in a decrease of EWM at survey sites in 2017 (18 sites + 17 visual) compared to 2016 (21 sites + 3 visual) but the decrease was not statistically significant. In addition, the littoral frequency of EWM was 29% in 2017 (below the 40% trigger, see above). No active management (continue to monitor), manual or mechanical removal of EWM is recommended for 2018. Hummingbird Bay is not a designated sensitive area.

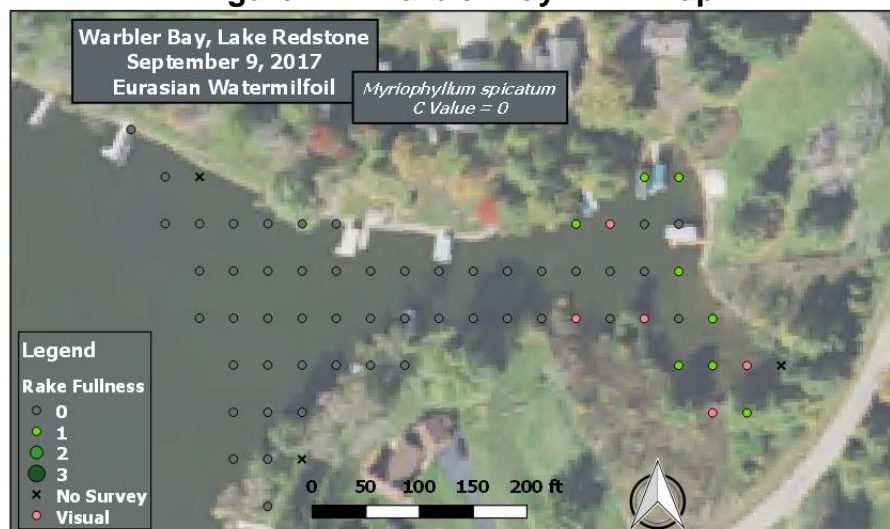
Figure 27 - Warbler Bay EWM Map

EWM was the most common plant with occurrence at 8 sites and visual observation at another 5 points. Plant occurrence was low overall with vegetation at only 9 sites. No herbicide treatment has occurred in Warbler Bay. Relative frequency of EWM was high at 57% and littoral frequency was 44%.

This was the first year of surveying for Warbler Bay and no herbicide treatment has been done. The bay had very little vegetation with aquatic plants at only 9 sites and only 18 sites were shallower than the maximum rooting depth of 3 feet (62 sites total visited). EWM was found 8 sites + 5 visual observations. The littoral frequency of EWM was 44%, but that value should be considered artificially high because there were so few littoral sites in the bay (18) and a shallow maximum rooting depth of only 3 feet compared to other bays. Due to the low EWM occurrence overall, herbicide treatment is not recommended for 2018. No active management (continue to monitor), manual or mechanical removal of EWM is recommended for 2018. Warbler Bay is not a designated sensitive area.

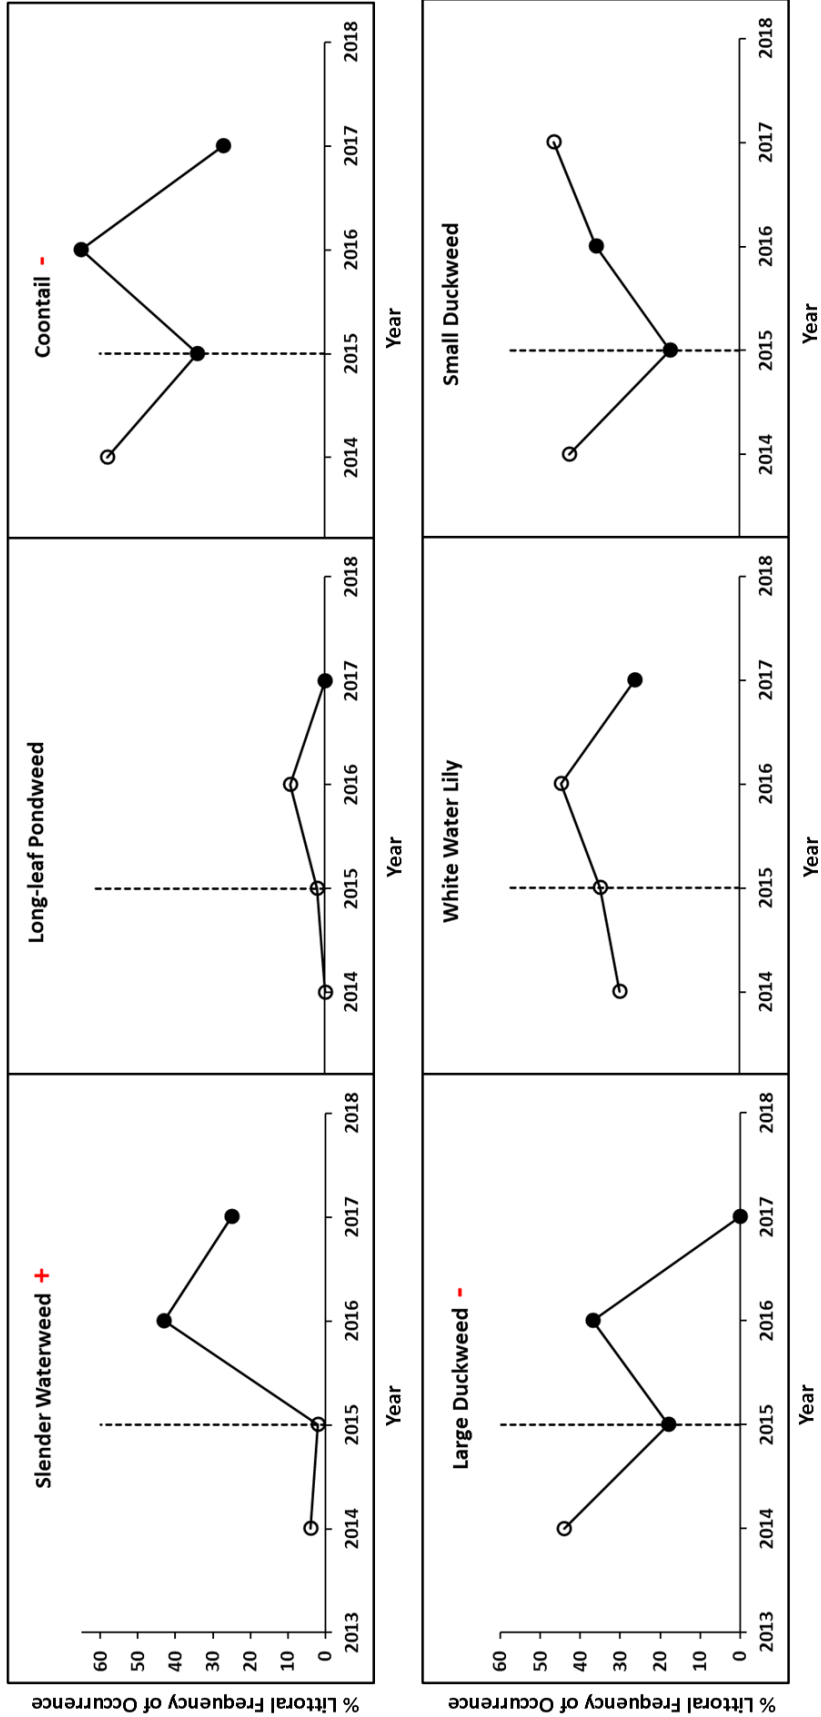
Martin-Meadowlark Bay 2014-2017

Percent littoral frequency (# sites plants found at points shallower than maximum rooting depth) is on the y-axis and each year a plant survey was completed is on the x-axis. Only species with a statistically significant change (using Chi-square tests) for at least one of the years are displayed. The dashed vertical lines represent years when herbicide treatments were done. Open circles represent no statistically significant change, solid circles represent a statistically significant change. Statistically significant changes between the first year of surveying and 2017 data are represented by + or – adjacent to plant names.
