LAKE REDSTONE, SAUK COUNTY

2017-18 AQUATIC PLANT MANAGEMENT
SUMMARY REPORT
WDNR WBIC: 1280400

Prepared by: Dave Blumer, Lake Educator

January 7, 2019

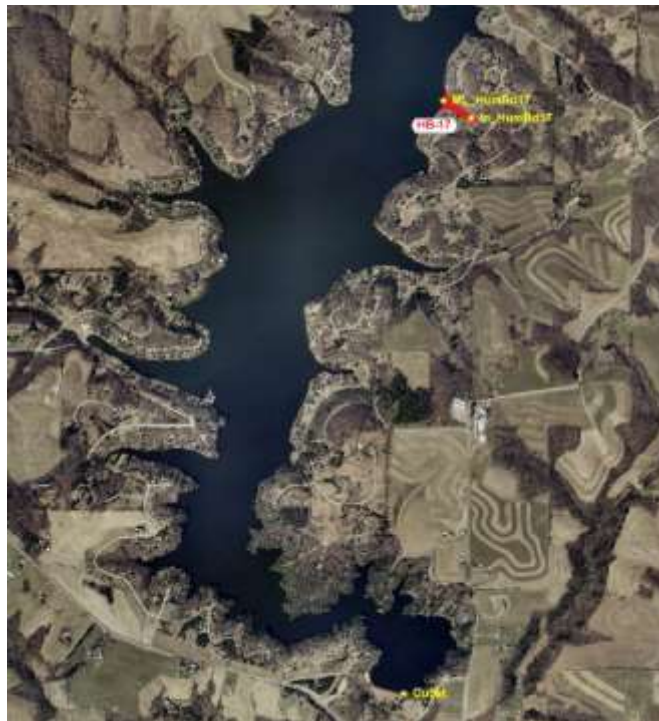
Figure 2 - Chemical Concentration Testing Sites in Hummingbird Bay and the Outlet of Lake Redstone

Following the 2017 early season herbicide application volunteers from the LRPD collected chemical concentration data for 2,4-D from two sites in Hummingbird Bay and at the outlet of Lake Redstone (Figure 2). No herbicide concentration testing was completed in the areas treated with diquat in Woodpecker Bay because the Wisconsin State Lab of Hygiene does not have the capability to run assays for diquat. Each site was sampled at seven different times after treatment: 3, 6, 9, 24, 36, 48 and 72 HAT (Hours After Treatment). Chemical concentration testing is used to determine the concentration reached in the treated areas and to determine how long the herbicide remains in contact with the target plant. In the 2017 early season treatment, the target concentration in Hummingbird Bay was 2000 ppb or 2.0 mg/l.

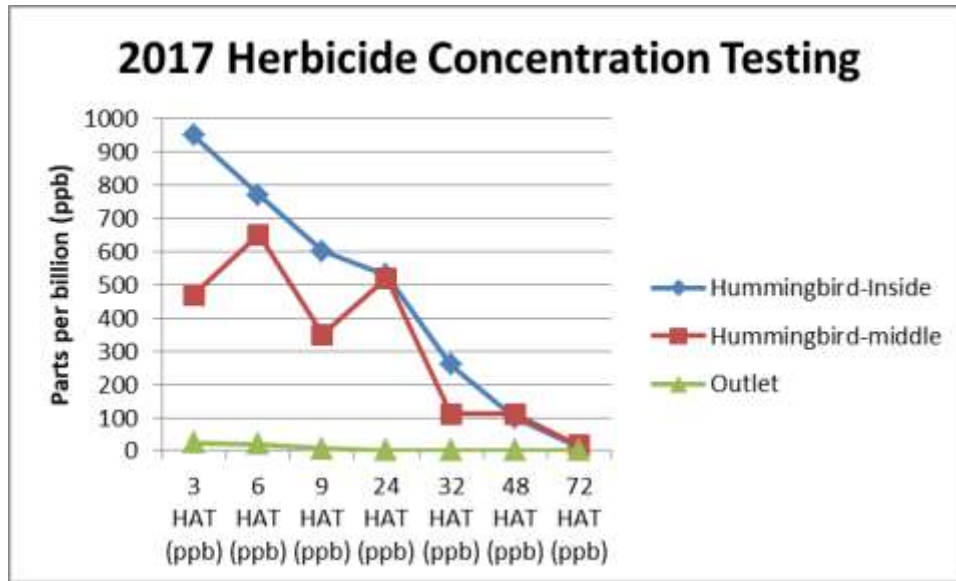
Figure 3 - 2017 Lake Redstone Concentration Testing Results

The concentration of herbicide in Hummingbird Bay never reached the target concentration of 2000 ppb. At 3 HAT, the concentration in the inland site of the Bay reached nearly 1000 ppb but it steadily declined after that (Figure 3, Table 2). The herbicide did stick around for 24 HAT at about 1/4 the expected concentration. The middle site in the bay showed a concentration of only a 1/3 of the expected dose at its highest point. At the outlet of the lake, very low levels of 2,4-D were documented in the first day, but by 24 HAT, it was not detected at all.

The results of 2017 herbicide concentration testing suggest that a higher concentration of herbicide containing 2,4-D was needed to reach the target 2000 ppb, and keep it at that level for at least 24 hours. Hummingbird Bay is a very small bay (less than 1.5 acres) and it appears that the herbicide applied left the bay shortly after being applied. Given the size of the bay and the amount of herbicide used during the treatment, once the herbicide left the bay, it dissipated rather quickly, although it did reach the outlet, albeit, at a very low concentration.

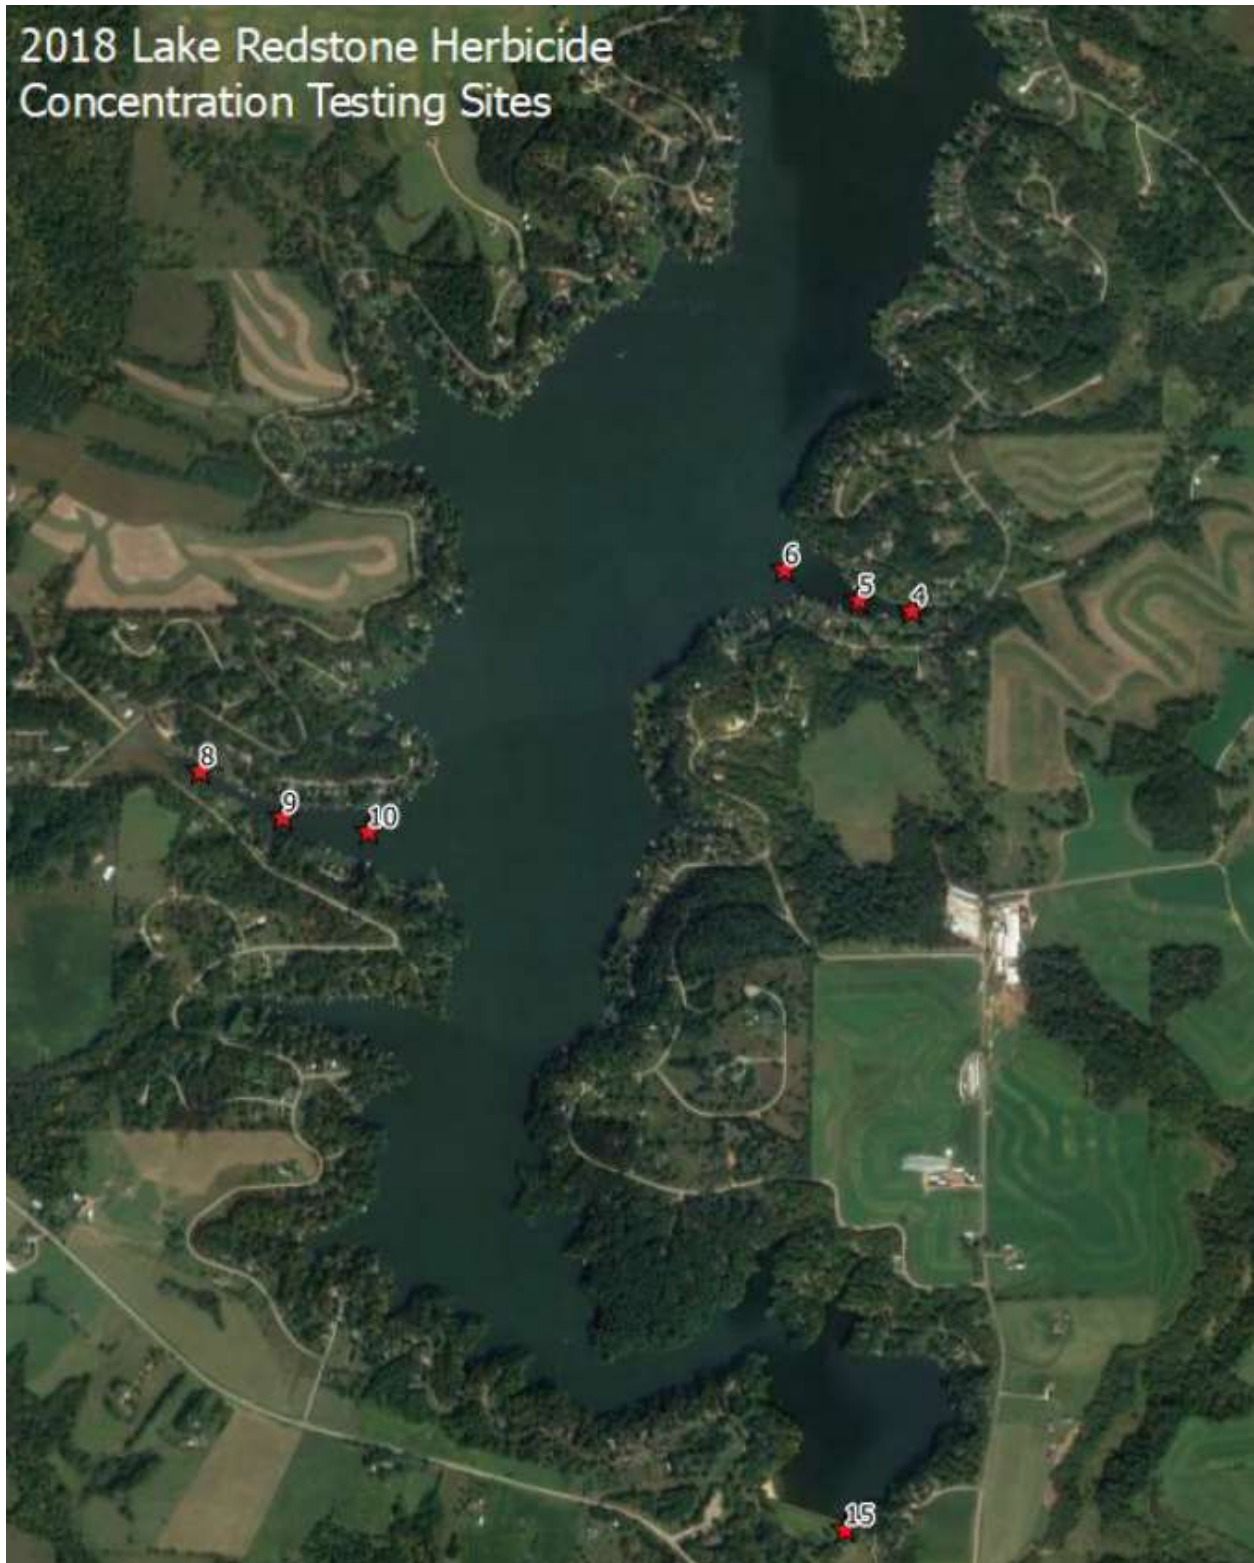
Figure 11 - Chemical Concentration Testing Sites in Eagle (4-6) and Mourning Dove (8-10) Bays, and at the Outlet of Lake Redstone (15)

2018 Lake Redstone Chemical Concentration Monitoring Planning 5-2-2018 (LEAPS)				
Location	SITE_NAME	Station Name	Station ID	WBIC
Eagle (site 4 on map)	Eagle Bay In	Lake Redstone - Eagle Bay In (Site 1)	10051038	1280400
Eagle (site 5 on map)	Eagle Bay Middle	Lake Redstone - Eagle Bay Middle (Site 2)	10051039	1280400
Eagle (site 6 on map)	Eagle Bay Out	Lake Redstone - Eagle Bay Out (Site 3)	10051040	1280400
Mourning Dove (site 8 on map)	MourDove In	Lake Redstone - Mourning Dove Bay In (Site 1)	10051041	1280400
Mourning Dove (site 9 on map)	MourDove Middle	Lake Redstone - Mourning Dove Bay Middle (Site 2)	10051042	1280400
Mourning Dove (site 10 on map)	MourDove Out	Lake Redstone - Mourning Dove Bay Out (Site 3)	10051043	1280400
Outlet/Spillway (site 15 on map)	Outlet_18	Big Creek - Below Dam	573127	1280200

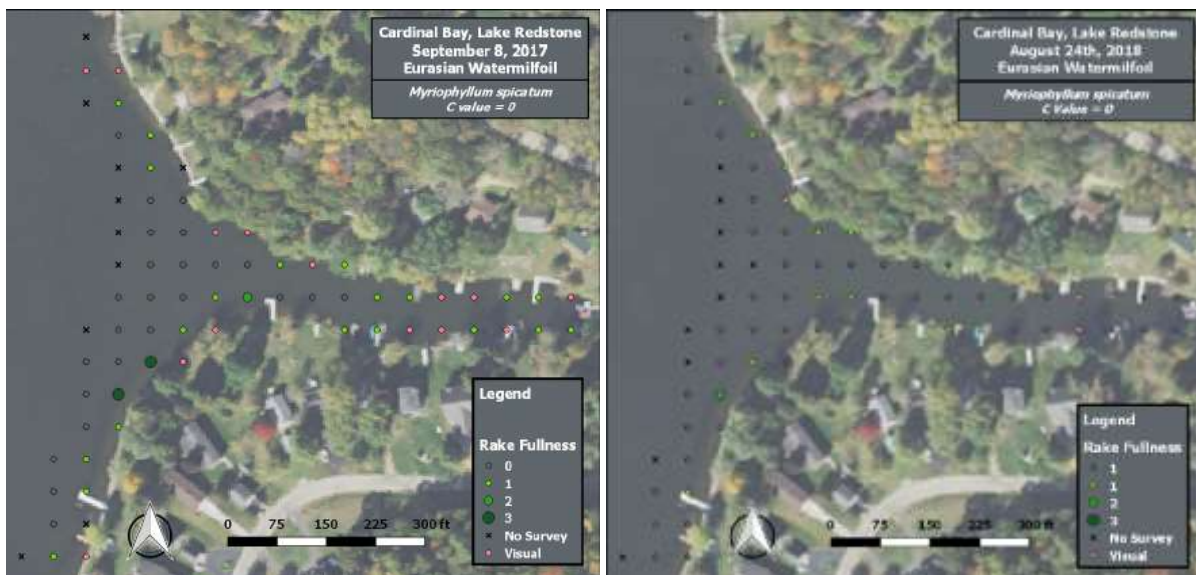
Figure 14 – 2017 & 2018 Summer PI EWM Results, Cardinal Bay (APHS, 2017 & 2018)

These results were welcomed given that chemical treatment of EWM in Cardinal Bay in 2016 using diquat was for the most part ineffectual. It was theorized that the failure of the 2016 EWM treatment was due to just the outer portions of the bay nearest the main body of the lake being chemically treated. In 2018, the entire bay was chemically treated, not just the outer most edges. Comparing EWM numbers across the four years the bay has been surveyed and the two years it has been treated shows the decline in EWM brought about in 2018 (Table 20).

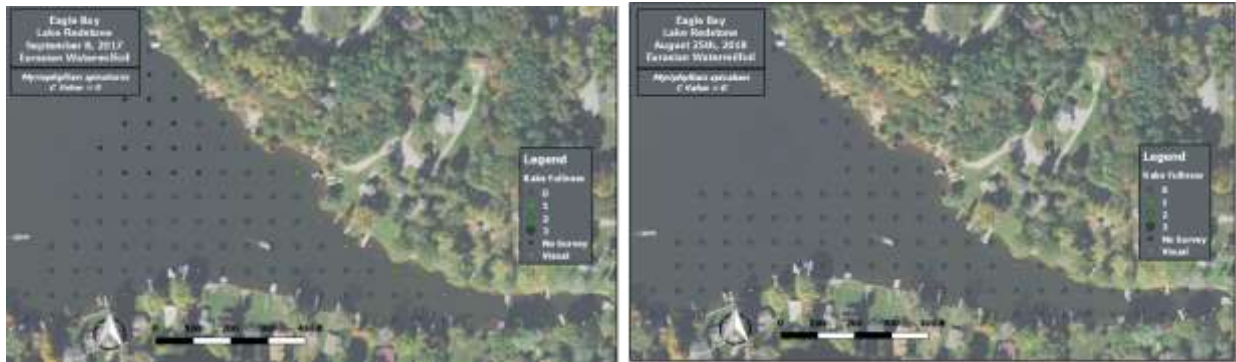
Figure 15 - 2017 & 2018 Summer PI EWM Results, Eagle Bay (APHS, 2017 & 2018)

In 2017 EWM was the most common plant in the bay. In 2018, after chemical treatment it was only the 5th most common plant. In 2018 EWM was only found at 2 survey points and another 8 visual observations (Figure 15). Littoral frequency of EWM was <5% in 2018, 30% in 2017, and 15% in 2014. Herbicide treatment was done in spring 2018 to control EWM. Comparisons between 2017 and 2018 using chi-squared tests reveal a significant decrease in EWM. Comparing EWM numbers across the two years the bay has been surveyed shows the decline in EWM brought about in 2018 (Table 21).

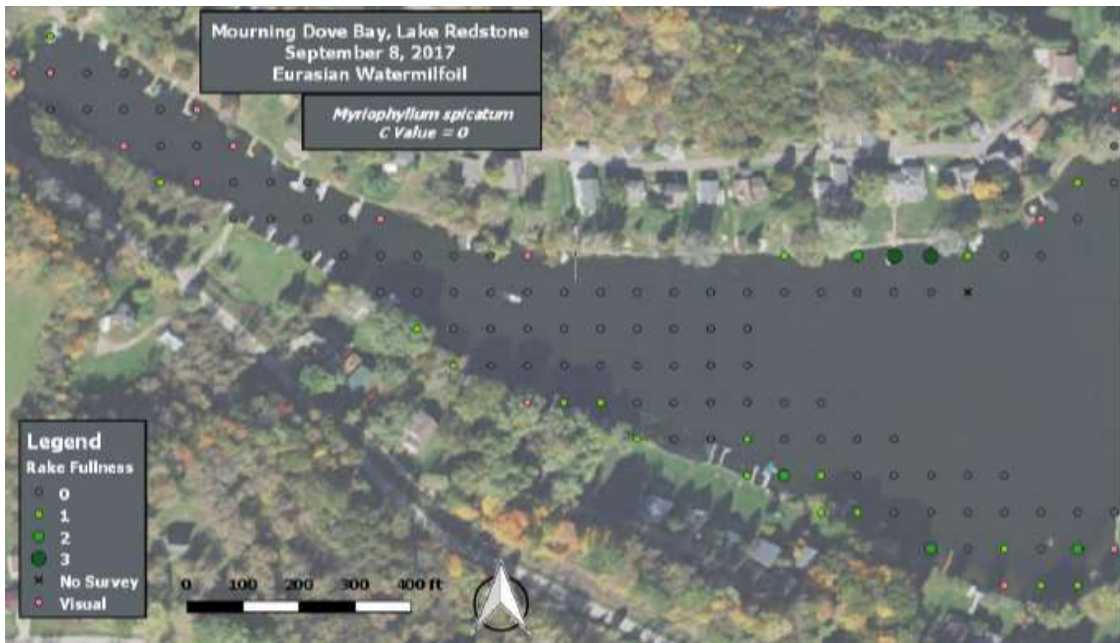
Figure 16 - 2017 & 2018 Summer PI EWM Results, Mourning Dove Bay (APHS, 2017 & 2018)

In 2017, EWM was the 2nd most common plant. In 2018, after chemical treatment it was only the 5th most common plant. In 2018, EWM was found at 2 survey points and another 2 visual observations. Littoral frequency of EWM was 3% in 2018, 31% in 2017 and 17% in 2016. Herbicide treatment occurred in spring 2013 and 2018 to control EWM. There was a significant decrease in EWM occurrence between 2017 and 2018. Comparing EWM numbers across the three years the bay has been surveyed shows the decline in EWM brought about in 2018 (Table 22).

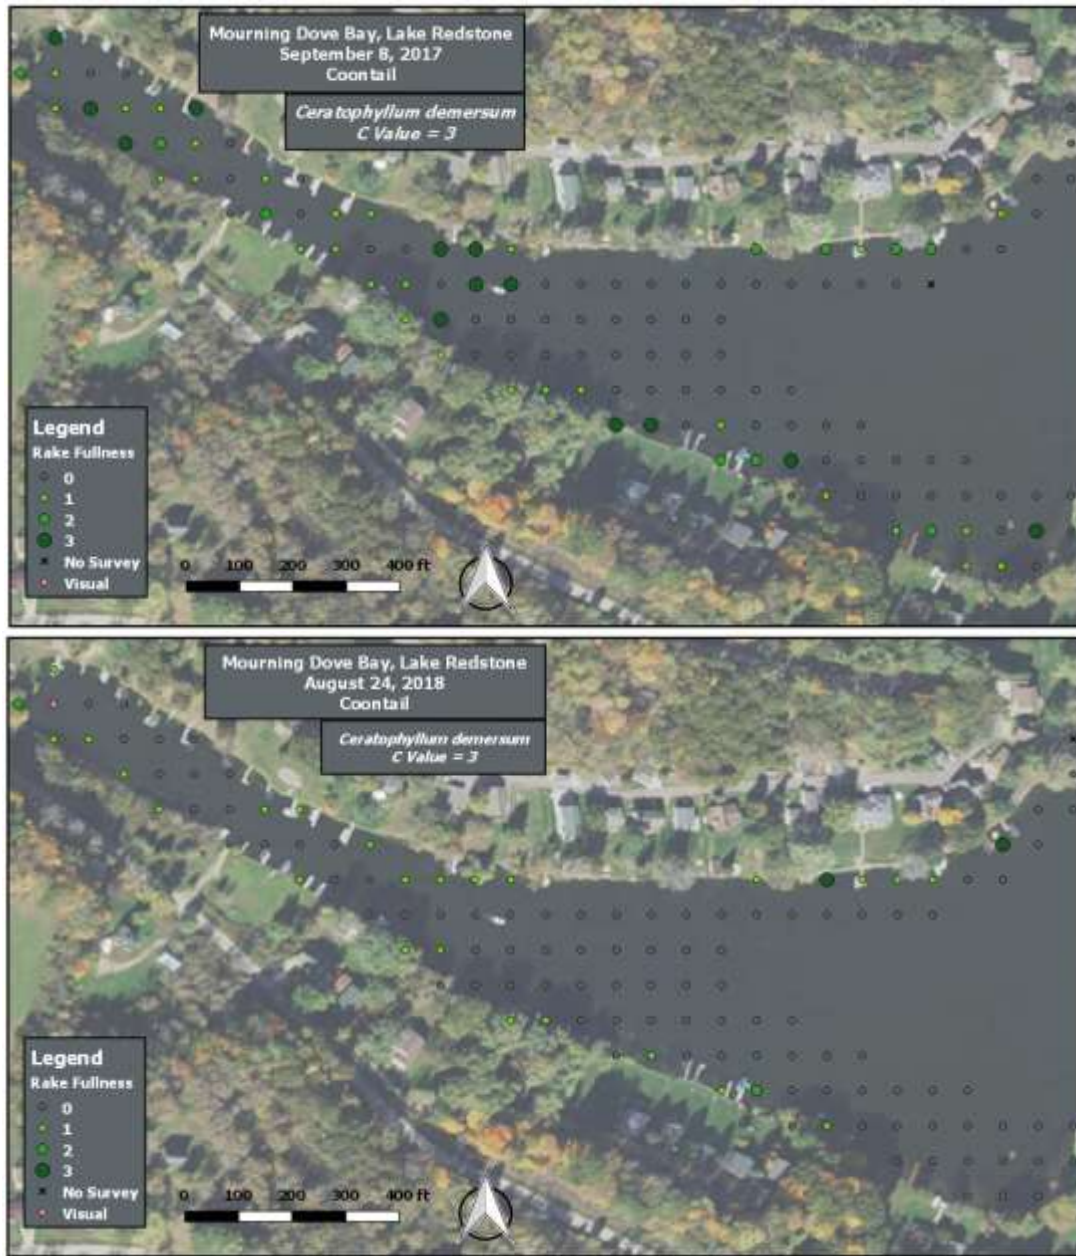
Figure 17 – Changes in Coontail distribution and density in Mourning Dove Bay from 2017 to 2018 after chemical treatment (APHS, 2017 & 2018)

There was a significant decrease in coontail between 2017 and 2018 (Figure 17). While this change in coontail is of note, unless a summer PI survey in 2019 reveals a similar change, it is of not great concern. In both 2017 and 2018, coontail is the most common aquatic plant species in the bay.
