Lundgren Lake

Rapid Response Grant Final Report & Aquatic Invasive Species Management Plan

Chuck Druckrey
Marinette County Land Information Department
Land & Water Conservation Division
December 2019

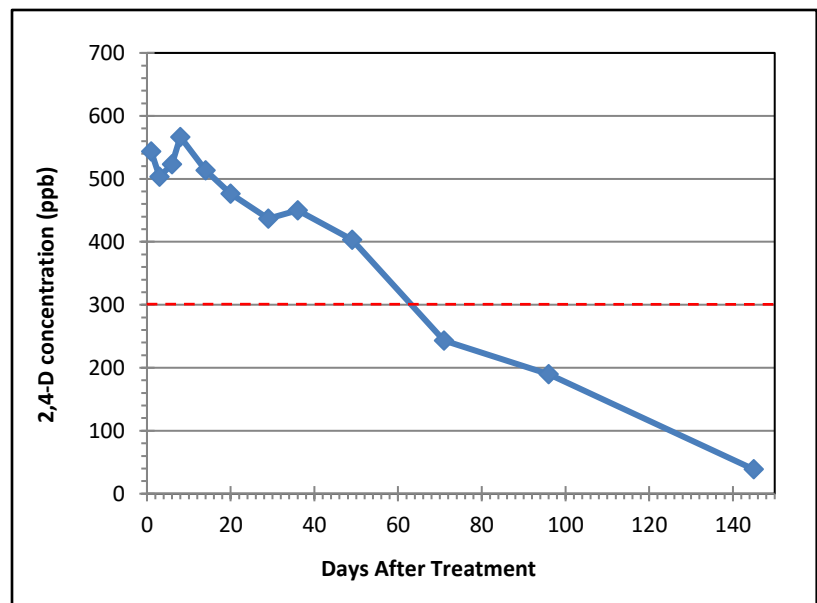
Figure 5. Post-treatment herbicide concentration.

Herbicide degradation was also very slow. While the goal was to maintain the target herbicide concentration for 7 days, the average surface integrated 2,4-D concentration remained above 500 ppb for approximately 18 DAT and did not fall below 300 ppb for nearly 62 DAT (figure 5). The calculated 2,4-D half-life was 76 days. Much higher than the WDNR large-scale treatment study average (30 days). Slow

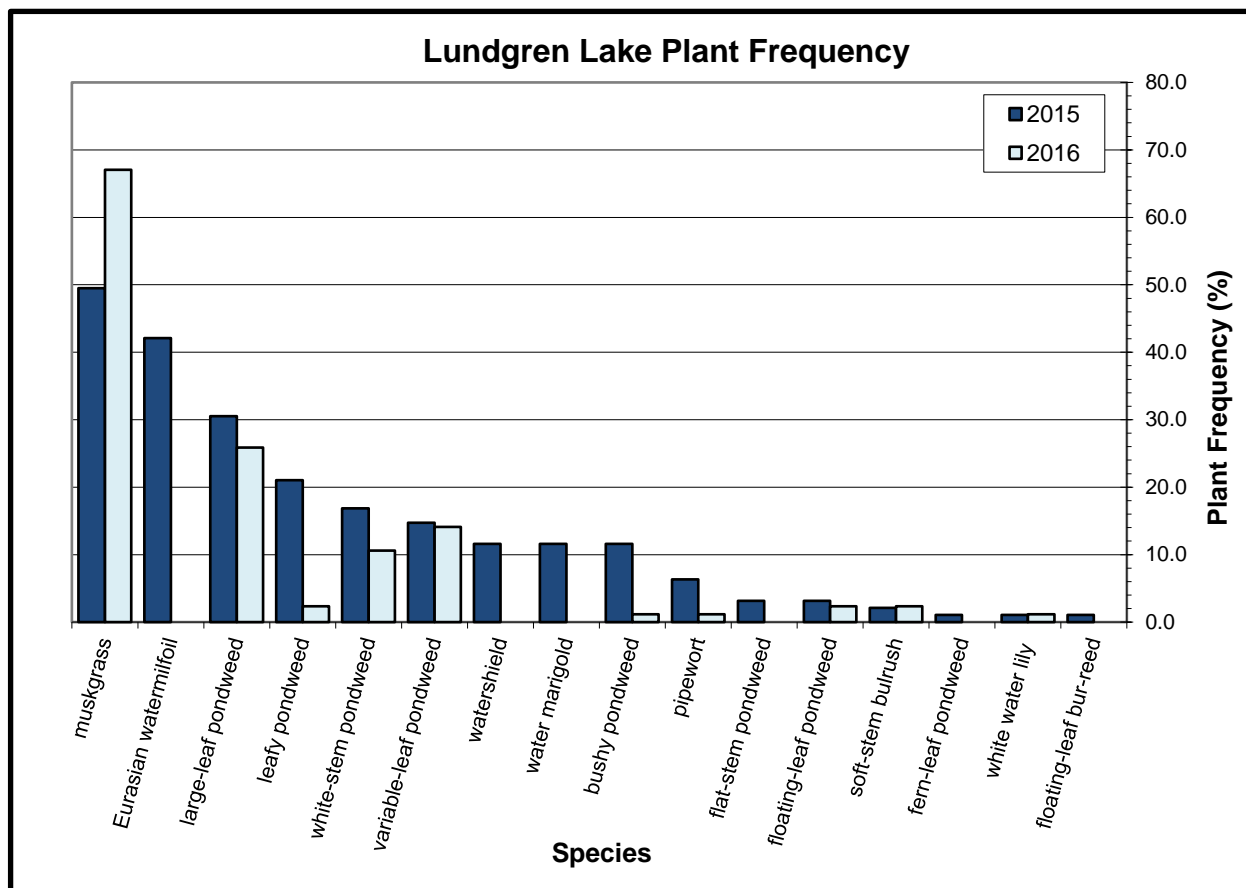
Figure 6. Pre-treatment versus post-treatment aquatic plant frequency in Lundgren Lake.

higher than planned. More importantly, the duration of herbicide exposure lasted well into the summer when all of the native plants are actively growing. These factors resulted in significant declines in some native species in Lundgren Lake (figure 6).

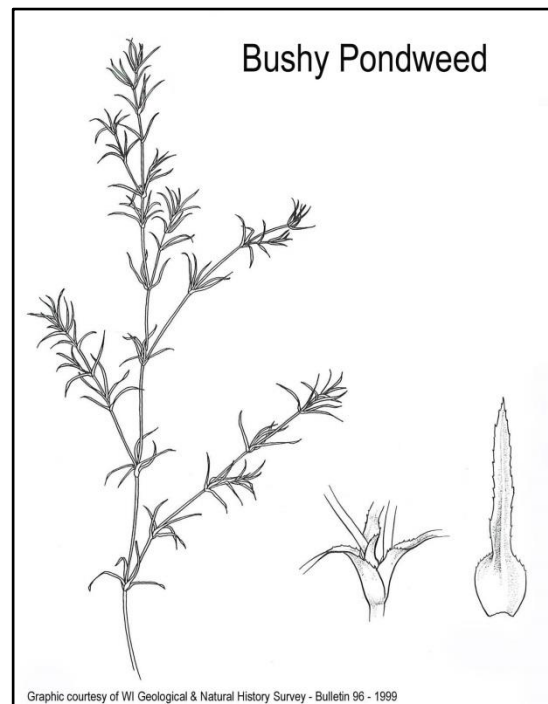
Bushy Pondweed

Bushy pondweed (*Najas flexilis*) is a common aquatic plant that, like variable-leaf pondweed, can look very different depending on the depth and sediment type where it’s found. The needle-like leaves are ½”- 1” long and very narrow (1/16”) with toothed edges. The leaves are broad at the base with sloping shoulders where they clasp the stem. In shallow water, the stems are heavily branched and the leaves are crowded on the stems giving the plant its “bushy” appearance. In deep

water, the stems can be up to three feet long with less branching and greater spacing between the leaves. In deep water, the plant often forms dense mats of intertwining stems on the lakebed.

Most aquatic plants are long-lived perennials. Bushy pondweed is unique because it's one of the few annual aquatic plants. Mature plants die each winter but produce abundant seeds to fuel next year's growth. The plants and seeds are both important food for waterfowl. Bushy pondweed also provides shelter for fish, particularly in very shallow sandy areas where it's often the only cover available for minnows and juvenile fish.

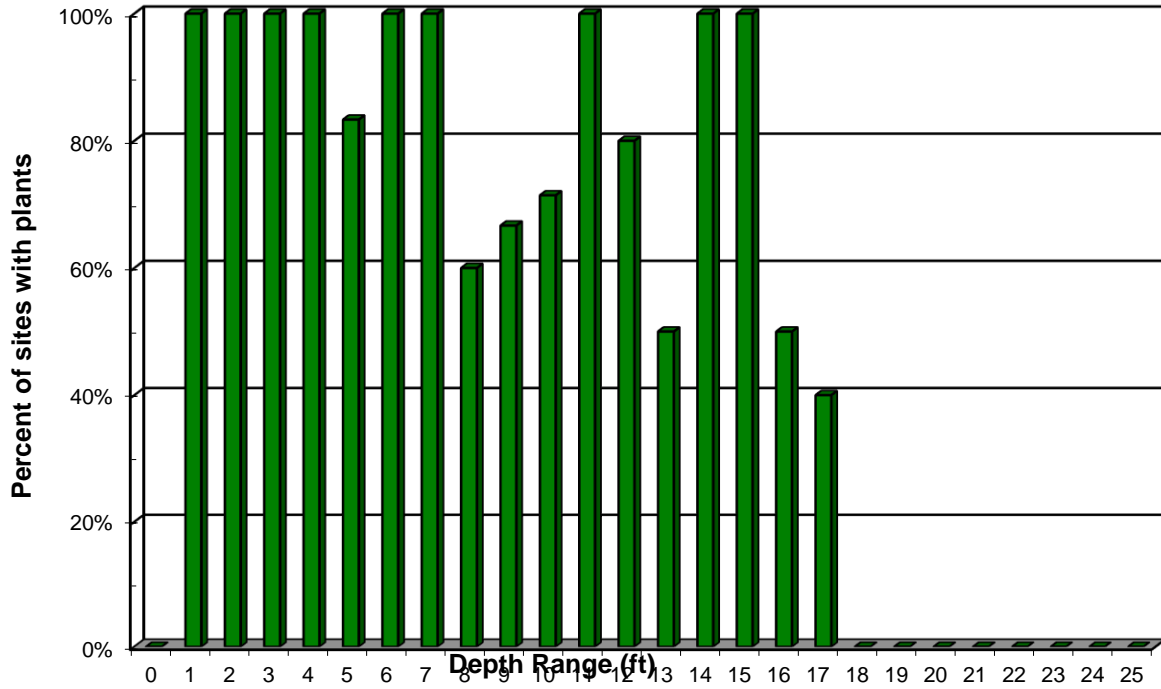
**Plant Colonization by Depth
Lundgren Lake 2016**
