# Presque Isle Wilderness Waters Program

## Aquatic Plant Management Plan – Twin Island Lake

**Cite as:** Premo, Dean, Angie Stine, and Kent Premo. 2020. Presque Isle Wilderness Waters Program: Twin Island Lake Aquatic Plant Management Plan. White Water Associates, Inc.

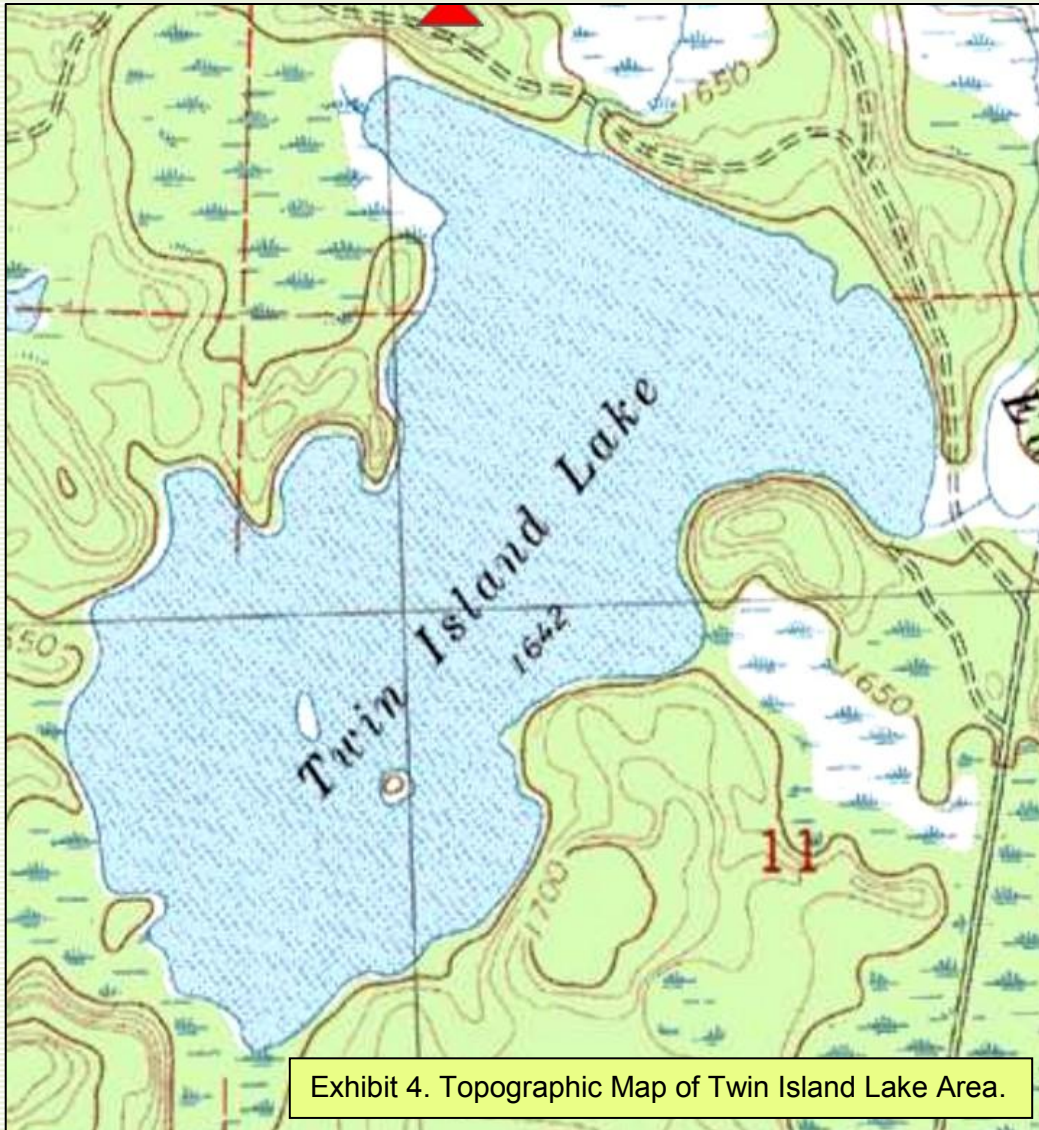
Exhibit 4. Topographic Map of Twin Island Lake Area.

Twin Island Lake has no access site for the general public, although it does have an improved access site for members of the Frontier Lakes development.. We observe a total of 32 piers on the shoreline of Twin Island Lake from recent aerial photography or about 9.2 piers per mile of shoreline. The riparian area consists of both upland and wetland areas (Exhibit 4).

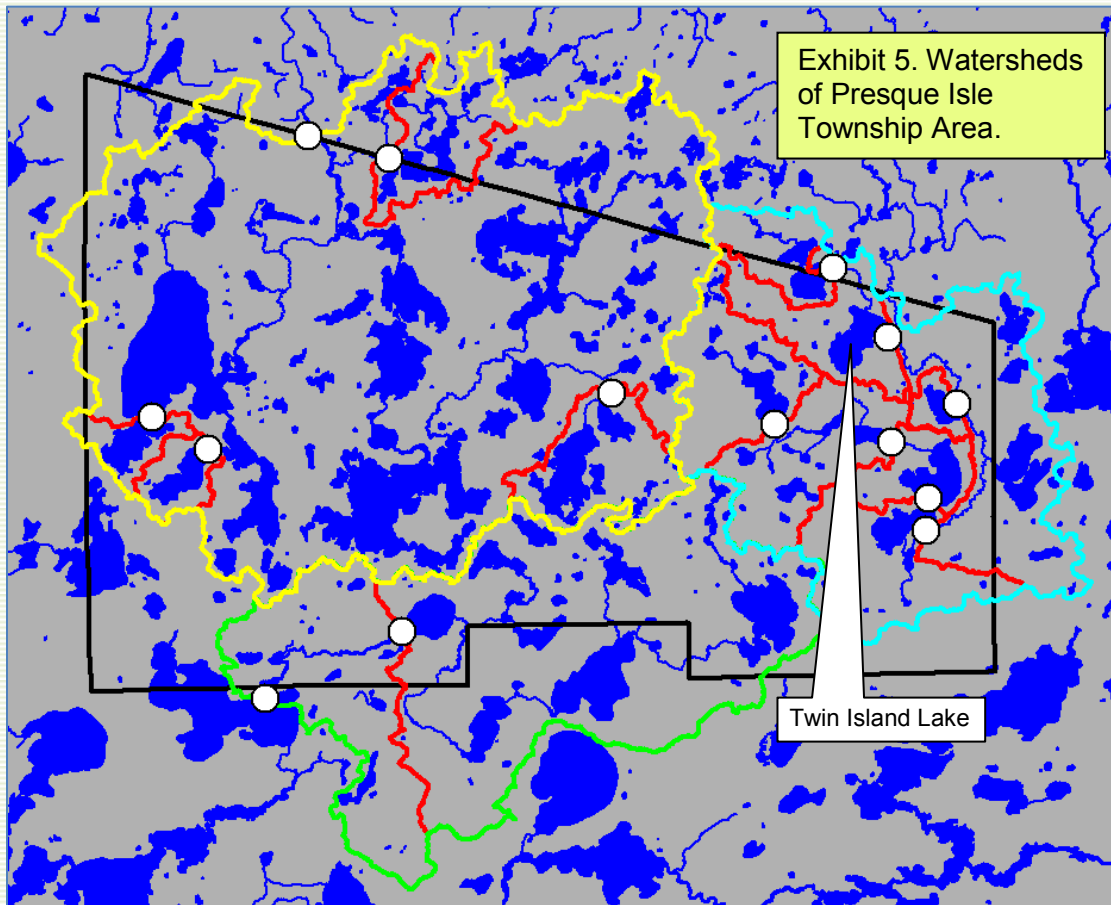
Description: Portions of 3 federal hydrologic sub-watersheds are illustrated: (1) S.Br. Presque Isle River (bounded by yellow), (2) Pomeroy Cr-E.Br. Presque Isle River (bounded by blue and yellow), and (3) Rice Cr. (bounded by green, yellow, and blue). Also shown are the smaller watersheds of individual water bodies subject to the Wilderness Waters studies (bounded by red). White dots show outlet points for the smaller watersheds.

The Presque Isle Township waterscape sits on a large-scale watershed divide. Some of the water drains north through the Presque Isle River system and eventually enters Lake Superior. Some of the water drains into the Wisconsin River system to the Mississippi River and to the Gulf of Mexico. In fact there are two federal hydrologic sub-basins (designated by 8-digit HUC codes) that include Presque Isle Township. The Black-Presque Isle Rivers sub-basin (HUC#04020101) drains north to Lake Superior and the Flambeau River sub-basin (HUC#0705002) drains southwesterly to the Mississippi River. The Black-Presque Isle Rivers sub-basin contains two federal hydrologic sub-watersheds within Presque Isle Township: the South Branch Presque Isle River sub-watershed (HUC#040201010303) and the Pomeroy Creek-East Branch Presque Isle River sub-watershed (HUC#040201010301). The Flambeau River sub-basin contains one sub-watershed within Presque Isle Township: the Rice Creek sub-watershed (HUC#07050020103). Exhibit 5 illustrates these watersheds and the watersheds of the water bodies subject to the Wilderness Waters Program studies. Twin Island Lake is contained within the Pomeroy Creek-East Branch Presque Isle River sub-watershed (Exhibit 5).

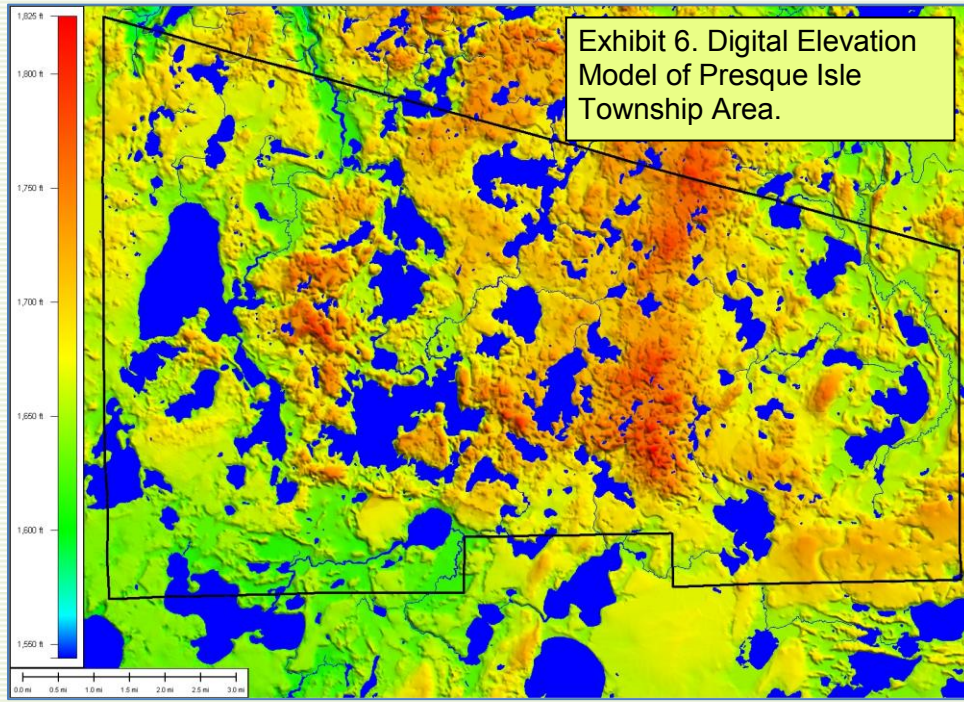
The elevation in Presque Isle Township ranges from around 1,550 feet above sea level to 1,750 feet above sea level. A digital elevation model is provided as Exhibit 6 and shows the relative elevations for the area with orange areas of the landscape being the highest elevations and greens and blues being the lowest elevations.

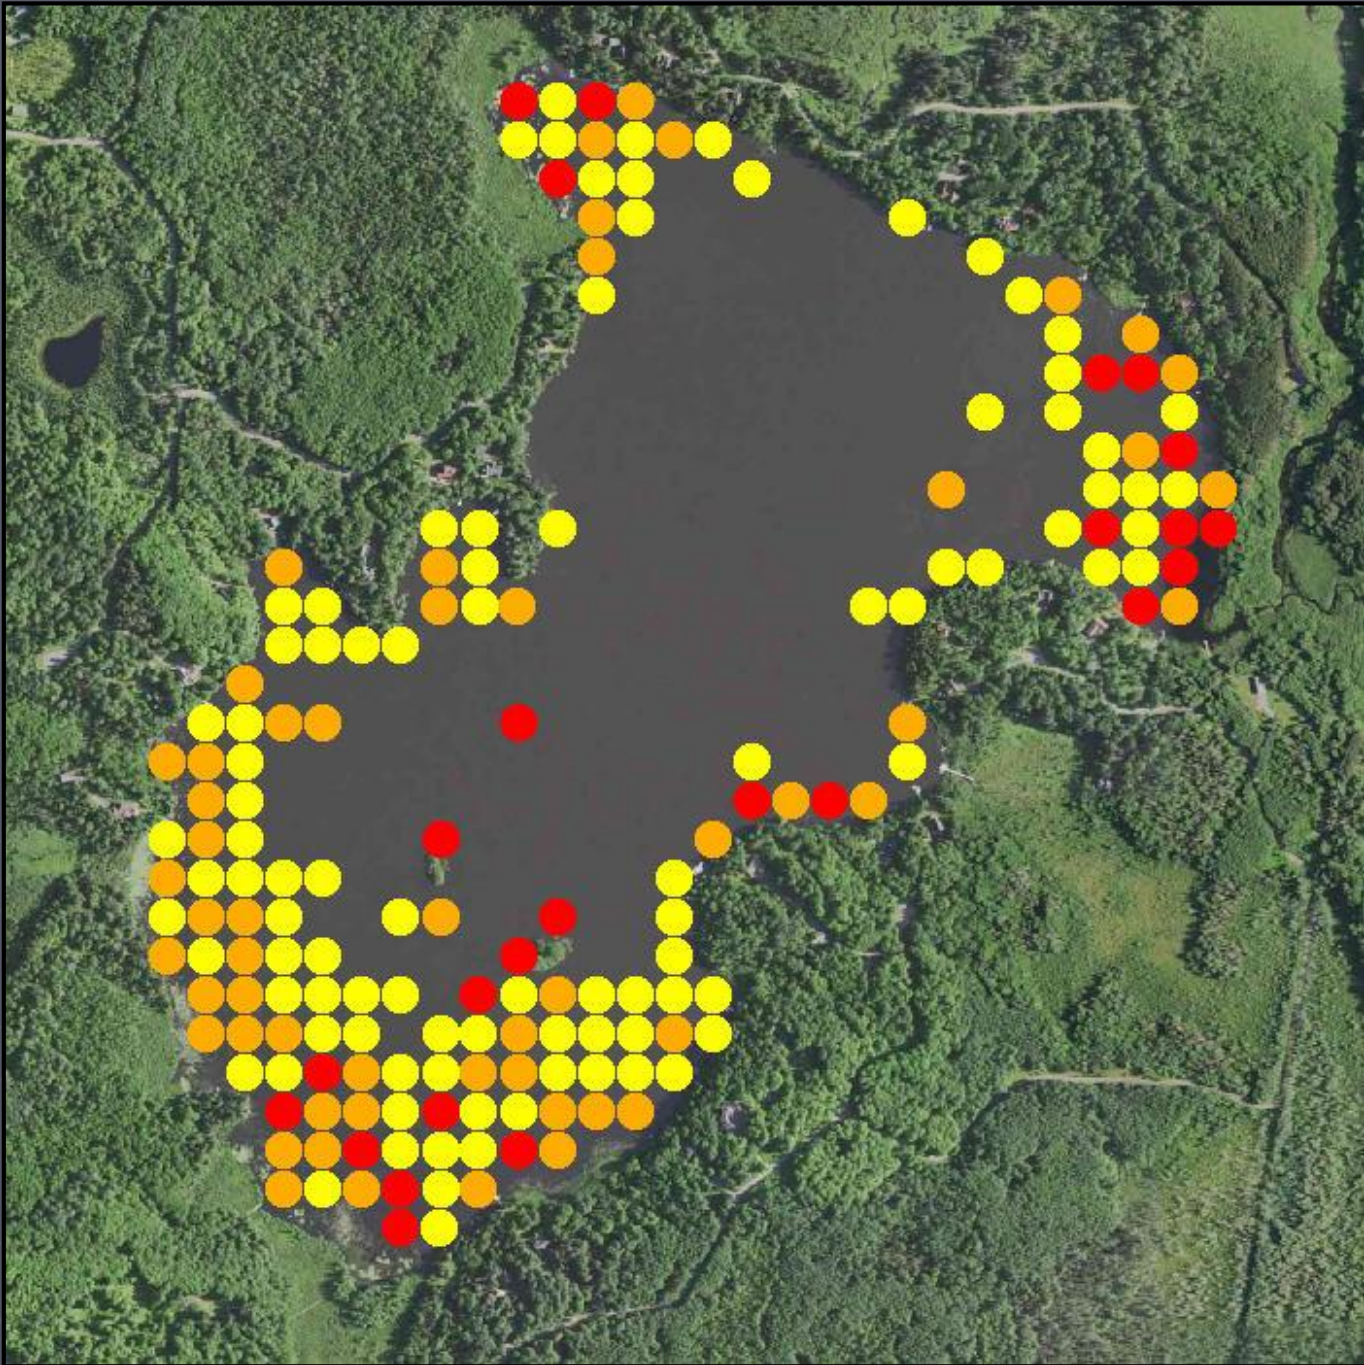
**Figure 3. Maximum Depth of Plant Colonization,  
Twin Island Lake, 2018.**

The maximum depth of plant colonization is 9.50 feet in 2018 (Table 1 and Figure 3). Rooted vegetation was found at 176 of the 210 sample sites with depth  $\leq$  the maximum depth of plant colonization (83.81% of sites). These sites are displayed as a black dot within a circle on Figure 4. This indicates that although availability of appropriate depth may limit the distribution of plants, it is not the only habitat factor involved. Substrate is another feature that influences plant distribution (e.g., soft substrate often harbors more plants than hard substrate). Figure 5 presents the substrates encountered during the aquatic plant survey (mud, sand, or rock).

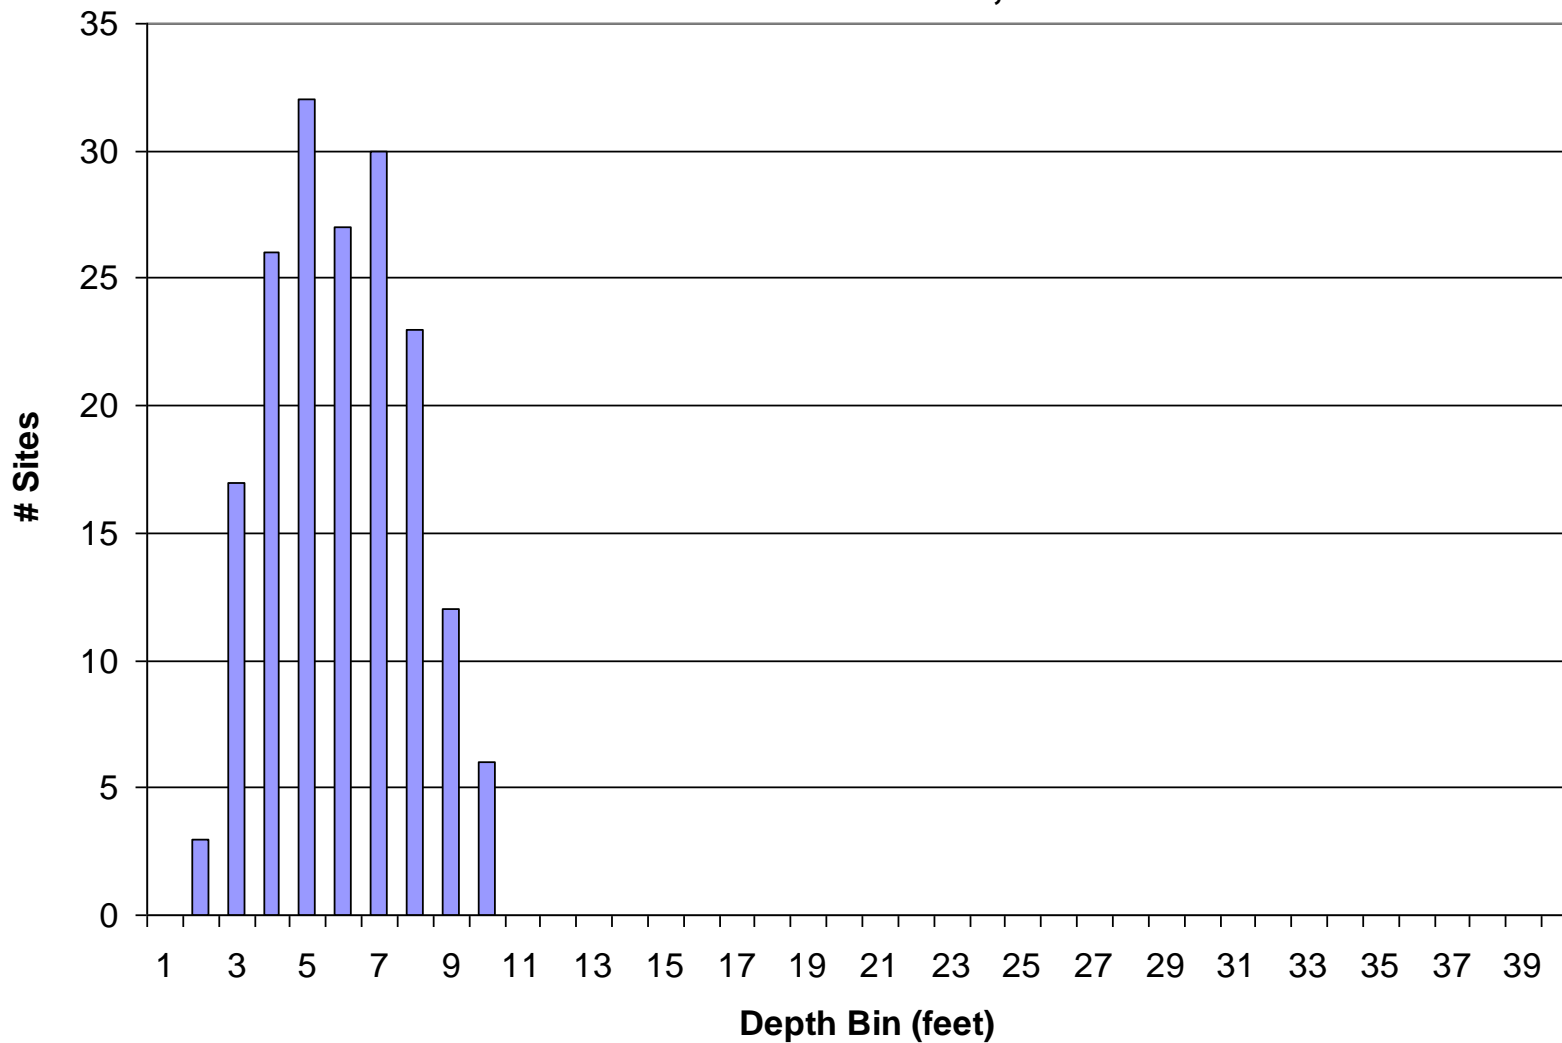
Figure 4. Twin Island Lake sampling sites less than or equal to maximum depth of rooted vegetation (2018).

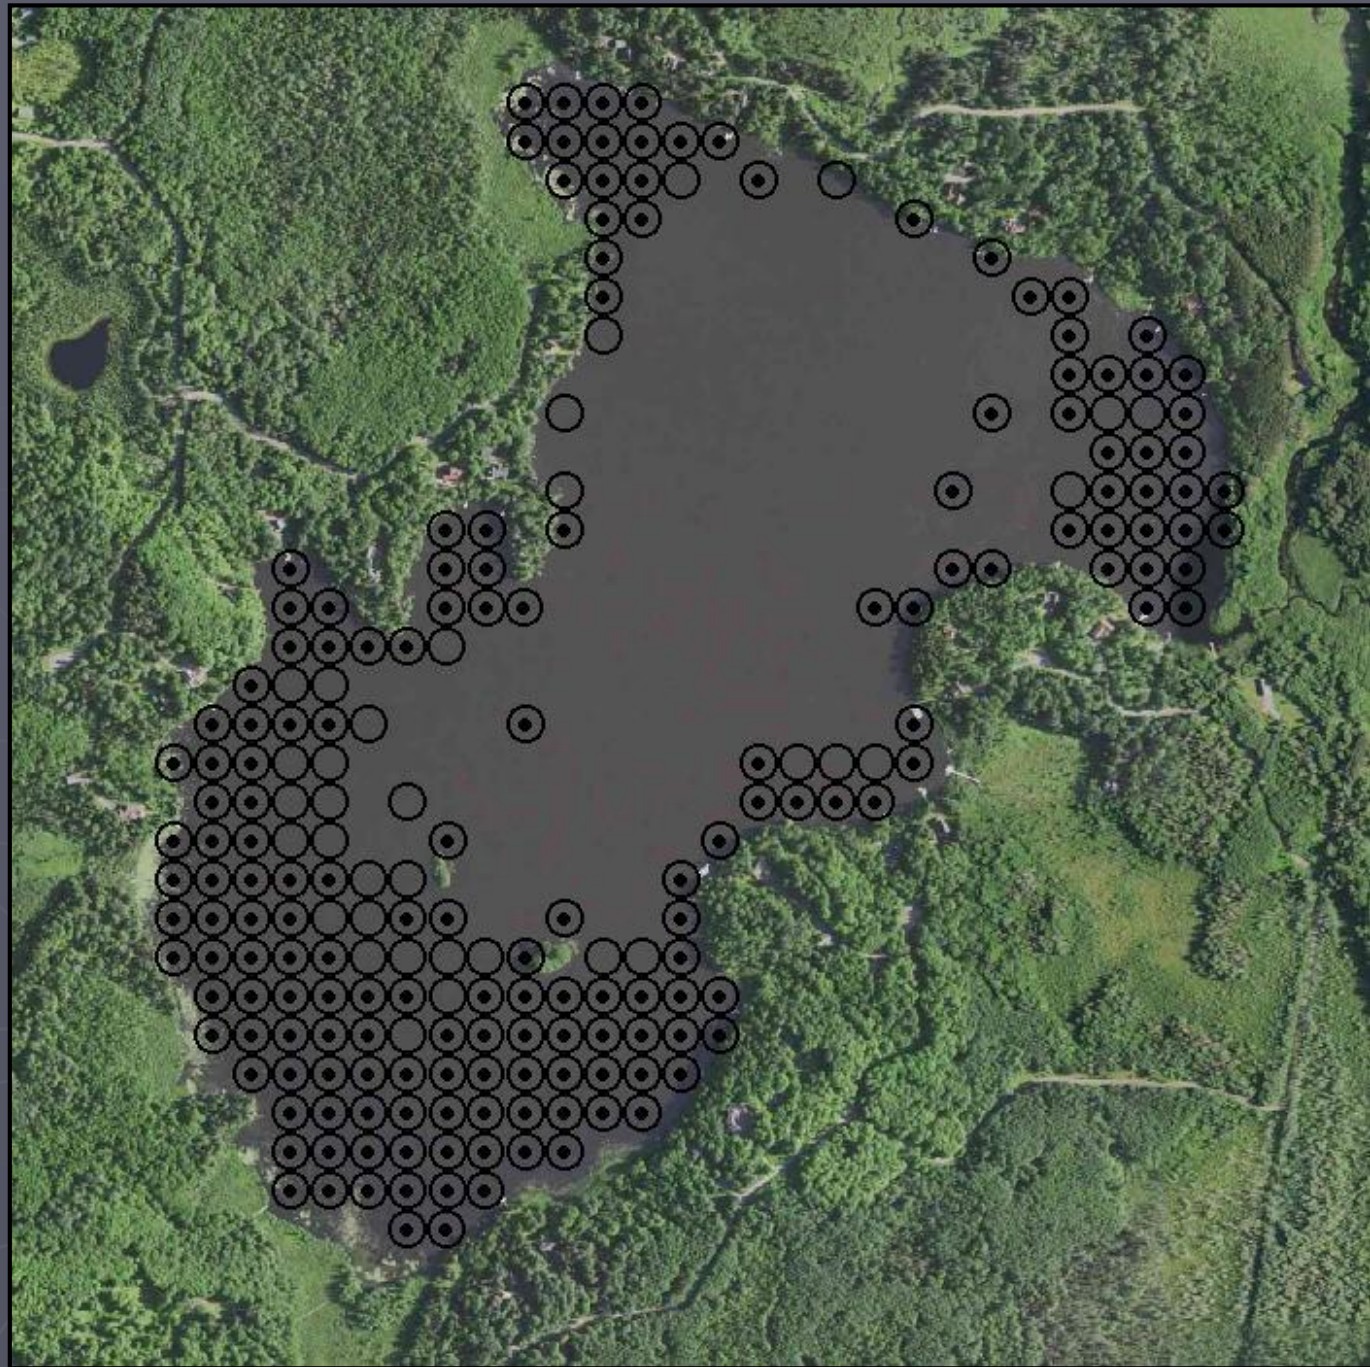
Figure 5. Twin Island Lake substrate encountered at point-intercept plant sampling sites (2018).

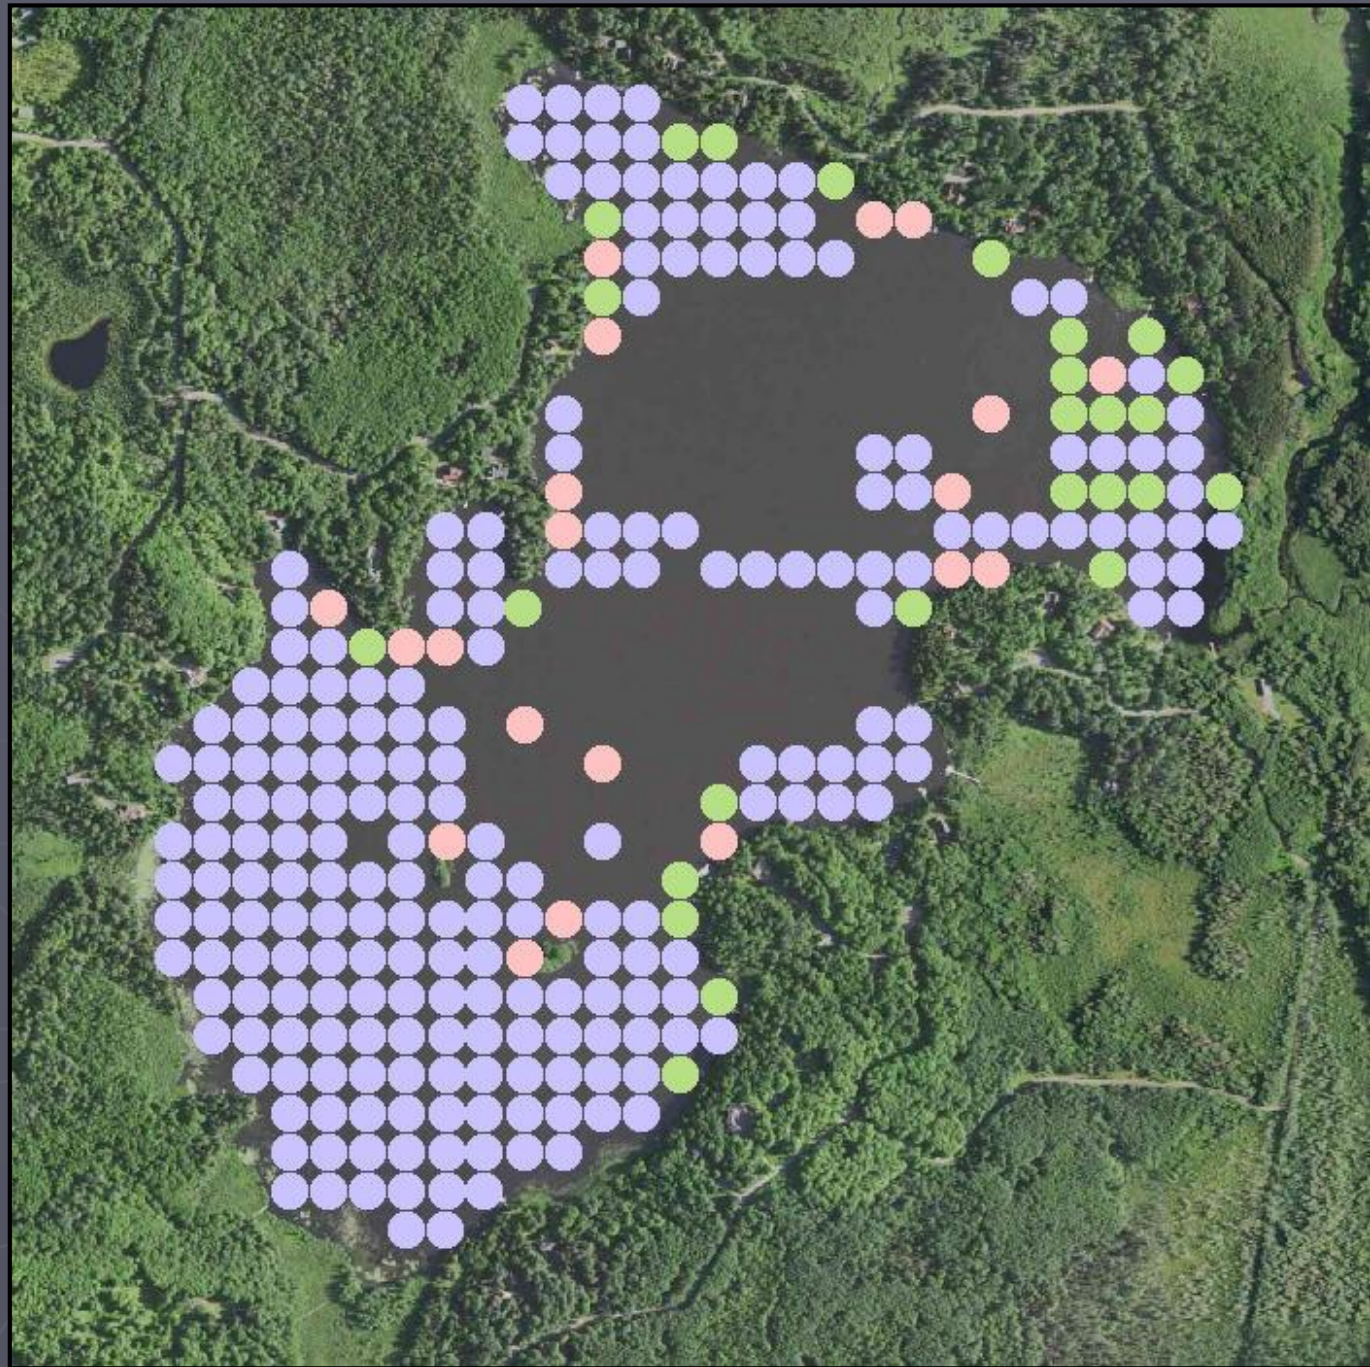
Figure 6. Twin Island Lake, Plant Finds in 2011 and 2018.

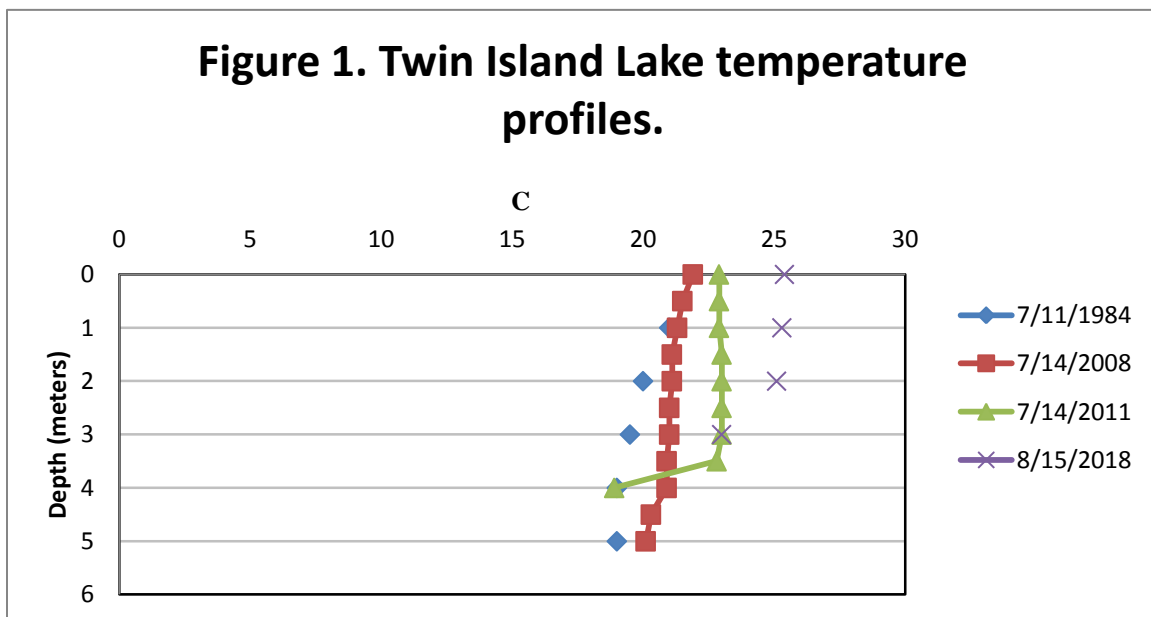
Measuring the temperature of a lake at different depths will determine the influence it has on the physical, biological, and chemical aspects of the lake. Lake water temperature influences the rate of decomposition, nutrient recycling, lake stratification, and dissolved oxygen (D.O.) concentration. Temperature can also affect the distribution of fish species throughout a lake. Twin Island Lake shows only slight stratification in the years analyzed (Figure 1).

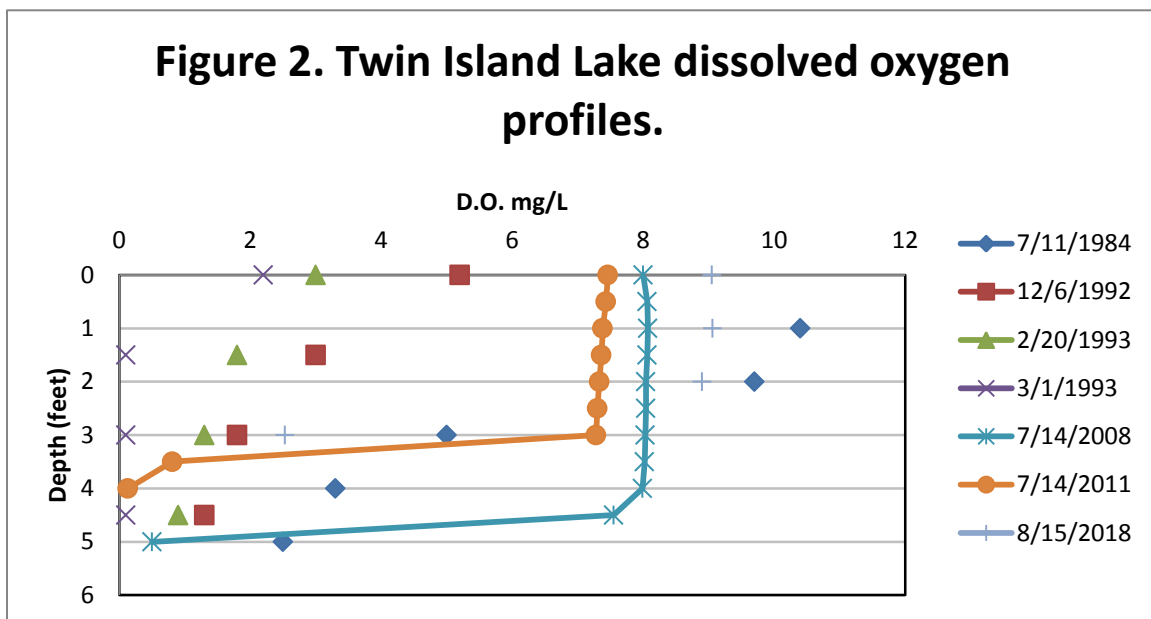
Figure 2 indicates that Twin Island Lake stratified between 6.5 and 10 feet in 1984; between 14 and 16 feet in 2008; and between 9 and 13 feet in 2011. In 2018 the D.O. drops around 2.5 meters. The dissolved oxygen in the epilimnion has varied over the years, along with where the low oxygen level occurs. Aqua Tech did an evaluation of dissolved oxygen for Twin Island Lake in the winter of 1992 and 1993, to see if the levels were able to sustain a fishery. The minimum amount of oxygen needed for “warm water” fish to survive is 5 mg/L. Winter dissolved oxygen concentrations have been problematic in the last thirty years in Twin Island Lake. Data collected in December 1992, February 1993, and March 1993 show very low concentrations of dissolved oxygen throughout much of the water column. These low winter oxygen conditions, reports of past winter kills, and fish community structure typical of occasional winter kill, led Frontier Lake Association to recommend the installation of an aeration device in the lake to add dissolved oxygen during the crucial winter period. An aeration permit application was approved by the WDNR for Twin Island Lake on September 21, 1993.

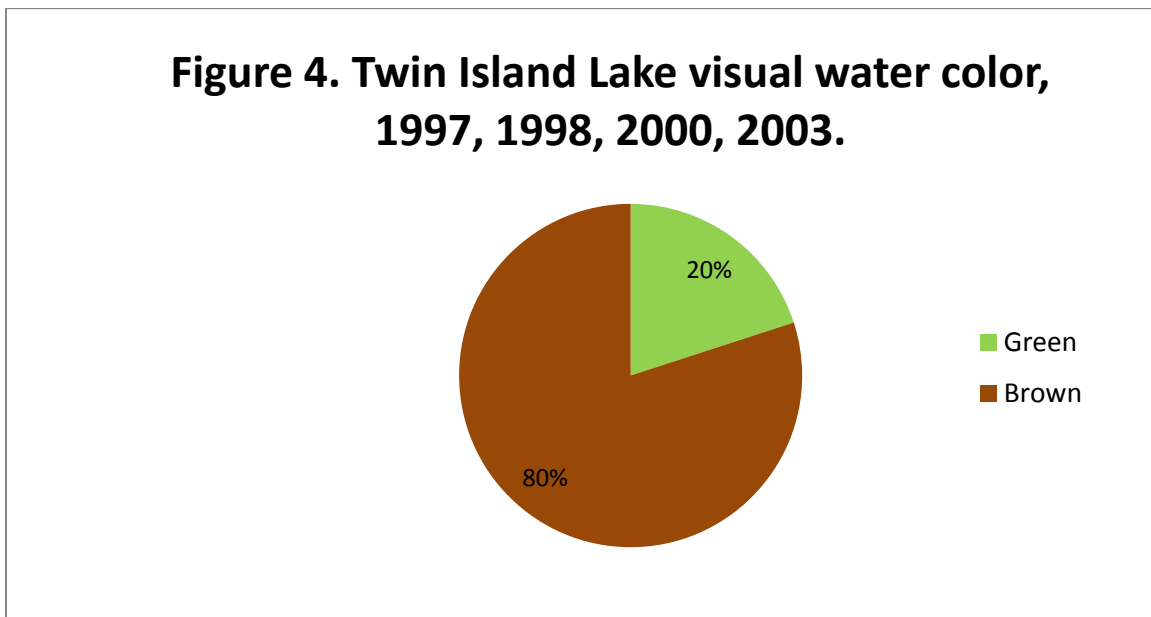
Color of lake water is related to the type and amount of dissolved organic chemicals. Its main significance is aesthetics, although it may also influence light penetration and in turn affect aquatic plant and algal growth. Many lakes have naturally occurring color compounds from decomposition of plant material in the watershed (Shaw et al., 2004). Units of color are determined from the platinum-cobalt scale and are therefore recorded as Pt-Co units. Shaw states that a water color between 0 and 40 Pt-Co units is low. Twin Island Lake was analyzed October 2, 1985 (30 Pt-Co) and August 15, 2018 (20 SU). The CLMN assessed the visual color of the lake while sampling and 80% noted that Twin Island Lake was “brown” in color (Figure 4).

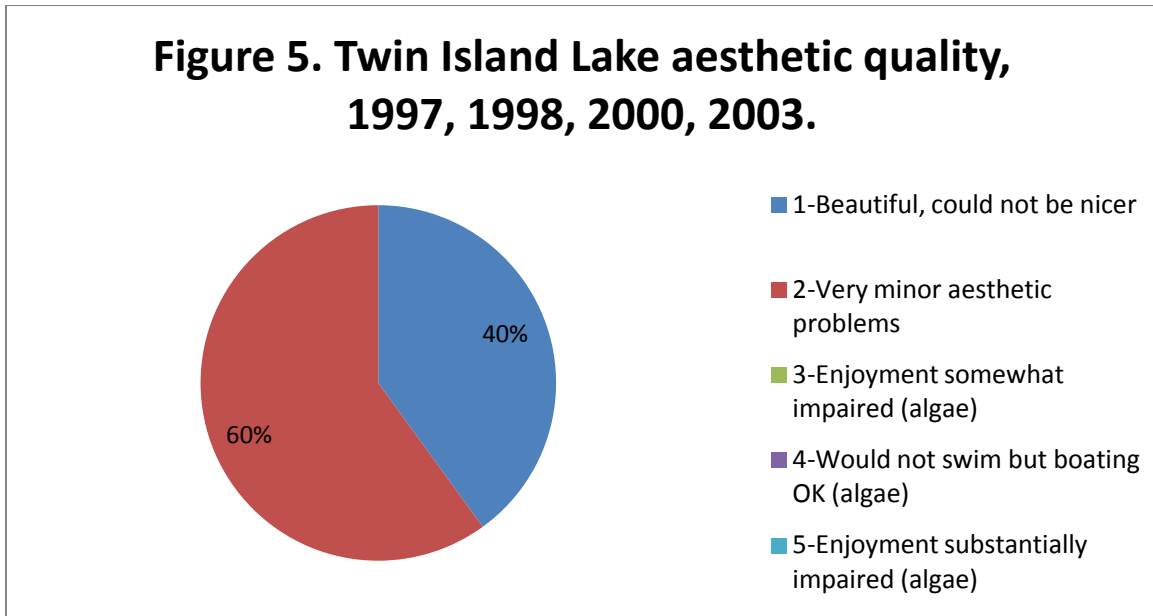
When Secchi depth readings are collected, the CLMN record their perceptions of the water, based on the physical appearance and the recreational suitability. These perceptions can be compared to water quality parameters to see how the lake user would experience the lake at that time. When interpreting the transparency data, we see that when the Secchi depth decreases, the rating of the lake's physical appearance also decreases. In sampled years, the majority (60%) of volunteers viewed Twin Island Lake as having "very minor aesthetic problems" (Figure 5).

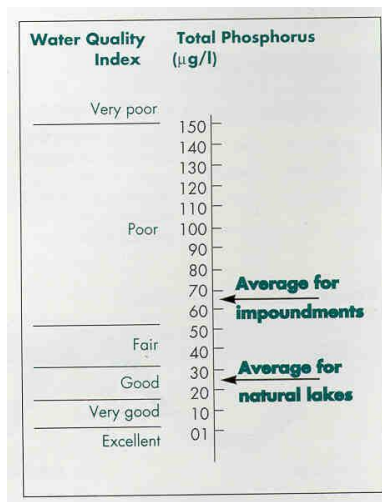
**Figure 8. Total phosphorus concentrations for Wisconsin’s natural lakes and impoundments (Shaw et al., 2004).**

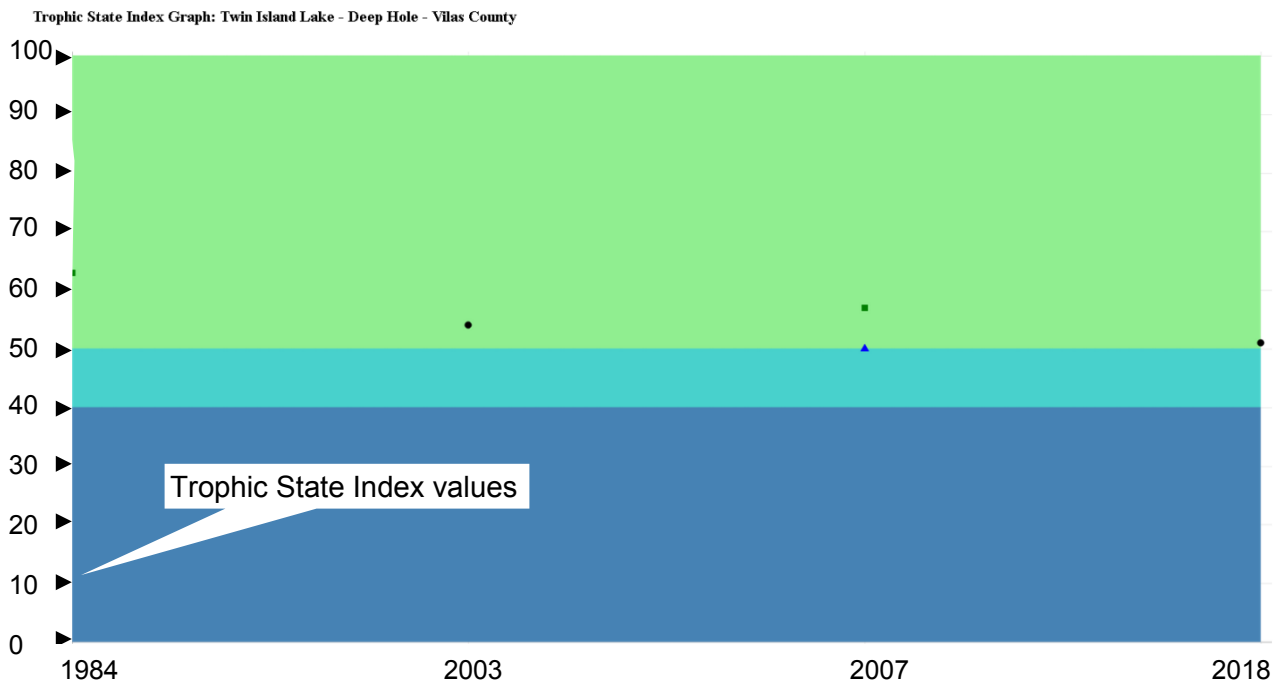
Figure 8. Twin Island Lake Trophic State Index (1984, 2003, 2007, and 2018).

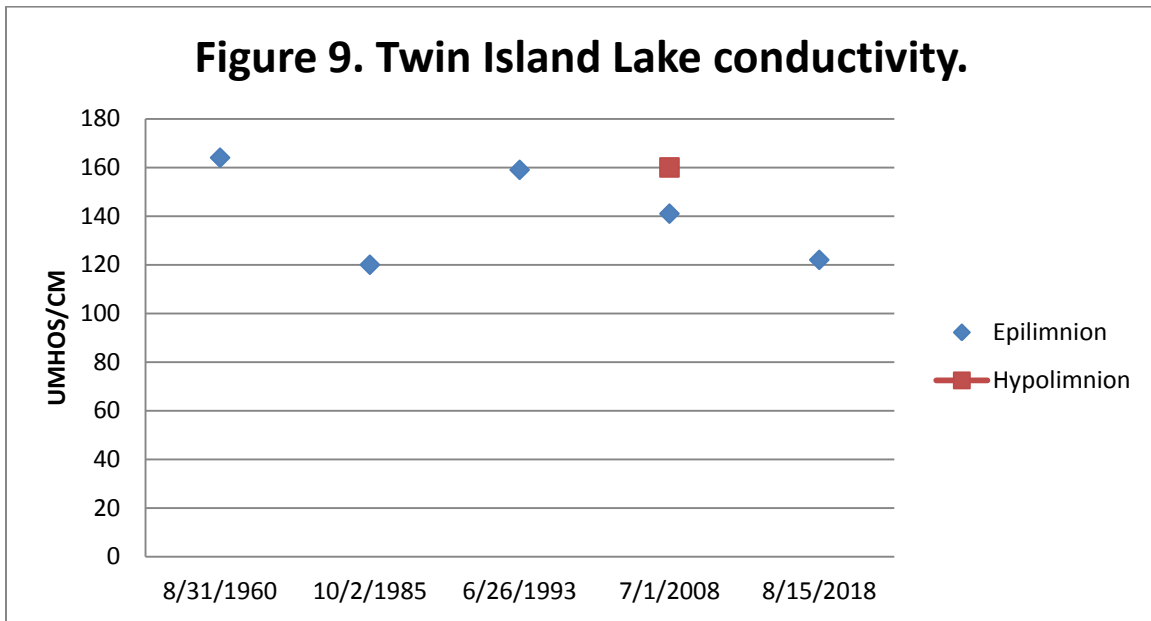
Conductivity is a measure of the ability of water to conduct an electric current. Conductivity is reported in micromhos per centimeter ( $\mu\text{mhos/cm}$ ) and is directly related to the total dissolved inorganic chemicals in the water. Usually, values are approximately two times the water hardness, unless the water is receiving high concentrations of human-induced contaminants (Shaw et al., 2004). Twin Island conductivity was analyzed four different dates (Figure 9).

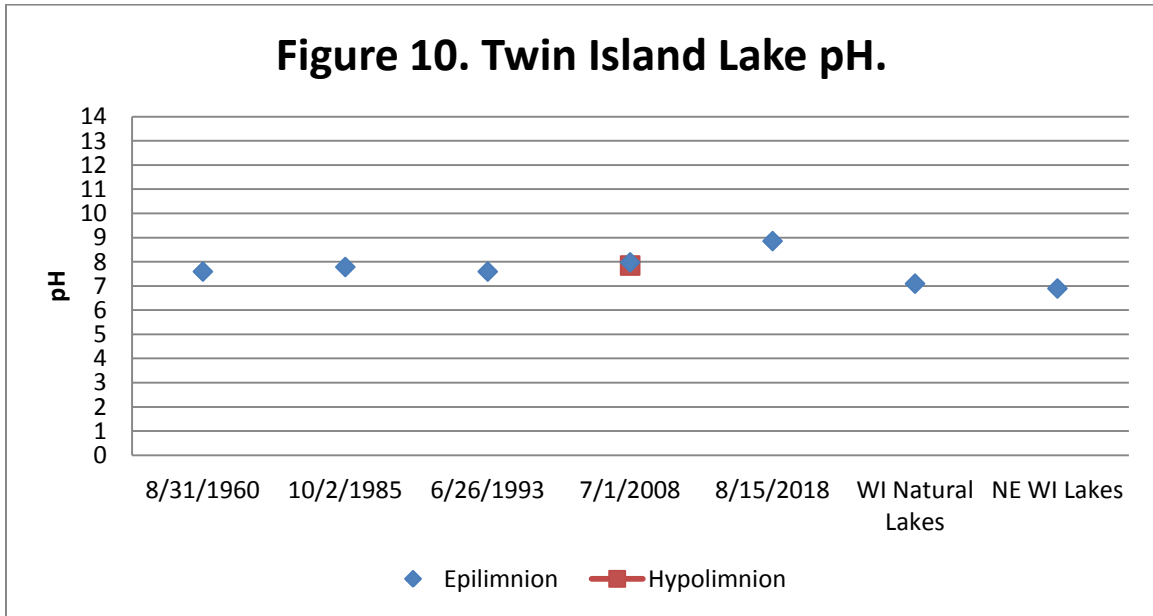
growth, fish reproduction and survival. A lake with neutral or slightly alkaline pH is a good lake for fish and plant survival. Figure 10 indicates that Twin Island Lake was alkaline in the years sampled.

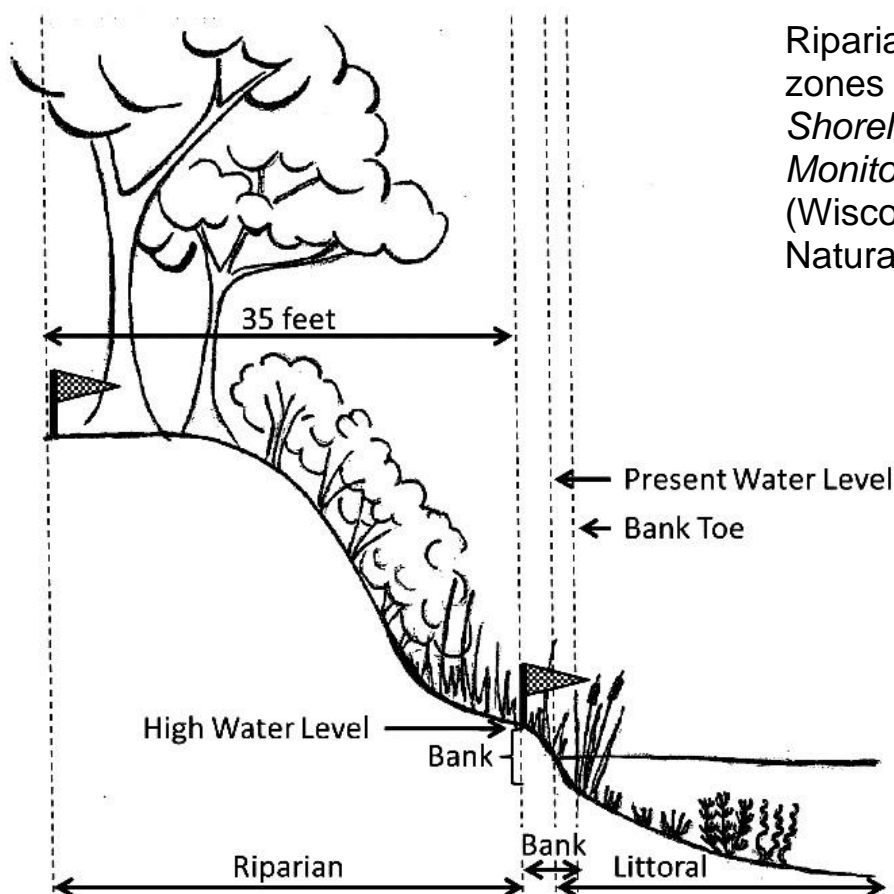
Riparian, bank, and littoral zones covered by the *Shoreland & Shallows Habitat Monitoring Field Protocol* (Wisconsin Department of Natural Resources 2016)

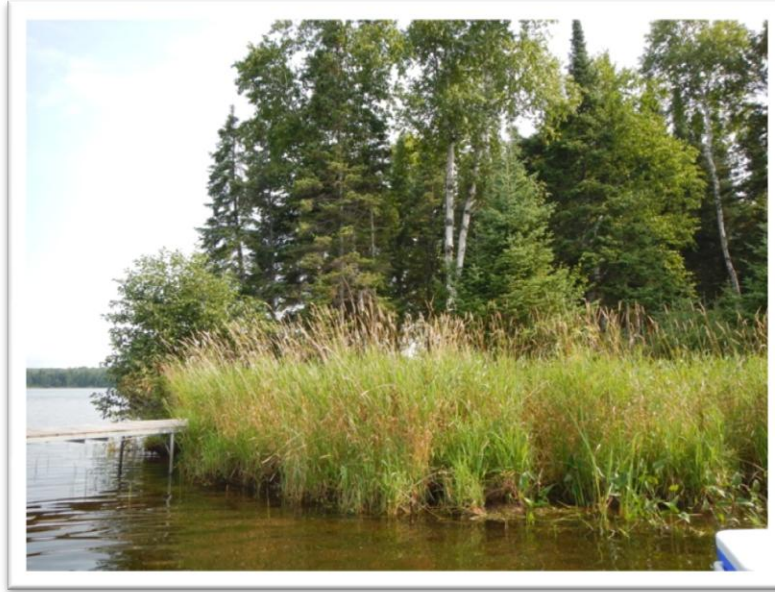
Exhibit 4. Photo of the reed canary grass along the shoreline, Twin Island Lake, 2018

Reed canary grass (*Phalaris arundinacea*) grass has been found in nearly every county in Wisconsin. It is on the *Restricted* species list. It forms dense, monocultured stands in wetland and riparian areas (Czarapata, 2005). It reproduces by spreading rhizomes, and seeds (Czarapata, 2005). It is one of the first grasses to sprout in the spring, increasing its chances of out-competing other plants.
