Presque Isle Wilderness Waters Program

Aquatic Plant Management Plan – Morton Lake

Cite as: *Premo, Dean, Angie Stine, and Kent Premo. 2020. Presque Isle Wilderness Waters Program: Morton Lake Aquatic Plant Management Plan. White Water Associates, Inc.*

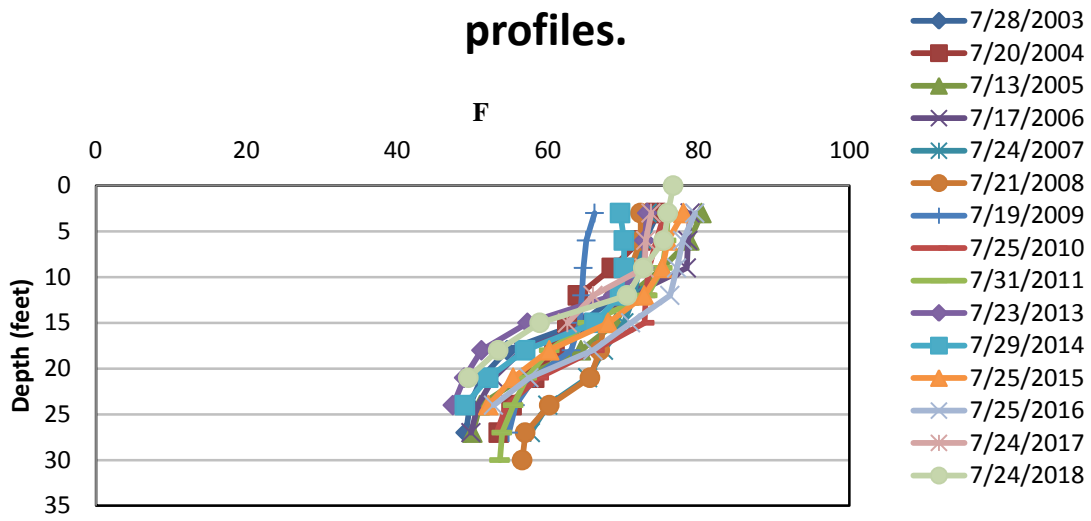
Figure 2. Morton Lake July temperature profiles.

Measuring the temperature of a lake at different depths will determine the influence it has on the physical, biological, and chemical aspects of the lake. Lake water temperature influences the rate of decomposition, nutrient recycling, lake stratification, and dissolved oxygen (D.O.) concentration. Temperature can also affect the distribution of fish species throughout a lake. Temperature profiles were completed in June, July, August, and October on Morton Lake (Figures 1-4). There is stratification in June, July, and August and in October the temperatures are the same from surface to bottom. Values are typical.

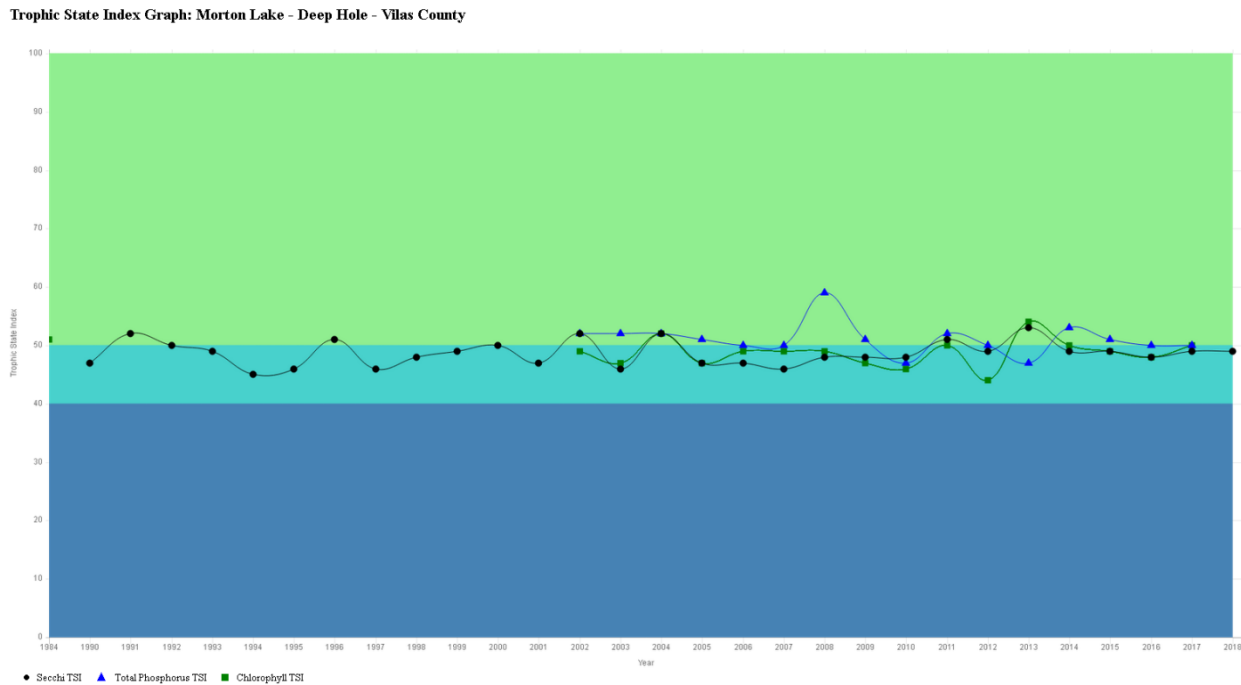
Figure 15. Morton Lake Trophic State Index (1984, 1985, 1990-2019).

Trophic state is another indicator of water quality (Carlson, 1977). Lakes can be divided into three categories based on trophic state – oligotrophic, mesotrophic, and eutrophic. These categories reflect a lake’s nutrient and clarity levels (Shaw et al., 2004).
