Presque Isle Wilderness Waters Program

Aquatic Plant Management Plan – Oxbow Lake

White Water Associates, Inc.
Dean Premo, Ph.D.
429 River Lane, P.O. Box 27
Amasa, Michigan 49903

Cite as: Premo, Dean, Angie Stine, and Kent Premo. 2020. Presque Isle Wilderness Waters Program: Oxbow Lake Aquatic Plant Management Plan. White Water Associates, Inc.

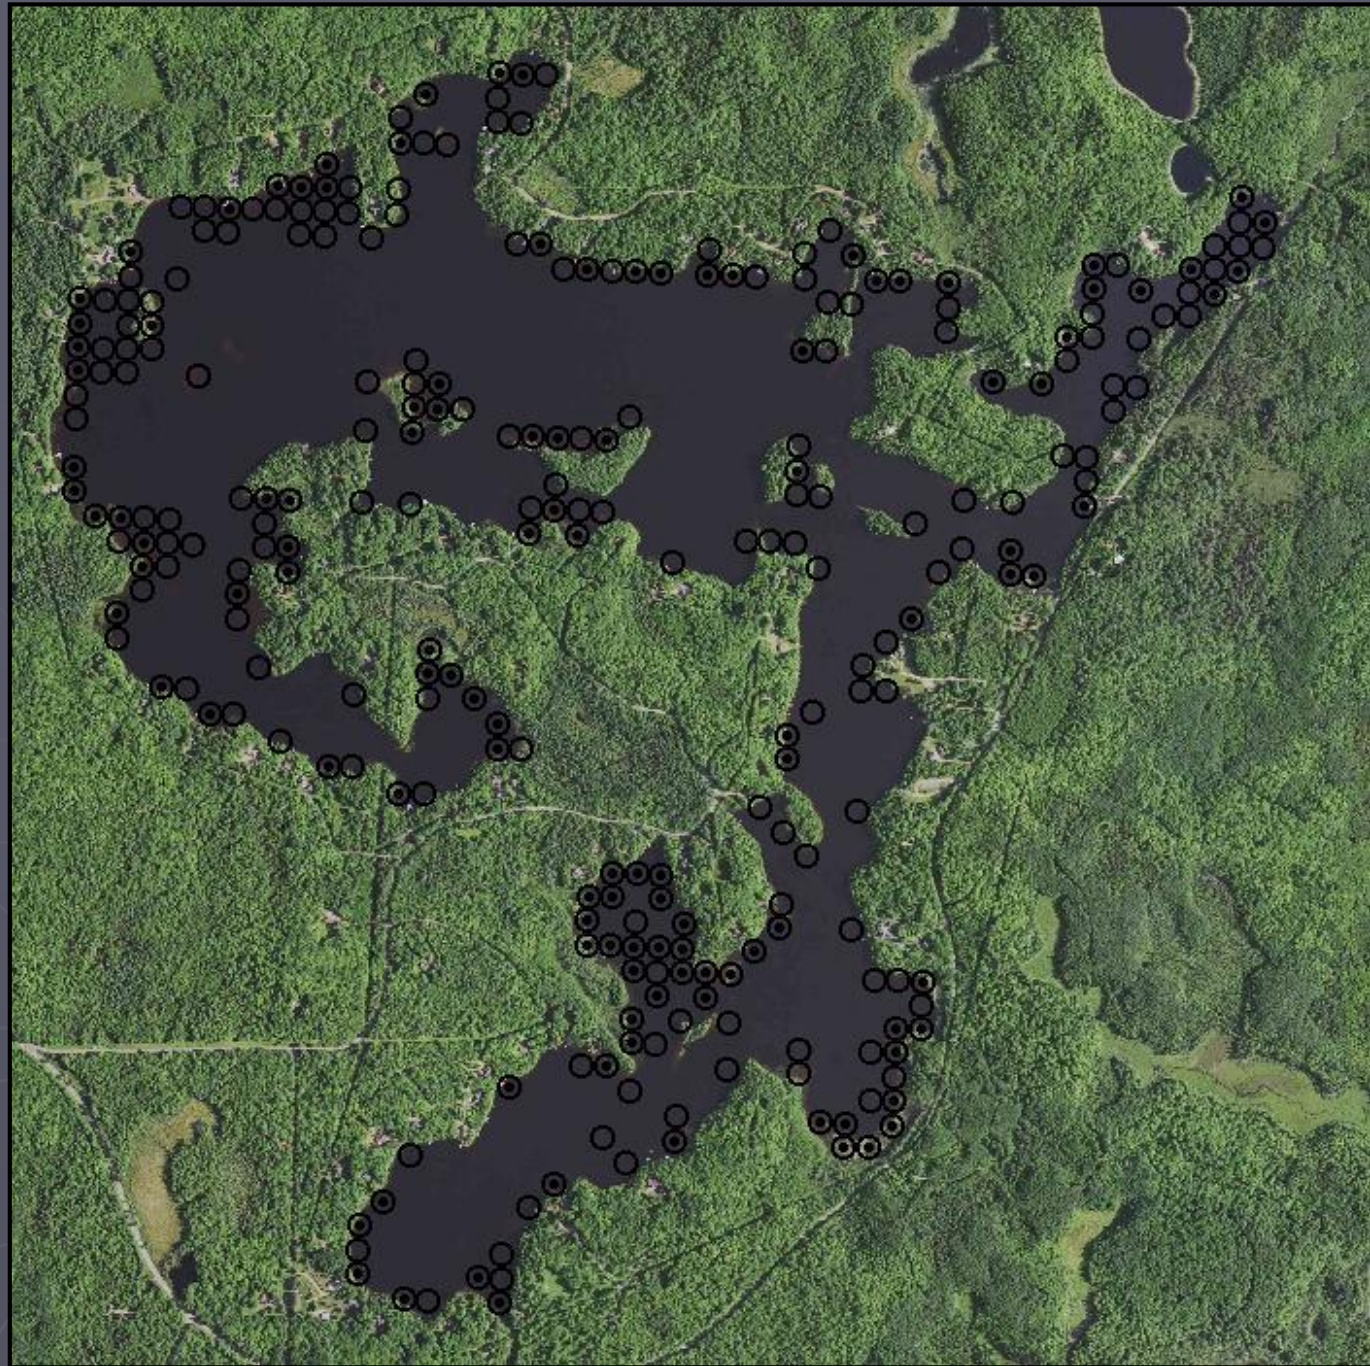
Figure 4. Oxbow Lake sampling sites less than or equal to maximum depth of rooted vegetation (2018).

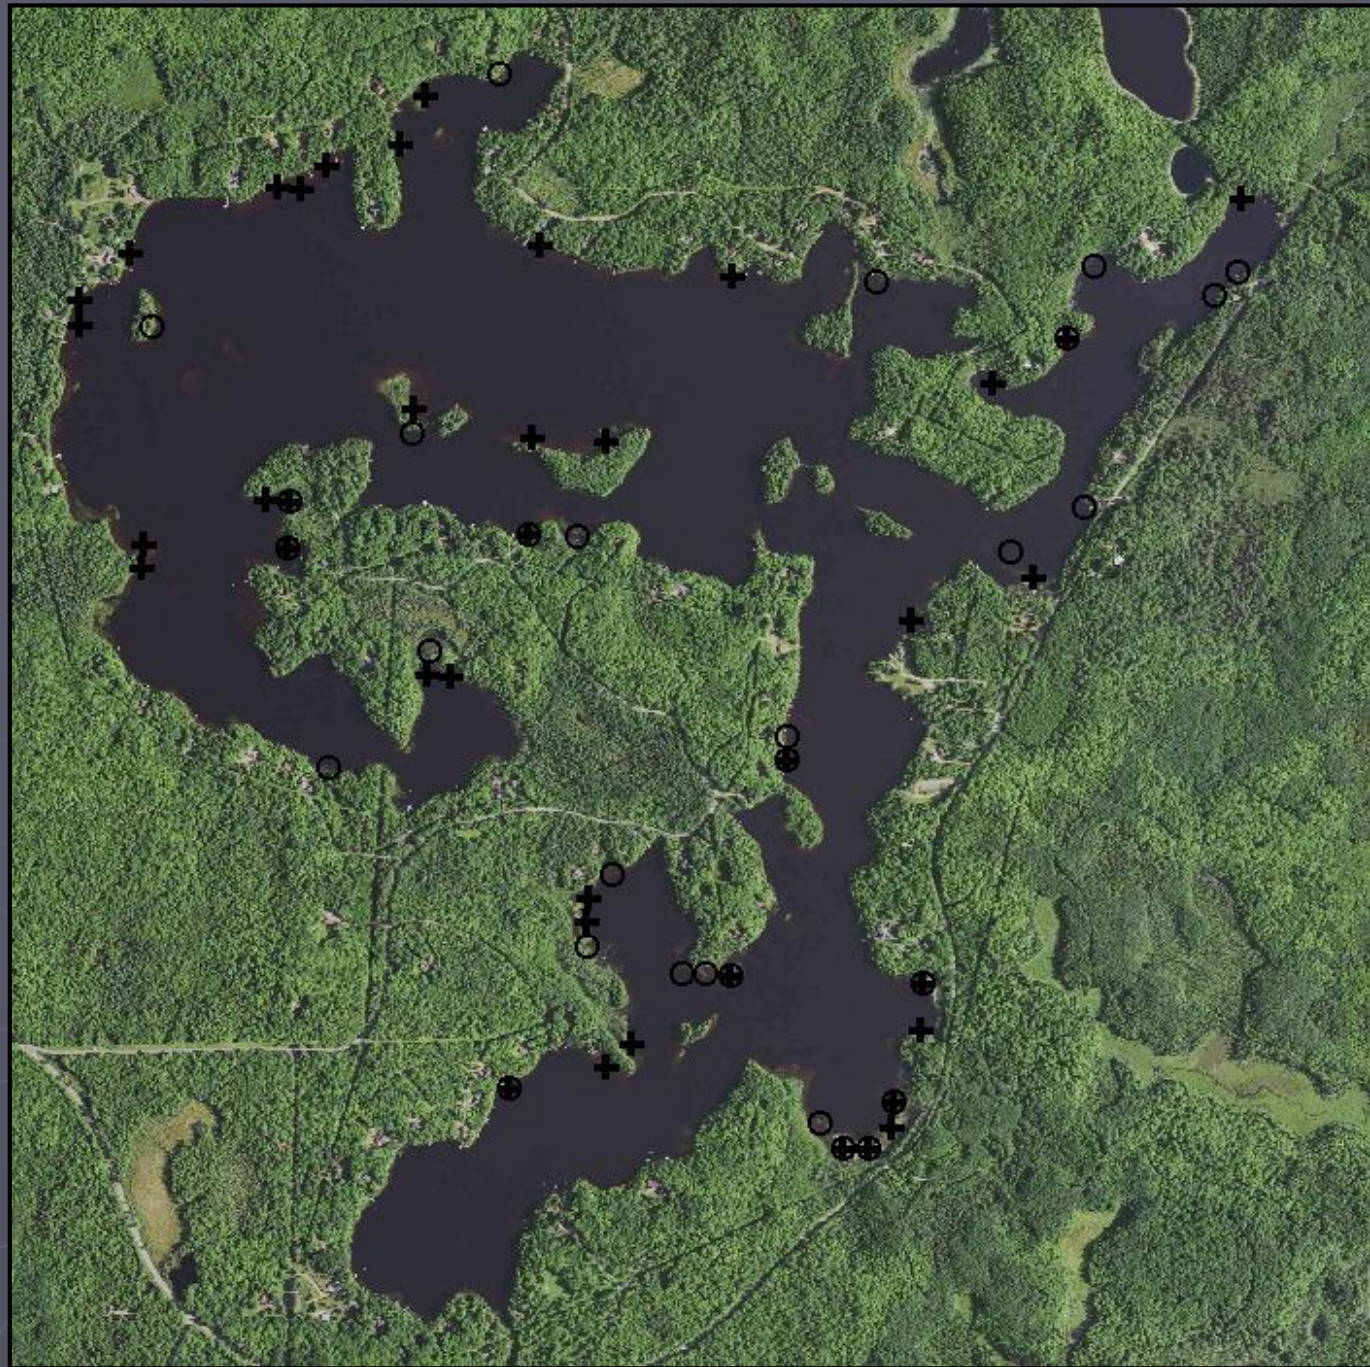
Figure 7. Oxbow Lake point-intercept plant sampling sites with emergent and floating aquatic plants (2018).

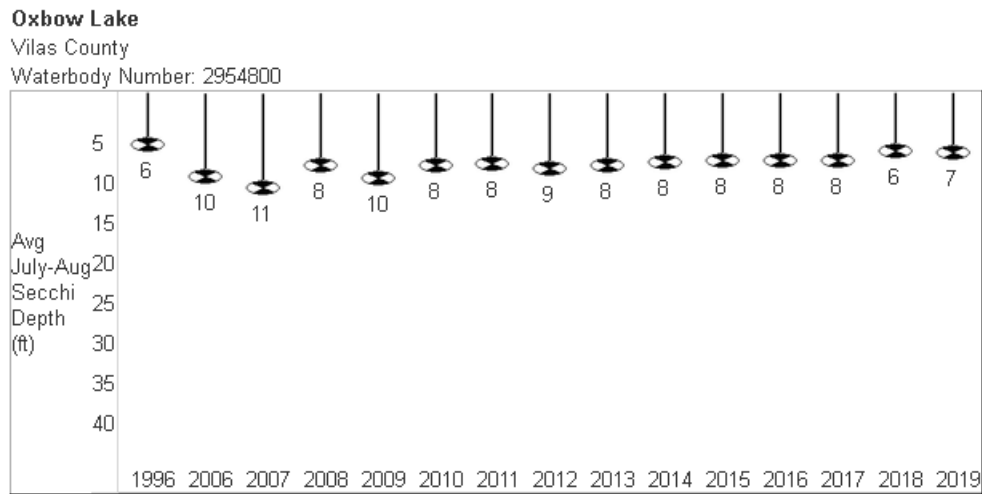
Figure 7. Oxbow Lake Secchi depth averages (July and August only).

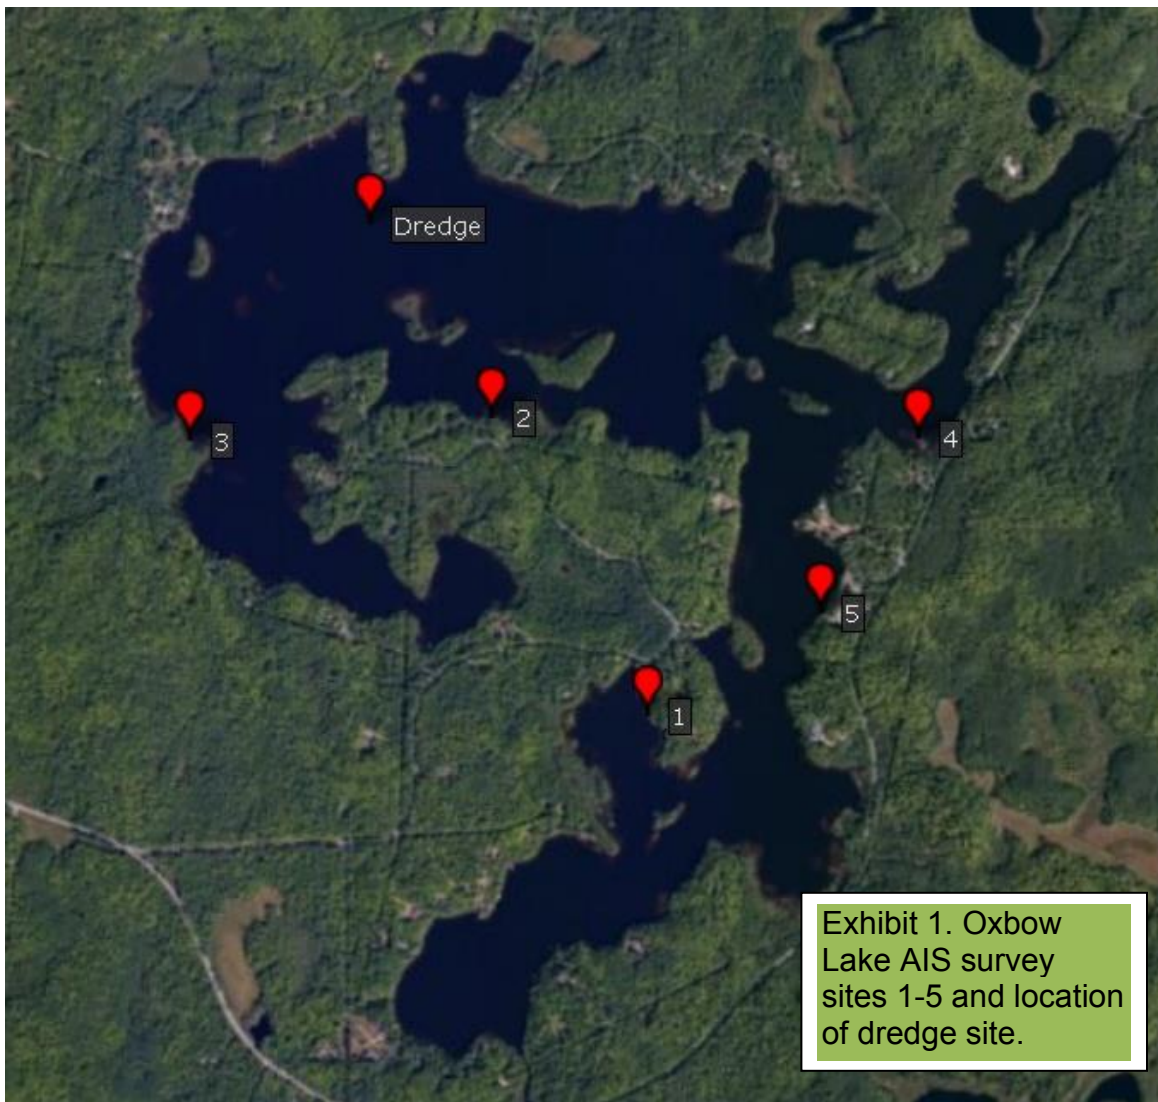
Exhibit 1. Oxbow Lake AIS survey sites 1-5 and location of dredge site.

There were two known AIS that were established in Oxbow Lake prior to this survey, the banded mystery snail and the freshwater jellyfish. During the survey the only AIS noted were aquatic forget-me-not and reed canary grass. A voucher specimen of reed canary grass (from the aquatic plant survey) was sent to Dr. Freckmann (UW Steven's Point: Herbarium) and was confirmed in January of 2019. The aquatic forget-me-not was not vouchered, but was present in abundance. An AIS Monitoring Wetland Data Form was filled out and emailed to the WDNR on February, 9, 2019. Many locations on the shoreline had reed canary grass and the aquatic forget-me-not. Site 2 and 5 had the aquatic forget-me-not (Exhibit 2).
