The Big Portage Lake Adaptive Management Plan

(Town of Land O' Lakes, Vilas County, Wisconsin)

Prepared by:
White Water Associates, Inc.
Contact: Dean Premo, Ph.D.
429 River Lane, P.O. Box 27
Amasa, Michigan 49903

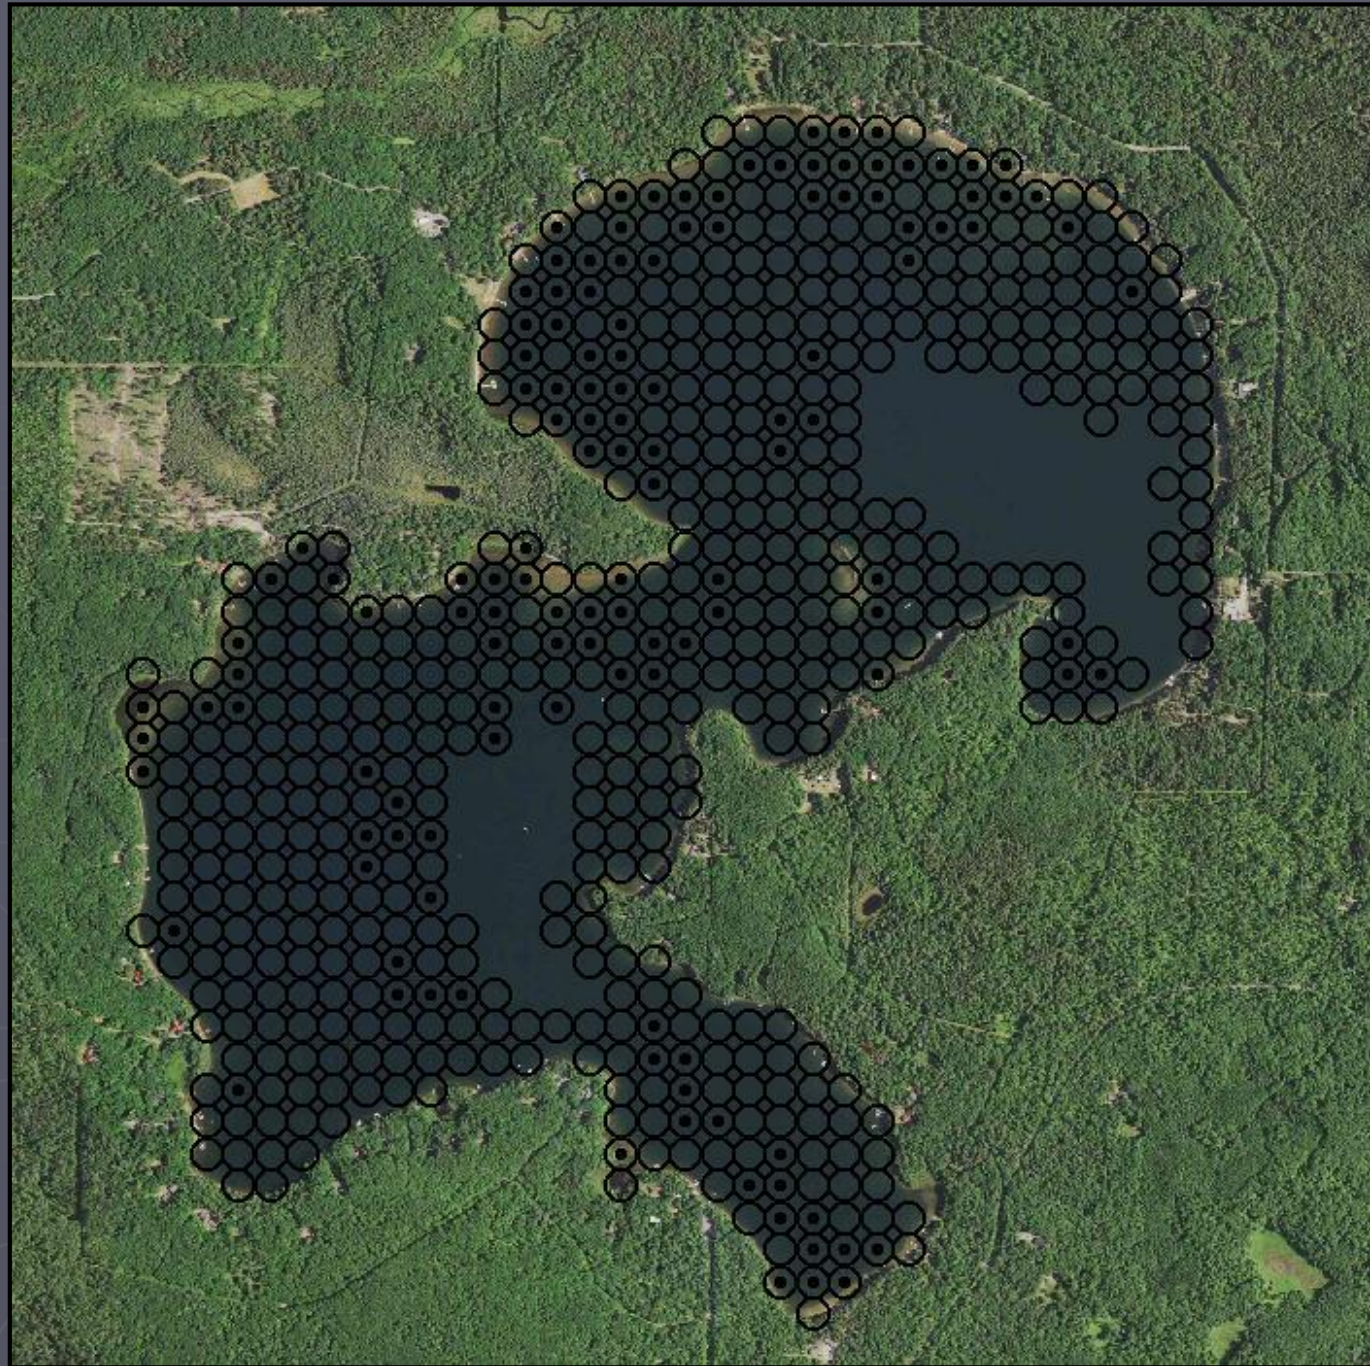
Figure 4. Big Portage Lake sampling sites less than or equal to maximum depth of rooted vegetation (2018).

- Site less than or equal to maximum depth of plant colonization (MDC).
- Plant find(s) at site less than or equal to MDC.
