LONG LAKE STARRY STONEWORT GRANT SUMMARY

AIRR19516

Lake and Pond Solutions Co.

January 12th, 2017

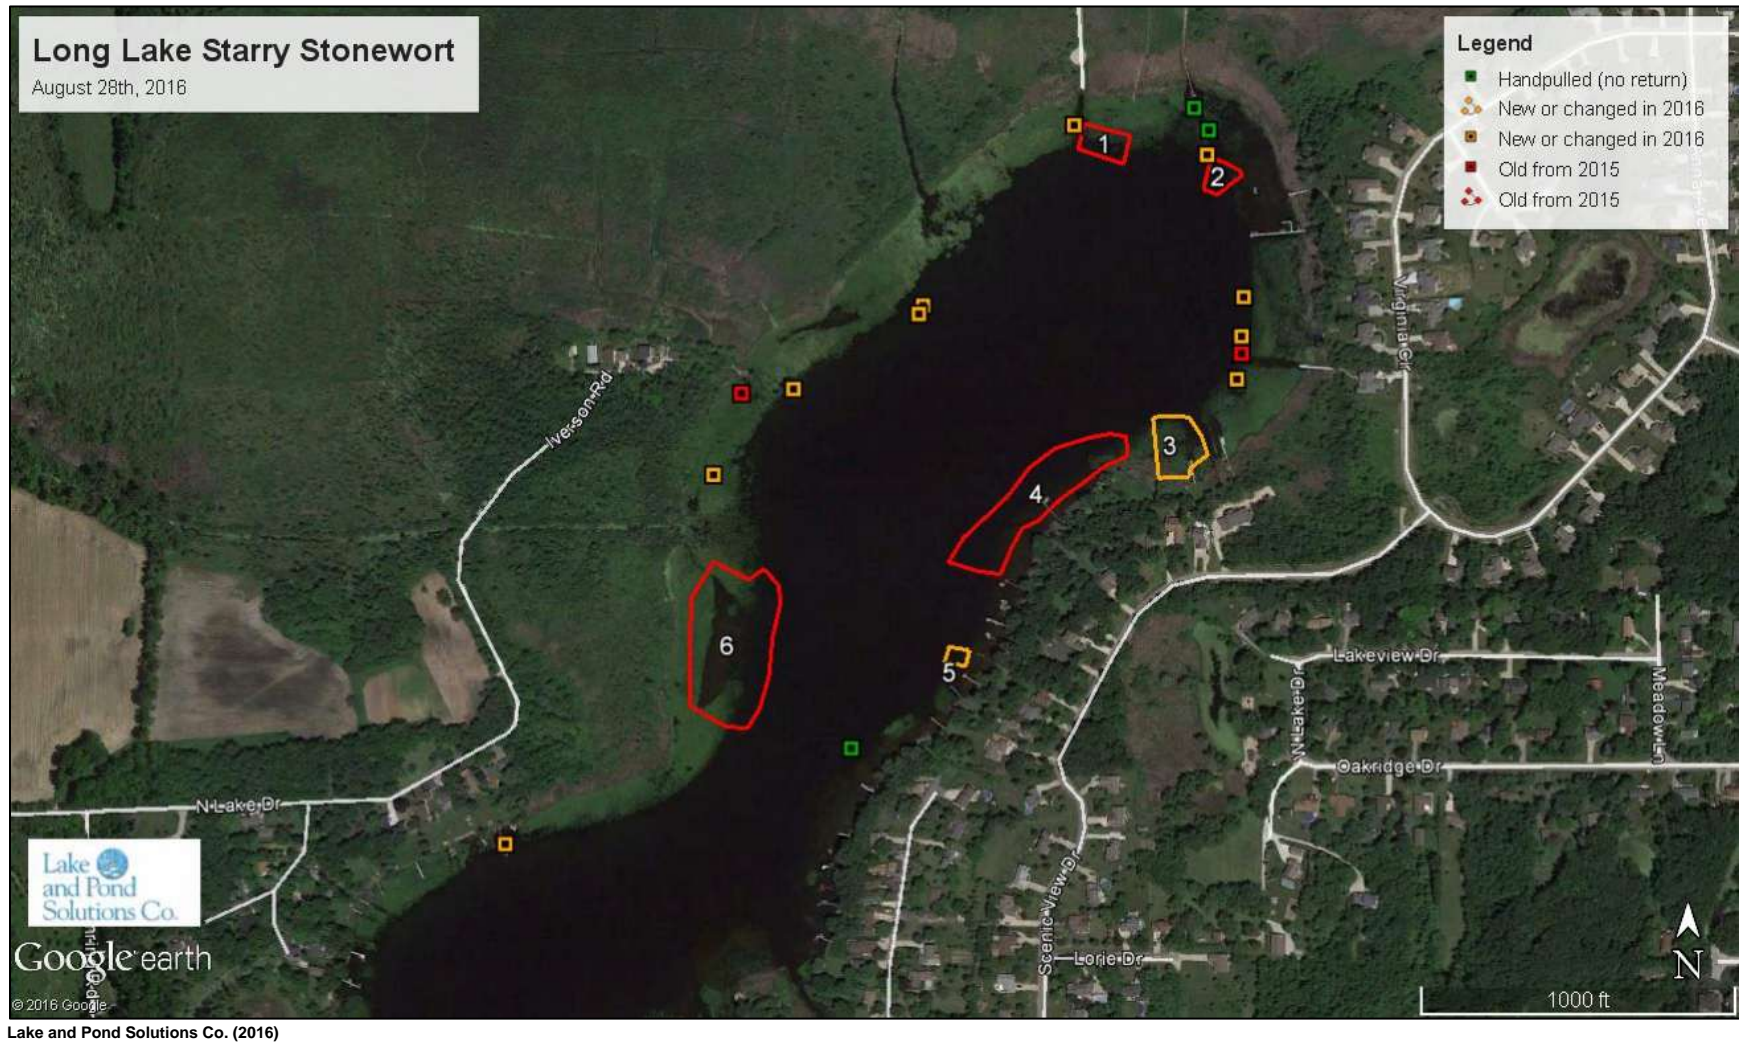
Figure 16: 2016 Starry Stonewort Survey Results

The 2016 survey built on previous data by adding new points and expanding bed configuration based on current growth. Figure 16 shows the most recent populations from August of 2016. There are now approximately 6.08 acres of SSW.

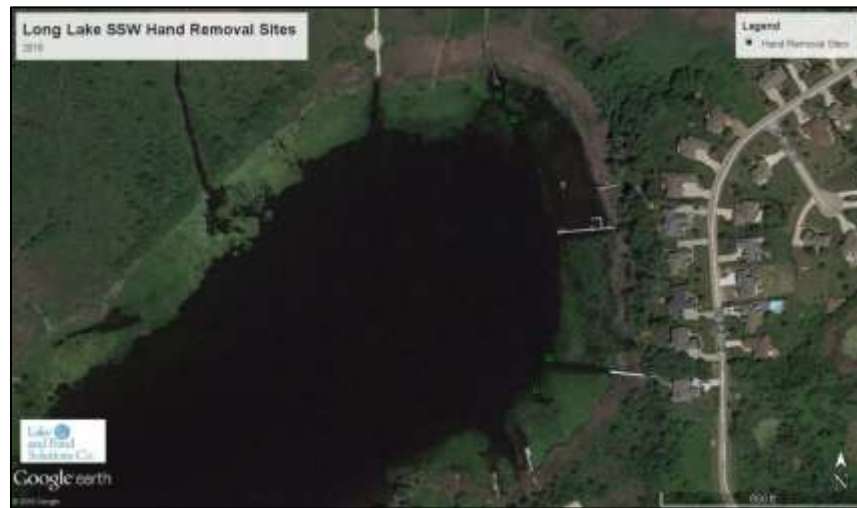
Figure 17: Long Lake 2015 Hand Removal Sites

Hand removal of SSW was performed during the intensive survey work in 2015. Any individual stands less than 5' x 5' were removed by snorkeling crews (Figure 17).

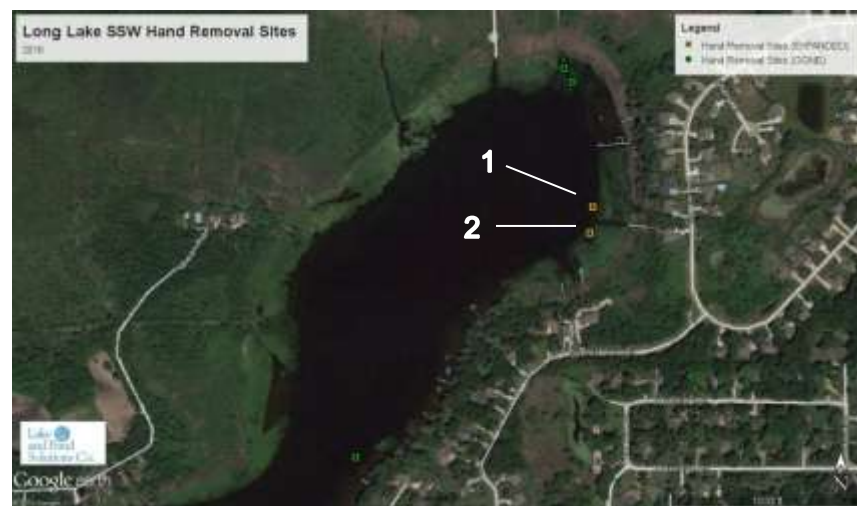
Figure 18: Long Lake 2016 Hand Removal Sites

By 2016, the two north hand removal sites had not returned and a new hand removal site was added to the south (Figure 18). However, the other two hand removal sites expanded significantly. Point 1 was now a 20' x 20' patch while Point 2 was a 30' x 30' patch.

Due to the varied responses of hand removal sites, it is difficult to truly assess the effectiveness. It is our theory that in the failed hand removal areas, bulbils left behind in the sediment served to repopulate in the subsequent year. In the successful sites, young populations may not have produced a significant amount of bulbils to support reproduction. To be a truly viable option, hand removal should only occur in new and small infestations and soft sediment should also be removed.

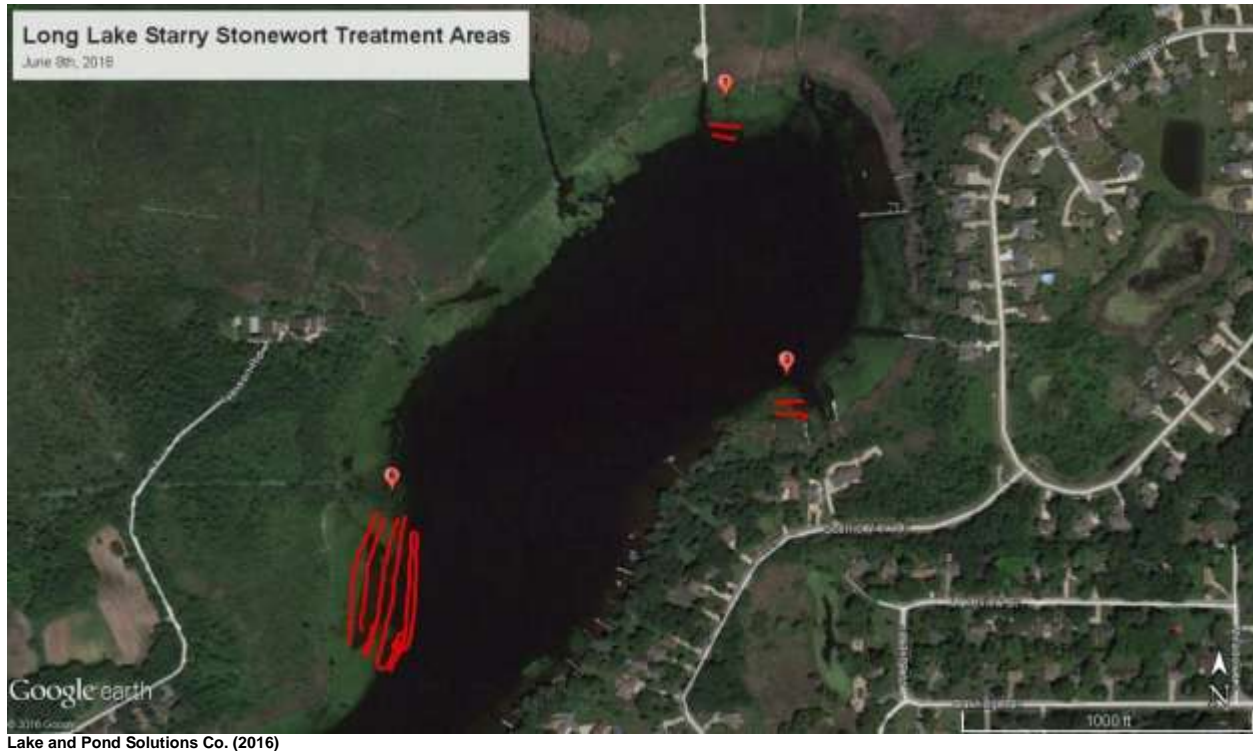
Figure 21: Long Lake SSW Treatment – June 8th, 2016

The treatment on 6/8/16 occurred in Polygons 1, 3, and 6 using Captain XTR (Figure 21). Polygon 1 (0.30 acres) and 3 (0.30 acres) were injected with 0.94 ppm Cu while Polygon 6 (2.73 acres) was sprayed and injected with 0.80 ppm Cu and a tracer dye. Unfortunately, general surveys on 6/24/16 showed that SSW was unaffected in all three polygons. Native plants were also unaffected except in Polygon 6 where chara was reduced in shallow water. These natives included white water lily, Illinois pondweed, small pondweed, elodea, bladderwort, algae, chara,

small pondweed, spadderdock, coontail, and flat-stem pondweed. It is unclear why the failures occurred but SSW heights (biomass) had swelled from 0.20 feet tall when treatment was requested on 5/24/16 to 1.80 feet tall when treatment was performed. Also, algae was more prevalent at the time of treatment which could have affected the uptake of copper by SSW.

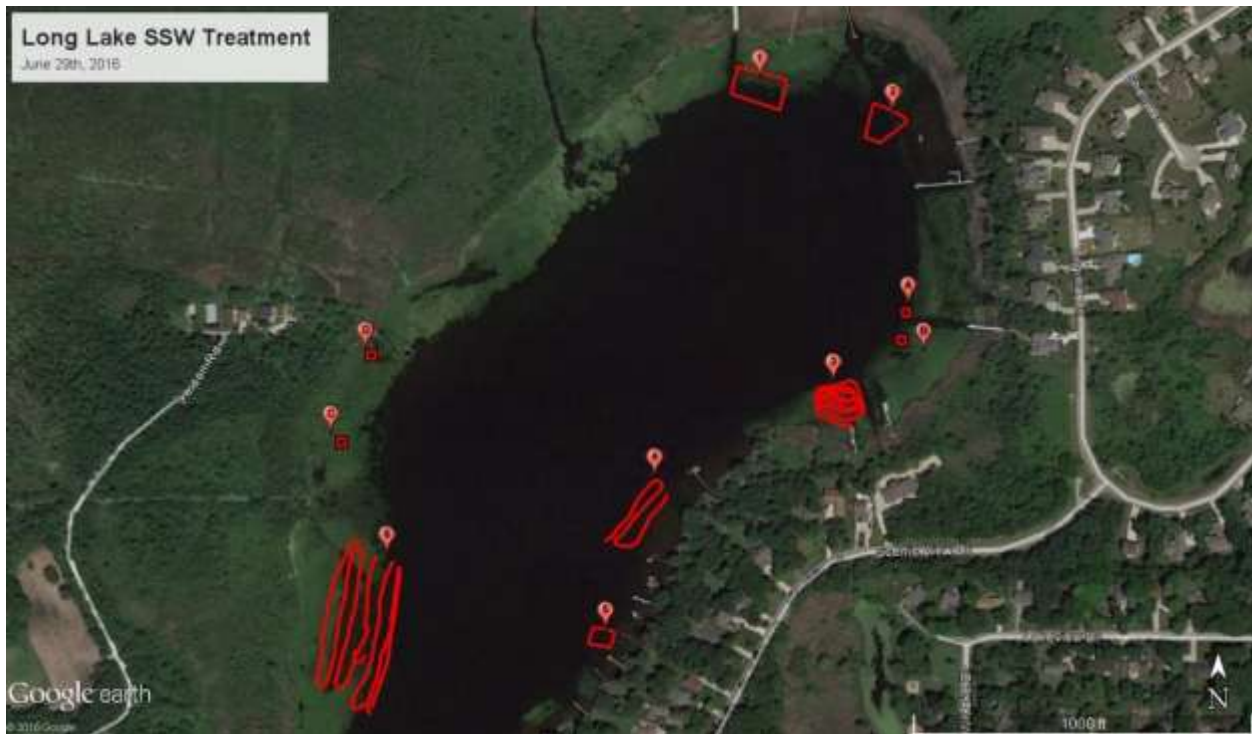
Figure 23: Long Lake SSW Treatment – June 29th, 2016

The treatment on 6/29/16 focused on treating all known beds of SSW with a mixture of different products (Figure 23). SSW heights ranged from 0.5 feet to 2.25 feet tall. Polygons 1, 2, and 5 along with all individual points were treated with Komeen Crystal at 0.98 ppm. Polygon 6 was sprayed with Komeen liquid at 0.8 ppm and Hydrothol at 0.29 ppm. Finally, Polygons 3 and 4S were injected with Komeen liquid at 0.86 ppm and Reward at 0.35 – 0.5 ppm (differences based on depth).

Komeen crystal treatments were successful on Polygons 1 (0.30 acres), 2 (0.19 acres), and 5 (0.07 acres) with no impacts to native plants. These natives included Illinois pondweed, elodea, coontail, watermeal, duckweed, bladderwort, white water lily, small pondweed, water celery, and chara. Unfortunately, Komeen crystals were not successful in treating individual points containing smaller beds (all 0.02 acres in size). Although this looks to be a viable treatment option, the smallest treatment area should be at least 0.10 acres in size.

The treatment on Polygon 6 (2.73 acres) with Komeen liquid and Hydrothol was unsuccessful with SSW showing heights expanding to 2.30 feet from 2.05 feet. There were no documented impacts to natives which included white water lily, small pondweed, bladderwort, algae, elodea, chara, and variable pondweed. The SSW bed in this area was the most dominant on the lake with thick monotypic growth in many areas. Interestingly, this area also saw a failed treatment back on 6/8/16. It is unclear if the mixes of products, thick growth, or other external factors are influencing treatment success.

Lastly, polygons 3 (0.60 acres) and 4S (0.74 acres) were injected with Komeen liquid at 0.86 ppm and Reward at 0.50 ppm and 0.35 ppm, respectively. The treatment on Polygon 3 was successful but impacts were observed for all native plants except water lilies (due to injection). These natives included chara, small pondweed, algae, elodea, and Illinois pondweed (limited impact). The polygon 4S treatment failed completely with no impacts to SSW or any natives (coontail, Illinois pondweed, small pondweed, and water celery). This site was generally much deeper and product may have been diluted by moving off site.
