**Map 2.26**  
**Transect Lines Used for Pewaukee Lake Aquatic Plant Surveys by Wisconsin Lutheran College: 2000, 2002, 2004, 2006, 2007, 2008, and 2009**

**Map 2.27**  
**Transect Lines Used for Pewaukee Lake Aquatic Plant Surveys by Wisconsin Lutheran College: 2010, 2013, and 2014**

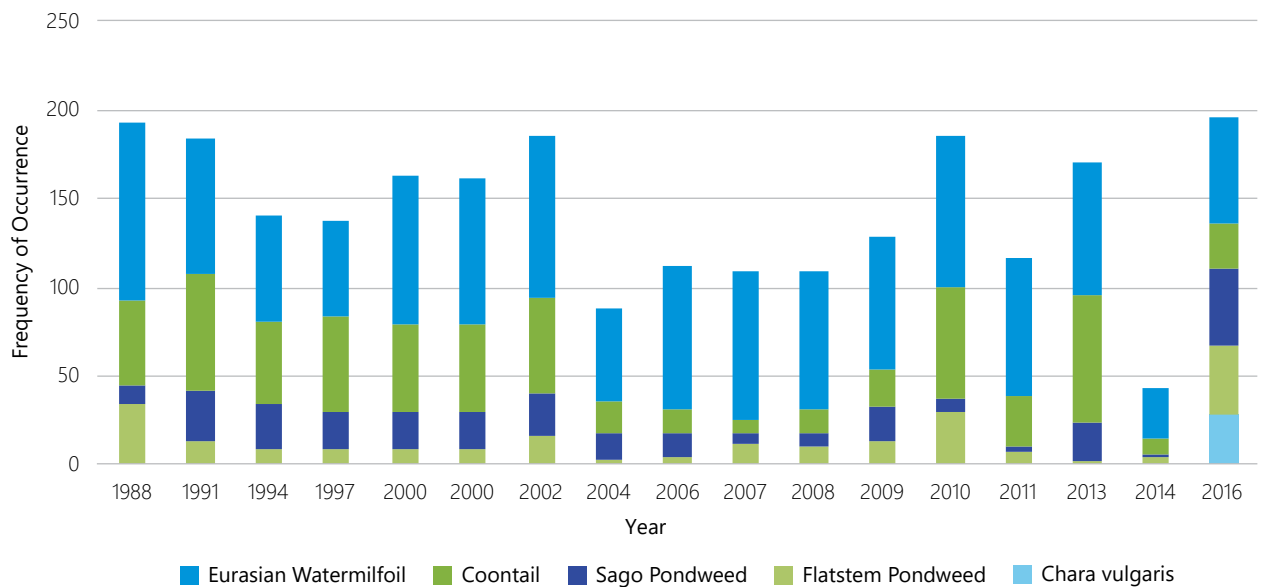
**Figure 2.66**  
**Frequency of Occurrence Trends of Five Species Abundant in Pewaukee Lake: 1988-2016**

Note: Two separate surveys were conducted in 2000, one by SEWRPC, and the other by Wisconsin Lutheran College.

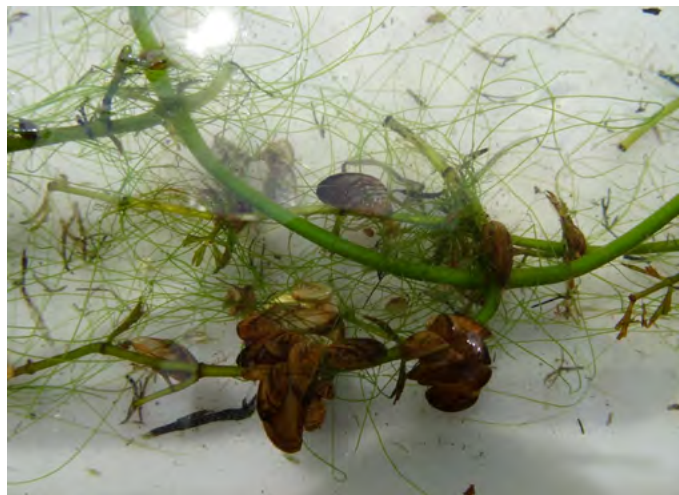
**Figure 2.83**  
**Zebra Mussels Attached to Eurasian Watermilfoil**

Populations of zebra mussel (*Dreissena polymorpha* – see Figure 2.83), a nonnative species of mussel, have been verified in Pewaukee Lake since 2004. Zebra mussels are small fingernail-size clams with D-shaped shells. Adults typically range from one-quarter to one and one-half inch in size. The shells commonly have yellow and brownish stripes. This invasive species reproduces rapidly (females can produce up to a half million eggs per year) forming colonies on nearly any clean, hard, flat underwater surface. This behavior has caused the zebra mussel to become a costly nuisance to humans as massive populations of the mollusk have clogged municipal water intake pipes and fouled underwater equipment. Zebra mussels feed by filtering small plants, animals, and particles from the water column, an action that deprives native zooplankton (small aquatic animals that form an important food source for many larger organisms), native mussels, juvenile and larval fish, and many other organisms of key food sources.

curious interplay between zebra mussels, water clarity, EWM, and native aquatic plants has been observed within Southeastern Wisconsin. Zebra mussels have been observed to attach themselves to stems of the EWM plants (see Figure 2.83). The increased weight of the shells and live mussels drags the plant deeper below the surface and partially out of the *photic zone* (the depth to which sufficient sunlight penetrates lake water to support photosynthesis). This interferes with the competitive strategy of the EWM plants and has sometimes contributed to regrowth of beneficial native aquatic plants. In other instances, decreased EWM has led to nuisance growths of filamentous algae (which is too large to be ingested by the zebra mussels). Regardless of the seemingly beneficial impact of zebra mussels on water clarity, the overall environmental, aesthetic, and economic tolls of invasive aquatic animals on lake ecosystems and recreational resource values generally outweigh positive factors.

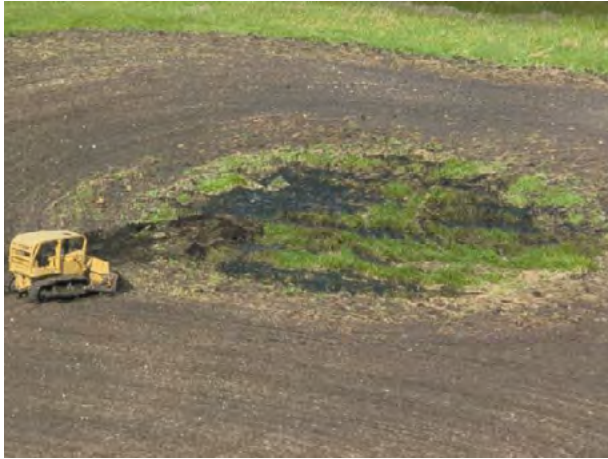
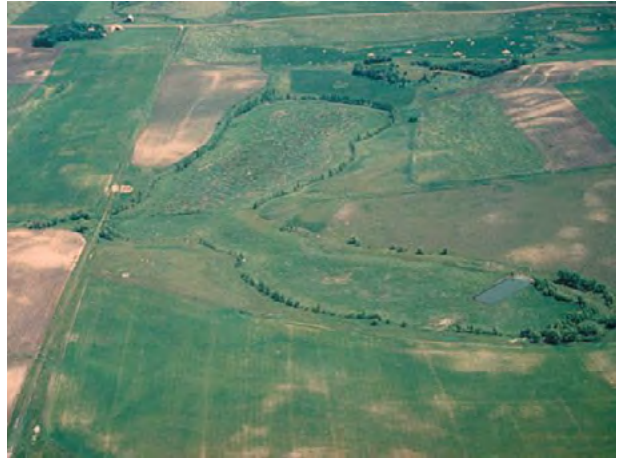
Recreation or Reconnection of Wetland and Upland Habitats

- ▶ **Recommendation 6.16: Encourage adoption of best management practices to improve wildlife populations**  
This should be a medium priority, although this should increase to a higher priority if wildlife populations decline. The acceptance and employment of BMPs can be fostered through voluntary, educational, or incentive-based programs for properties adjacent to the shoreline, and by directly implementing these practices on public and protected lands. Special interest non-governmental organizations (“NGOs”, e.g., Pheasants Forever, Ducks Unlimited, Trout Unlimited, Walleyes for Tomorrow, etc.) exist to foster habitat improvement projects, some of which collaborate with land owners to install beneficial projects. If this recommendation is implemented, a complete list of BMPs and relevant NGOs should be compiled and provided to landowners (see Figure 3.8 for examples of enhancing herptile habitats).

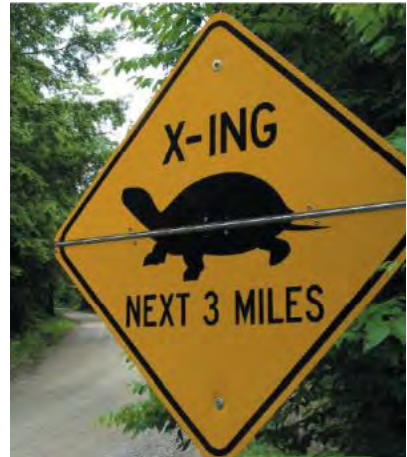
Removing Obstacles and/or Placing Signage Can Improve Safety and Effectiveness of Travel Between Habitats

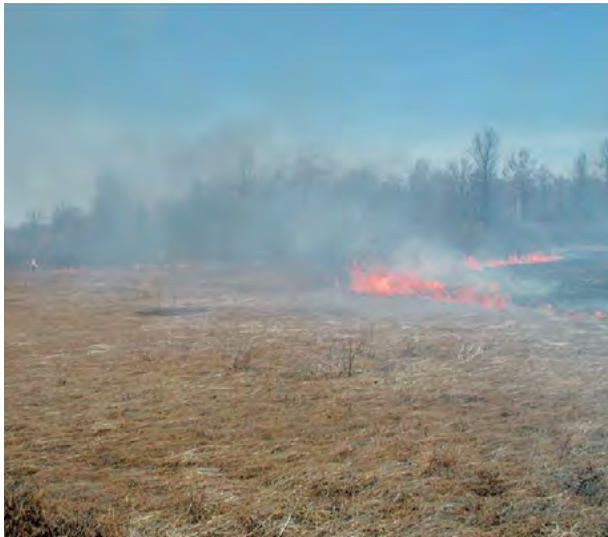
Burning Can Be an Effective Management Tool

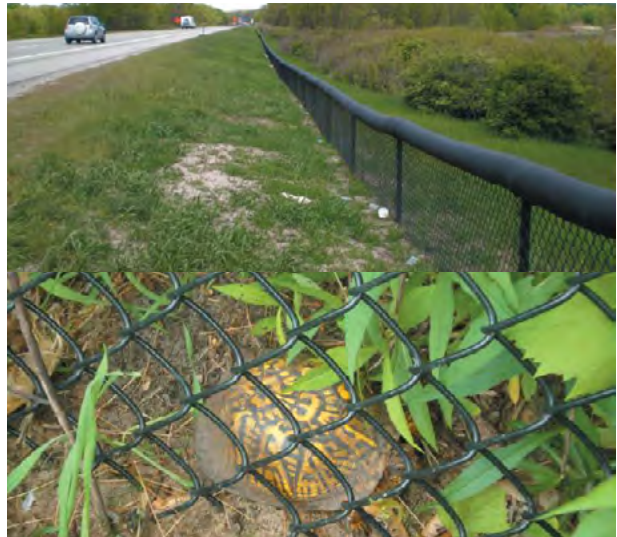
Roadside Fences Can Reduce Mortality
