Lake Study Report
Silver Lake – Portage, Wisconsin
WBIC #107700

Final Report
to Columbia County, City of Portage and
Wisconsin Department of Natural Resources

R. Haney & P. McGinley

Center for Watershed Science and Education
College of Natural Resources
University of Wisconsin-Stevens Point

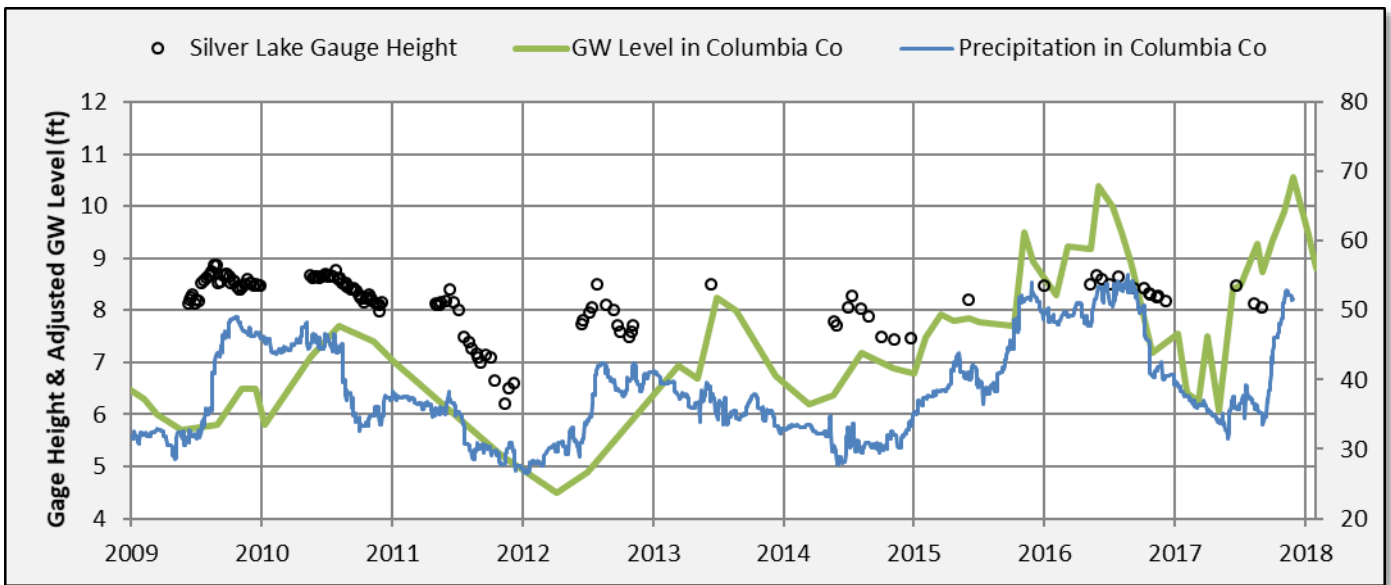
FIGURE 6. WATER LEVELS AND PRECIPITATION, 2009-2018. PRECIPITATION SHOWN AS TOTAL FOR THE PREVIOUS 365 DAYS (RIGHT AXIS), GROUNDWATER LEVEL RECORDED AT WELL USGS CO-12/09E/27-0620 IN THE SANDSTONE AQUIFER AND WATER LEVEL ADJUSTED BY ADDING 39 FEET TO FIT GRAPH SCALE (LEFT AXIS).

Silver Lake water level data (referenced to a staff gauge located on the bridge abutment between the two basins) between 2009 and 2018 is shown (black circles) in Figure 6 below. The data indicates nearly 3 feet in water level fluctuation with a high of almost 9 feet on the gauge in 2009 and a low of almost 6 feet in late 2011.

There is good correlation between the trend in annual precipitation (blue line) and water levels in Silver Lake for this time period which illustrates the lake’s response to these contributions. For further comparison, water level data from a monitoring well (green line) in Columbia County shows that water table elevations also show a similar trend with a low in early 2012 and high water levels in 2016 and late 2017.

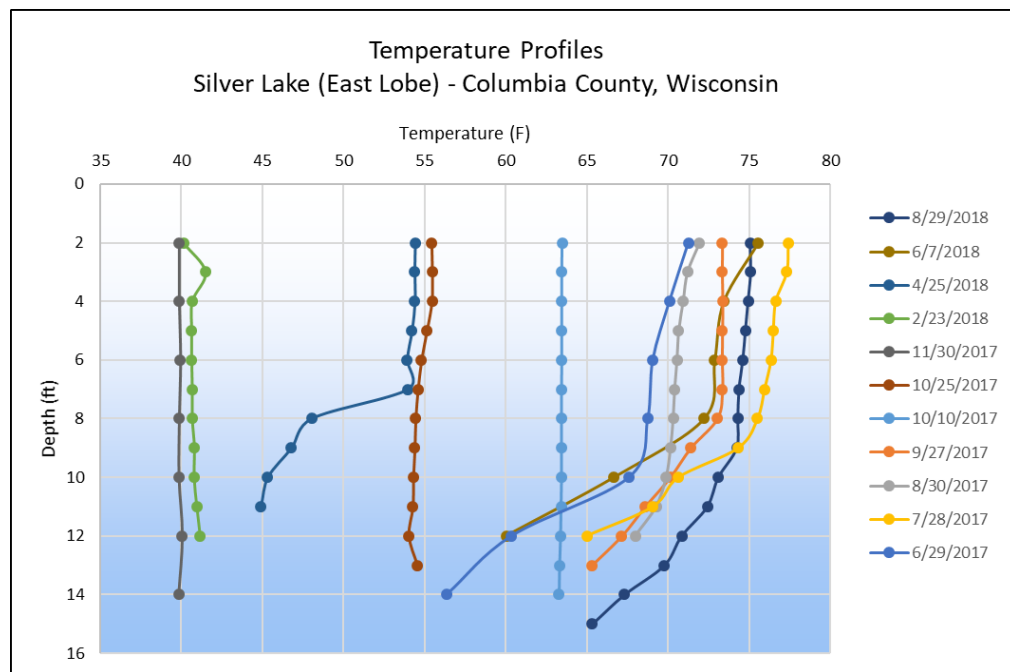
FIGURE 8. TEMPERATURE PROFILES IN SILVER LAKE, 2017-2019.

In a lake, the water temperature changes throughout the year and may vary with depth. Water temperature was measured in each basin of Silver Lake from the surface to the bottom at the time of sample collection (Figure 8). During the 2017-2019 study, temperature data illustrated a typical deep lake profile in the west basin with a well-developed thermocline by June between 15 and 25 feet. Spring and fall overturn profiles are apparent with temperatures between 37 and 42 degrees maintained with depth. The east basin illustrates typical profiles of a shallow, mixed lake that maintain a similar temperature from surface to bottom. During the summer months, a period of slight stratification develops as surface temperatures warm.

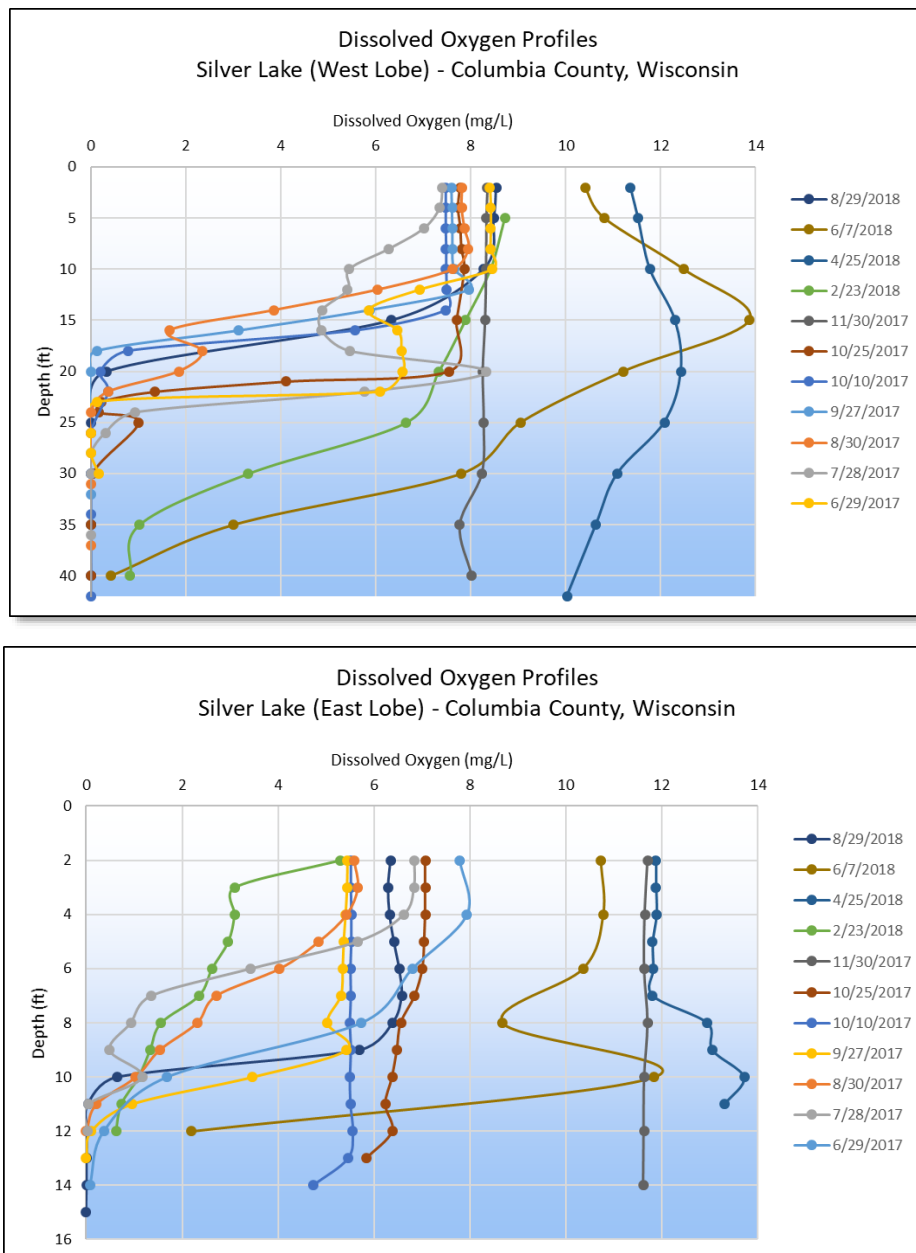
FIGURE 9. DISSOLVED OXYGEN PROFILES IN SILVER LAKE, 2017-2019.

Dissolved oxygen was measured in each basin of Silver Lake from the surface to the bottom at the time of sample collection. During the 2017-2019 study, dissolved oxygen data in the west basin illustrated a typical profile for a deep, stratified lake with moderate levels of nutrients. Most the year, these concentrations start near saturation at the surface and drop off significantly as depths reach the thermocline between 10 and 25 feet. During the summer, there is low oxygen concentrations below the thermocline. During spring and fall overturn, mixing of the lake leads to oxygen concentrations that are relatively uniform from surface to bottom (Figure 9). The bumps in concentration during the June, July and August 2017 profiles (west basin) at 20 feet are indicative of algae blooms at depth. This is largely absent in the east basin where more plants are available to outcompete algae for nutrients.

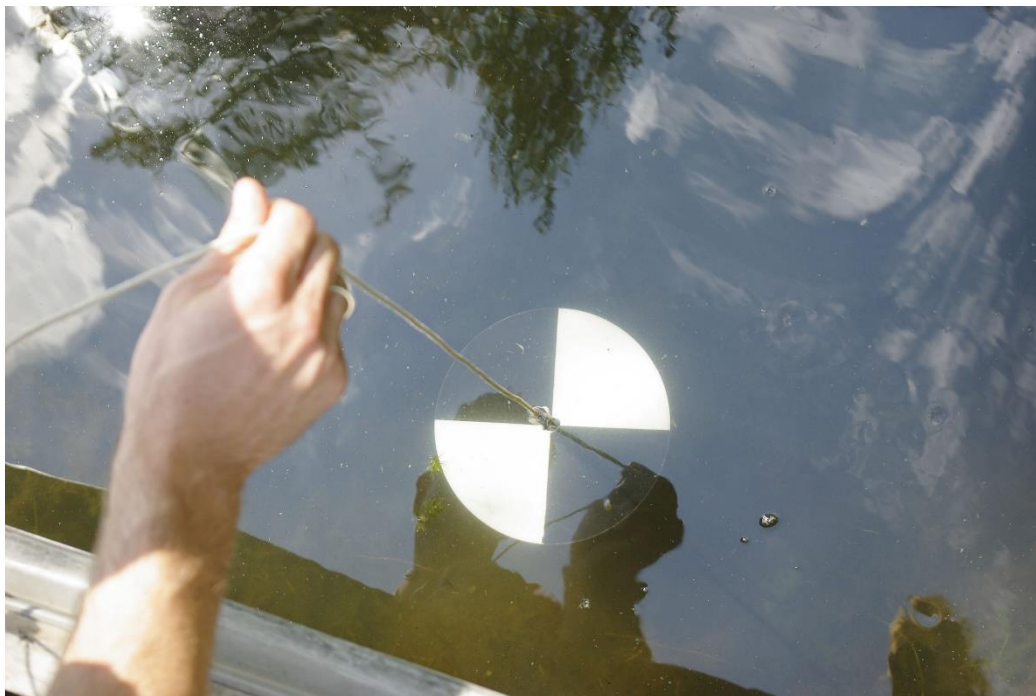
FIGURE 10. WATER CLARITY IN SILVER LAKE-WEST.

The west basin, which generally has slightly deeper secchi depths than the east basin, observed depths ranging from 7 feet to 17.7 feet during the study (Figure 10) and shows a decreasing trend over the long term (based on July/August data). When compared with past data as far back as the early 1970s, the average water clarity measured during the study was similar in all sampled months except. Water clarity in Silver Lake was typically reduced during the late summer and early fall.

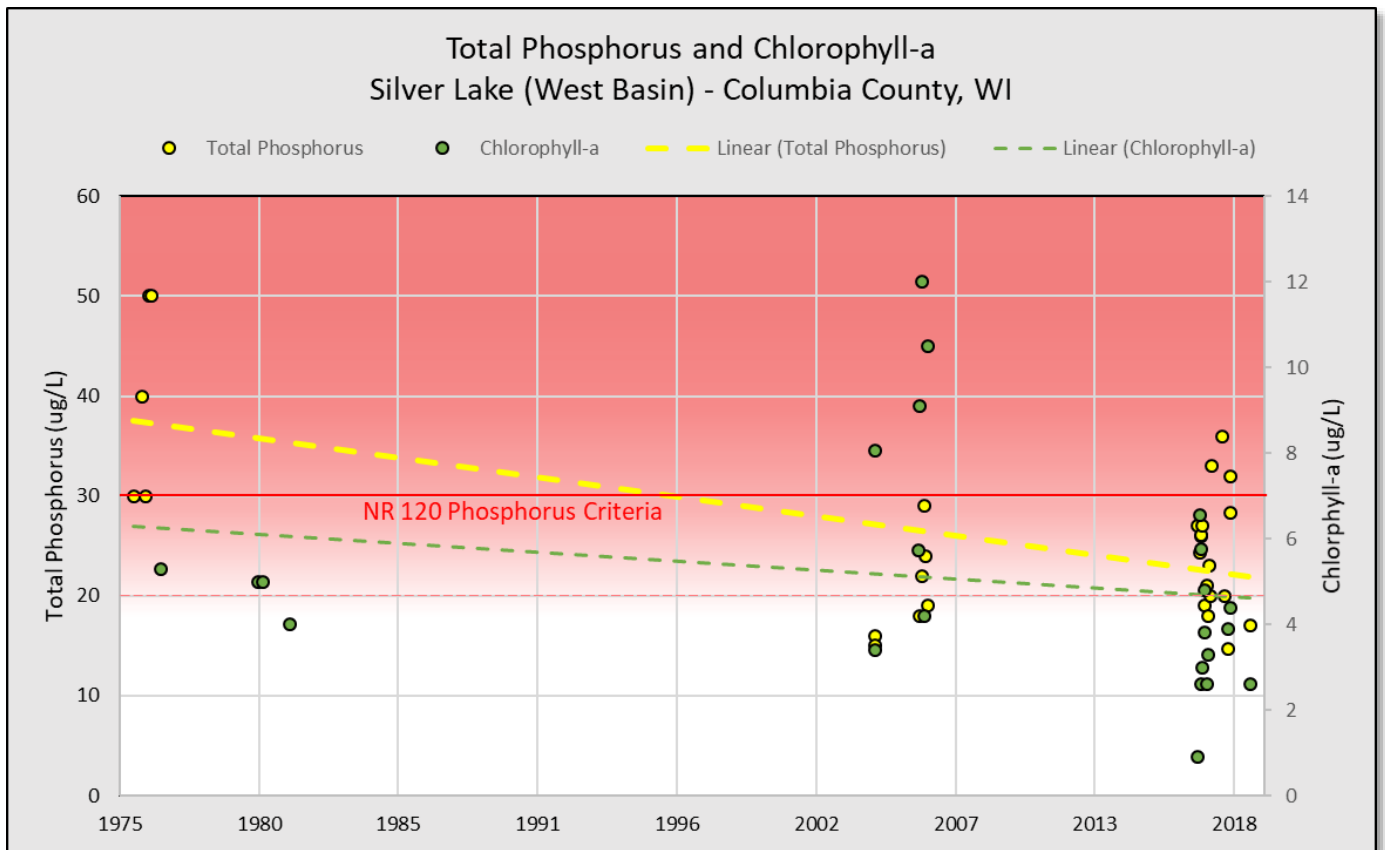
FIGURE 12. TOTAL PHOSPHORUS AND CHLOROPHYLL-A.

During the study, total phosphorus concentrations in Silver Lake (West) ranged from a high of 51 ug/L April 2019 to a low of 14.7 ug/L in July 2018 (Table 3). The summer median total phosphorus concentrations were 24.5 ug/L, 23.8 ug/L and 16.7 ug/L in 2017, 2018 and 2019, respectively. This is just above Wisconsin’s phosphorus standard of 20 ug/L for deep seepage lakes and just below 30 ug/L for drainage lakes (Figure 12). Silver Lake is a headwater drainage lake that likely has a large seepage component to its behavior. So, though the 3-year growing season average is technically below standard, it is at levels that are approaching threshold levels. Inorganic nitrogen concentrations in Silver Lake were within the natural background range for lakes in Columbia County.

Chlorophyll *a* is a measurement of algae in the water. Chlorophyll *a* concentrations in Silver Lake varied only slightly throughout the monitoring period ranging from a high of 6.5 ug/L in June 2017 to a low of 0.9 ug/L in May 2017. The average over the monitoring period was 3.7 ug/L. It should be noted that the standard Wisconsin Department of Natural Resources sample acquisition protocol was followed, collecting integrated samples of the upper six feet of water. Dissolved oxygen concentrations suggest that
