High, Fishtrap, and Rush Lakes Stewardship Program

Report on 2019 Aquatic Plant Surveys and Aquatic Invasive Species Surveys on High, Fishtrap, and Rush Lakes

Date: December 6, 2019

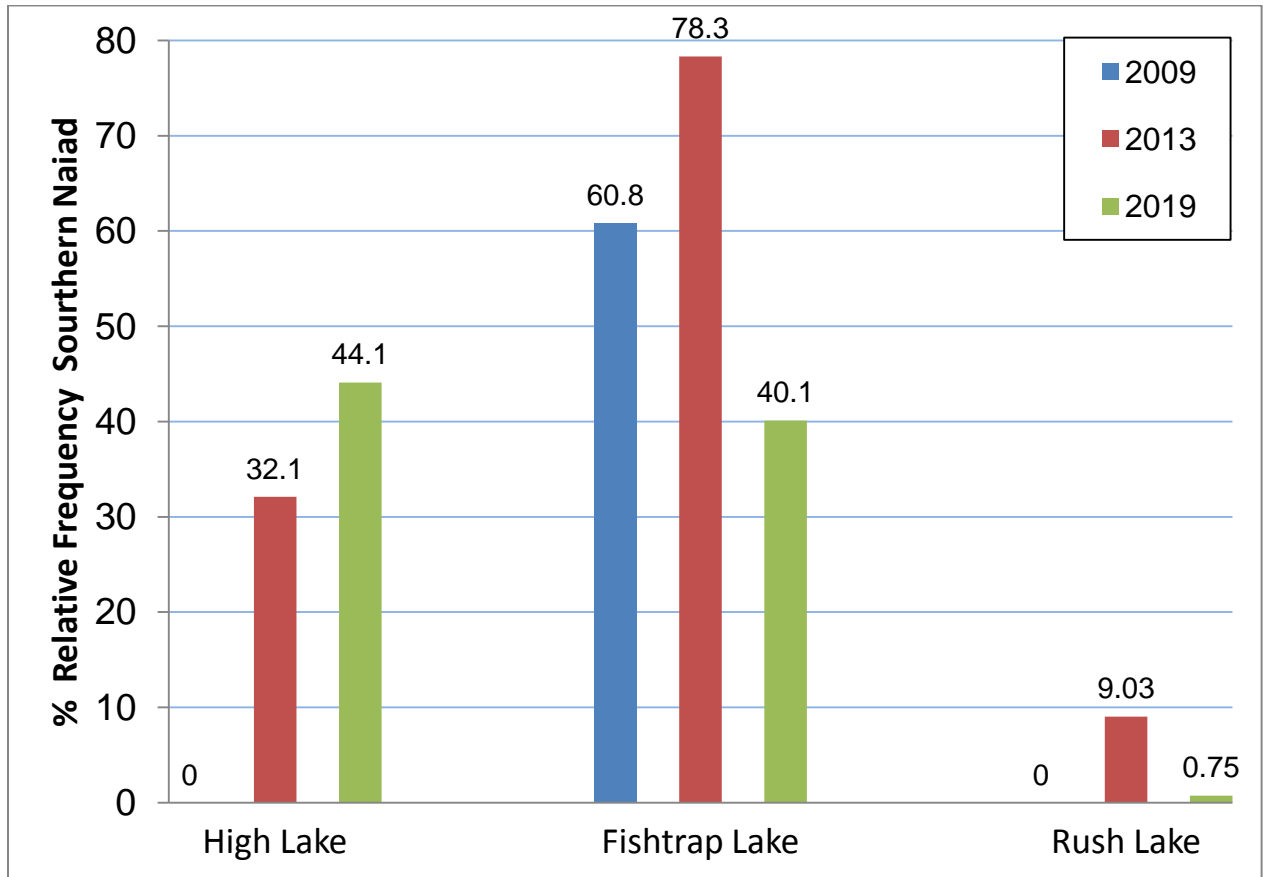
Exhibit 10. Relative frequencies of Southern Naiad in High, Fishtrap, and Rush Lakes in 2009, 2013, and 2019

Exhibit 10 (relative frequencies of Southern Naiad in High, Fishtrap, and Rush Lakes over the survey years) – Since the native plant Southern Naiad has been a concern to the HFRLA over the past few years, we created this comparative histogram that shows the trends of relative frequency of occurrence in each of the lakes over time. High Lake increased since 2013 whereas Fishtrap and Rush decreased. This demonstrates the ebbs and flows of populations that are not unusual in natural ecosystems.

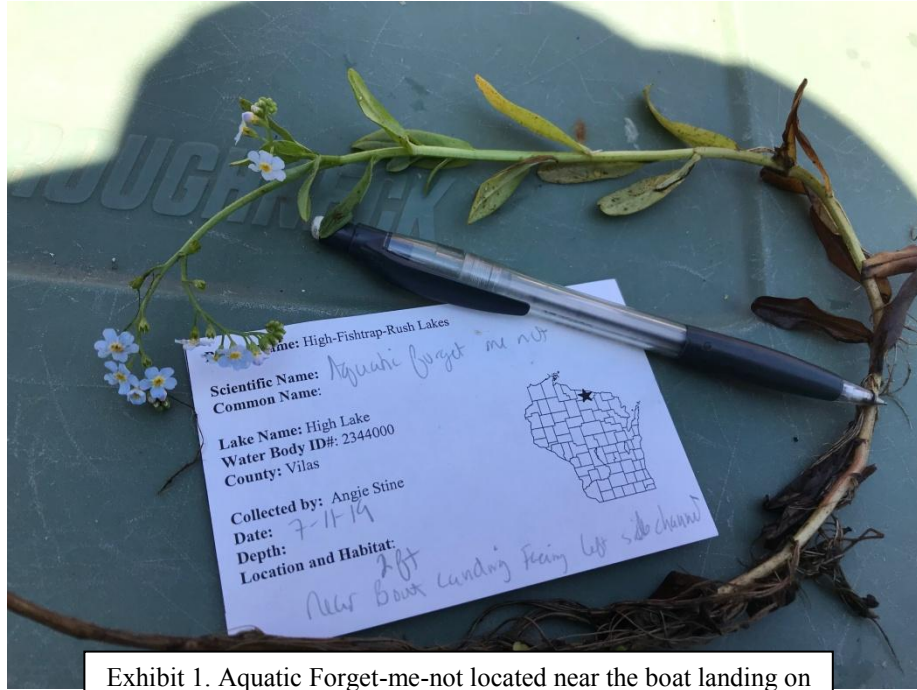
Between sites a meander search is used to look for any AIS that may appear. A new find of the Aquatic Forget-me-not (*Myosotis scorpioides*) was found near the boat landing (Exhibit 1). A voucher was pressed and sent to Dr. Freckmann for verification.

Exhibit 1. Aquatic Forget-me-not located near the boat landing on High Lake, Vilas County.

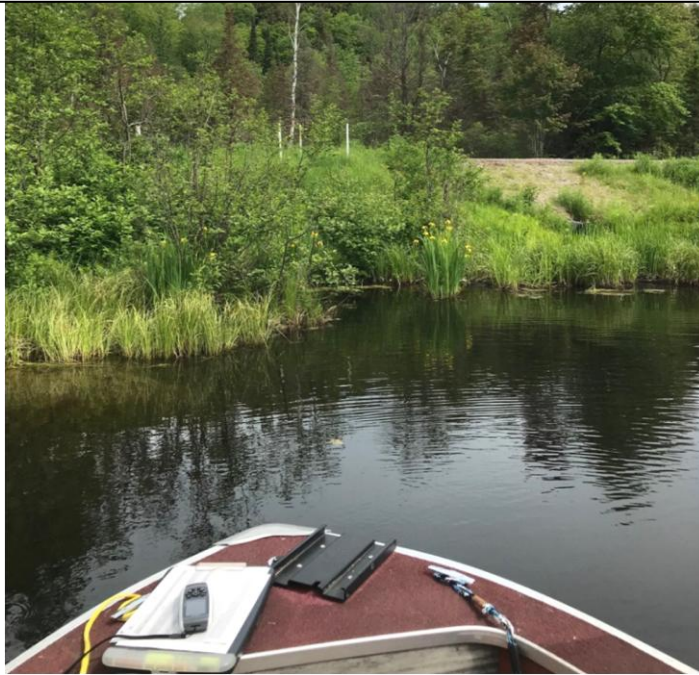
Exhibit 2. Yellow Iris located on High Lake, Vilas County.

Four known AIS are established in High Lake; the rusty crayfish, Chinese mystery, Banded mystery snail, and the yellow iris (Exhibit 2). As Table 1 indicates, for the 2019 survey the yellow iris, Chinese mystery snail and banded mystery snail were found. The only new aquatic invasive was the Aquatic Forget-me-not (*Myosotis scorpioides*).

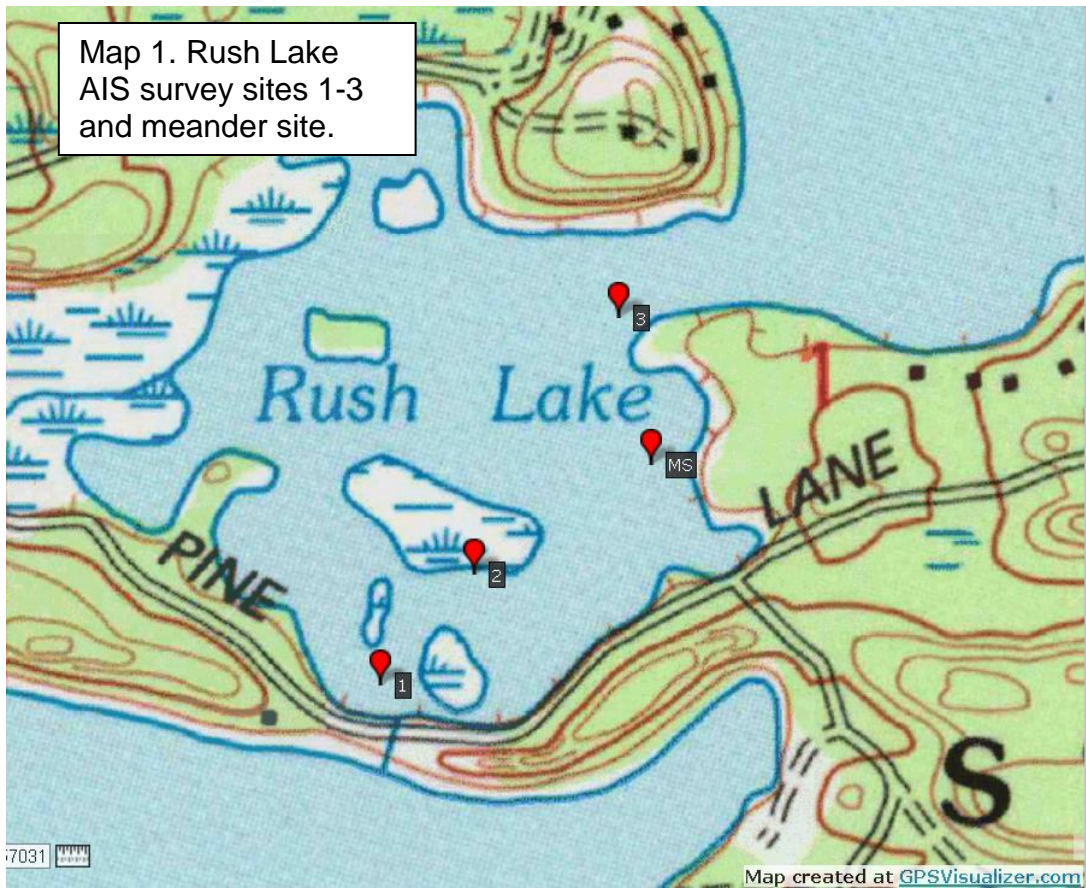
Map 1. Rush Lake
AIS survey sites 1-3
and meander site.

Three sites around the lake shoreline were searched along with a meander search in between sites. The three shoreline sites were randomly selected and are identified in Map 1 and Table 1. Snorkeling was not used to search for AIS due to the water temperature. A long rake was used to collect any suspicious aquatic plants for closer inspection and identification. A D-net was used to collect any suspicious invertebrate animals to look for AIS. Any invasive species observed were recorded. In the event of a new AIS record, specimens are collected for verification.

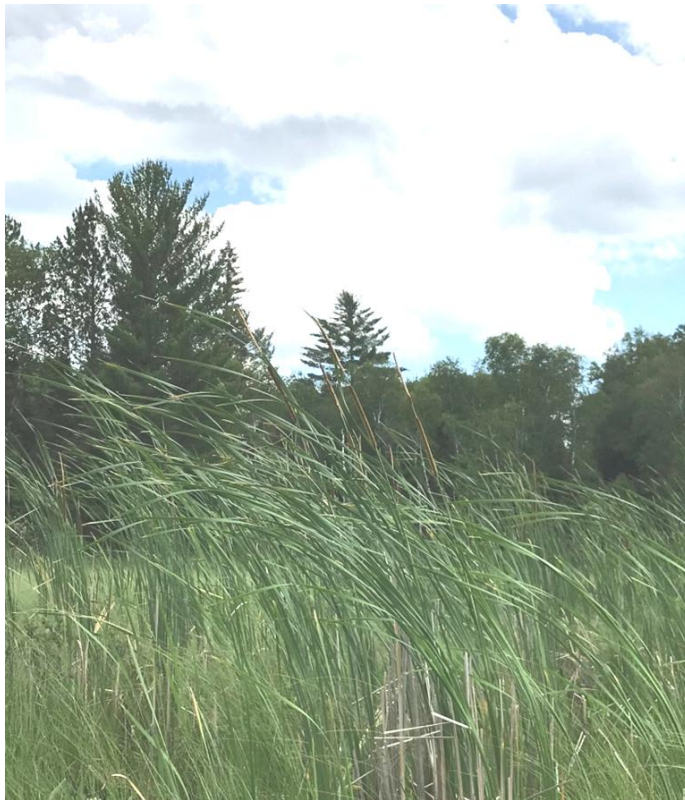
Between sites a meander search is used to look for any AIS that may appear. A new find of the Narrow-leaf cattail (*Typha angustifolia*) was found (Exhibit 1). A voucher was pressed and sent to Dr. Freckmann for verification. It was verified and now resides at the UW Stevens Point Herbarium.

Exhibit 1. Narrow-leaf cattail located near the shore on Rush Lake, Vilas County.
