City of Stoughton
2021 URBAN SERVICE AREA
AMENDMENT

51 West Addition

April 30, 2021

51 WEST ADDITION

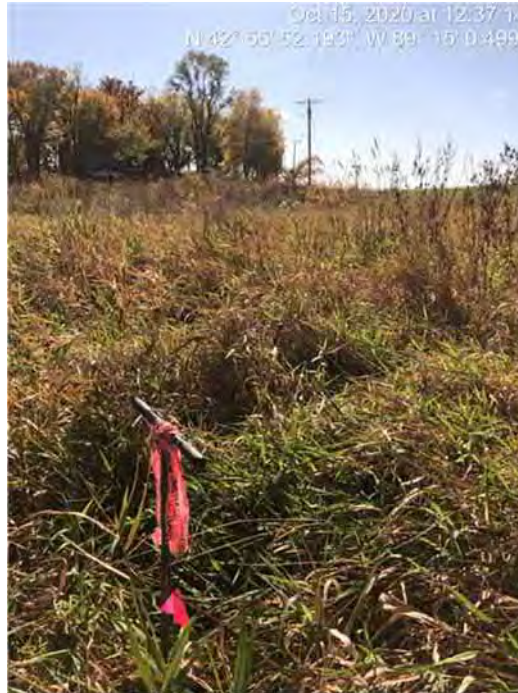
Facing south – shows the location and surrounding vegetation at Sample Plot 1A.

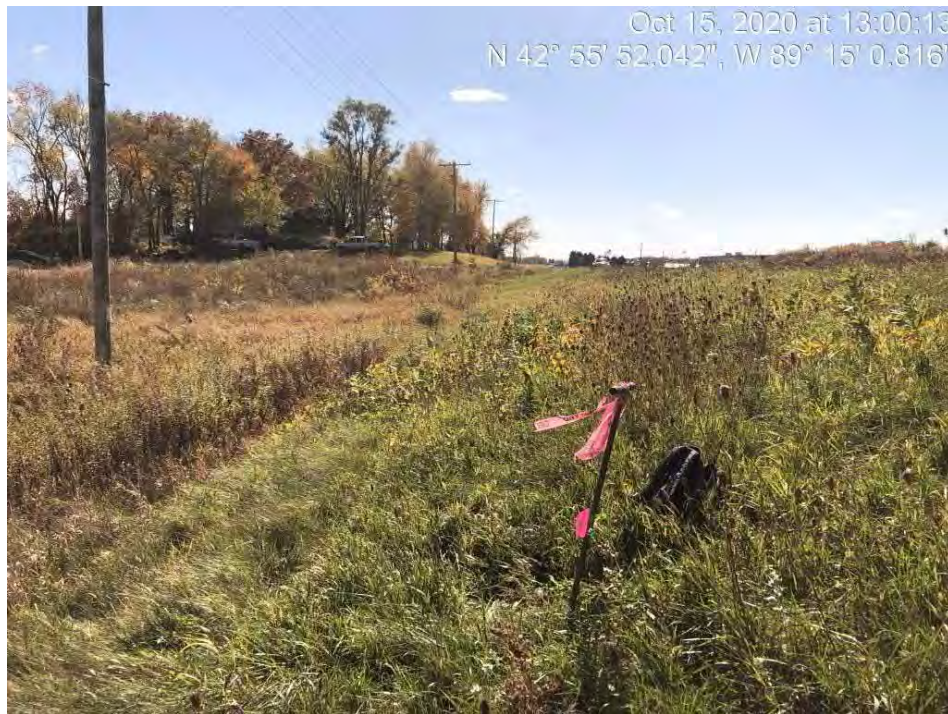
Facing south - shows the location of Sample Point 1B and the slope from the road shoulder.

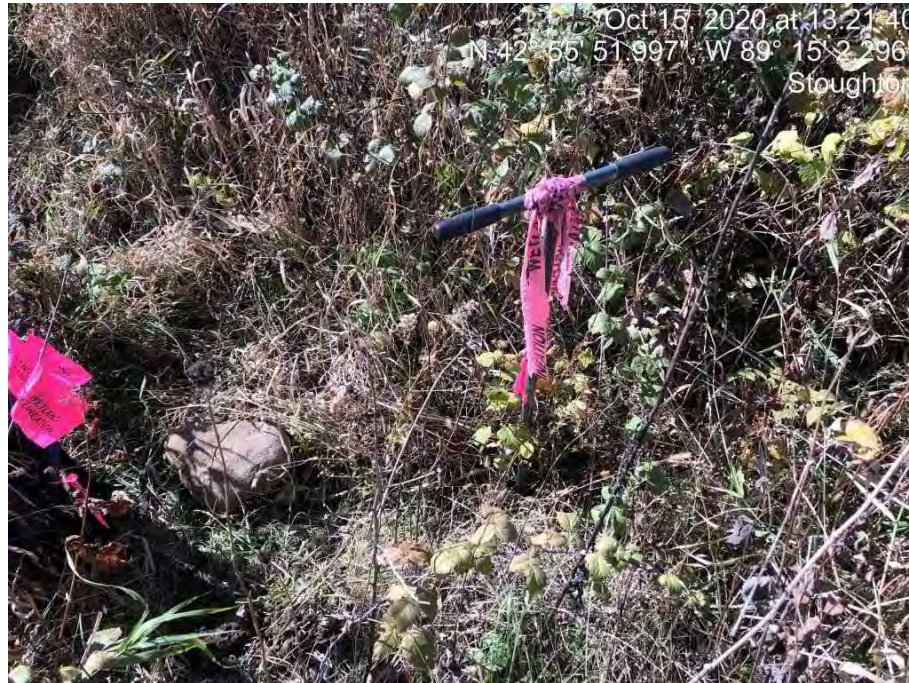
Shows the vegetation and ground condition at Sample Point 2A.

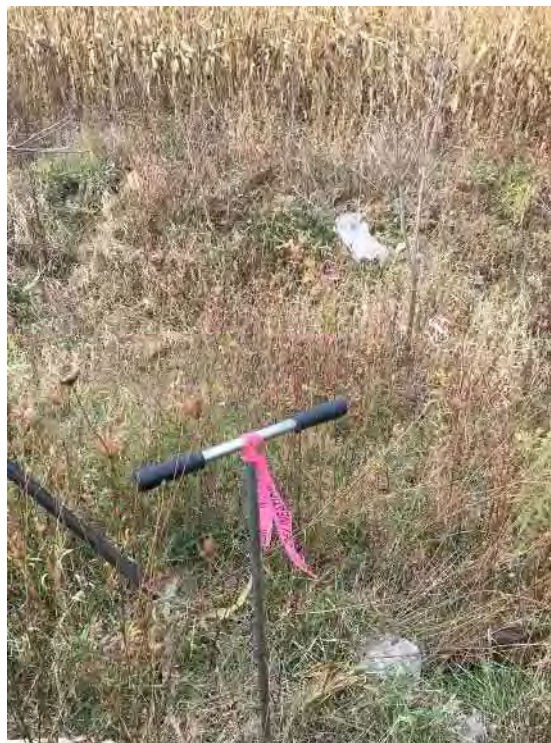
Facing west - shows Sample Plot 2B with Sample Plot 2A in background

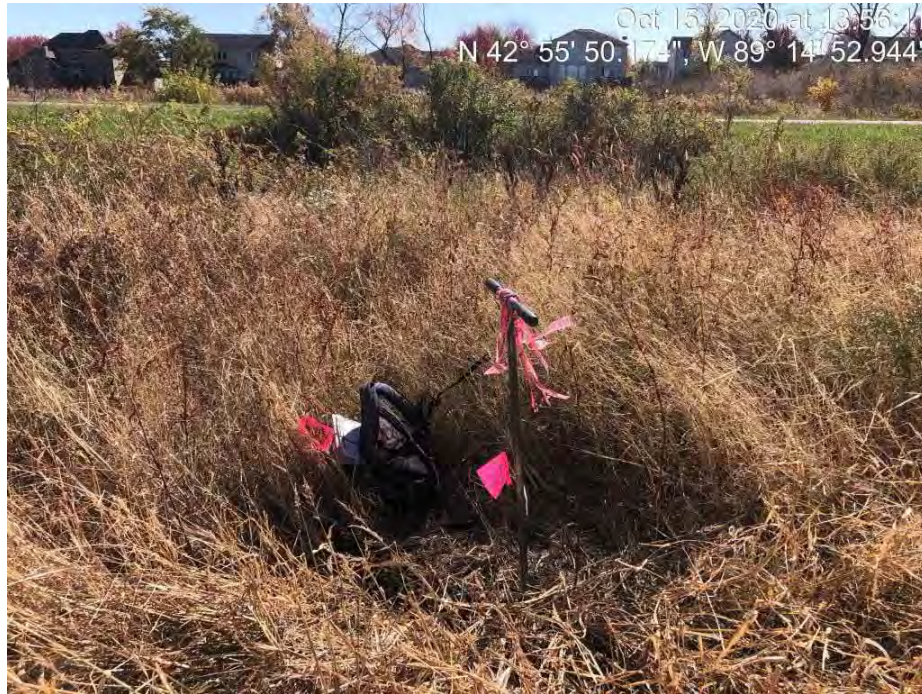
Facing south toward Velkommen Way – shows the surrounding vegetation at Sample Plot 3A.

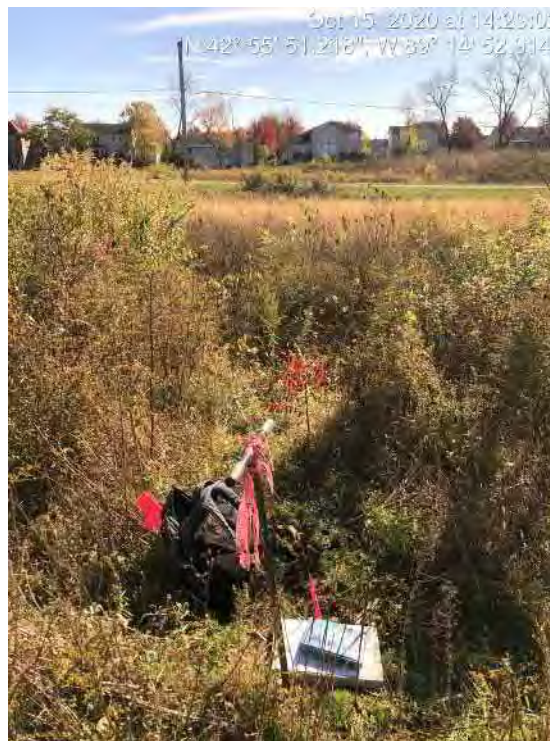
Facing south - shows the location of Sample Plot 3B and Wetland 3 in the distance.

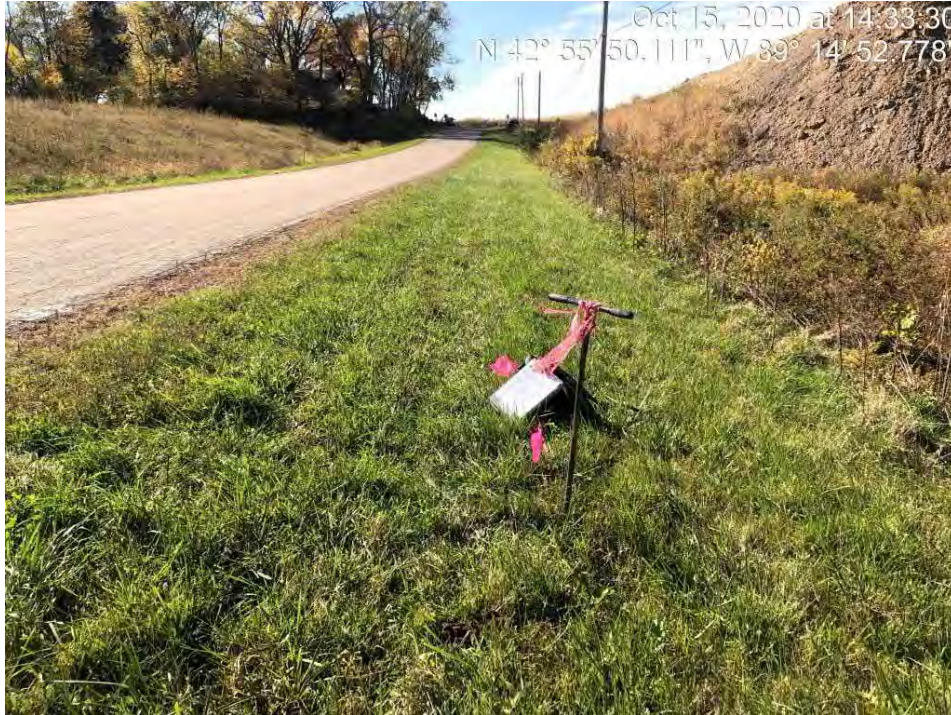
Facing west - shows the location of Sample Plot 3C and some of the existing earthwork on site.

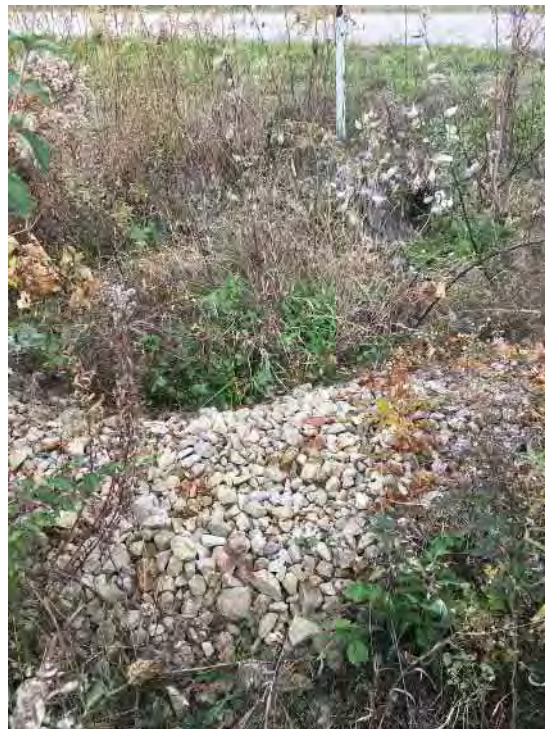
Shows rocks at culvert outlet in Velkommen Way

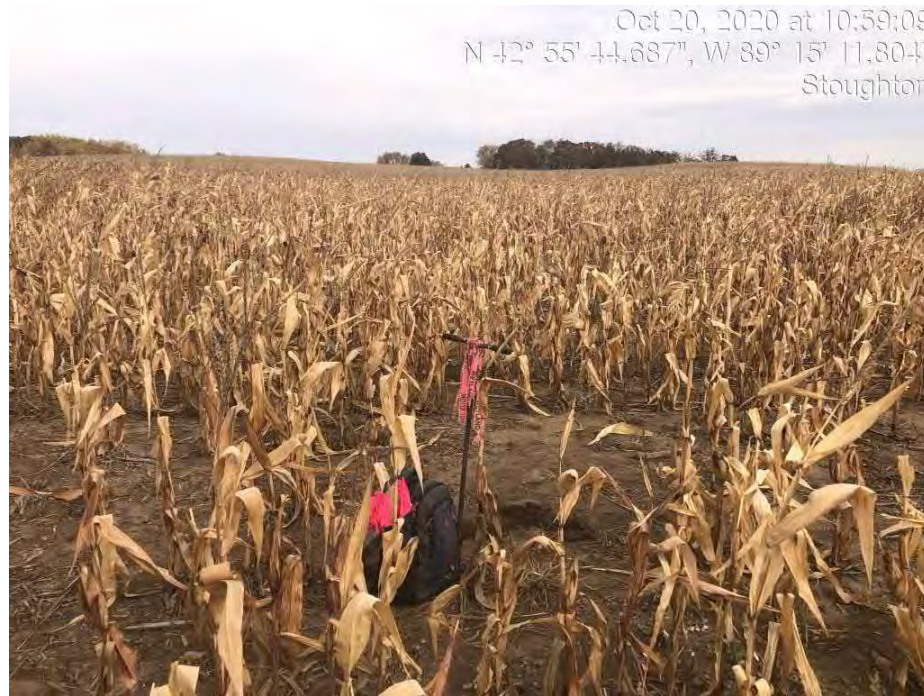
Facing west at sample point 4A showing underdeveloped crops

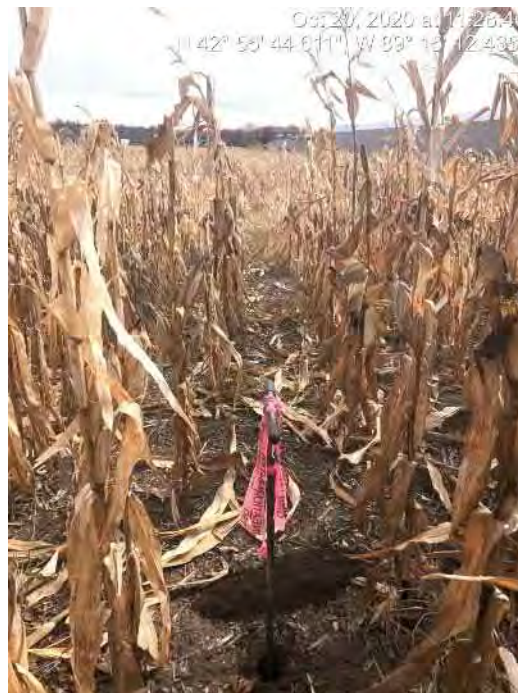
Facing east at sample point 4B toward sample point 4A and wetland 4

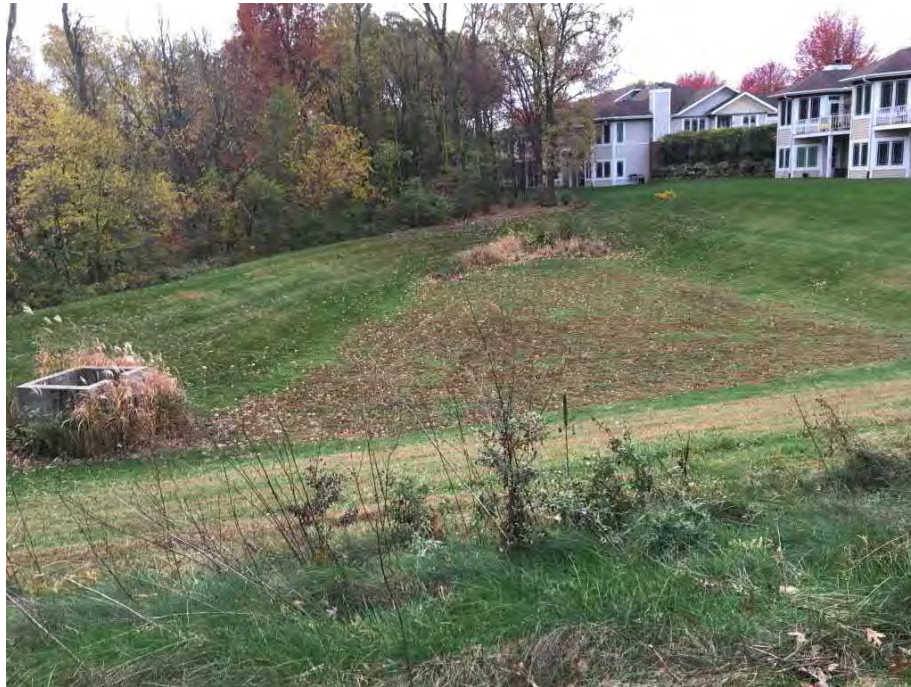
Facing south - shows infiltration basin and location of Sample Plot 21A
