Rice Lake Management Plan November, 2020 Iron County, Wisconsin

Rice Lake Association, Inc.

Aquatic Invasive Species Committee

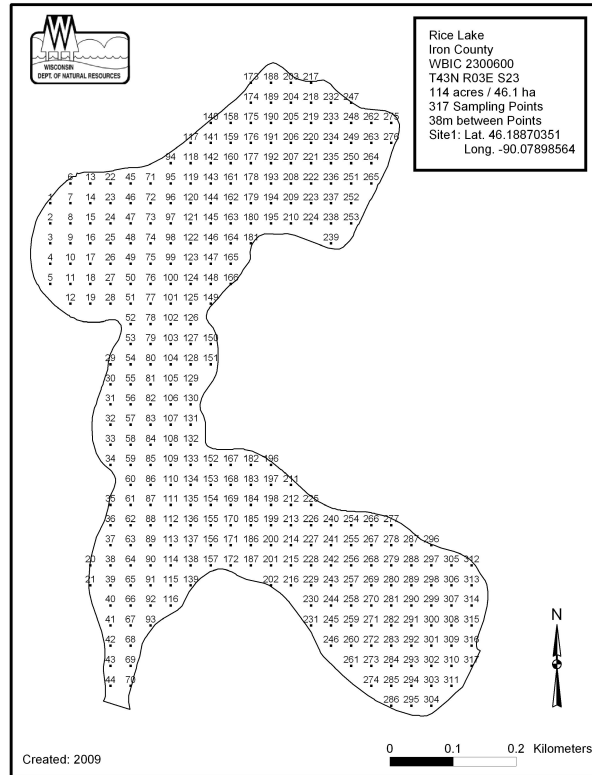
Figure 7: Map of point intercept sampling grid.

In June of 2020 a point intercept survey was conducted on Rice Lake. The survey involved sampling plants at each of 279 pre-determined sample points. Each species on the rake was given a density rating from 1-3.

There were 279 sample points for aquatic macrophytes in Rice Lake. There were 187 sites with vegetation sampled or 84%. The greatest depth plants were sampled was 12.7 feet. This is relatively shallow for the deepest growth of plants, but is probably due to the dark brown color of the water (from tannins). There were 266 sample sites with vegetation that were shallower than 12.7 feet, which calculates to 91% of the littoral zone (depth where plants can grow) with plant growth.

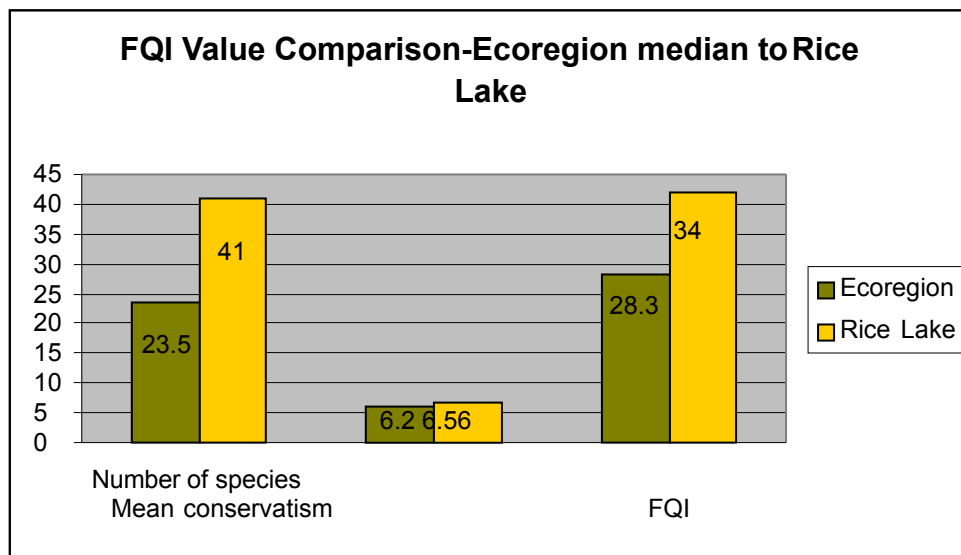
Figure 9: Comparison of FQI median value for the ecoregion (Northern Lakes and Forests-Flowages) to the Rice Lake FQI values.

The FQI for Rice Lake is very high. This shows that the plant community has several intolerant plant species. These are plants that do not respond well to habitat changes and/or water quality degradation in the lake. The mean conservatism for the Rice Lake FQI is 7 which is higher than normal.

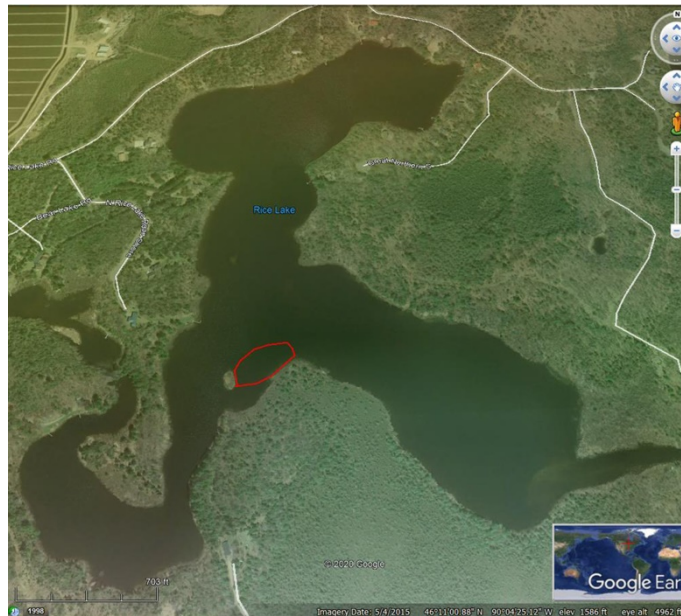
In June of 2020 we conducted a test run of hand pulling of CLP on Rice Lake. Approximately 27 boat-hours* were spent in effective mass pulling. In the area covered we estimate that 90% of the weeds were pulled. The area covered is approximately 2% of the total lake, not including the river outlet.

Approximately 140 cubic feet of CLP (compacted) were removed.

If we were able to accomplish 800 boat-hours using our improved rakes and methods, we should be able to remove about 4,100 cubic feet and thoroughly cover a minimum area of about 87 acres. If we were to get on to the lake earlier in the CLP growth cycle, the numbers would improve.
