Beecher Lake EWM Control Project Phase II – Final Report

(AIS Control Grant # ACEI-172-15)

Chuck Druckrey
Marinette County Land Information Department
Land & Water Conservation Division
June 2020

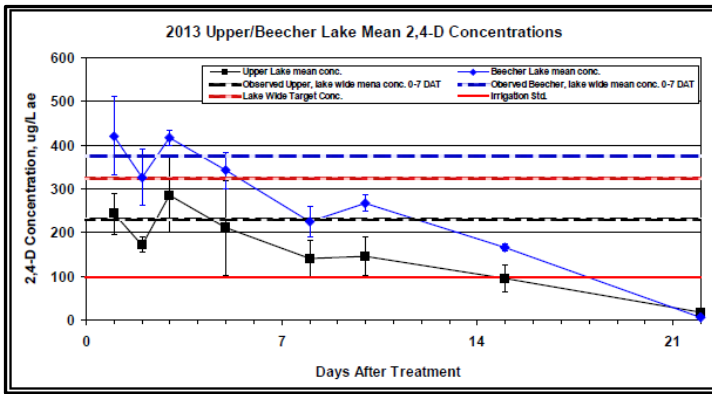
Figure 11. 2,4-D concentration monitoring results for the 2013 whole-lake treatment.

The Upper Lake basin mean herbicide concentration, 0 to 7 DAT was 232 ug/l. The Beecher Lake Basin mean herbicide concentration, 0 to 7 DAT was 377 ug/l. This indicates some flushing of herbicide from the Upper Lake basin into the Beecher Lake basin (figure 11).
