Fenwood Creek Targeted Watershed Assessment: A Water Quality Report to Protect & Restore Wisconsin Waters

A Water Quality Monitoring Report created by the Bureau of Water Quality in support of the Clean Water Act.

*Marathon County
Monitored 2016-2017
HUC12 070700021602*

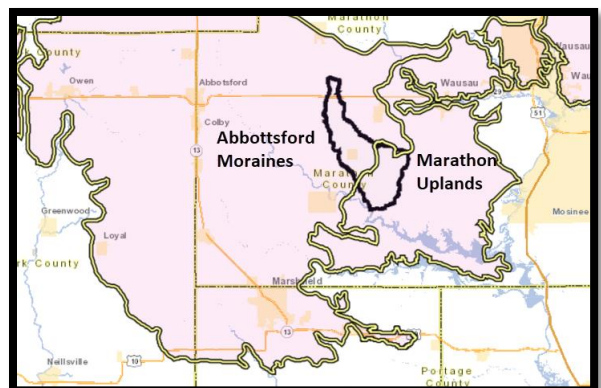
Figure 5. Fenwood Creek Watershed and Landtype Associations

Soil descriptions are described in “Wisconsin Landtypes”(Figure 5). The watershed spans two landtypes. **Abbotsford Moraines Landtype:** The characteristic landform pattern is undulating moraine. Soils are predominantly somewhat poorly drained silt loam over acid loam till. **Marathon Uplands Landtype:** The characteristic landform pattern is rolling bedrock-controlled erosional surface. Soils are predominantly well drained silt loam over acid loam till, loamy residuum, or igneous/metamorphic bedrock.

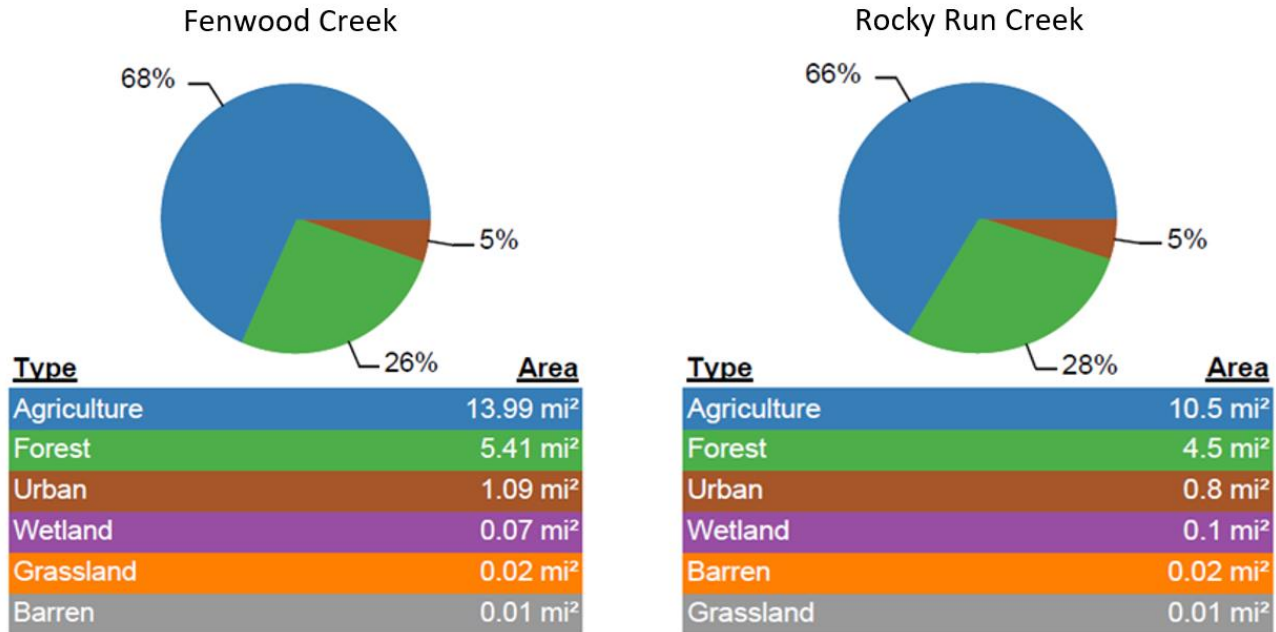
Figure 7. Land use comparison between Fenwood Creek and Rocky Run Creek.

Land use in the Fenwood Creek Watershed is dominated by agricultural crop fields with some riparian cattle pasturing. These land use types can result in excessive sedimentation and nutrients to surface water if not properly managed on the land. Median growing season total phosphorus concentrations in Fenwood Creek all exceeded the statewide criteria and confirms the existing 303(d) impaired waters listing. Median growing season total phosphorus concentrations on Rocky Run Creek did not exceed the statewide criteria.

Total phosphorus concentrations were nearly twice as much at every station on Fenwood Creek compared to Rocky Run Creek (Table 4). After reviewing the differences in management and land use between Fenwood Creek and Rocky Run Creek, there is not a remarkable difference in land use, which suggests that changes in land use is not the cause of higher phosphorus in the Fenwood watershed. (Figure 3). Considering these land uses are so similar, it is assumed that farming practices are also similar.

This suggests the differences in phosphorus concentrations are a result of natural variability in topography, soils, and groundwater inputs. Soil in the Fenwood Creek watershed is higher in clay content which allows for the potential of higher phosphorus adsorption whereas soil in the Rocky Run Watershed is higher in sand and therefore may have less phosphorus adsorption. Also, a preliminary review of flows in the two streams, indicates a stronger baseflow in Rocky Run which may indicate groundwater dilution of total phosphorus concentrations. Further investigation of the soils, and groundwater inputs would be needed to fully explain the apparent natural differences in the two streams.
