Big and Little Twin Lakes Shoreline Assessment Summary Report

June 2017

Developed by Golden Sands Resource & Development Council and Green Lake County Land Conservation Department

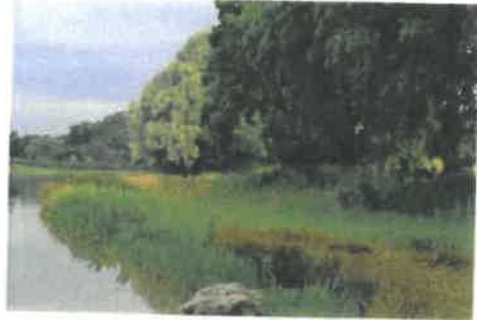
Natural – A healthy buffer of vegetation and/or natural shoreline, which is undisturbed and undeveloped.

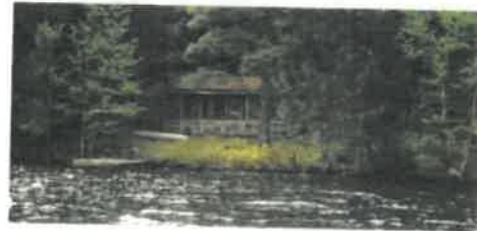
Impacted – Some layers of natural vegetation (shrub and/or canopy) have been removed, but the majority of the shoreline buffer is intact. Structures such as docks are present, but are not predominantly present at the shore.

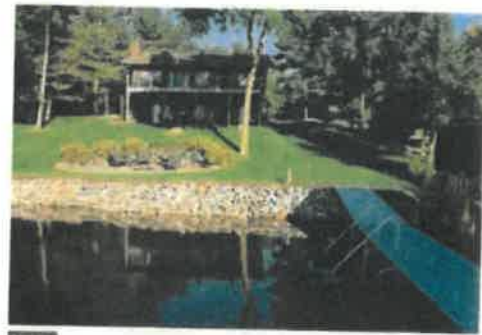
Developed – All natural vegetation has been removed and replaced with manicured lawns, and non-native vegetation. Structures such as docks, decks, retaining wall, boathouses, and/or other structures are predominantly present at the shore.

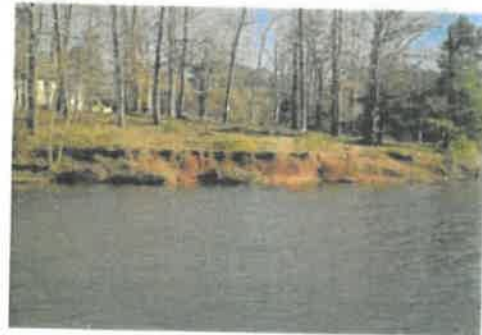
Degraded – Soil erosion, undercutting of the bank, and/or exposed roots of trees and shrubs are significant.

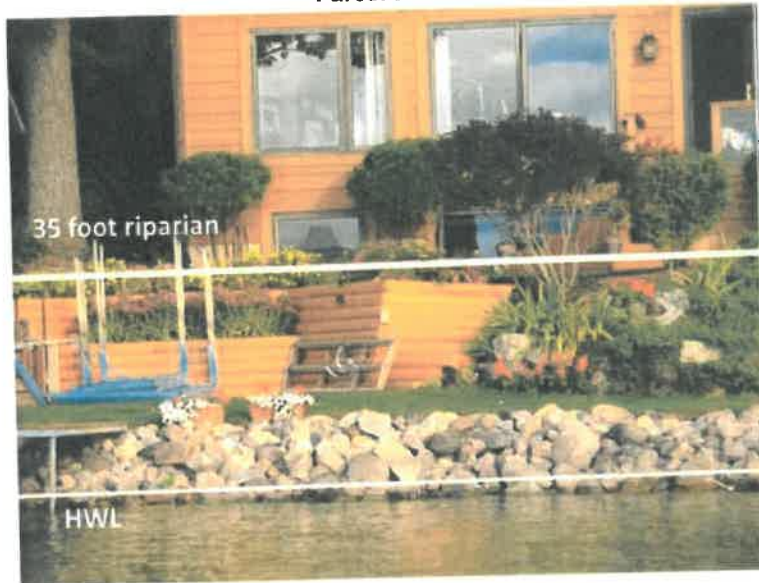
Parcel D

Example of a highly impacted shoreland.

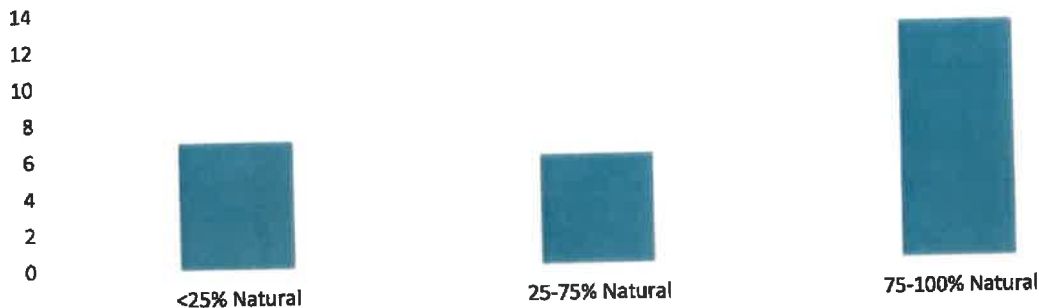
Riparian Ground Cover in Disturbed Area

Of the 64 parcels located on Twin Lakes, 26 (41%) showed some level of disturbance within the primary buffer (35 feet). Of those 26 parcels, approximately 50% of them had 75-100% ground cover remaining intact, which means the groundcover was preserved by using access corridors. This contradicts the trend observed across most lakes in the region.

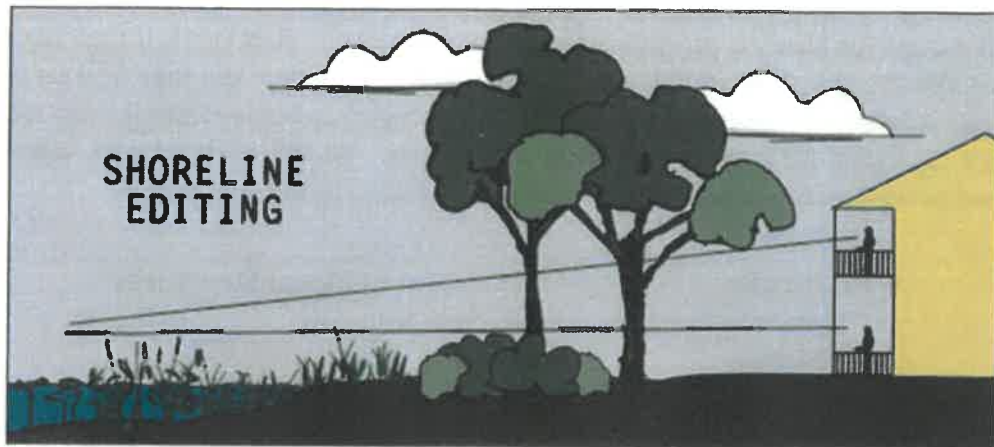
Shoreland Editing is a design approach that utilizes viewing corridors and trimming in place of clear cutting or complete removal of vegetation. This provides both ecological benefits for the lake, and increased privacy for the homeowner.

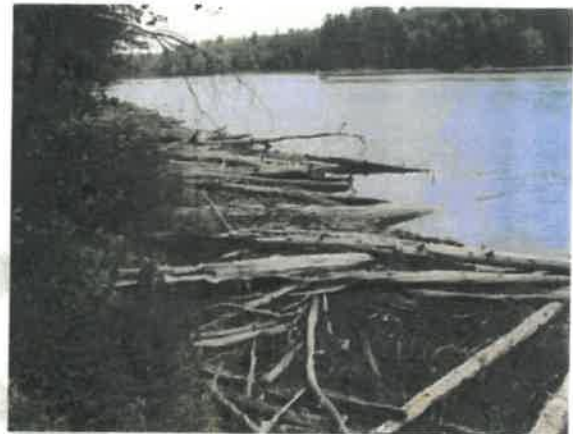
Figure 5. Wood stranded above water should be counted if below the HWL.

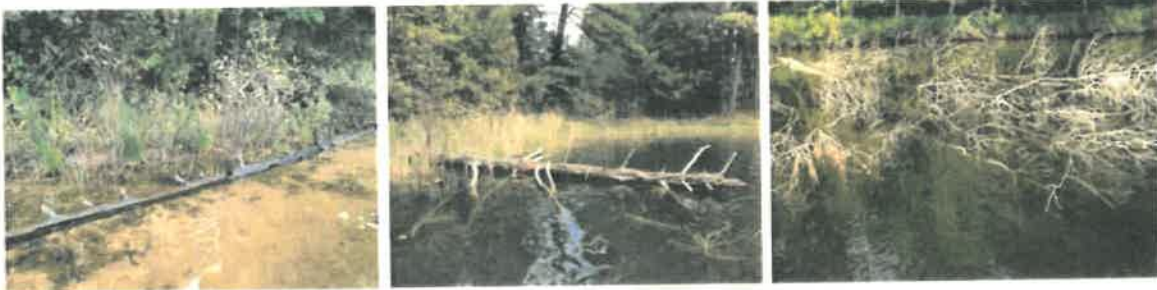
Figure 6. From left to right, woody habitat without branches (0), with few branches (1), and with a full crown (2).

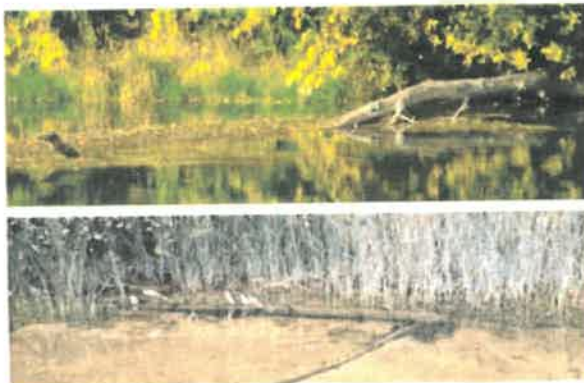
Figure 7. Example of woody habitat connected to shore (top). If bog mats extend far out from shore, count as connected to shore when wood extends above water and touches the bog mat. Woody habitat parallel to shore may be counted if the log touches shore. In the bottom photo, the piece of wood is off shore and would not be counted as connected to shore.

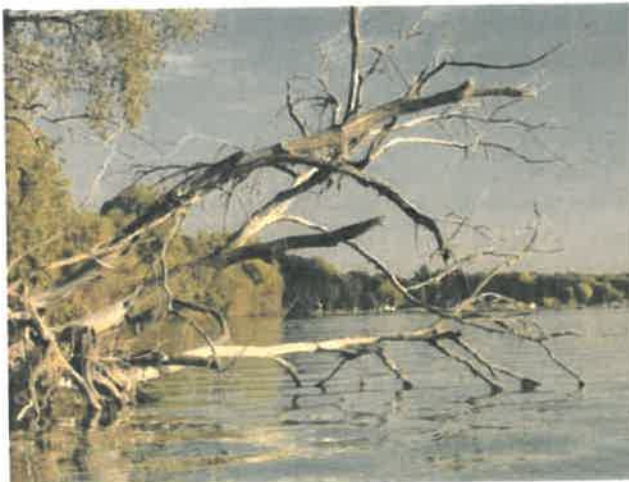
Figure 8. This photo illustrates an example of trees hanging over the water. In this case, only the trunk closest to the water with inundated branches will be counted. It has few branches, touches shore, and is out of the water (Branch = 1, Touch Shore = 1, In Water = 0). The other trunks are too far above the water.

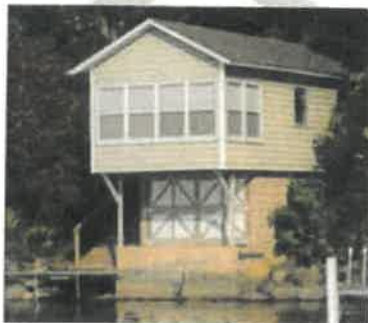
Building – any roofed structure (house, cabin, shed, boathouse, garage, commercial)

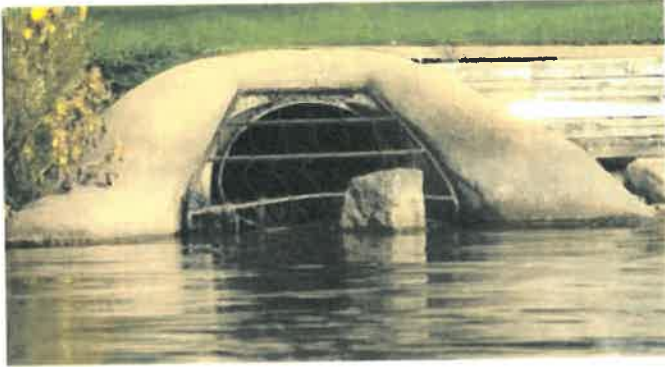
Point Source – look for a pipe bringing water directly to the lake. This pipe could be directing stormwater, gray water, or other water sources to the lake.

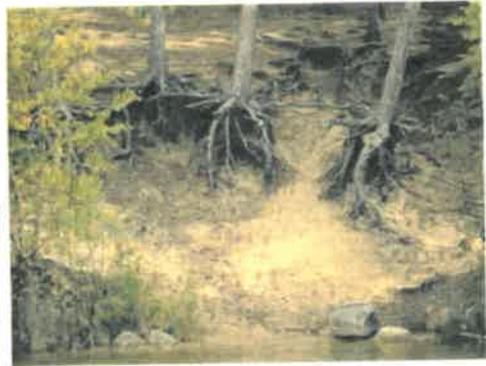
Channelized water flow/gully – sharp indentation into the ground where water flows downhill and has eroded away the soil

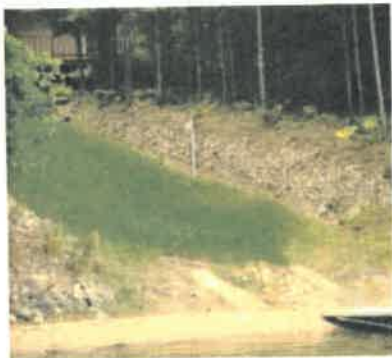
Lawn/Soil Sloping to Lake – the land slopes toward the lake and lacks natural vegetation that would prevent runoff/erosion (e.g., slope covered by lawn, bare soil, gravel, mulch)

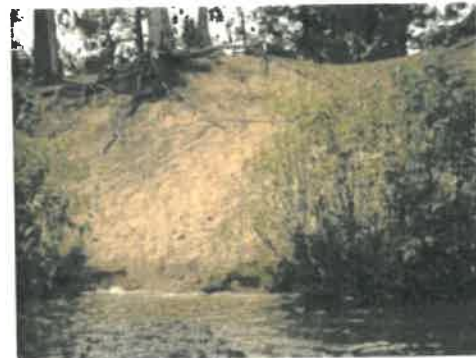
Bare soil – unvegetated ground that could be eroded in a rain storm

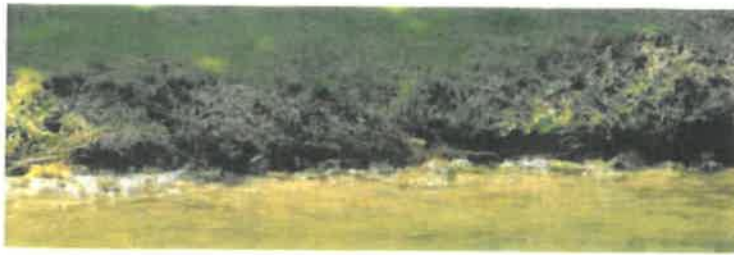
Eroding, Slumping bank – obvious signs that soil on the bank is washing into the lake, location on the shoreline where the bank is lower than expected due to erosion

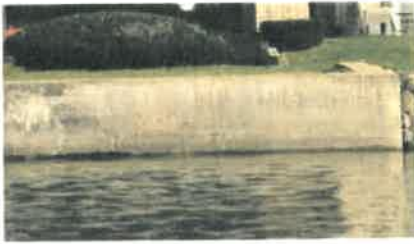
Vertical Sea Wall – upright structure that is steeper than 1.5 feet vertical to one foot horizontal installed parallel to the shore to prevent the sliding or slumping of the land and to protect the adjacent upland from wave action. **Note:** Seawalls are commonly constructed of timber, rock (including gabions), concrete, steel or aluminum sheet piling and may incorporate biological components

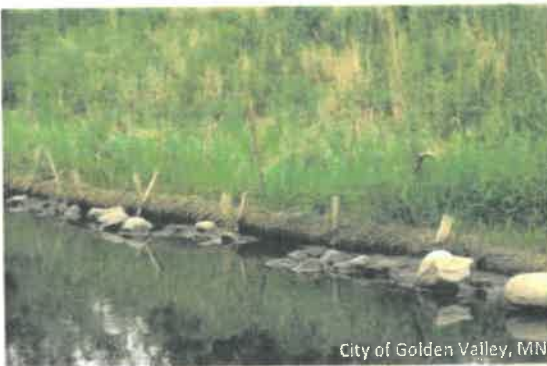
Other erosion control structures – any other type of erosion control structure on the shoreline; may include inert materials (rocks) at the bank toe and biological materials on the upper portion of the bank, non-treated wood, stakes and posts, jute netting, biologs, fiber rolls and mats, logs, and branches

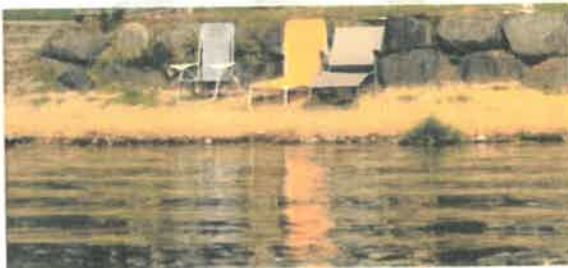
Artificial beach– sand along the shoreline used to create a beach (versus shorelines that naturally have sand substrate). It may have been created by dumping sand along the bank or by scraping away top soil and vegetation to expose sand underneath.

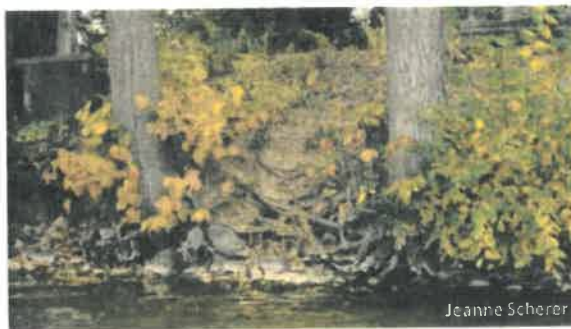
Erosion $>/< 1$ ft. face – estimate the length (to the nearest 10 feet) of shoreline with eroding banks that are less than or greater than 1 foot vertical height. The picture to the left shows about 10 ft. of eroding bank face > 1 ft. tall.

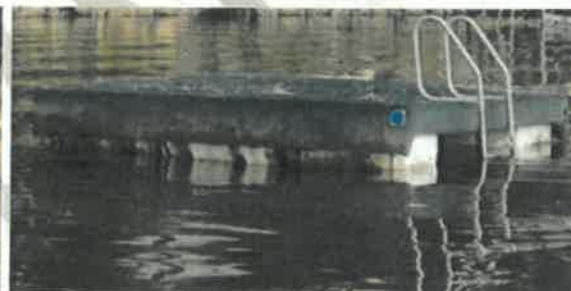
Swim raft/water trampoline – floating structure that is anchored up to 200 ft. from shore. Count rafts within ~50 ft. from shore.

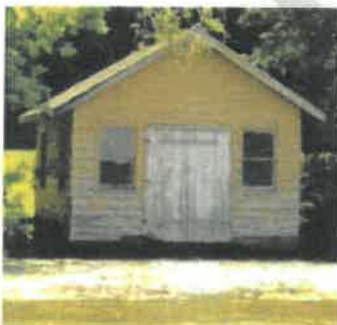
Boathouse – roofed structure over the water used to store boats

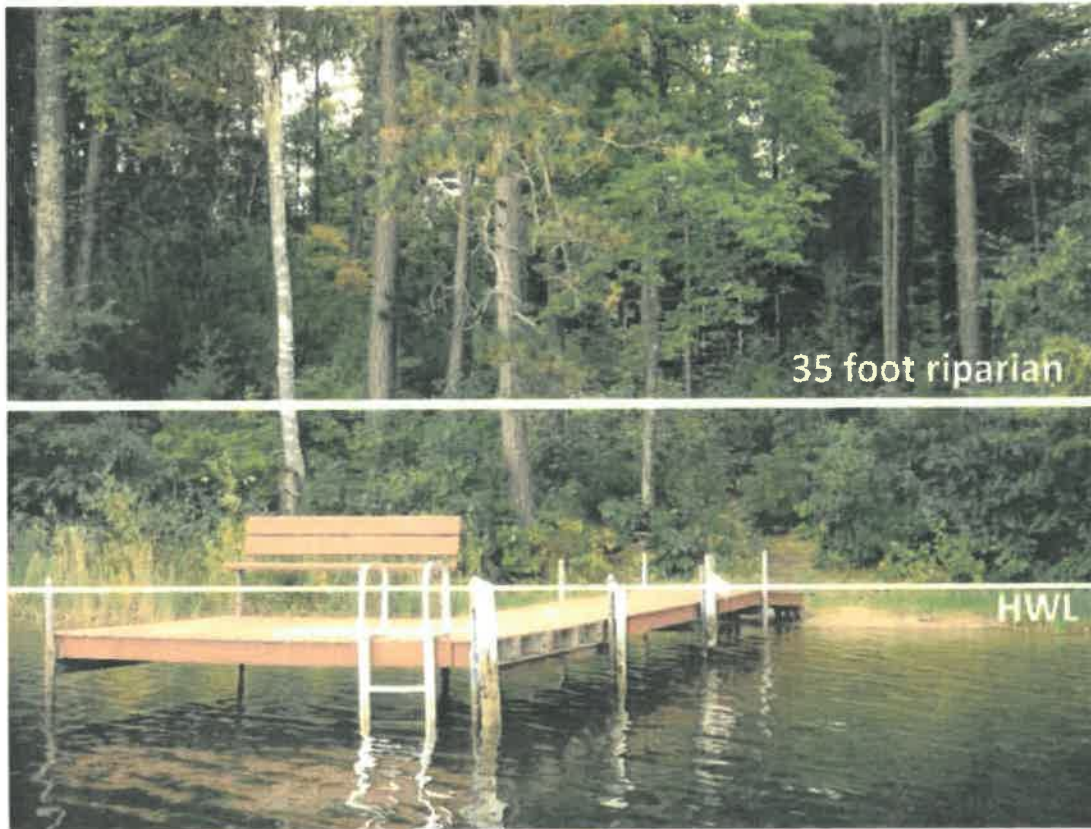
Parcel C

Note that the HWL is slightly above the present waterline, so the sand and small grasses between the present waterline and HWL will not be a part of the percent cover estimation in the Riparian Buffer Zone. There are a lot of trees on the parcel, but some gaps near shore (90% canopy cover). The entire parcel except for the path leading to the water is covered by shrubs and herbaceous plants (mark as 95% cover and check both the shrub and herbaceous boxes). The remaining 5% cover is other (bare dirt on the path). There are no human structures in the Riparian Buffer Zone, but there is 1 pier in the Littoral Zone. There is a narrow path leading to the lake, which should be checked under "Present in Riparian" as "Stair/trail/road to lake" and "Bare soil". Emergent plants are present. The Exposed Lake Bed Zone applies to this parcel because the width of the Exposed Lake Bed is at least 3 feet between the HWL and present water level. Herbaceous plants are present and there are no signs of disturbance.

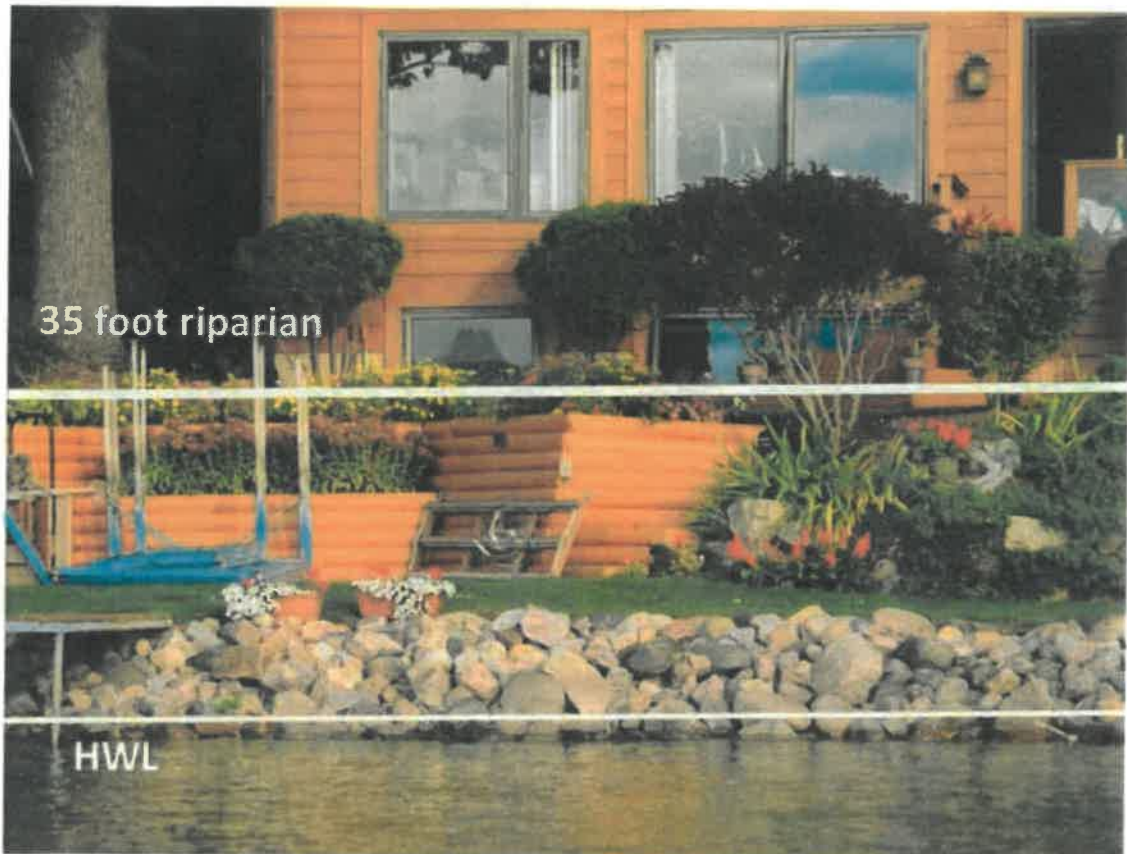
For instructional purposes, we will describe how to assess the portion of Parcel D pictured here. The house is just barely outside the Riparian Buffer Zone. Canopy cover is 0%. The garden area may be counted for shrub and herbaceous vegetation because it serves a structural function even though many of the species are ornamentals. Note the spaces between plants that are mulched; mulch will count as "other". The top of the wooden boards that form the planter and the rip rap will count as impervious surface, but not the upside down pier section, which may only be stored there temporarily. Thus, the percent cover of shrub/herbaceous vegetation is 30%, impervious surface is 15%, lawn is 50%, and other is 5%. The garden planter may be counted as a human structure in the Riparian Buffer Zone under "Other". There is 1 pier in the Littoral Zone. There are no runoff concerns. Rip rap covers the entire shoreline (approximately 20 feet in this photo). There are no aquatic plants and no visible plant removal areas. The Exposed Lake Bed Zone does not apply.

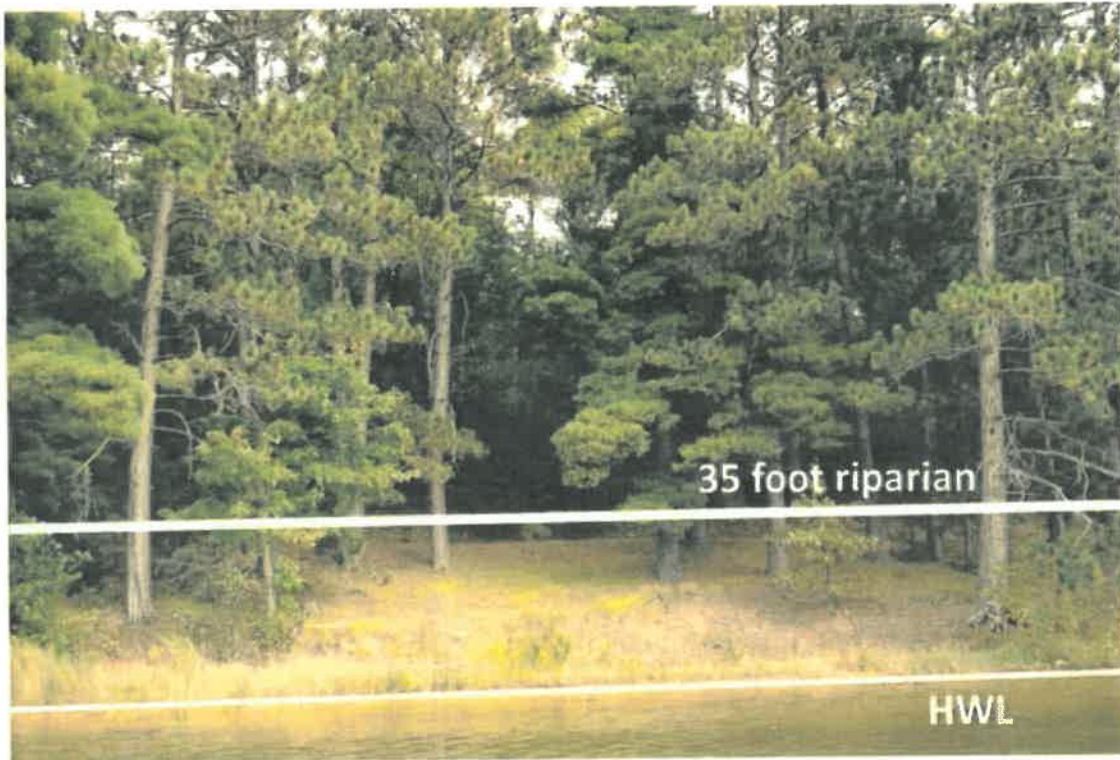
This is an example of state land that is natural, but shows signs of previous human disturbance. Parcels WR 163 – 183 in the map below are state land; the orange bar depicts the disturbed area in the photo above. There is an old forest road in the Riparian Buffer Zone. The area in the center of the photo lacks shrubs and trees, has sparse herbaceous vegetation, and large areas of bare soil with pine needles on top, but the majority of the 1600 feet of shoreline in parcel WR 173 has full coverage of herbaceous plants, shrubs, and trees. Assume that this disturbed

area is 5% of the entire Riparian Buffer Zone in this parcel. Report 95% canopy cover, 95% shrub/herbaceous, and 5% other for the entire parcel. After “description”, note that other percent cover is bare soil with pine needles. Runoff Concerns Present in Riparian include: “Lawn/soil sloping to lake” and “Bare soil”. Human structures are absent in the Riparian Buffer and Littoral Zones. The Bank Zone is not modified. Emergent plants are present.
