**Total Maximum Daily Load:  
Hardies Creek  
Trempealeau County, WI**

Hardies Creek, Trempealeau County, WI  
Prepared by Dan Helsel and Nicole Richmond

**Wisconsin Department of Natural Resources  
Bureau of Watershed Management**

**Sediment Total Maximum Daily Load for Hardies Creek**

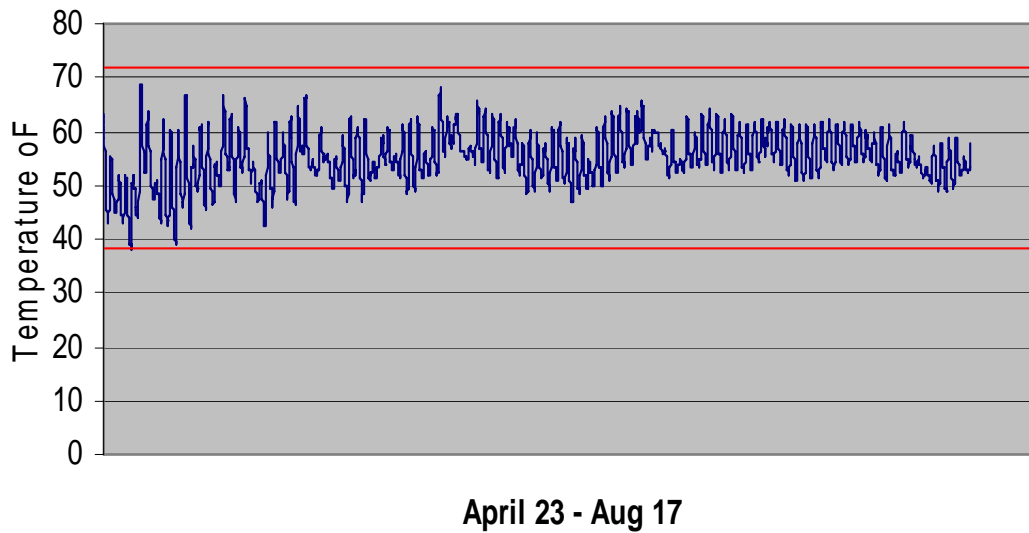
Figure C-1. Continuous temperature data from station 3 in 2005. Red lines show upper and lower thresholds for coldwater brook trout species.

Currently, poor agricultural practices and cattle access to the creek directly affect the biological community in Hardies Creek and prevent the creek from obtaining its designated use as a coldwater stream. More recently, historical deposits of sediment continue to impact Hardies Creek through stream bank erosion and degraded habitat. The fish community is depressed with low numbers and low diversity. Many of the fish surveys did not collect the prerequisite 25 fish to calculate a valid IBI (although included in Appendix C, these IBIs are flagged as invalid). The coldwater fish species present in Hardies Creek like brook trout, American lamprey and burbot, are consistent with monitored continuous water temperature data collected in Hardies Creek, indicating that Hardies Creek has the potential to be a cold water trout stream with improvement of habitat by stabilization of the streambanks (Appendix C, Figure C-1).

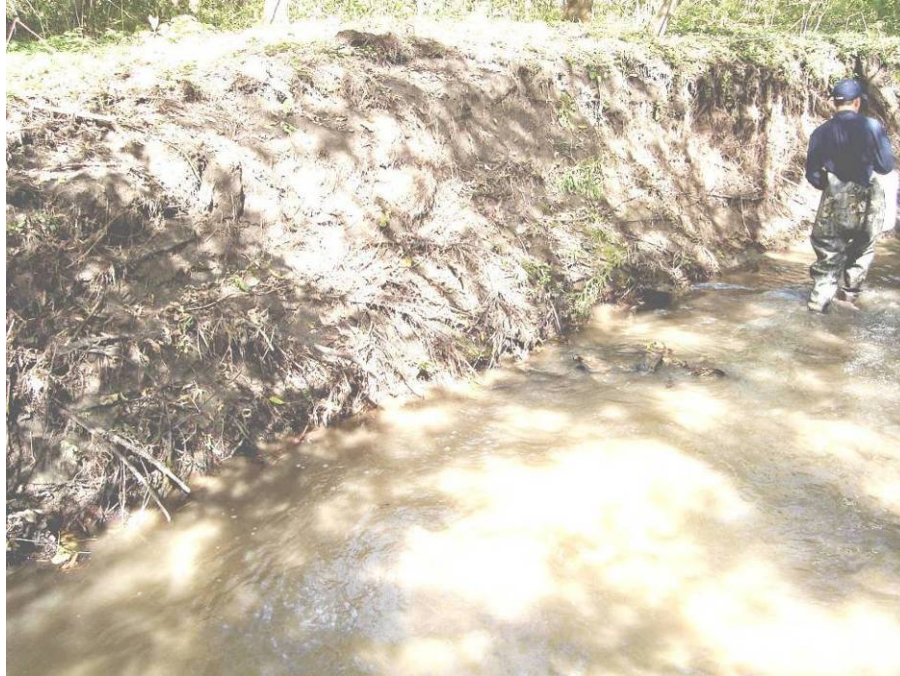
Figure E-1. Typical bank erosion along the lower portion of Hardies Creek

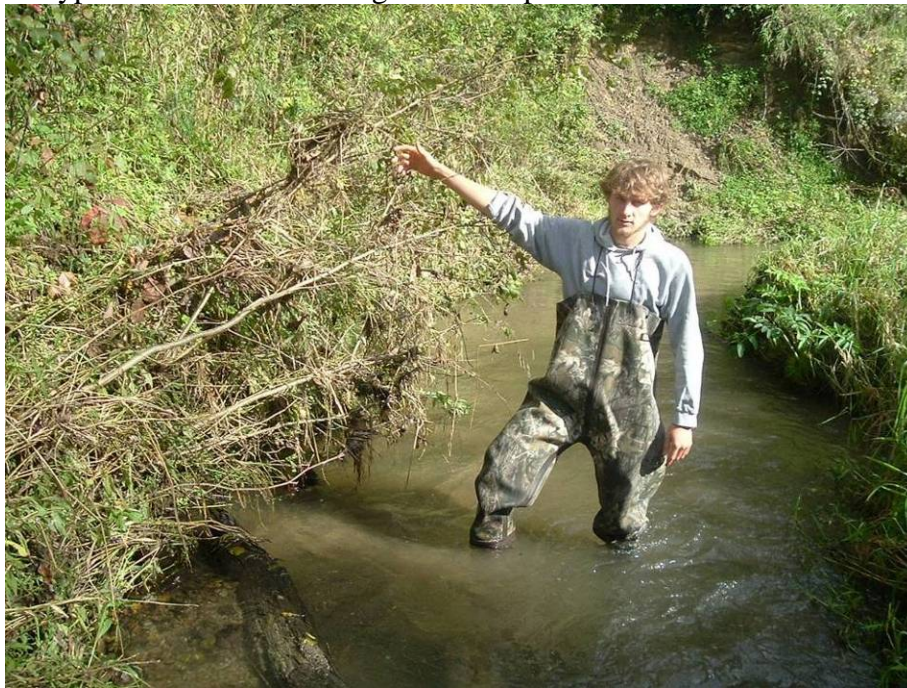
Figure E-2. GET High School Student points to debris left in bank vegetation as a result of high flows

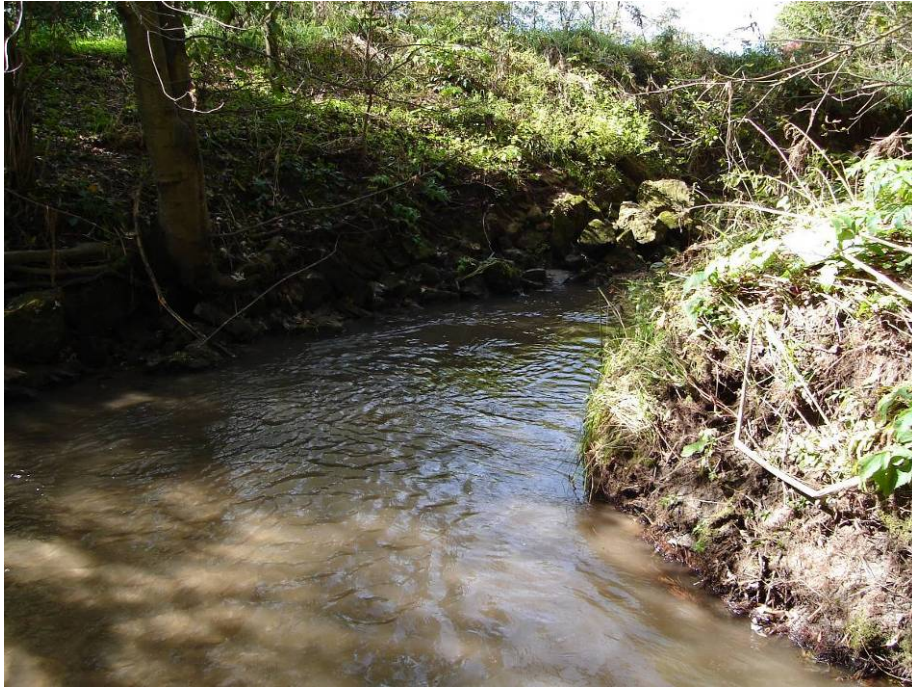
Figure E-3. Typical bank erosion along the outside of stream bend of Hardies Creek
