Appendix 1
**Results of Nuisance Plant Control Plan
Monitoring**

2020 MONITORING REPORT

Monitoring the Bergland Dam Project (Lake Gogebic) for Purple Loosestrife and Eurasian Watermilfoil Part of the Bond Falls Hydroelectric Project (FERC No. 01864)

Monitoring the Bond Falls Dam Project for Purple Loosestrife and Eurasian Watermilfoil Part of the Bond Falls Hydroelectric Project (FERC No. 01864)

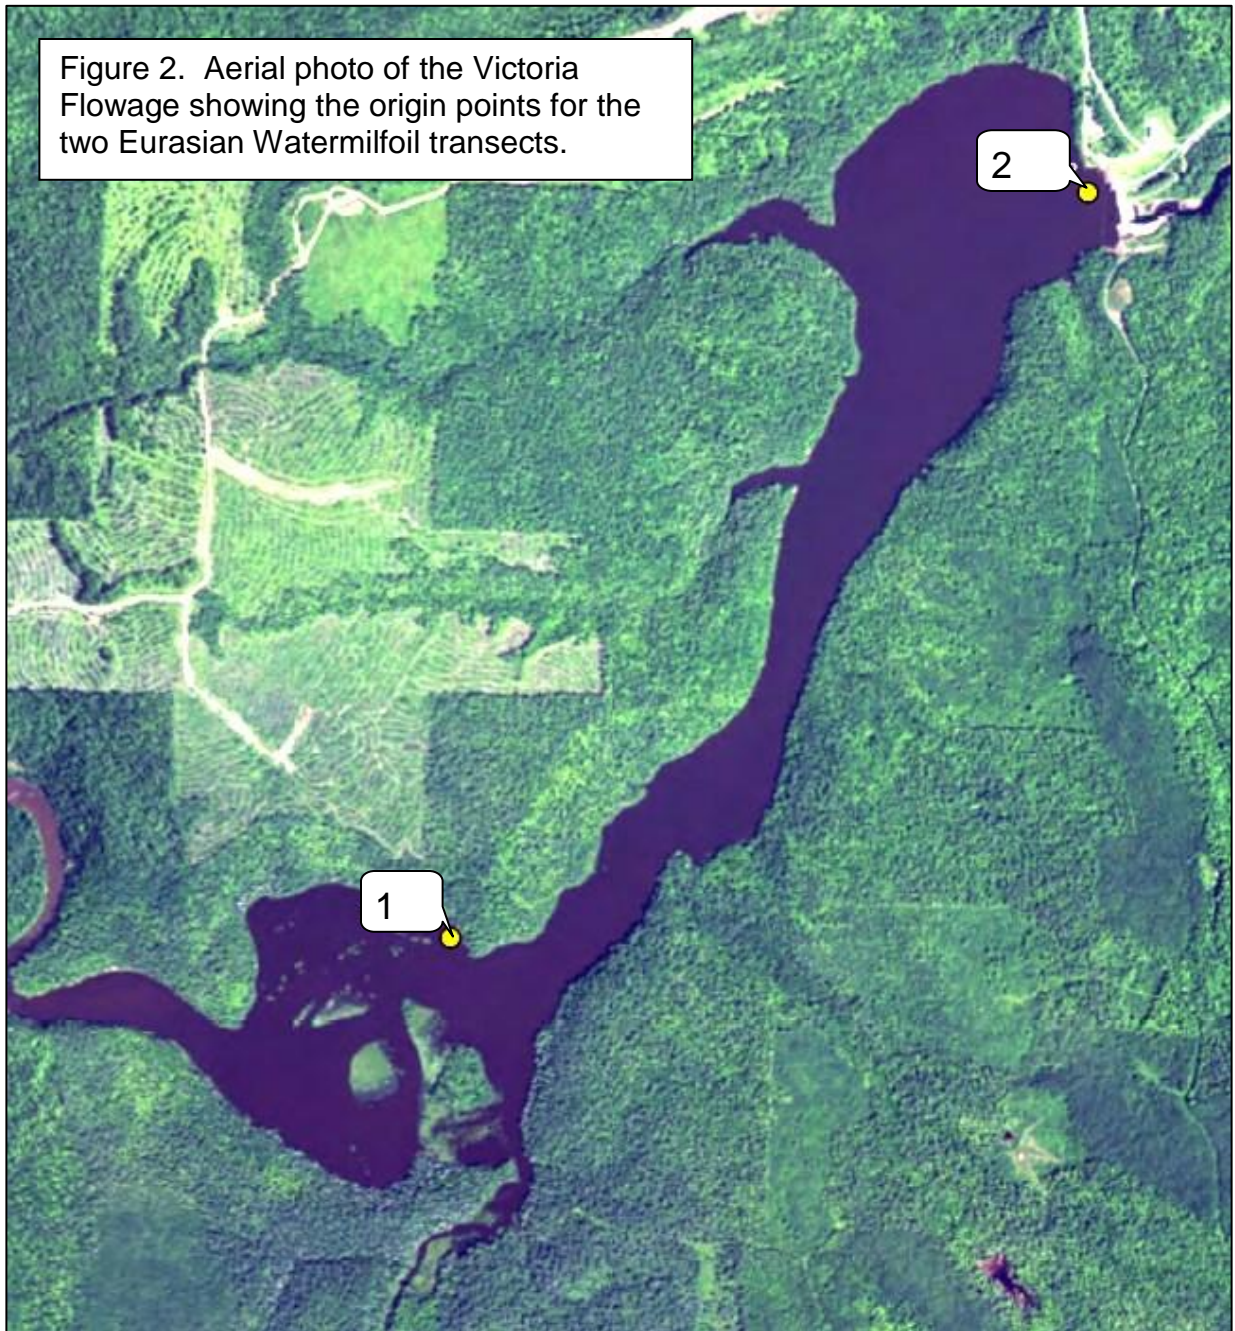
Figure 2 shows an aerial photo of the project area with the origin points for the two transects used for monitoring for Eurasian Watermilfoil.

Table 2 provides sampling results from each of the Victoria Flowage transects. Each transect had three circular plots from which samples were collected in four depth quadrants. If a depth was not represented in the plot, “NA” (not applicable) was entered. No Eurasian Watermilfoil was found on transects, during meander searching, or at the launch site in 2020.
