**Re: Article 406 – Invasive Plant Monitoring Report for 2018
Sturgeon Falls Project, FERC No. 2720**

Invasive Watermilfoil and Aquatic Vegetation Monitoring Survey Report for Sturgeon Falls Hydroelectric Project Area

August 12, 2020

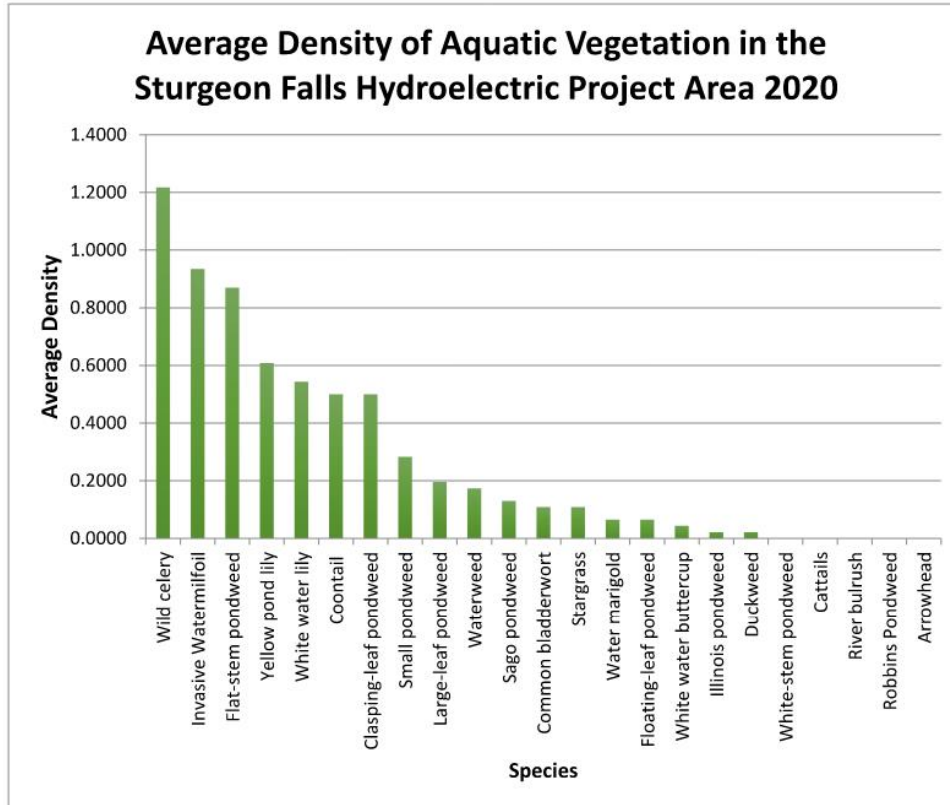
Figure 1. Average density of aquatic vegetation in the Sturgeon Falls Project area in 2020

Throughout the project area, 18 different native aquatic plant species were identified. The most dominant species were Wild Celery (*Vallisneria americana*), invasive Watermilfoil (*Myriophyllum spicatum* X *M. sibiricum*), and Flat Stem Pondweed (*Potamogeton compressus*) (Appendix A – Table 2), which is fitting seeing as it was the focus of the survey and not all plants beds were surveyed if milfoil was not present.

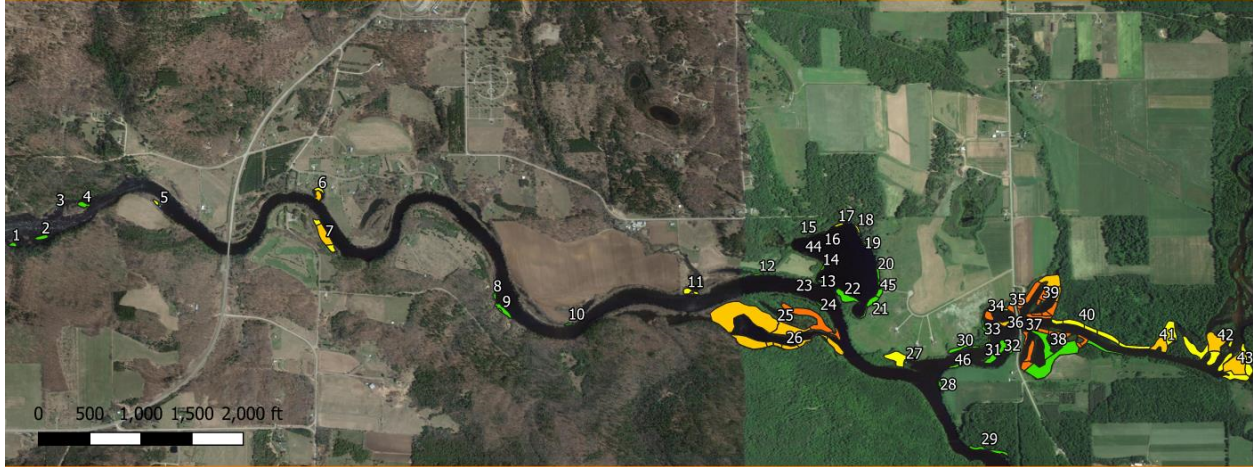
Sturgeon Falls Hydroelectric Project Area: Milfoil Beds Location and Densities

The above map shows the location of all surveyed aquatic plant beds, highlighting the extent and density of milfoil where it was documented. The density is categorized by color according to the legend.

Quantitative milfoil surveying was conducted on July 30, 2020. In total, 46 individual beds, equating to approximately 60 acres of milfoil, were mapped throughout the Sturgeon Falls Project area, accounting for about 14.12% of the total surface acres, which is an approximately 3.45% decrease from 2018 (Appendix A-Figure 1). Of the 60 acres of milfoil, about 16.508 acres were at the 'found' density level, while 0 acres were at the dense category. The largest density level in total acres came from the 'sparse' density level (Table B and Appendix A – Table 1). Many of the larger beds varied in their densities throughout the entire area. Therefore, to more accurately represent the populations found, larger beds were broken up and may be assigned multiple densities for different parts but are considered a single bed overall.

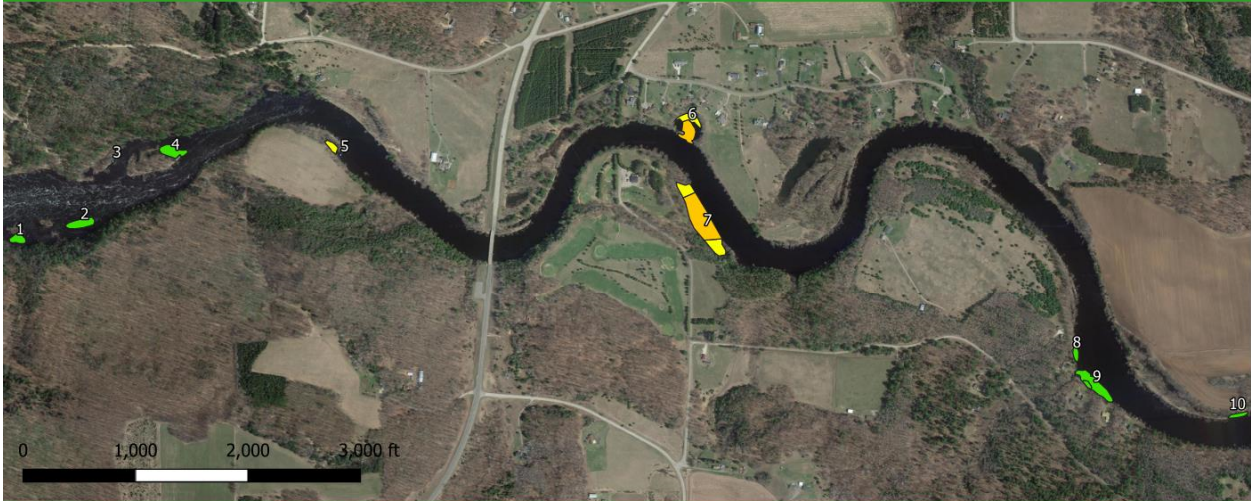
Sturgeon Falls Hydroelectric Project Area: Milfoil Bed Locations and Densities Sites 1-10

The above map shows the location of all surveyed aquatic plant beds, highlighting the extent and density of milfoil where it was documented. The density is categorized by color according to the legend.

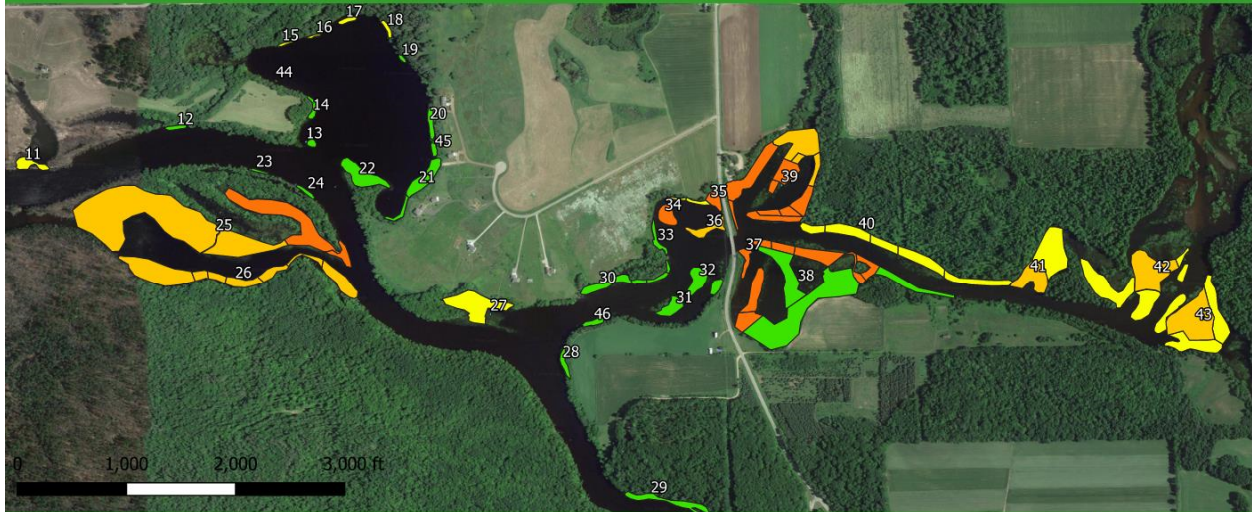
Sturgeon Falls Hydroelectric Project Area: Milfoil Bed Locations and Densities- Sites 11-46

The above map shows the location of all surveyed aquatic plant beds, highlighting the extent and density of milfoil where it was documented. The density is categorized by color according to the legend.
