**Subject: 2021 Purple Loosestrife Monitoring Report  
White River (P-2444), Superior Falls (P-2587), Hayward (P-2417), Big Falls  
(P-2390-01), and Thornapple (P-2475)**

**2021 Purple Loosestrife Monitoring Report for:**

## **2021 Purple Loosestrife Monitoring at Superior Falls Flowage, White River Flowage, Lake Hayward, Big Falls Flowage and Thornapple Flowage.**

**2021 Purple Loosestrife Survey Maps for  
Lake Hayward and Thornapple Flowage**

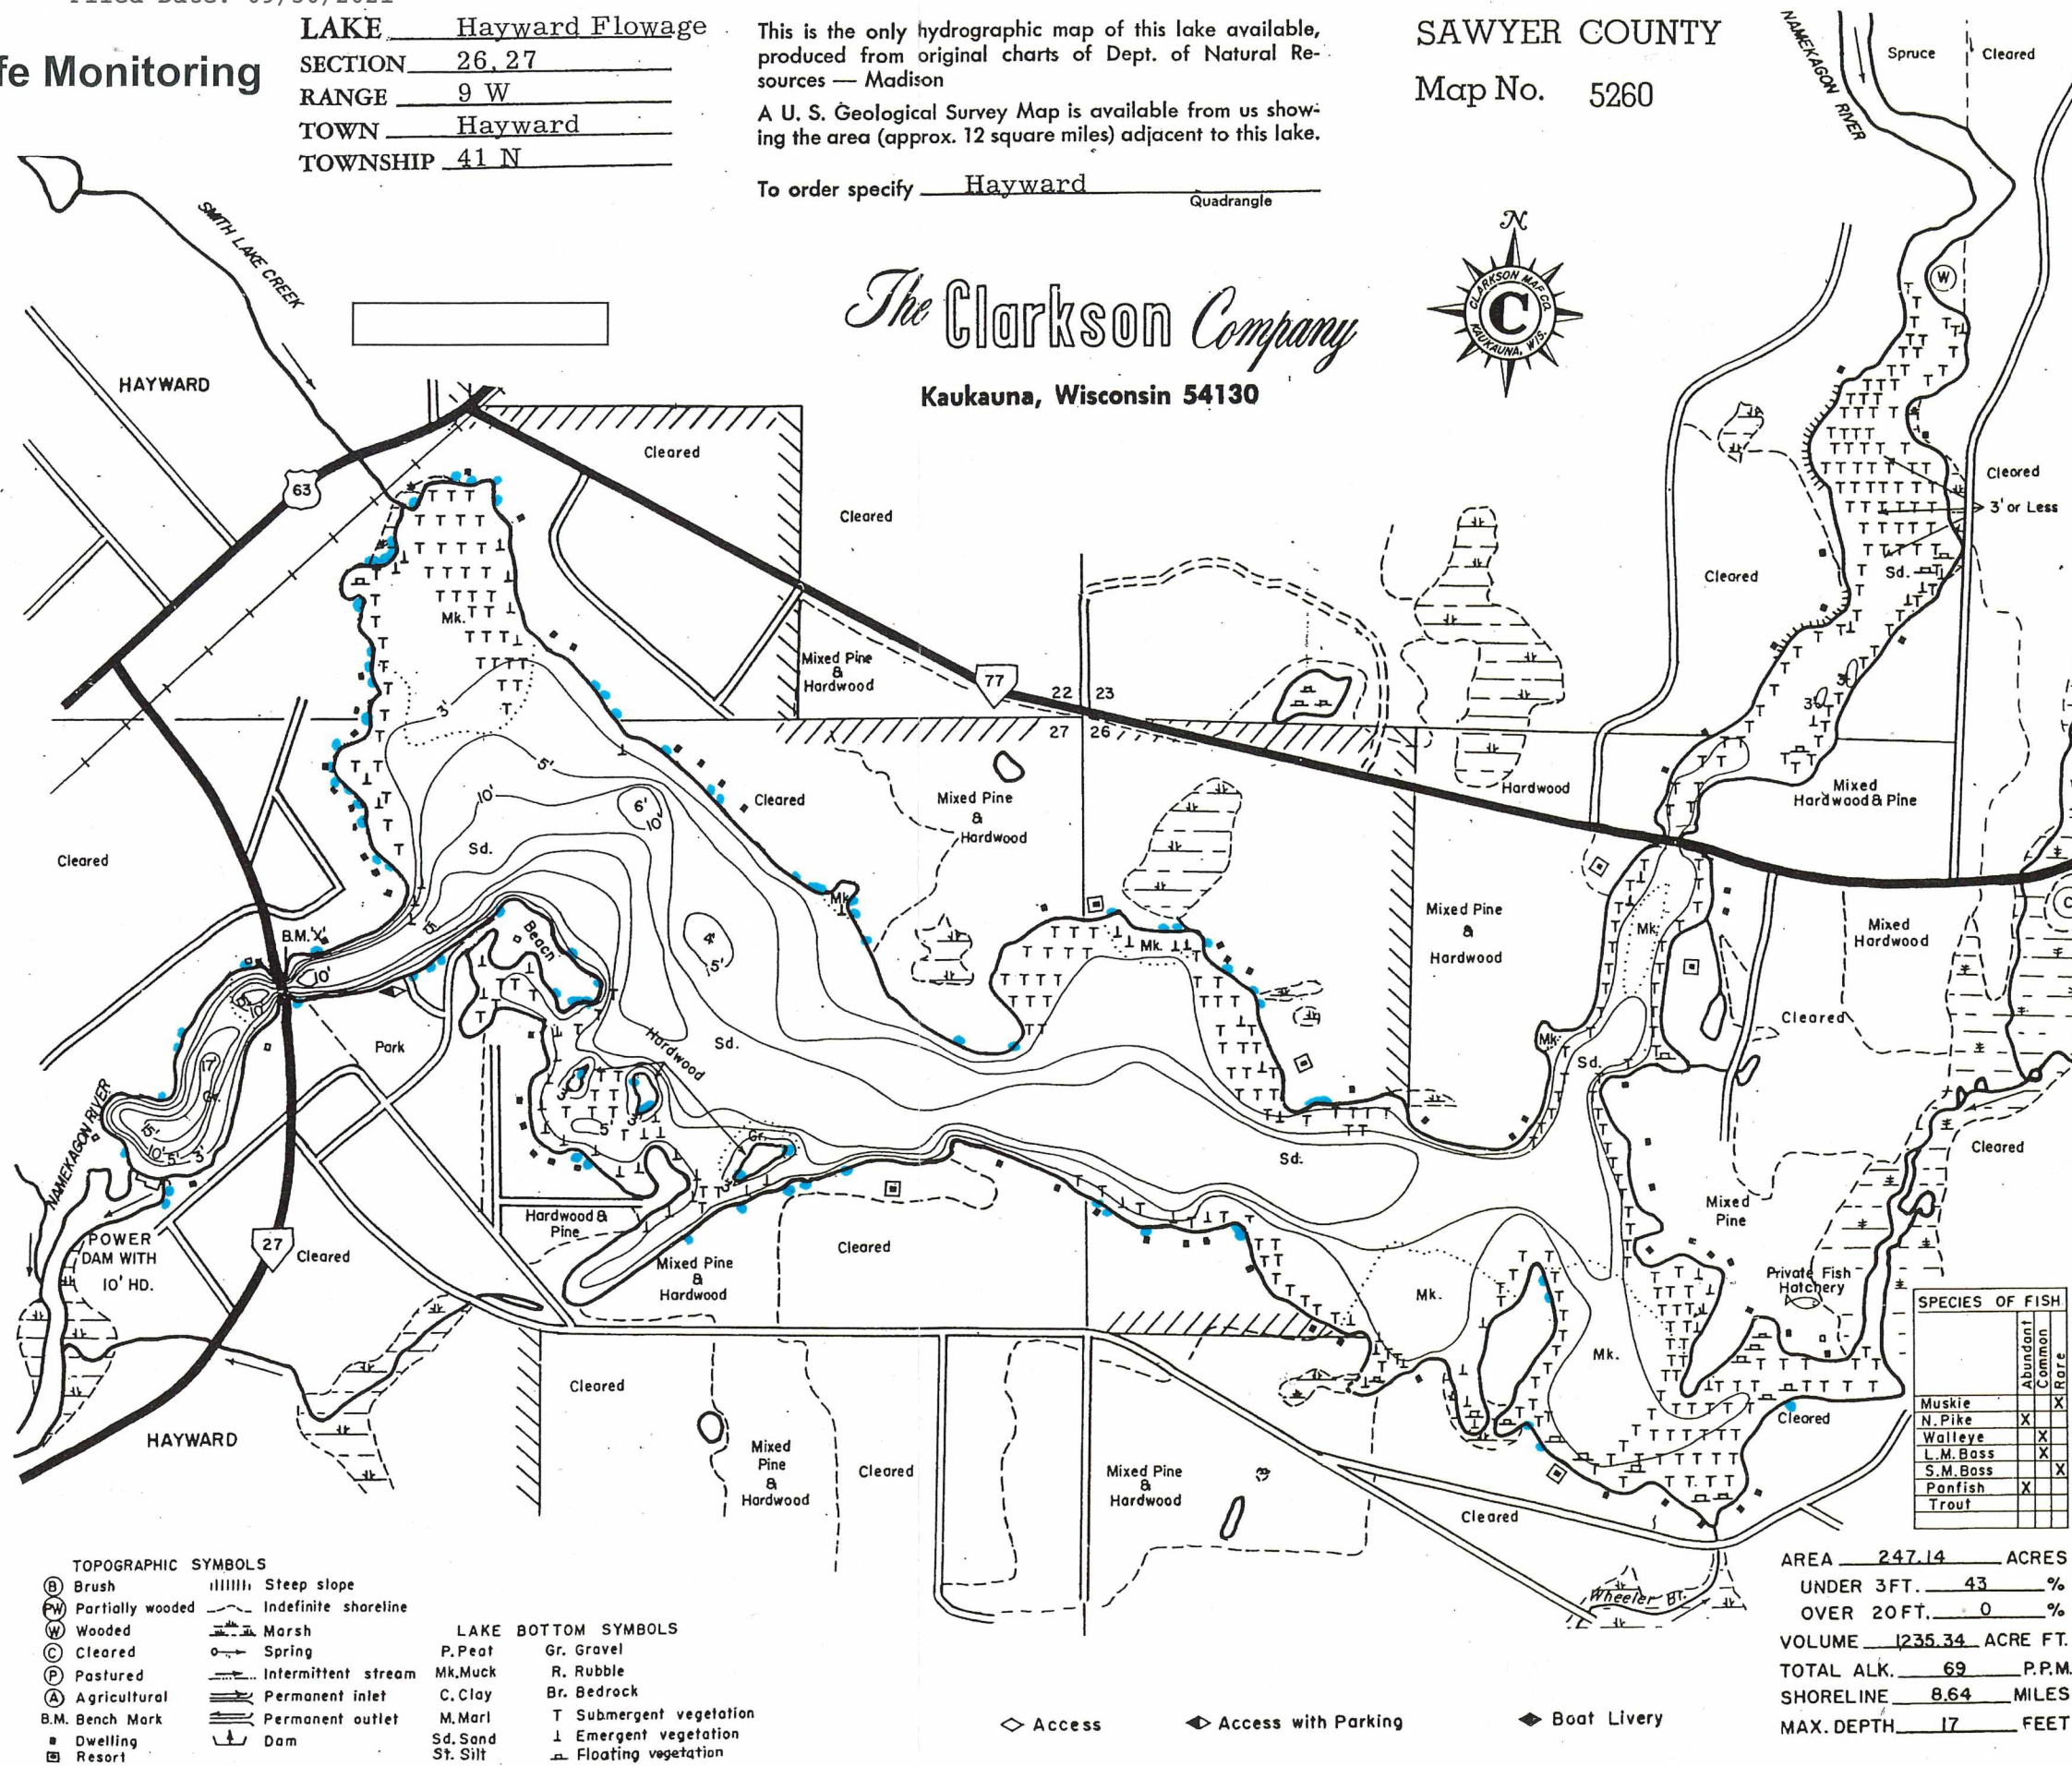
# Annual Purple Loosestrife Monitoring August 11, 2021

Areas of loosestrife present or common

**7.2 clicks = 4.1 clicks**  
**mile x miles**

**x = 0.57 miles = 3,010 ft.**

**or 6.6% of shoreline**

Areas of loosestrife abundant

**0.0 ft.**

3.3 Lake Hayward. The presence of purple loosestrife on Lake Hayward has been relatively stable over the last ten years. Shoreline coverage this year was the same as last year (0.57 miles). Appendix A includes a map of Lake Hayward depicting this year's loosestrife coverage. There were no areas classified as abundant this year.

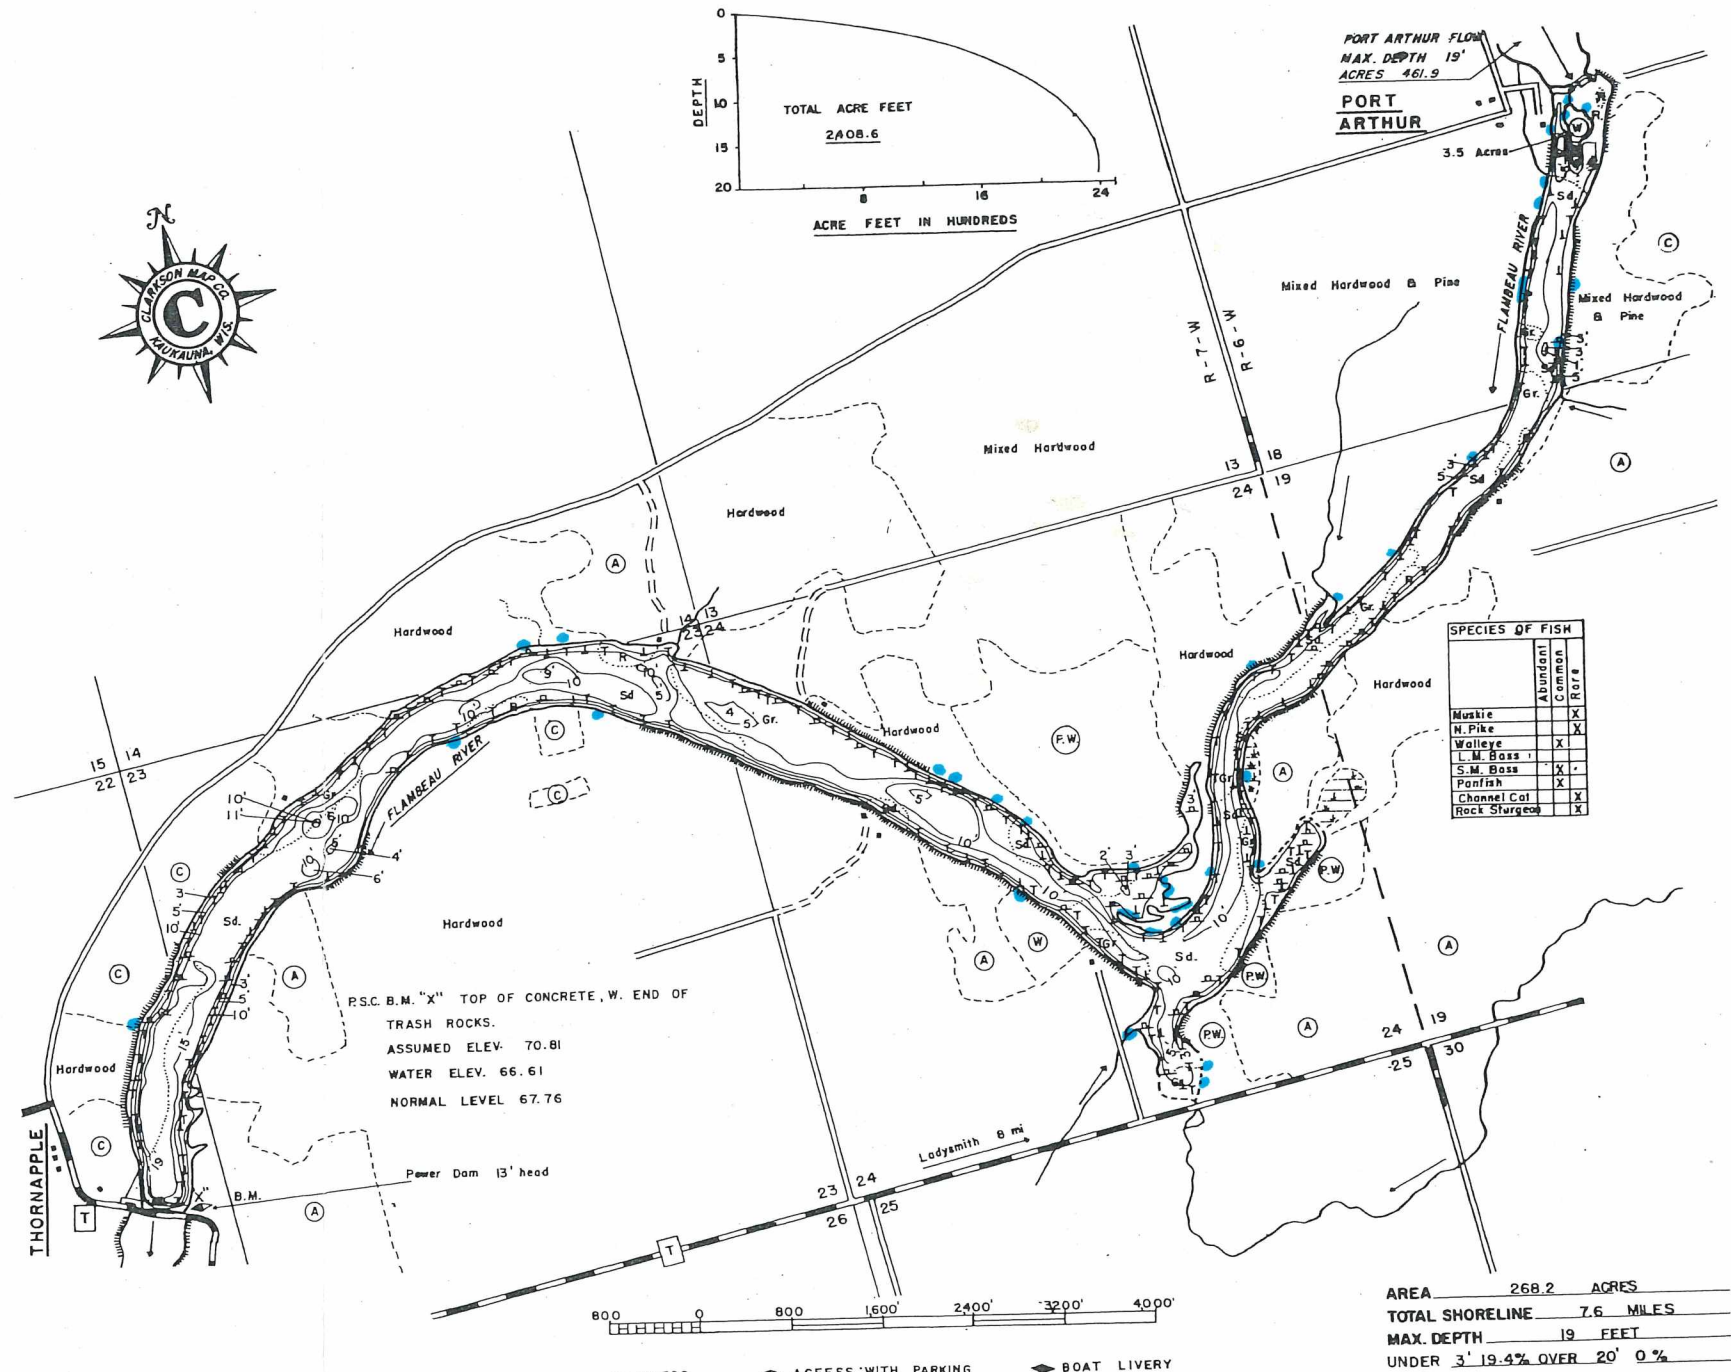
# Annual Purple Loosestrife Monitoring - August 25, 2021

Areas of Loosestrife Common

**2.5 clicks = 1.6 clicks**  
**4,000 ft. x ft.**

**x = 2,560 ft. = 0.48 miles**

**or 6.4% of shoreline**

Areas of Loosestrife Abundant

**0.0 ft.**

3.5 Thornapple Flowage. The length of shoreline infested with purple loosestrife this year was approximately one-half as much as last year and the second lowest level recorded since monitoring began in 1998. Purple loosestrife was found to be present or common along 0.48 miles of shoreline compared to 0.94 miles in 2020. There were no areas classified as abundant. Drought-like conditions this year may have played a role in the marked reduction of loosestrife. The wetland area near the middle of the flowage, which has historically exhibited the greatest concentrations of loosestrife, has seen a significant reduction in loosestrife coverage over the last few years. Appendix A includes a survey map of Thornapple Flowage depicting the results of this year's monitoring.

Much of the northern shoreline of Thornapple Flowage is scattered with purple loosestrife plants. The central portion of the impoundment, which historically has seen the heaviest concentrations of loosestrife, has seen a drastic reduction over the last few years. Shoreline classified as present or common this year was 0.48 miles versus 0.94 miles last year. There were no areas classified as abundant this year, the same as in 2020.
