Thunder Lake AIS Monitoring and Water Clarity Report

Field Date: June 29, 2022
WBIC: 1618100
Previous AIS Findings: Chinese Mystery Snails, Banded Mystery Snails
New AIS Findings: No new AIS found.
Field Crew: Aubrey Nycz, AIS Lead Program Assistant, and Madeline Hetland, AIS
Project Assistant, Oneida County Land and Water Conservation
Department
Report By: Madeline Hetland

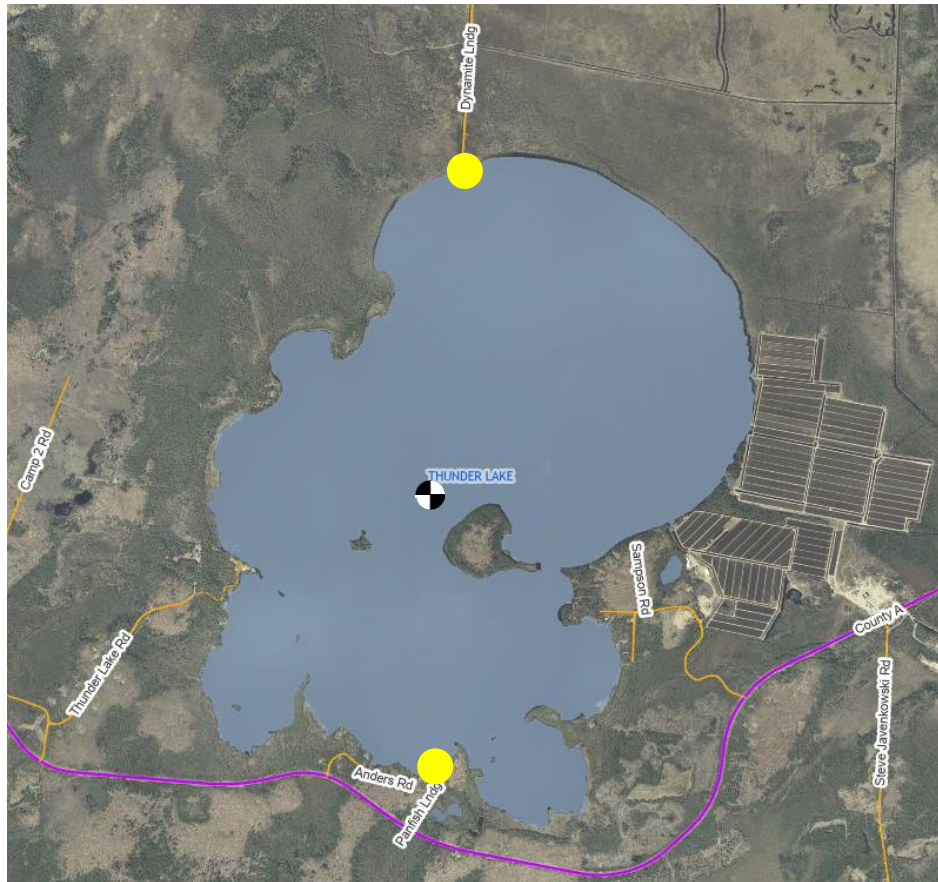
Figure 2. Map of Thunder Lake.

Map Key

Boat Landings

Location of dissolved oxygen and Secchi disk reading

Latitude: 45.787341

Longitude: -89.219707

Thunder Lake Data: Thunder Lake, located in the Town of Three Lakes, Oneida County, is a 1794-acre drainage lake with a maximum depth of 10.5 feet (Figure 1.). There are two public boat landings on Thunder Lake located off of Rice Lake Road and County Hwy A. (Figure 2). The substrate is 60% sand, 15% gravel, 5% rock, and 20% muck. Along with reporting the depth and substrate, the Wisconsin Department of Natural Resources (DNR) reports that the lake has panfish, largemouth bass, northern pike, and walleye.

Field Notes (water quality monitoring): To observe the water clarity and quality on Thunder Lake, we used a depth finder and maps indicating where data had been collected in the past to locate the deep hole. After locating the deep hole, we used a Secchi disk to measure water clarity and a dissolved oxygen meter to measure water quality. Oxygen is needed for a healthy fish population, and also for plants to respire at night. The measurements from the dissolved oxygen meter can tell us if the organisms in the lake are under stress. The dissolved oxygen measurements on Thunder Lake were at healthy levels, and the water is well oxygenated. These measurements can be found in table 2. The Secchi disk reading was at 5 feet out of a maximum depth of 10.5 feet.

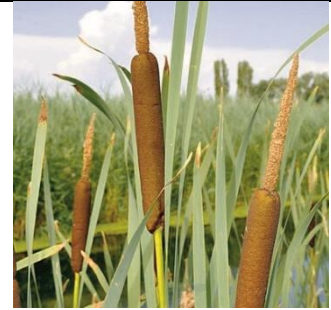
Broad-leaved Cattail (*Typha latifolia*)

Description: An emergent plant. Leaves are sword-like (10-23 mm wide, 1 – 3 m tall). The flower resembles a hotdog on a stick. The pollen that this plant contains is shed in clusters of four grains. Broadleaf cattail will often cross with narrow-leaf cattail to form the hybrid, *Typha x glauca*.

Status: Native
