RE: Stoughton Urban Service Amendment Request

City of Stoughton
**2022 URBAN SERVICE AREA
AMENDMENT**

Magnolia Springs

Prepared for the Capital Area Regional Plan Commission and the Wisconsin Department of Natural Resources
By the City of Stoughton and MSA Professional Services, Inc.

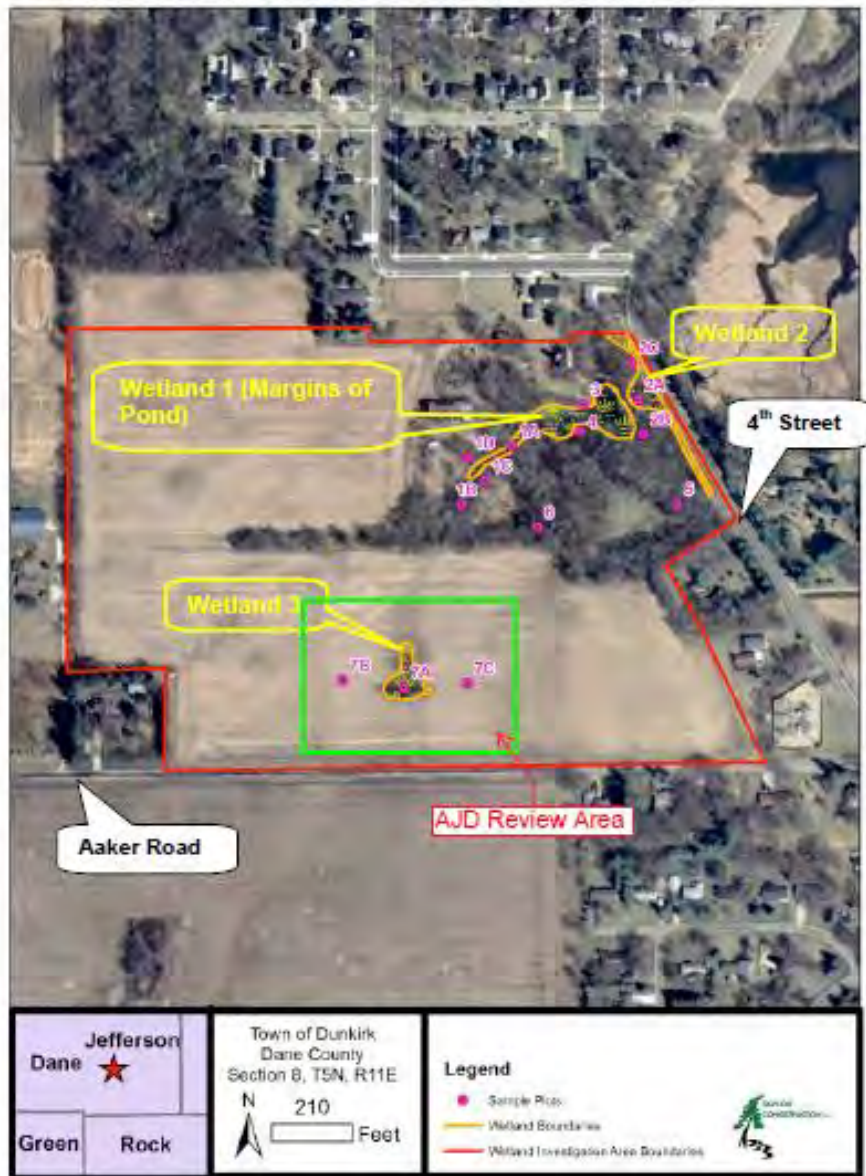
Figure 2: Investigation Area, Wetlands & Sample Plots.

Imagery Source: Wisconsin Regional Orthophotography Consortium, 2010.

There was a dammed pond in the northeast corner of the property (Figure 2). It was drained by a culvert that emptied into the head of a stream flowing east toward the Yahara River.

Three wetland areas were identified and delineated (Figure 2). The site is in Section 8 (SESW), T5N, R11E.

If the sample plot data suggested that the location was inside of a wetland, a second plot was placed in an upslope location with a different plant community. If data collected at this plot suggested that the location was inside of the upland, no further plots were sampled. Otherwise, the process was repeated. A total of 14 plots were sampled, 3 inside of wetlands and 11 on the uplands (Figure 2).

A pond was present in the northeast corner of the investigation area (Figure 2). It was fringed by Wetland 1. The pond was drained by a culvert that emptied into a stream flowing east to a nearby wetland complex that abutted the Yahara River.

The uplands (non-wetlands) were the crop fields and wooded areas that comprised the majority of the investigation area (Figure 2). There was an old barn on the uplands north of the pond.
