Phase VI Lake Management Protection Grant Report  
English Lake  
Manitowoc County, Wisconsin

Wisconsin Dept. of Natural Resources Project Number LPT-79  
NES Ecological Services Job Number 13750001

English Lake Protection & Rehabilitation  
District

July 1, 2001

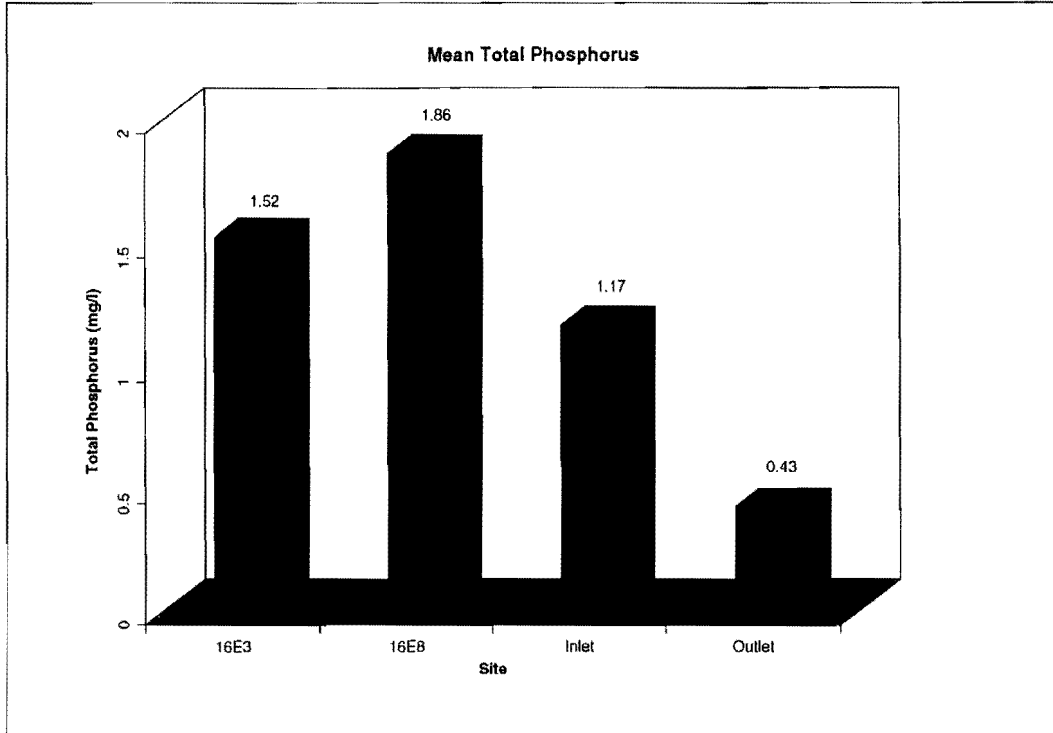
**Figure 3. Mean Total Phosphorus levels from sample locations used in Phase I-III studies (16E3 & 16E8) and sample locations used in this study (Inlet & Outlet).**

Comparisons with data from the Phase III study were also made to determine the effectiveness of the wetland detention basin. During the Phase III study, eight sites were sampled during storm events (Figure 2 and Table 3). The results from Sites 16E3 and 16E8 represent total phosphorus and nitrogen data prior to the construction of the detention pond and the relocation of the cattle outside the English Lake drainage basin. These results were compared to similar data collected at the inlet and outlet of the detention basin (Figures 3 and 4). Although these data actually represent improvements made by two restoration alternatives, the cattle relocation and construction of the detention, and as a result each alternative's portion of the improvement cannot be determined, it is apparent that there is a definite improvement in the amount of nutrients entering English Lake.

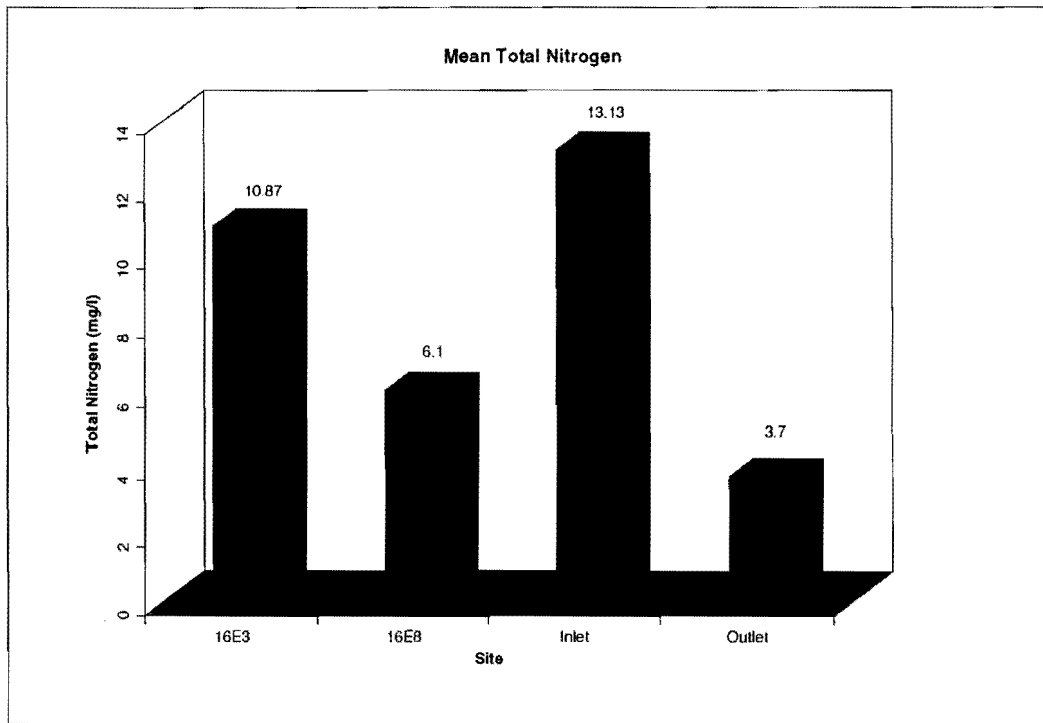
**Figure 4. Mean Total Nitrogen levels from sample locations used in Phase I-III studies (16E3 & 16E8) and sample locations used in this study (Inlet & Outlet).**
