# Kangaroo Lake

## Kangaroo Lake Bulrush Restoration Project

September 2008

LPT-264-05

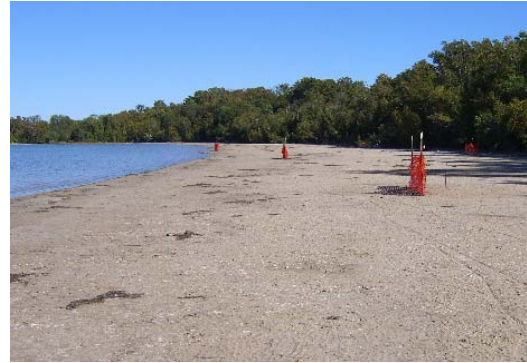
**Photo 3. Low water levels during the summer of 2007.**

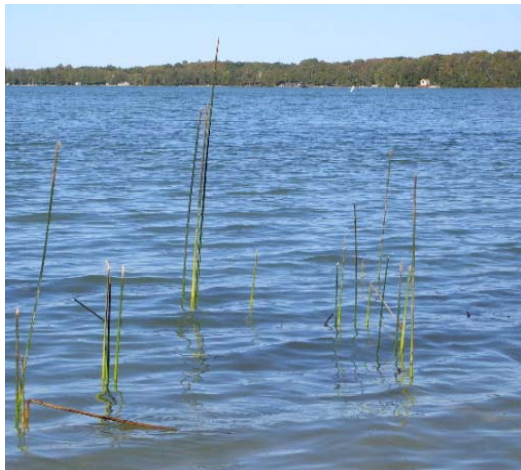
**Photo 4. Broken bulrush stems within a control plot.**

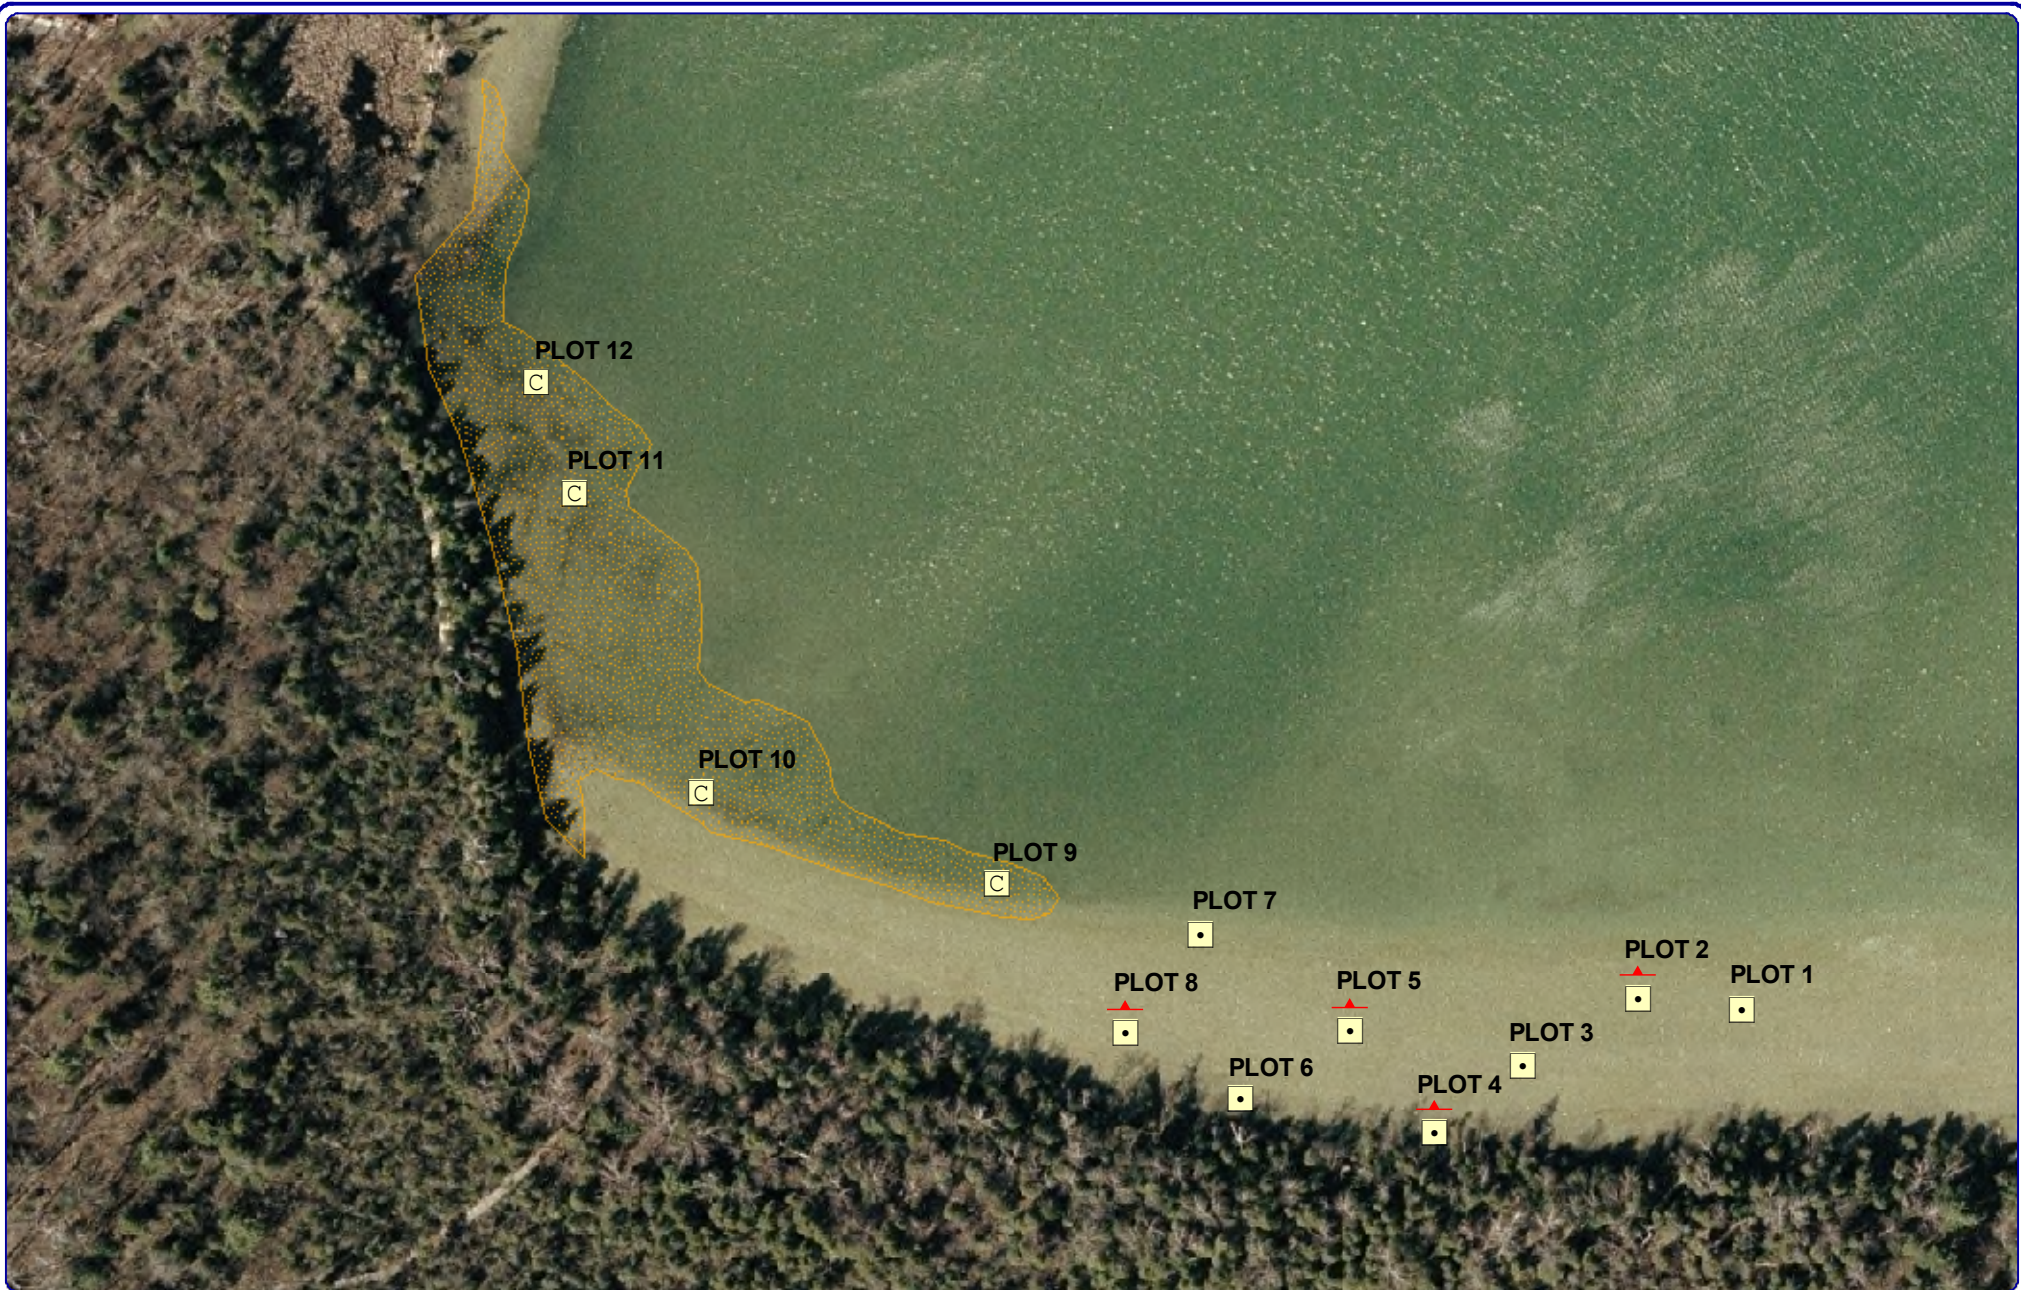
**Map 1**

**Bulrush Plot  
 Monitoring Locations**

A healthy, but small stand of bulrushes exists in the southern slow-no-wake zone (Map 1). Four control plots (4m x 4m) were delineated using the same corner markers, center post, and t-posts as the experimental plots. Attempts were made to place the plots near the lakeward edge of the existing colony to minimize the possible effects of wave protection by other individuals within the colony. However, the bulrush colonies extended into water too deep for volunteers to effectively monitor them so more shallow locations were chosen.

As stated above, control plots were placed within the existing bulrush community to monitor changes in their densities (Map 1). Figure 3 clearly shows that although the bulrush densities in these plots varied during differing monitoring dates, they remained relatively the same during the duration of this project (Photo 2). Plots 9 and 10 were observed to be insignificantly different at the end of the project compared to at the start. Plot 11 displayed a slight increase of bulrush density during the current project and Plot 12 displayed a noticeable decrease. Actually, a 52% reduction in bulrush density was observed in Plot 12 where the initial monitoring contained bulrush densities near 28 stems/m<sup>2</sup> and the last monitoring date contained bulrush densities of slightly more than 13 stems/m<sup>2</sup>. It is important to note that between July and August 2006 in this plot, the bulrush density increased from around 20 to 33 stems/m<sup>2</sup> (65% increase). It is not known if the data suggests a dynamic bulrush population or is simply responding to differences in the randomly generated plots.
