Presque Isle Wilderness Waters Program

Aquatic Plant Management Plan – Armour Lake

Cite as: Premo, Dean, Angie Stine, and Kent Premo. 2021. Presque Isle Wilderness Waters Program: Armour Lake Aquatic Plant Management Plan. White Water Associates, Inc.

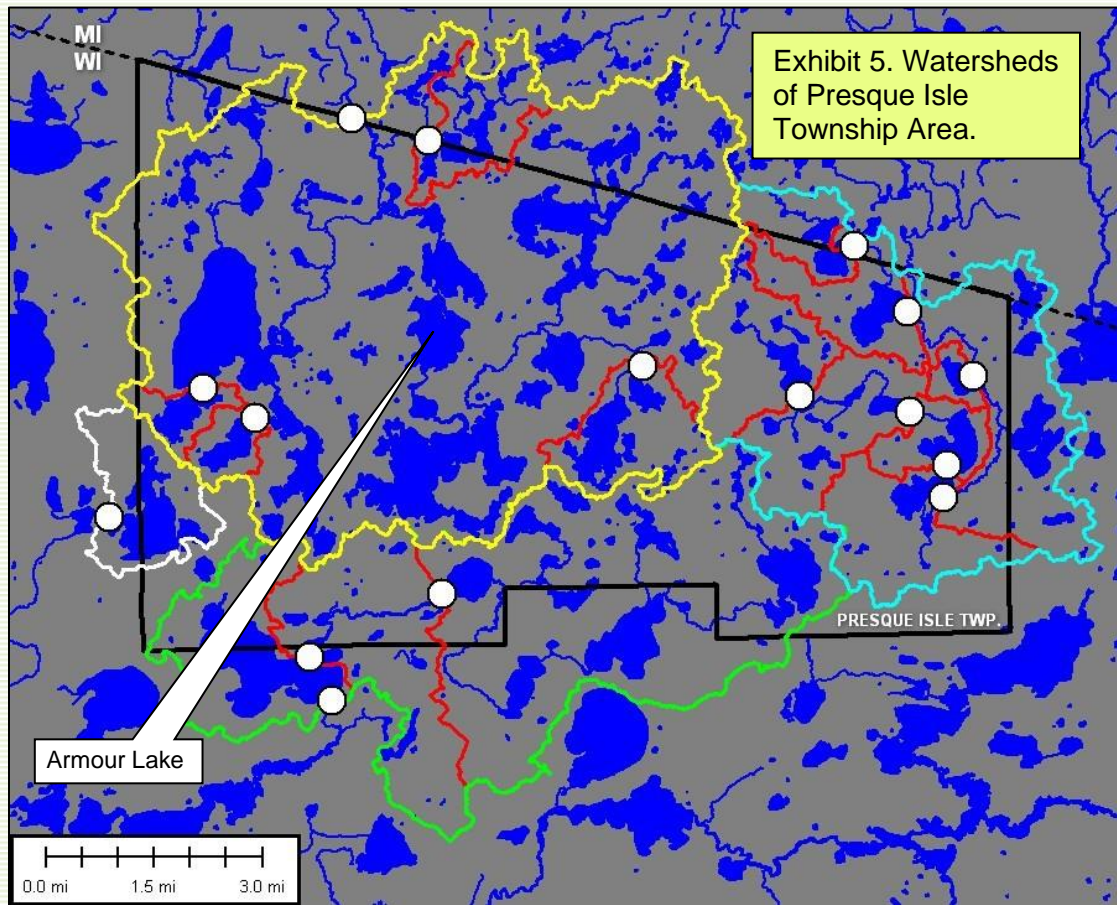
The Presque Isle Township waterscape sits on a large-scale watershed divide. Some of the water drains north through the Presque Isle River system and eventually enters Lake Superior. Some of the water drains into the Flambeau River system to the Mississippi River and to the Gulf of Mexico. In fact there are two federal hydrologic sub-basins (designated by 8-digit HUC codes) that include Presque Isle Township. The Black-Presque Isle Rivers sub-basin (HUC#04020101) drains north to Lake Superior and the Flambeau River sub-basin (HUC#0705002) drains southwesterly to the Mississippi River. The Black-Presque Isle Rivers sub-basin contains two federal hydrologic sub-watersheds within Presque Isle Township: the South Branch Presque Isle River sub-watershed (HUC#040201010303) and the Pomeroy Creek-East Branch Presque Isle River sub-watershed (HUC#040201010301). The Flambeau River sub-basin contains one sub-watershed within Presque Isle Township: the Rice Creek sub-watershed (HUC#07050020103). Exhibit 5 illustrates these watersheds and the watersheds of the water bodies subject to the Wilderness Waters Program studies. Armour Lake is contained within the South Branch Presque Isle River sub-watershed (Exhibit 5).

Description: Portions of 3 federal hydrologic sub-watersheds are illustrated: (1) S.Br. Presque Isle River (bounded by yellow), (2) Pomeroy Cr-E.Br. Presque Isle River (bounded by blue and yellow), and (3) Rice Cr. (bounded by green, yellow, and blue). Also shown are the smaller watersheds of individual water bodies subject to the Wilderness Waters studies (bounded by red and, in the case of Papoose Lake, bounded by white). White dots show outlet points for the smaller watersheds.

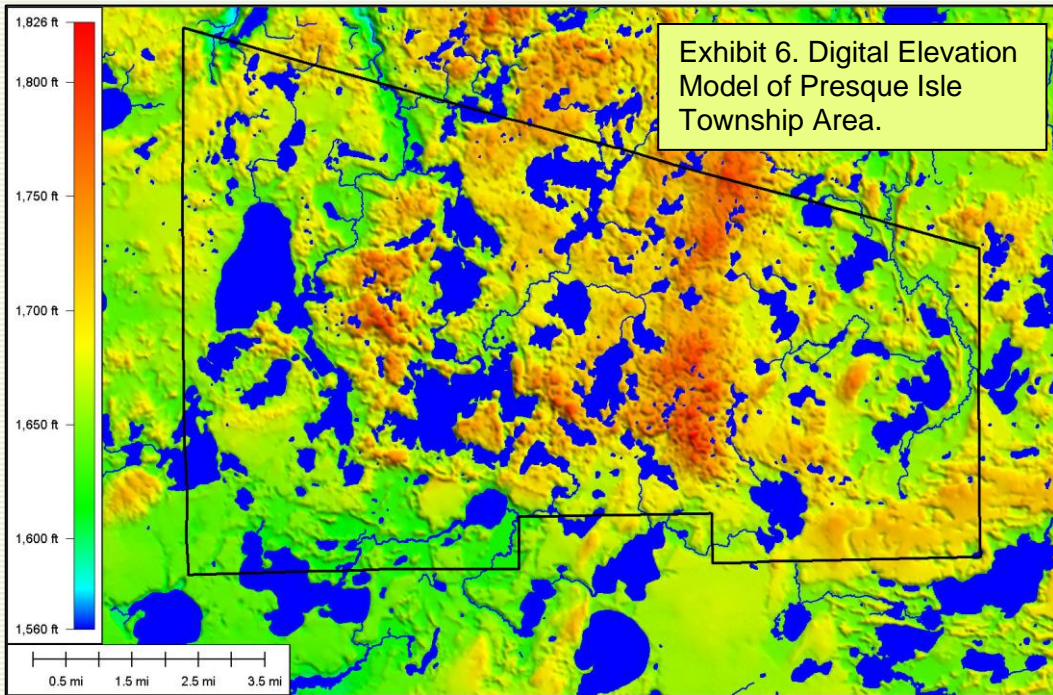
The elevation in Presque Isle Township ranges from around 1,550 feet above sea level to 1,750 feet above sea level. A digital elevation model is provided as Exhibit 6 and shows the relative elevations for the area with orange areas of the landscape being the highest elevations and greens and blues being the lowest elevations.

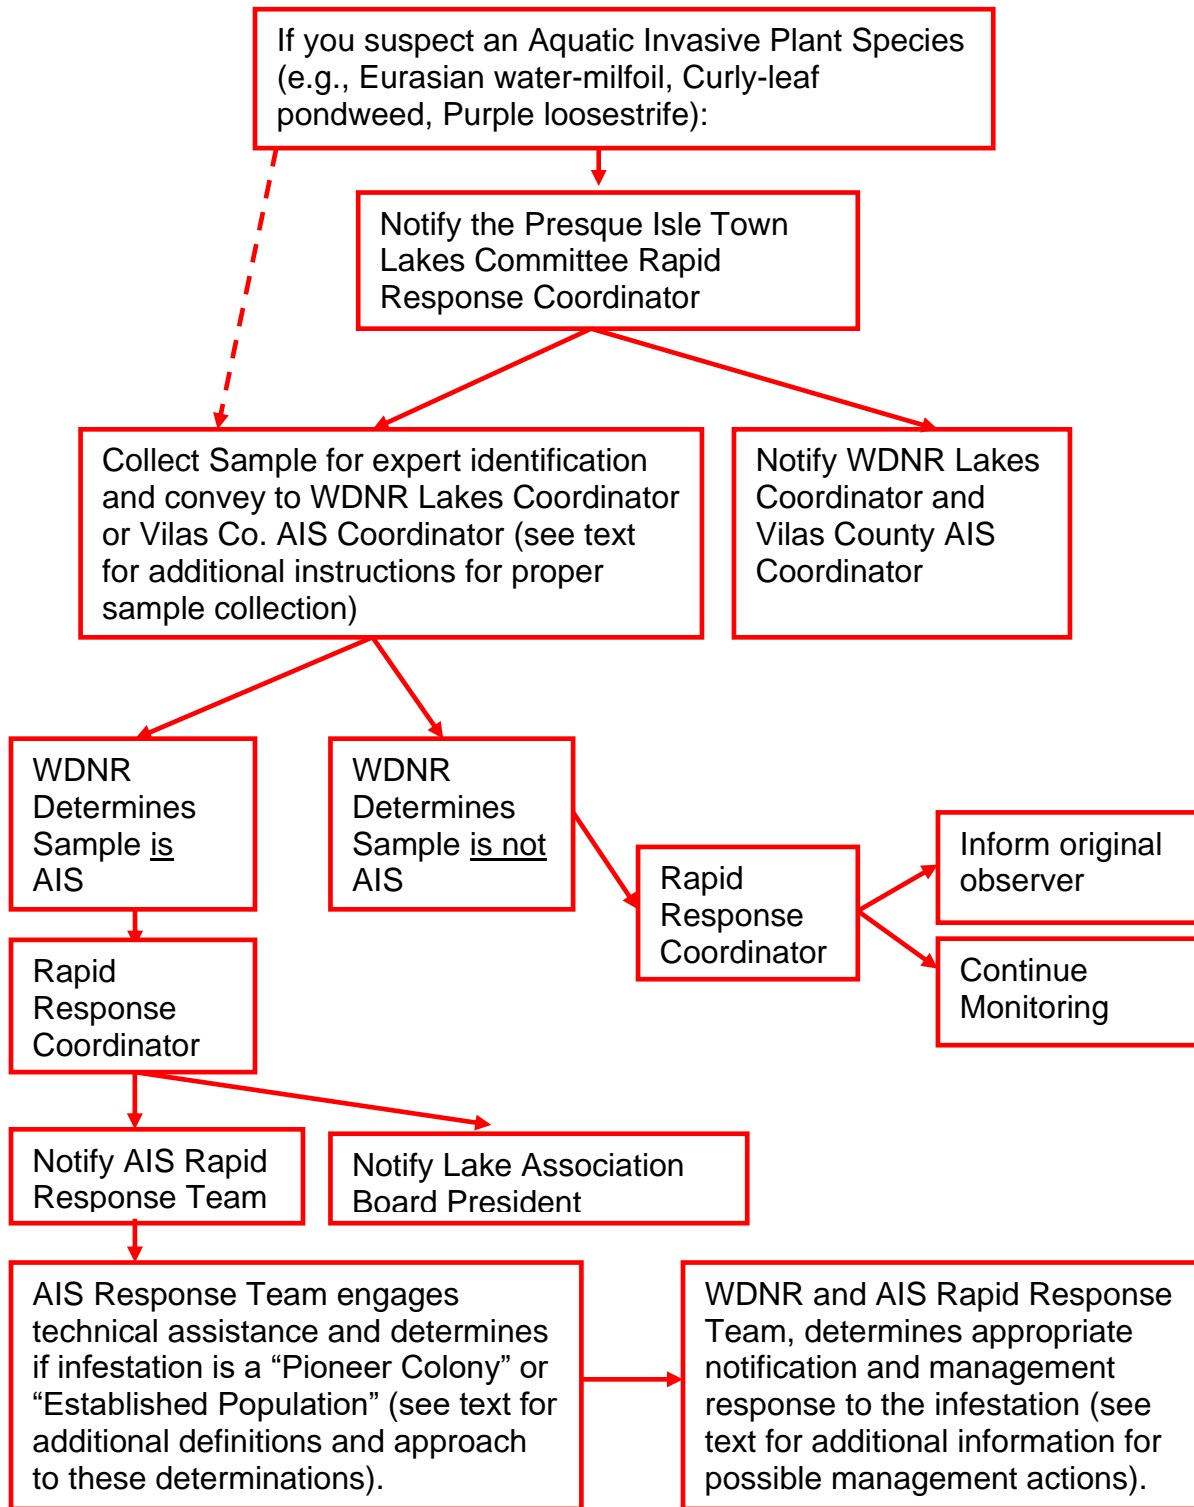
Exhibit 8. Aquatic Invasive Plant Species Rapid Response

When a suspect aquatic invasive plant species is found, either the original observer or a member of the Rapid Response Team (likely the coordinator) should collect an entire plant

specimen including roots, stems, and flowers (if present). The sample should be placed in a sealable bag with a small amount of water to keep it moist. Place a label in the bag written in pencil with date, time, collector's name, lake name, location, town, and county. Attach a lake map to the bag that has the location of the suspect AIS marked and GPS coordinates recorded (if GPS is available). The sample should be placed on ice in a cooler or in a refrigerator. Deliver the sample to the WDNR Water Resource Management Specialist (Kevin Gauthier in Woodruff) or the Vilas County AIS Coordinator as soon as possible (at least within three days). The WDNR or their botanical expert(s) will determine the species and confirm whether or not it is an aquatic invasive plant species.

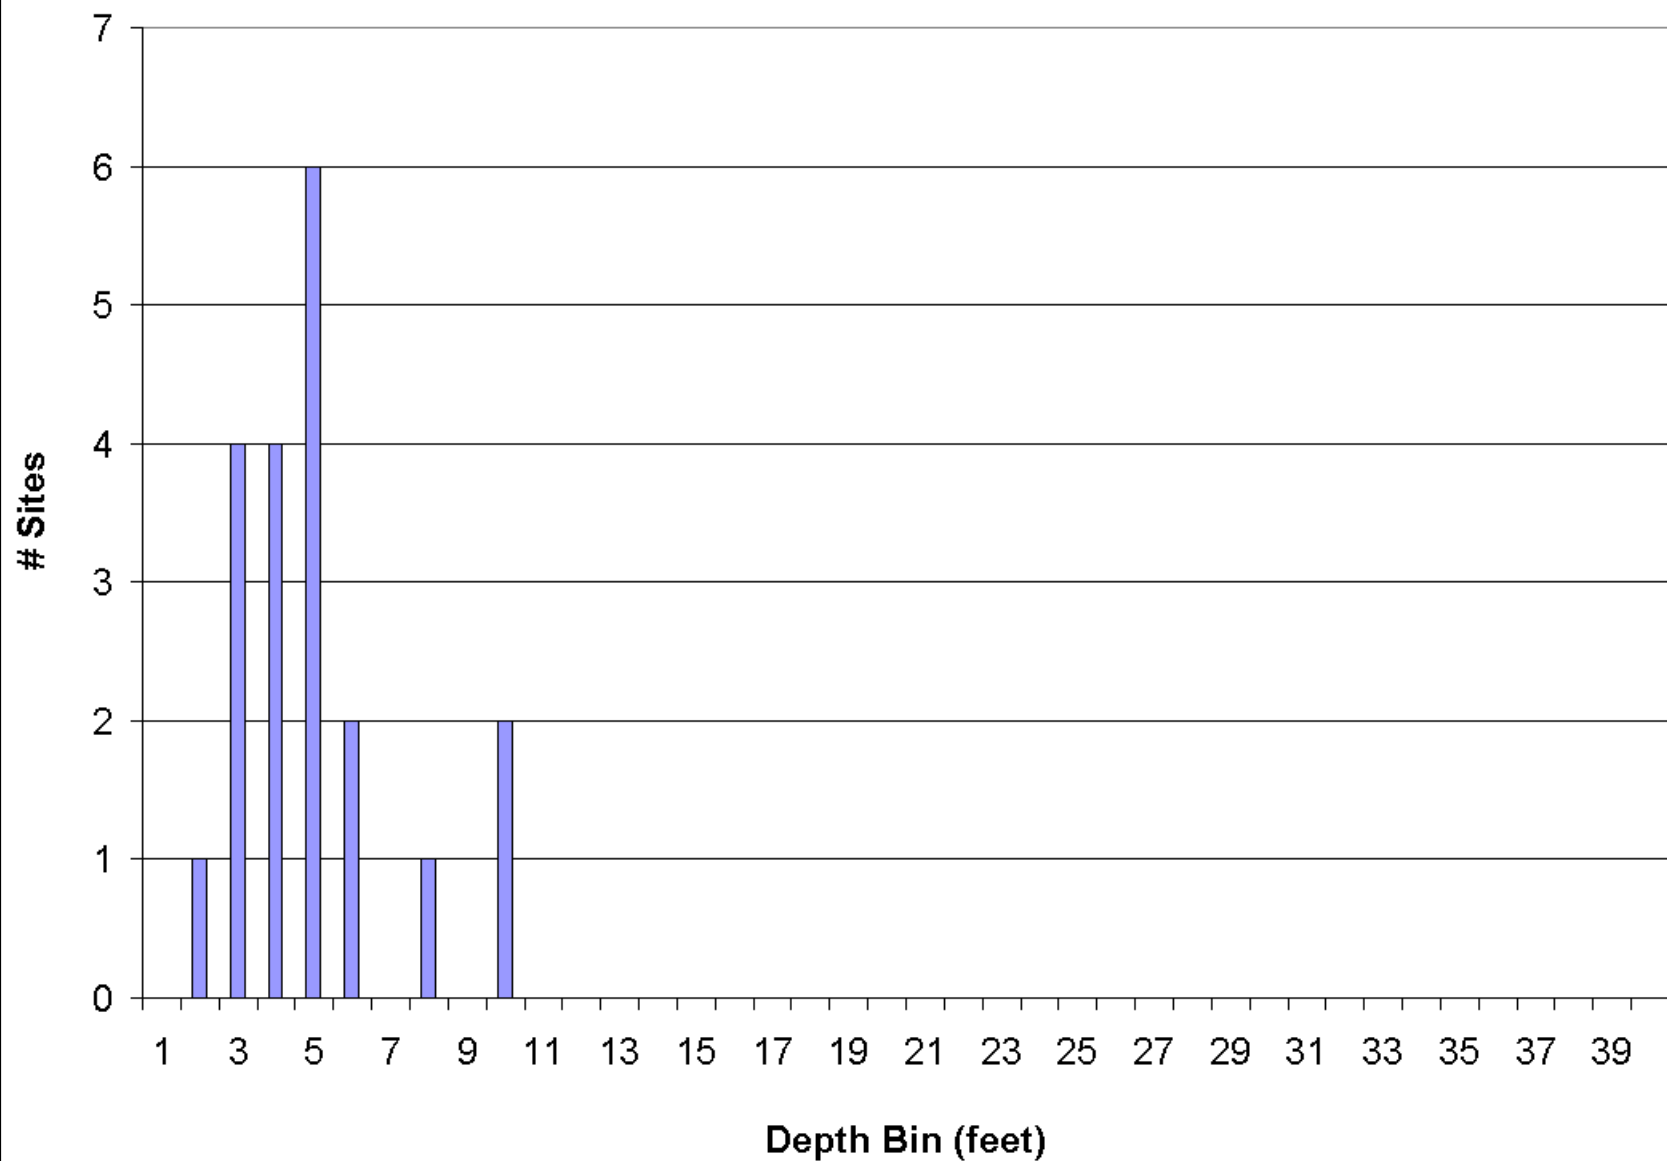
**Figure 3. Maximum Depth of Plant Colonization,
Armour Lake, 2020**

The maximum depth of plant colonization is 10.0 feet (Table 1 and Figure 3). Rooted vegetation was found at 20 of the 125 sample sites with depth \leq the maximum depth of plant colonization (16.00 % of sites). These sites are displayed as a black dot within a circle on Figure 4. This indicates that although availability of appropriate depth may limit the distribution of

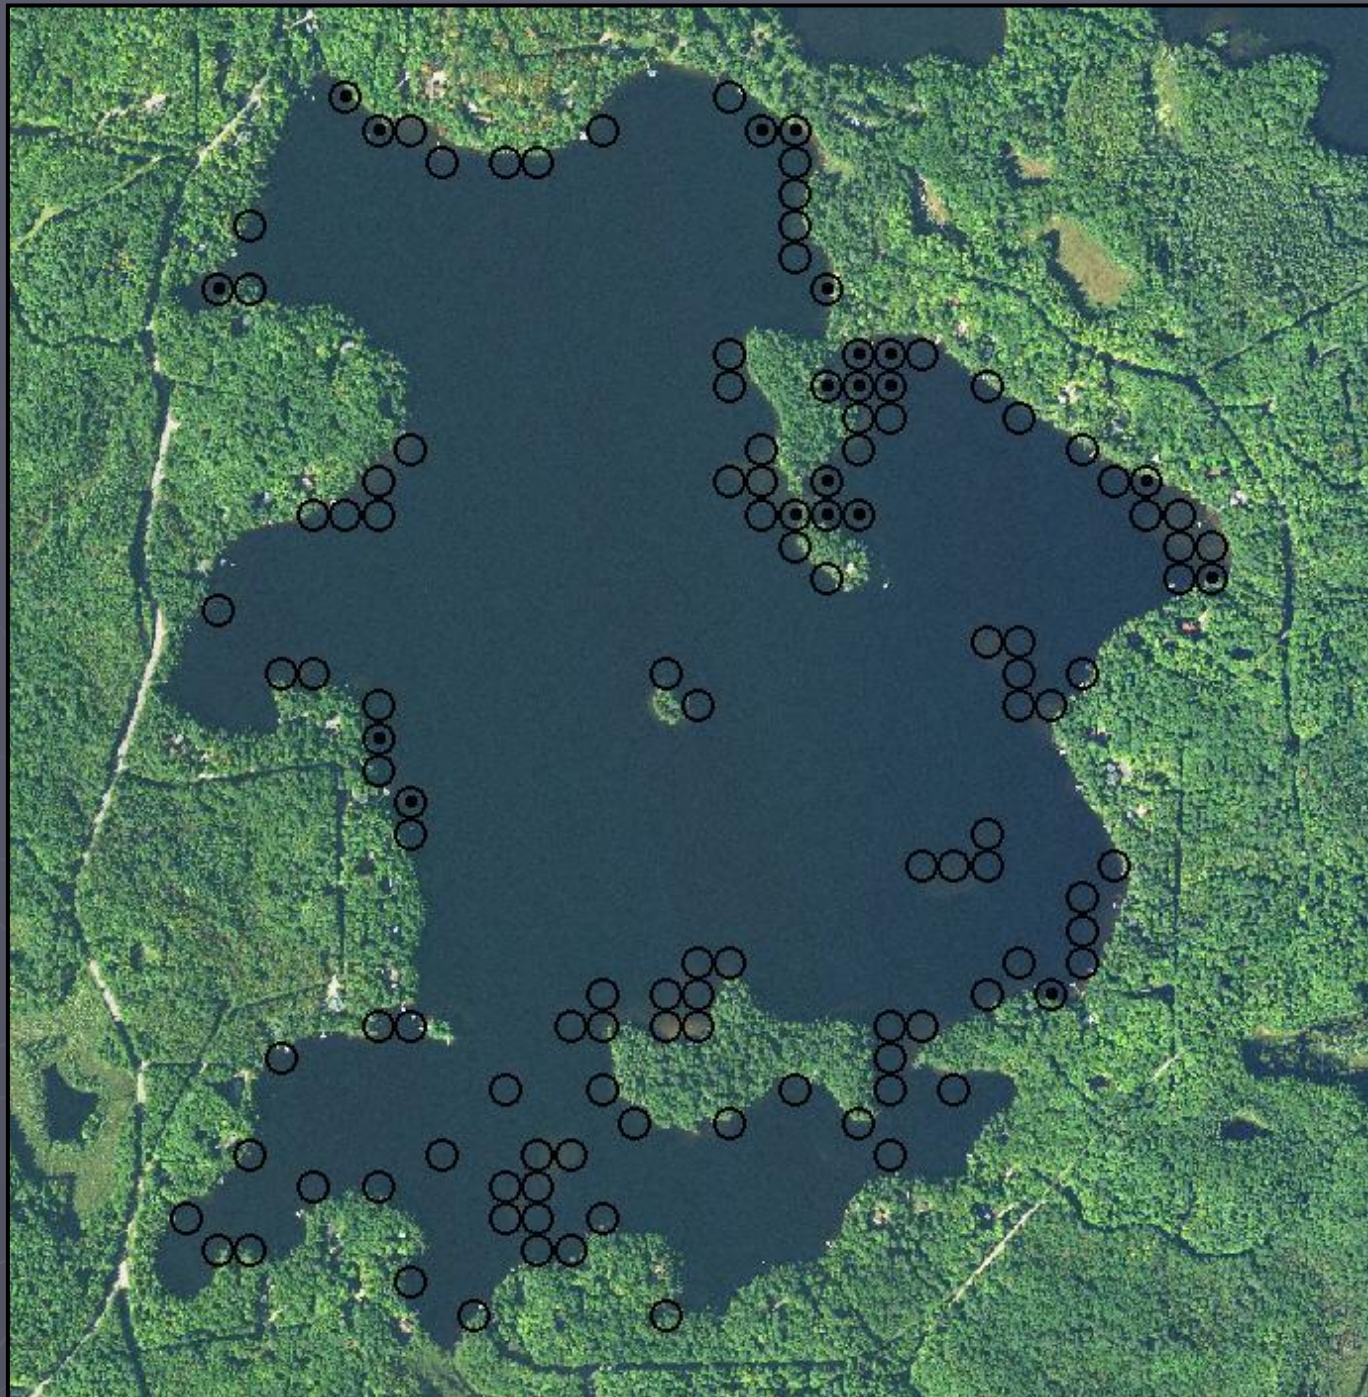
Figure 4. Armour Lake sampling sites less than or equal to maximum depth of rooted vegetation (2020).

- Site less than or equal to maximum depth of plant colonization (MDC).
- Plant find(s) at site less than or equal to MDC.

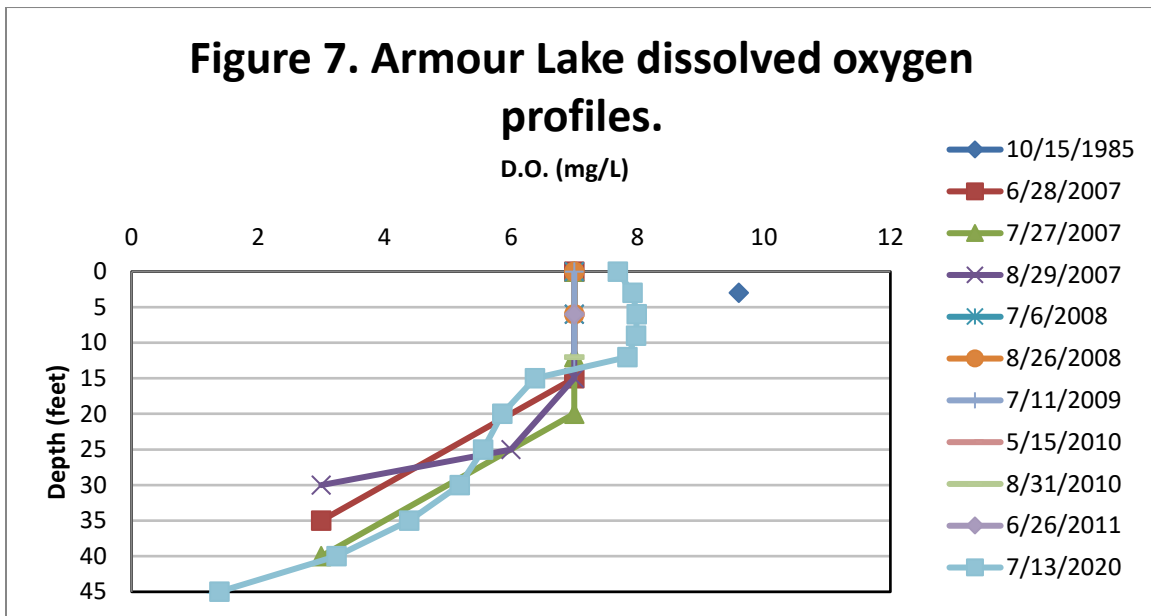
July, D.O. levels were 7.0 mg/L from the surface to 20 feet deep (Figure 7). In October, 1985 the surface D.O. was 9.6 mg/L. At depths below 30 feet, the D.O. levels decreased to around 3 mg/L.

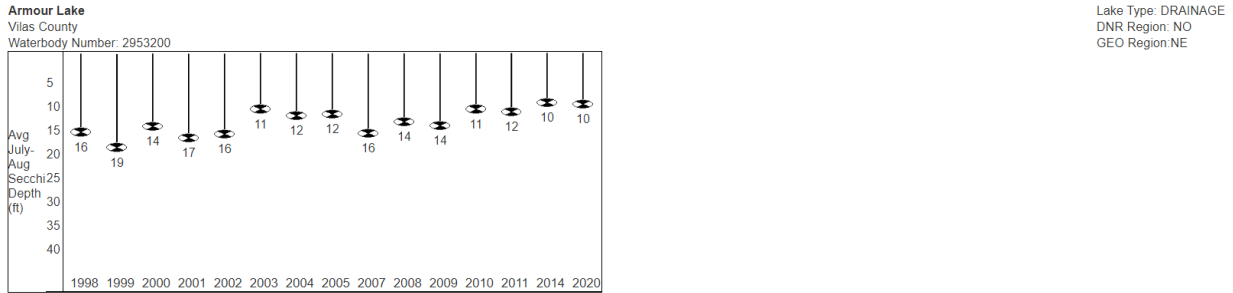
Figure 8. Armour Lake Secchi depth averages (July and August only).

Past secchi averages in feet (July and August only).

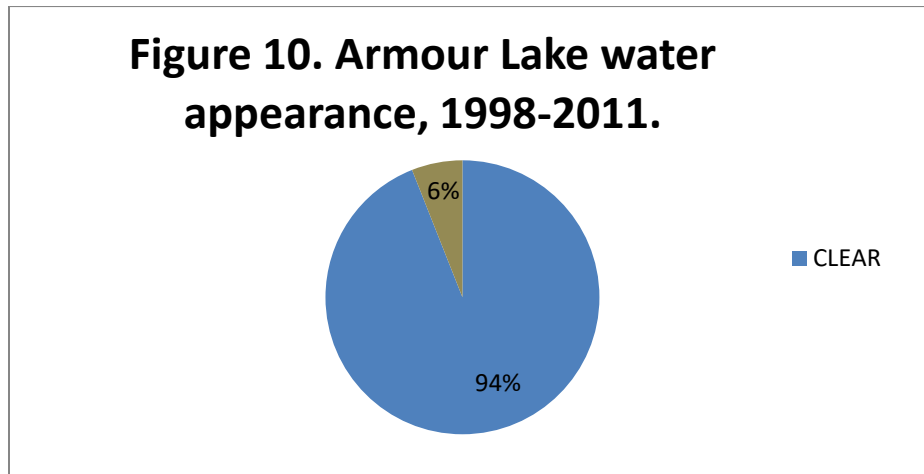
While checking Secchi depths, the CLMN volunteers also provided their perception of the water clarity and describe the water as “clear” or “murky.” From 1998 to 2011, 94% of volunteers rated the water in Armour Lake as “clear” (Figure 10).

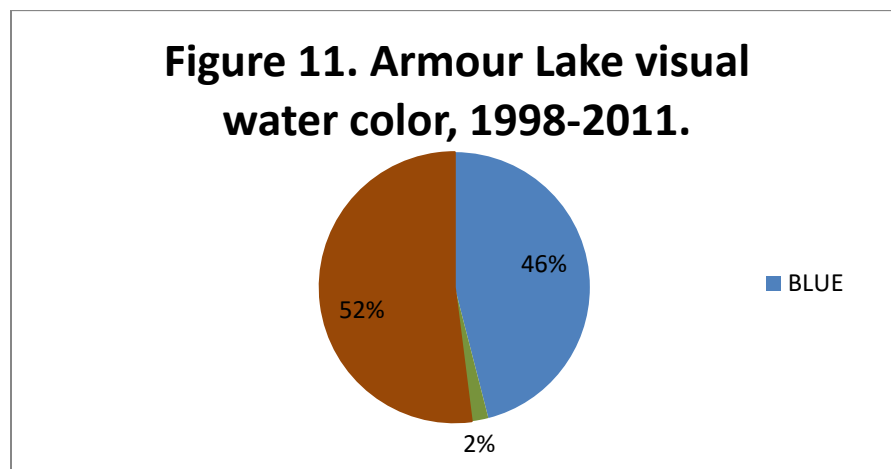
Color of lake water is related to the type and amount of dissolved organic chemicals. Its main significance is aesthetics, although it may also influence light penetration and in turn affect aquatic plant and algal growth. Many lakes have naturally occurring color compounds from decomposition of plant material in the watershed (Shaw et al., 2004). Units of color are determined from the platinum-cobalt scale and are therefore recorded as Pt-Co units. Shaw states that a water color between 0 and 40 Pt-Co units is low. Armour Lake was analyzed for color level on October 15, 1985 and had a value of 30 Pt-Co. Water color was last tested in 1985 and new samples should be collected. The CLMN also recorded their opinions of water color in Armour Lake. Since 1998, 52% indicated the water appeared “brown”, 46% thought it appeared “blue”, and 2% said “green” (Figure 11).

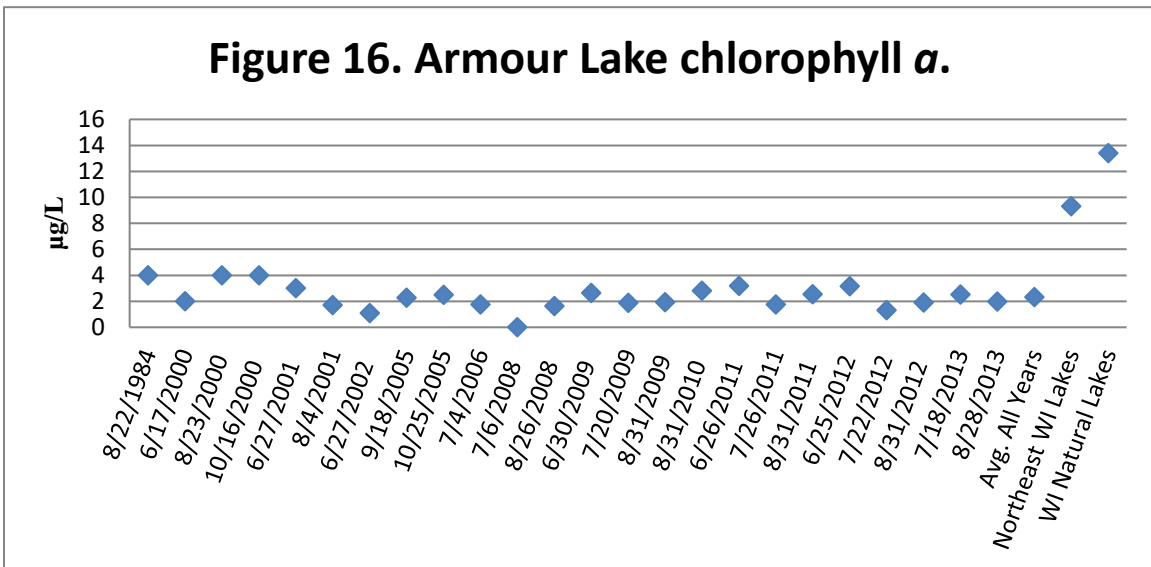
Figure 16. Armour Lake chlorophyll *a*.

Chlorophyll *a* is the photosynthetic pigment that makes plants and algae green. Chlorophyll *a* in lake water is therefore an indicator of the amount of algae. Chlorophyll *a* concentrations greater than 10 µg/L are perceived as a mild algae bloom, while concentrations greater than 20 µg/L are perceived as a nuisance. Chlorophyll *a* values in Armour Lake were well below nuisance levels and the average levels for Wisconsin natural lakes (Figure 16).

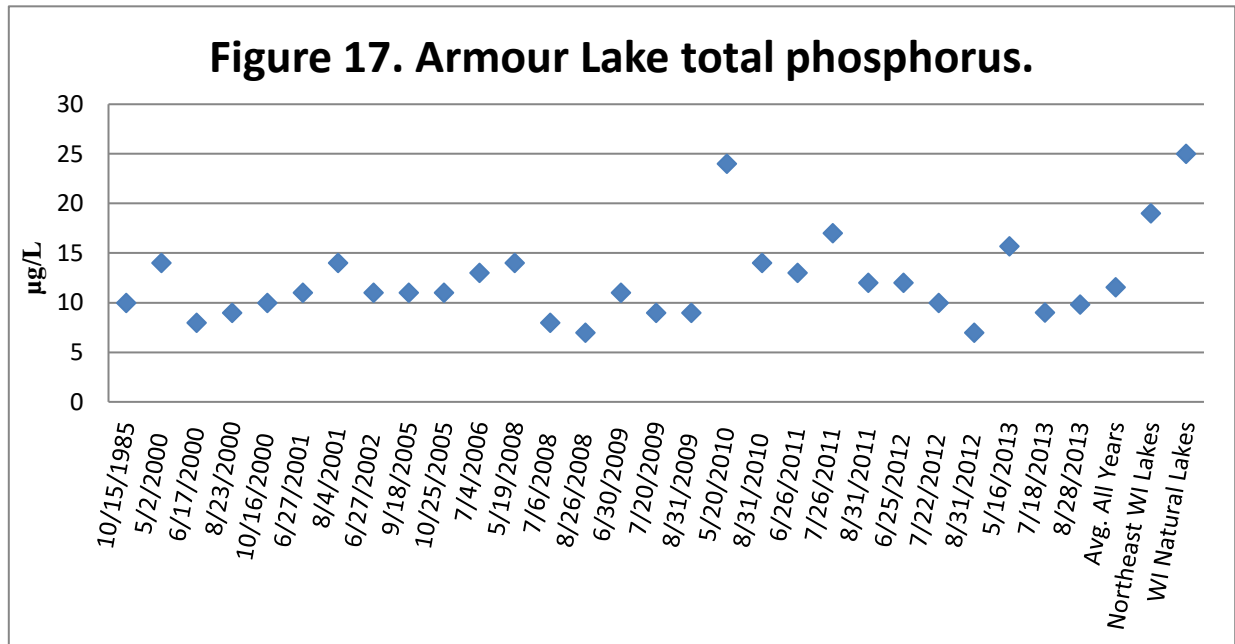
Since 1985, Armour Lake's total phosphorus levels averaged 11.56 µg/L. This is lower than northeast Wisconsin lakes and all Wisconsin natural lakes numbers (Figure 17). Only in May, 2010 was the total phosphorus level above 20 µg/L (24 µg/L). According to Figure 18, Armour Lake's average total phosphorus is classified as "very good," with respect to total phosphorus.

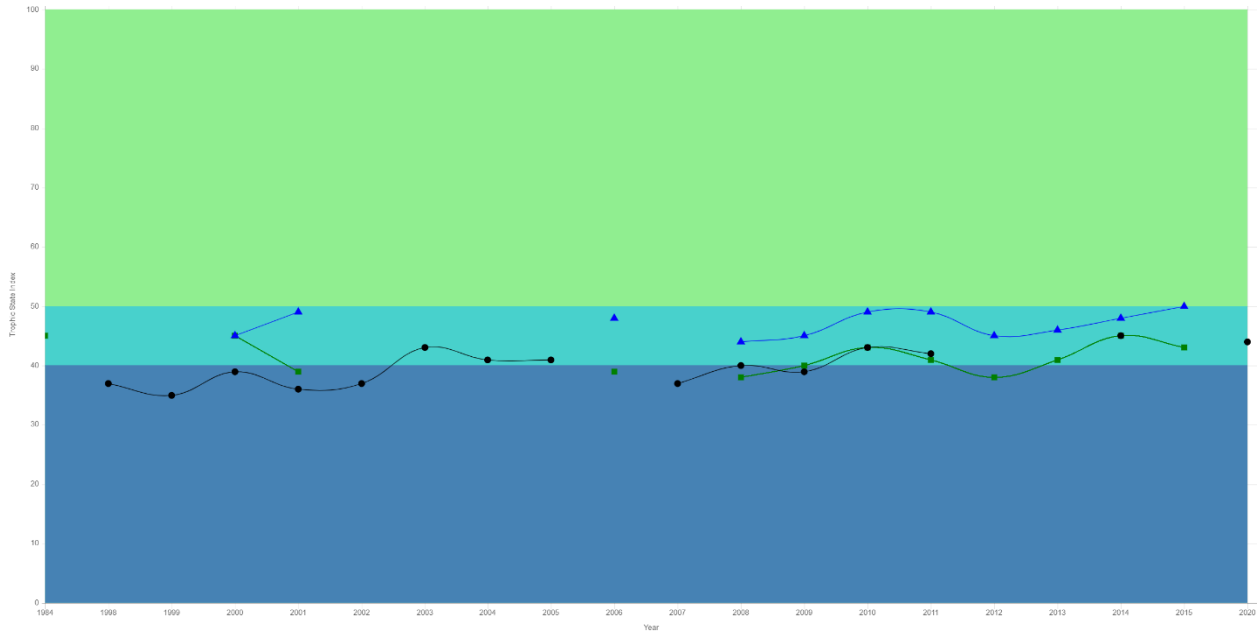
Figure 19. Armour Lake Trophic State Index (1984, 1998-2020).

Trophic state is another indicator of water quality (Carlson, 1977). Lakes can be divided into three categories based on trophic state – oligotrophic, mesotrophic, and eutrophic. These categories reflect a lake’s nutrient and clarity levels (Shaw et al., 2004).

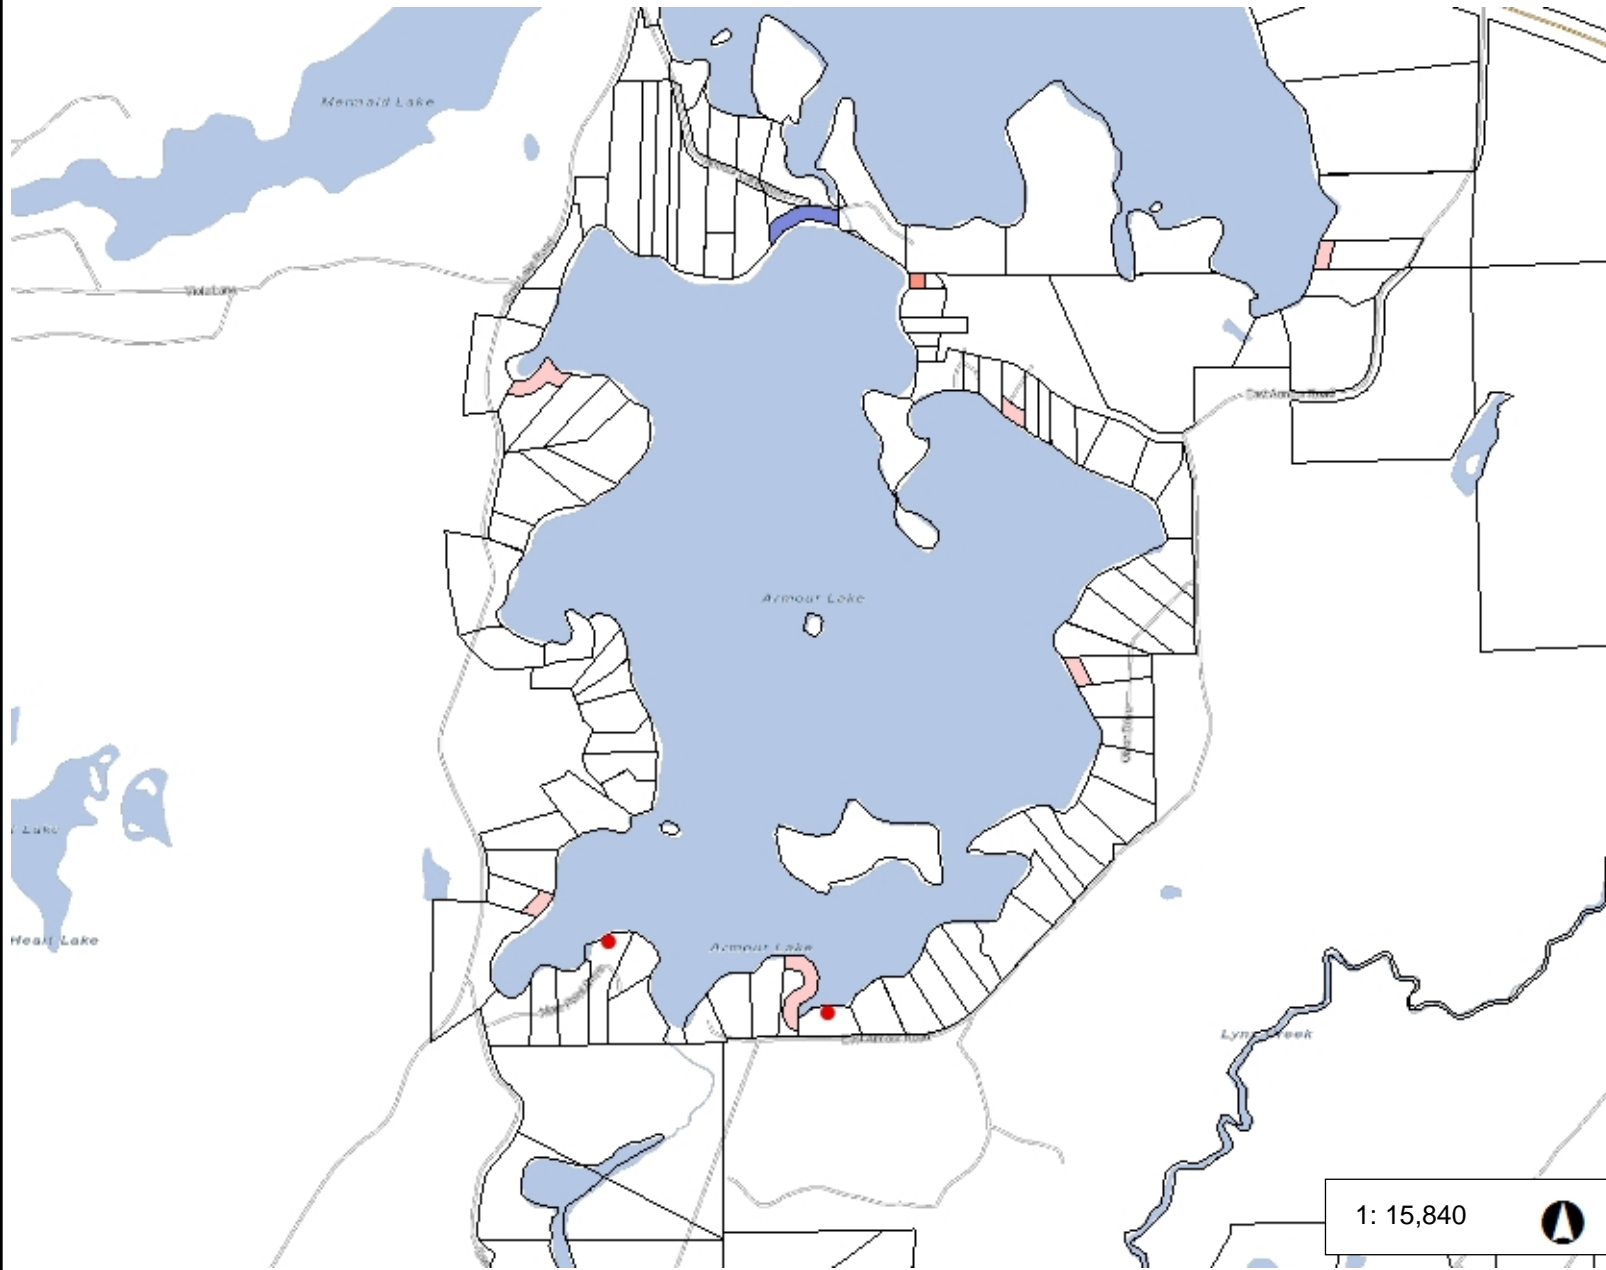
Exhibit 9. Armour Lake Bank Erosion and Modifications - 2020

- Bank Erosion >1ft
- Bank Erosion <1ft
- Vertical Sea Wall**
 - 1 - 50 ft
 - 51 - 100 ft
 - 101 - 200 ft
 - 200 + ft
- Rip Rap**
 - 1 - 50 ft
 - 51 - 100 ft
 - 101 - 200 ft
 - 200+ ft
- Other Bank Modifications**
 - 10 - 50 ft
 - 51 - 100 ft
 - 101 - 200 ft
 - 200+ ft
- Artificial Beach**
 - 0 - 50 ft
 - 51 - 100 ft
 - 101 - 200 ft
 - 200+ ft
- Shoreland Parcels
- County Boundary
- Municipality
- State Boundaries

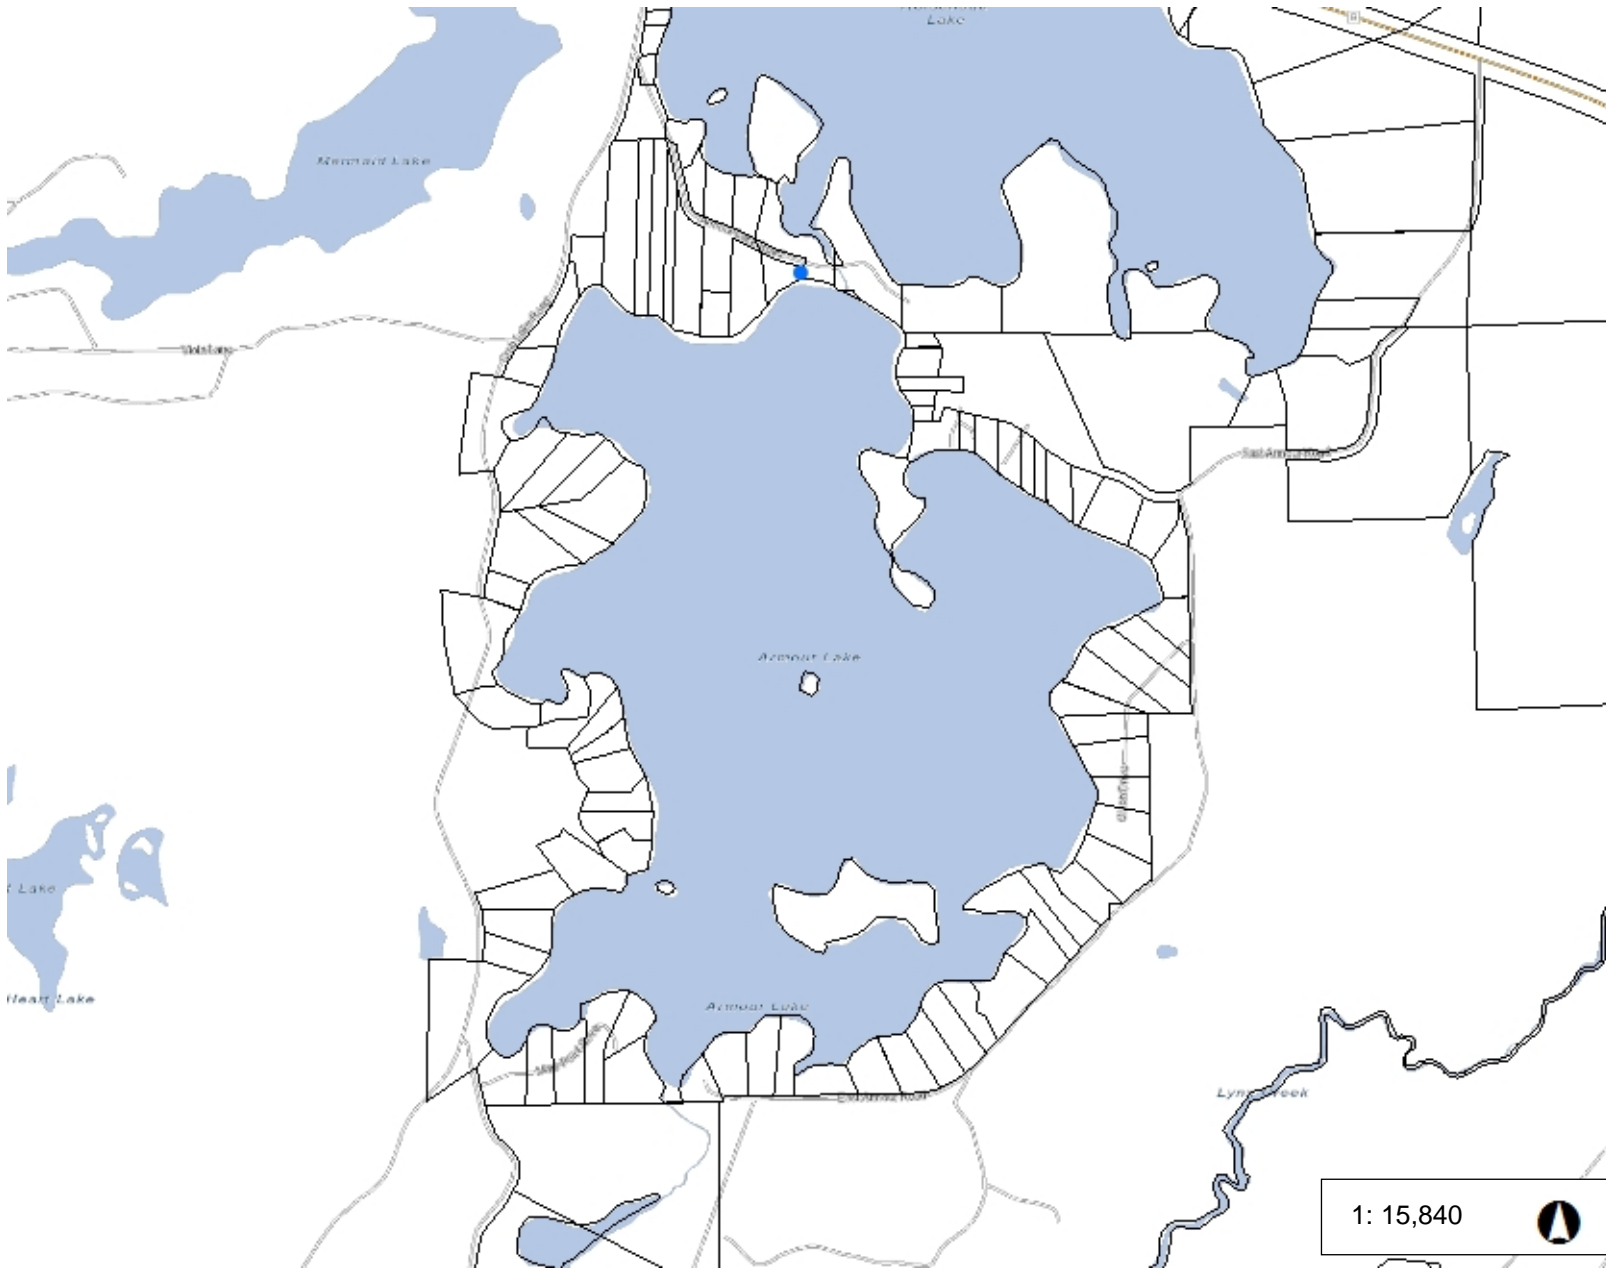
Exhibit 10. Armour Lake Runoff Concerns - 2020

- Channelized Flow
- Point Source
- Shoreland Parcels
- County Boundary
- Municipality
- State Boundaries
- County Boundaries

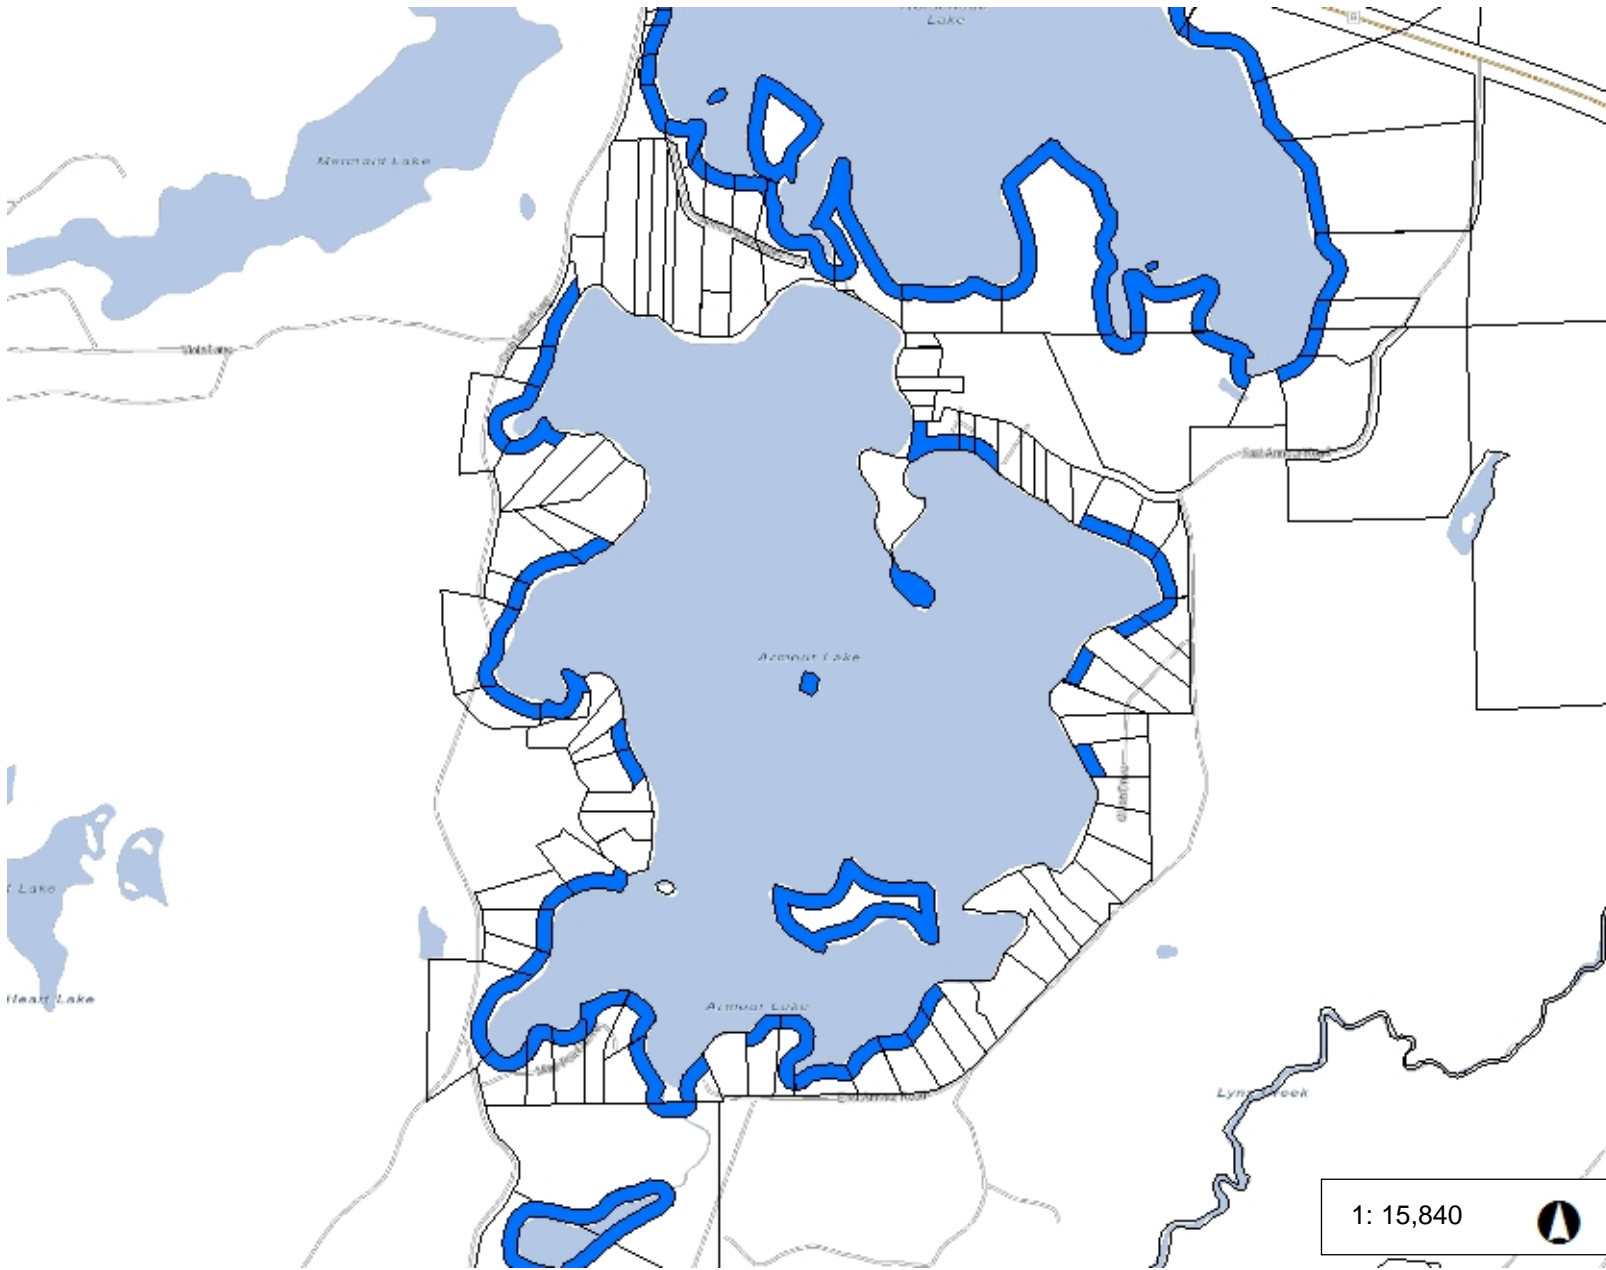
Exhibit 11. Armour Lake Littoral Zone - Aquatic Plants - 2020

- Aquatic Plant Removal
- Floating & Emergent Plants
- Emergent Plants
- Floating Plants
- Shoreland Parcels
- County Boundary
- Municipality
- State Boundaries
- County Boundaries
- Major Roads**
 - Interstate Highway
 - State Highway
 - US Highway
- County and Local Roads**
 - County HWY
 - Local Road
- Railroads
- Tribal Lands
- Rivers and Streams
- Intermittent Streams
- Open Water
- Great Lakes

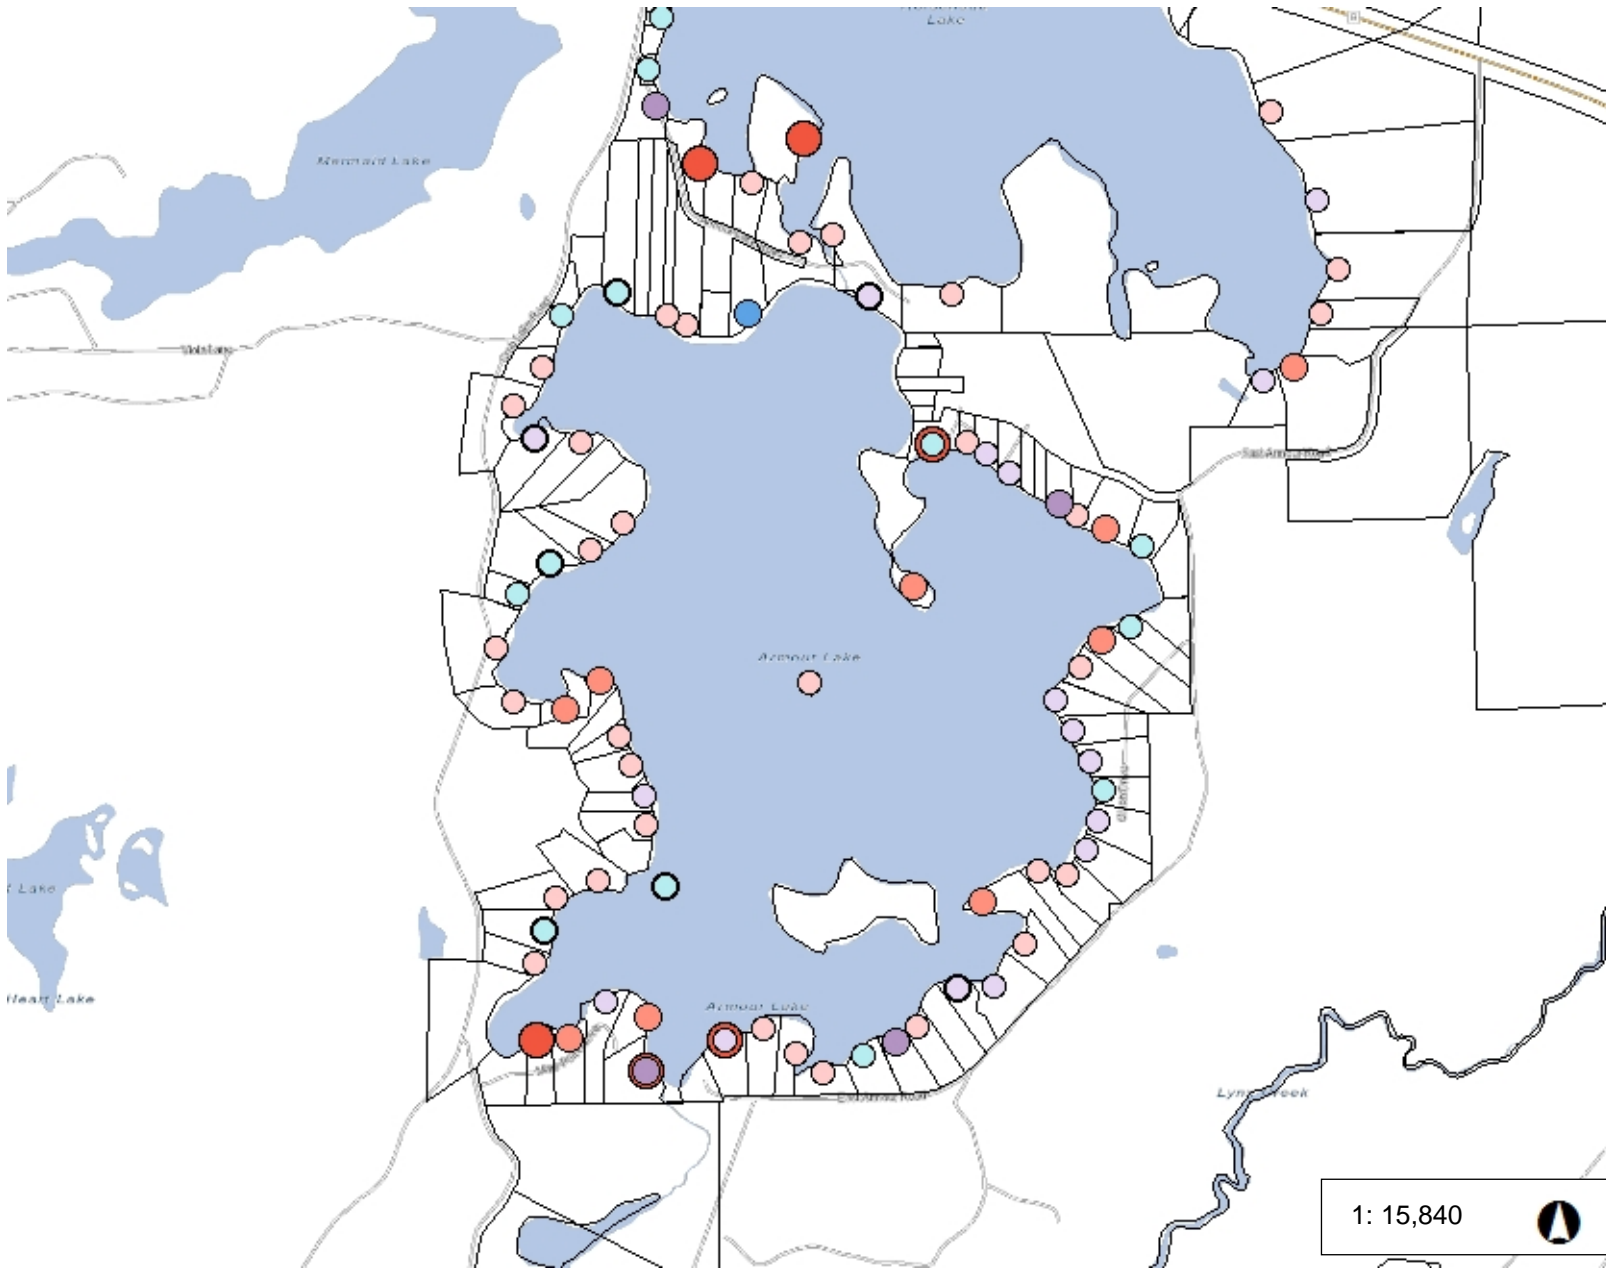
Exhibit 12. Armour Lake Littoral Zone - Human Structures - 2020

- Swim Rafts**
 - 1 (light blue circle)
 - 2 (medium blue circle)
 - 3-5 (dark blue circle)
 - 6+ (darkest blue circle)
- Boat Lifts**
 - 1 (light purple circle)
 - 2 (medium purple circle)
 - 3-5 (dark purple circle)
 - 6+ (darkest purple circle)
- Piers**
 - 1 (light pink circle)
 - 2 (medium pink circle)
 - 3-5 (dark pink circle)
 - 6+ (red circle)
- Boat Houses**
 - 1 (light orange circle)
 - 2 (medium orange circle)
 - 3-5 (dark orange circle)
 - 6+ (red-orange circle)
- Marinas**
 - 1 (light green circle)
 - 2 (medium green circle)
 - 3-5 (dark green circle)
 - 6+ (darkest green circle)
- Shoreland Parcels
